LOT 3 - Public Works Park West Picnic Shelters PEA

Preliminary Engineering Assessment (PEA) Pensacola Beach Park West Picnic Shelters

Pensacola Beach, Florida 32561

September 30, 2021

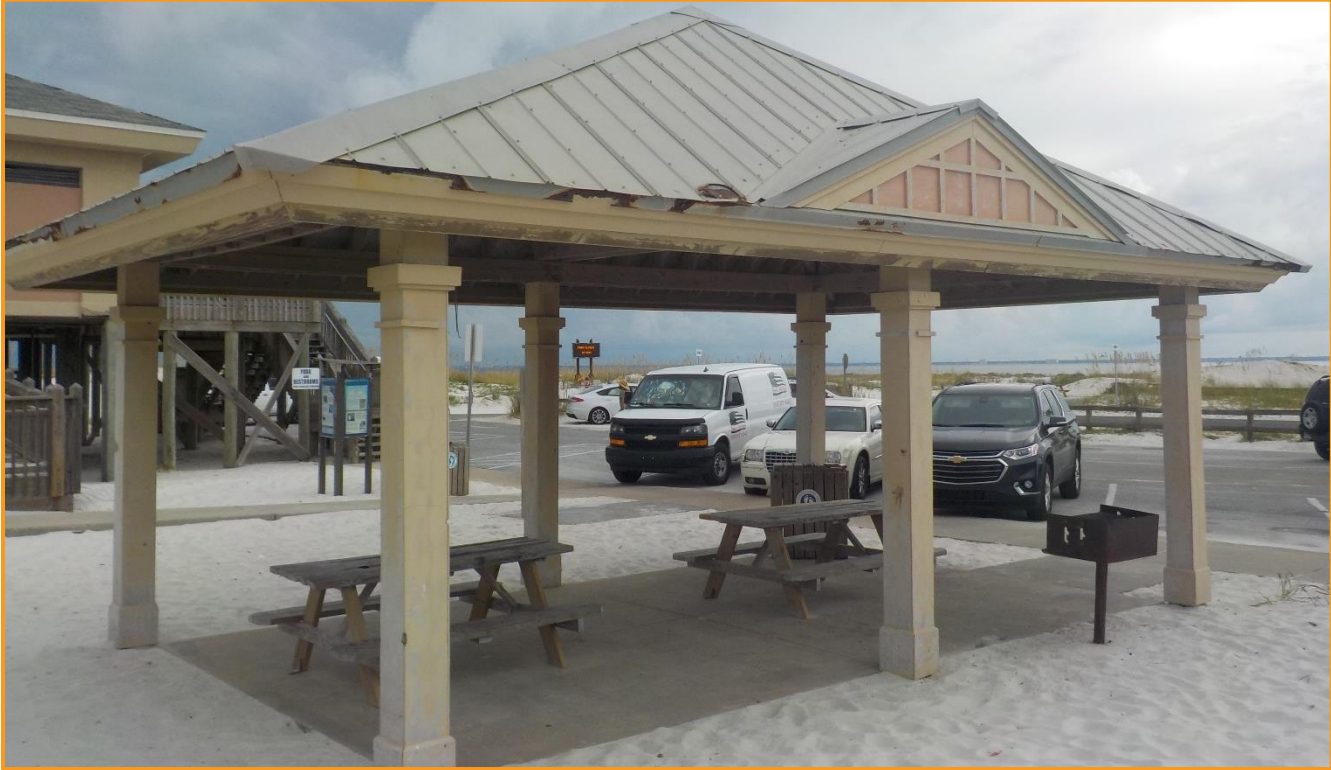
Figure 2.2.1.1

Damage to the Pensacola Beach Park West Picnic Shelters was caused by hurricane force winds and wind driven rain. It was observed that 102 of the 126 support columns onsite were affected by storm related damages. These damages include storm weathering, moisture staining, and damaged and/or missing fiber cement siding and trim. The number of columns and the degree to which each column was damaged varies from shelter to shelter. It was also noted that the paint color on every column had faded through time but is not related to any particular storm damages. It was noted that the lumber framing that makes up the structure of the roof had been damaged by the high winds whipping up sand and other forms of debris streaking the undersides of all twenty-one (21) picnic shelters roofs. Sand was found throughout the various components that comprise the roof structure. It was also observed that there was significant weathering damage to the fasciae and faux dormers of all twenty-one (21) picnic shelters. This includes a stripping of paint coverage, general fading due to storm related damages, and moisture staining especially on the faux dormers. At picnic shelters #2, #6, #7, #9, and #10, several portions of the metal roofing were observed to be loose and in need of repair. These repairs range from loose roofing panels to unsecured ridge caps. **Table 2.1** provides a detailed breakdown of all damaged components observed during the inspection.

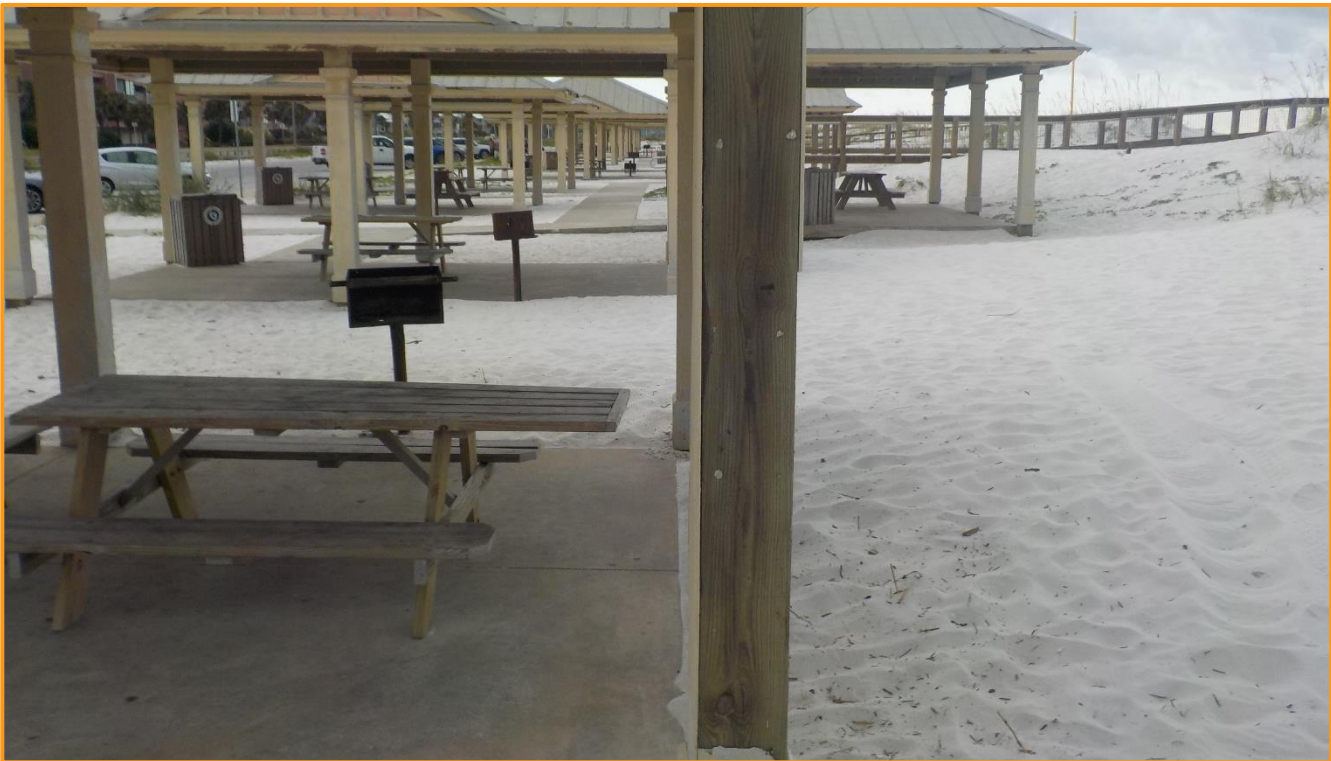
Location	Observed Damage	Condition Assessment Recommendations	Quantity	Reference Image
Picnic Shelter 1	Storm damage to exterior façade	Remove, Replace, and Repaint	532.25 SF of pressure washing underside of roof 16.6 LF of 1" x 4" fiber cement trim demolition 16.6 LF of 1" x 6" fiber cement trim demolition 16.6 LF of 1" x 12" fiber cement trim demolition 135 SF of vertical fiber cement siding demolition 135 SF of vertical fiber cement siding 16.6 LF of 1" x 4" fiber cement trim 16.6 LF of 1" x 6" fiber cement trim 16.6 LF of 1" x 12" fiber cement trim 203 SF of primer plus 2 coats of exterior latex paint on fiber cement column wraps 316 LF of primer plus 2 coats exterior paint on fascia 11 SF of paint plus waterproof sealer on lattice work	Figure 2.2.1.1
Picnic Shelter 2	Storm damage to exterior façade	Remove, Replace, and Repaint	532.25 SF of pressure washing underside of roof 19.92 LF of 1" x 4" fiber cement trim demolition 19.92 LF of 1" x 6" fiber cement trim demolition 19.92 LF of 1" x 12" fiber cement trim demolition 162 SF of vertical fiber cement siding demolition 162 SF of vertical fiber cement siding 19.92 LF of 1" x 4" fiber cement trim 19.92 LF of 1" x 6" fiber cement trim 19.92 LF of 1" x 12" fiber cement trim 244 SF of primer plus 2 coats exterior latex paint on fiber cement column wraps 316 LF of primer plus 2 coats exterior paint on fascia 11 SF of paint plus waterproof sealer on lattice work	Figure 2.2.1.2

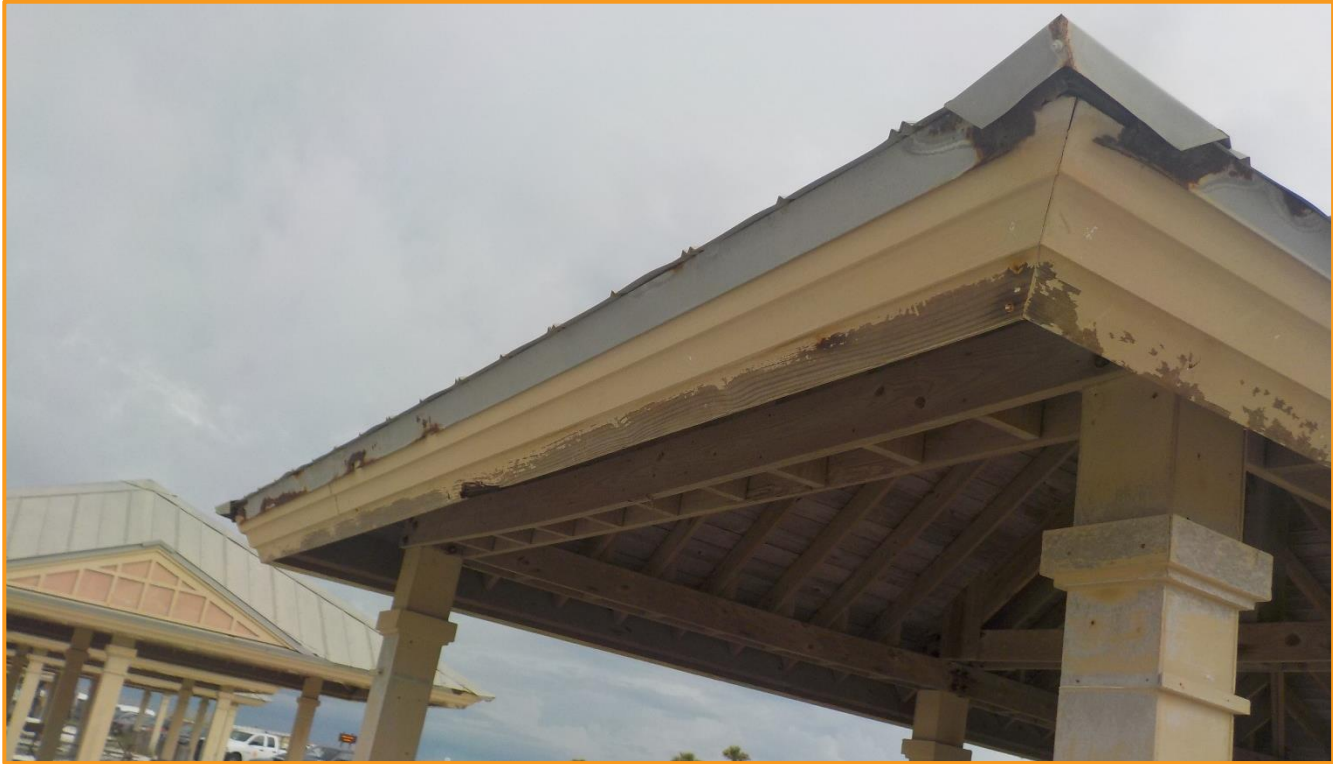
Location	Observed Damage	Condition Assessment Recommendations	Quantity	Reference Image
Picnic Shelter 8	Storm damage to exterior façade	Remove, Replace, and Repaint	532.25 SF of pressure washing underside of roof 19.92 LF of 1" x 4" fiber cement trim demolition 19.92 LF of 1" x 6" fiber cement trim demolition 19.92 LF of 1" x 12" fiber cement trim demolition 162 SF of vertical fiber cement siding demolition 162 SF of vertical fiber cement siding 19.92 LF of 1" x 4" fiber cement trim 19.92 LF of 1" x 6" fiber cement trim 19.92 LF of 1" x 12" fiber cement trim 244 SF of primer plus 2 coats exterior latex paint on fiber cement column wraps 316 LF of primer plus 2 coats exterior paint on fascia 11 SF of paint plus waterproof sealer on lattice work	Figure 2.2.1.4
Picnic Shelter 9	Storm damage to exterior façade	Remove, Replace, and Repaint	532.25 SF of pressure washing underside of roof 19.92 LF of 1" x 4" fiber cement trim demolition 19.92 LF of 1" x 6" fiber cement trim demolition 19.92 LF of 1" x 12" fiber cement trim demolition 162 SF of vertical fiber cement siding demolition 162 SF of vertical fiber cement siding 19.92 LF of 1" x 4" fiber cement trim 19.92 LF of 1" x 6" fiber cement trim 19.92 LF of 1" x 12" fiber cement trim 244 SF of primer plus 2 coats exterior latex paint on fiber cement column wraps 316 LF of primer plus 2 coats exterior paint on fascia 11 SF of paint plus waterproof sealer on lattice work	Figure 2.2.1.5 Figure 2.2.1.6

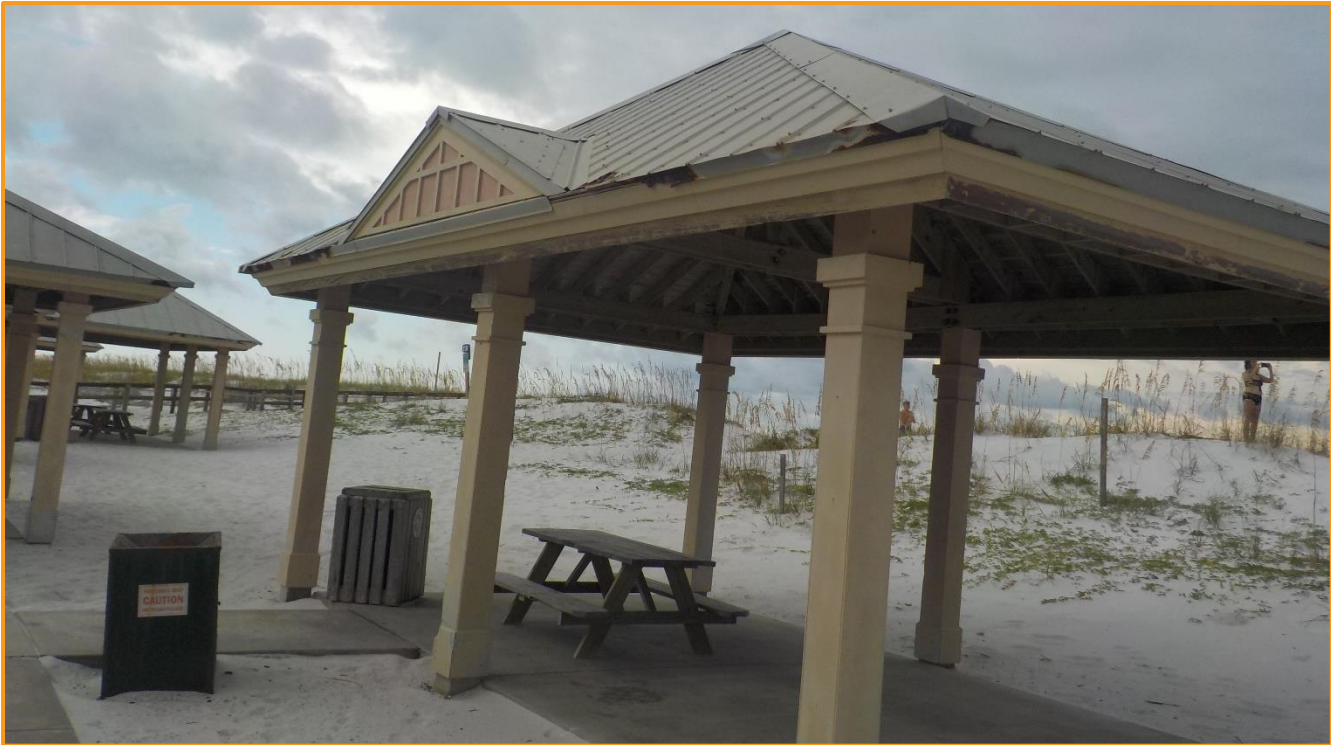
Picnic Shelter 13	Storm damage to exterior façade	Remove, Replace, and Repaint	532.25 SF of pressure washing underside of roof 13.33 LF of 1" x 4" fiber cement trim demolition 13.33 LF of 1" x 6" fiber cement trim demolition 13.33 LF of 1" x 12" fiber cement trim demolition 108 SF of vertical fiber cement siding demolition 108 SF of vertical fiber cement siding 13.33 LF of 1" x 4" fiber cement trim 13.33 LF of 1" x 6" fiber cement trim 13.33 LF of 1" x 12" fiber cement trim 163 SF of primer plus 2 coats of exterior latex paint on fiber cement column wraps 316 LF of primer plus 2 coats exterior paint on fascia 11 SF of paint plus waterproof sealer on lattice work	--
Picnic Shelter 14	Storm damage to exterior façade	Remove, Replace, and Repaint	532.25 SF of pressure washing underside of roof 13.33 LF of 1" x 4" fiber cement trim demolition 13.33 LF of 1" x 6" fiber cement trim demolition 13.33 LF of 1" x 12" fiber cement trim demolition 108 SF of vertical fiber cement siding demolition 108 SF of vertical fiber cement siding 13.33 LF of 1" x 4" fiber cement trim 13.33 LF of 1" x 6" fiber cement trim 13.33 LF of 1" x 12" fiber cement trim 163 SF of primer plus 2 coats of exterior latex paint on fiber cement column wraps 316 LF of primer plus 2 coats exterior paint on fascia 11 SF of paint plus waterproof sealer on lattice work	Figure 2.2.1.7

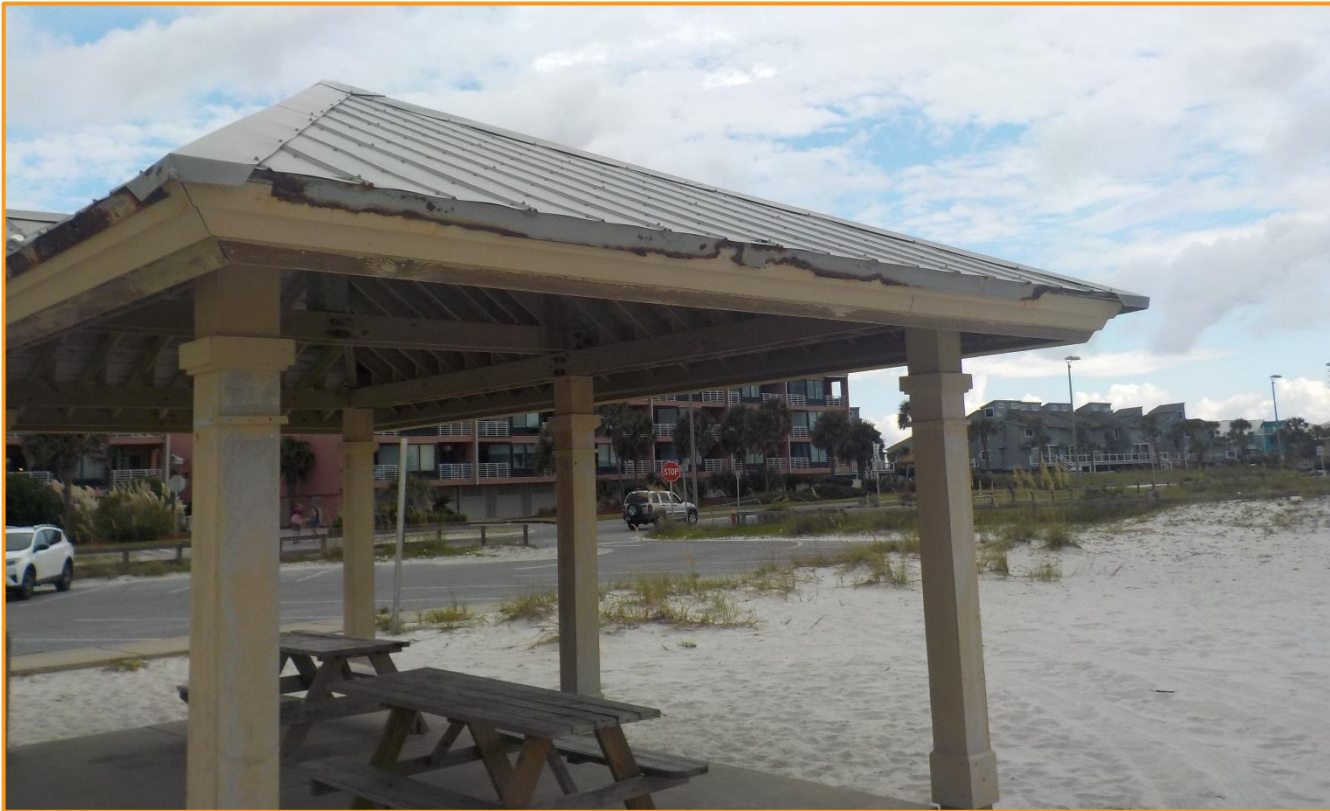
Picnic Shelter 21	Storm damage to exterior façade	Remove, Replace, and Repaint	532.25 SF of pressure washing underside of roof 13.33 LF of 1" x 4" fiber cement trim demolition 13.33 LF of 1" x 6" fiber cement trim demolition 13.33 LF of 1" x 12" fiber cement trim demolition 108 SF of vertical fiber cement siding demolition 108 SF of vertical fiber cement siding 13.33 LF of 1" x 4" fiber cement trim 13.33 LF of 1" x 6" fiber cement trim 13.33 LF of 1" x 12" fiber cement trim 163 SF of primer plus 2 coats of exterior latex paint on fiber cement column wraps 316 LF of primer plus 2 coats exterior paint on fascia 11 SF of paint plus waterproof sealer on lattice work	Figure 2.2.1.9
