TEST HOLE FORM

Project: M-0618-0201-D48S (N Ohio)	Prepared By: Bryson Ricks	Date: 2023-04-04
City: Arlington	State: VA	Test Hole: 1 of

General Location: N Ohio St

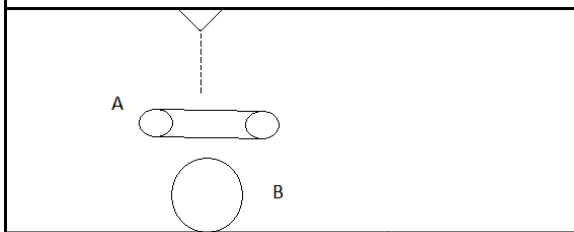
PROFILE VIEW

Utility Size: 4 1/2"	Material: Steel	Good Condition: YES
Utility Type: Communication Conduit		Utility Owner: ATT

Utility Size: 24"	Material: RCCP	See Test Hole No.:
Utility Type: Storm Line		Utility Owner:

Top of utility field measurement: A = 12.03' **Elevation:** A = 256.09'

Bottom of utility field measurement: B = 15.19' **Elevation:** B = 252.93'

Facing: East	Utility Width/Spacing:
---------------------	-------------------------------
