**NOTICE TO CONSULTANT ENGINEERS  
REGARDING A REQUEST FOR LETTERS OF INTEREST**

# Subsurface Exploration

Amherst Road  
Slope Stability Investigation  
Knoxville, Tennessee

5/10/2016  
FSE Project No. 315152

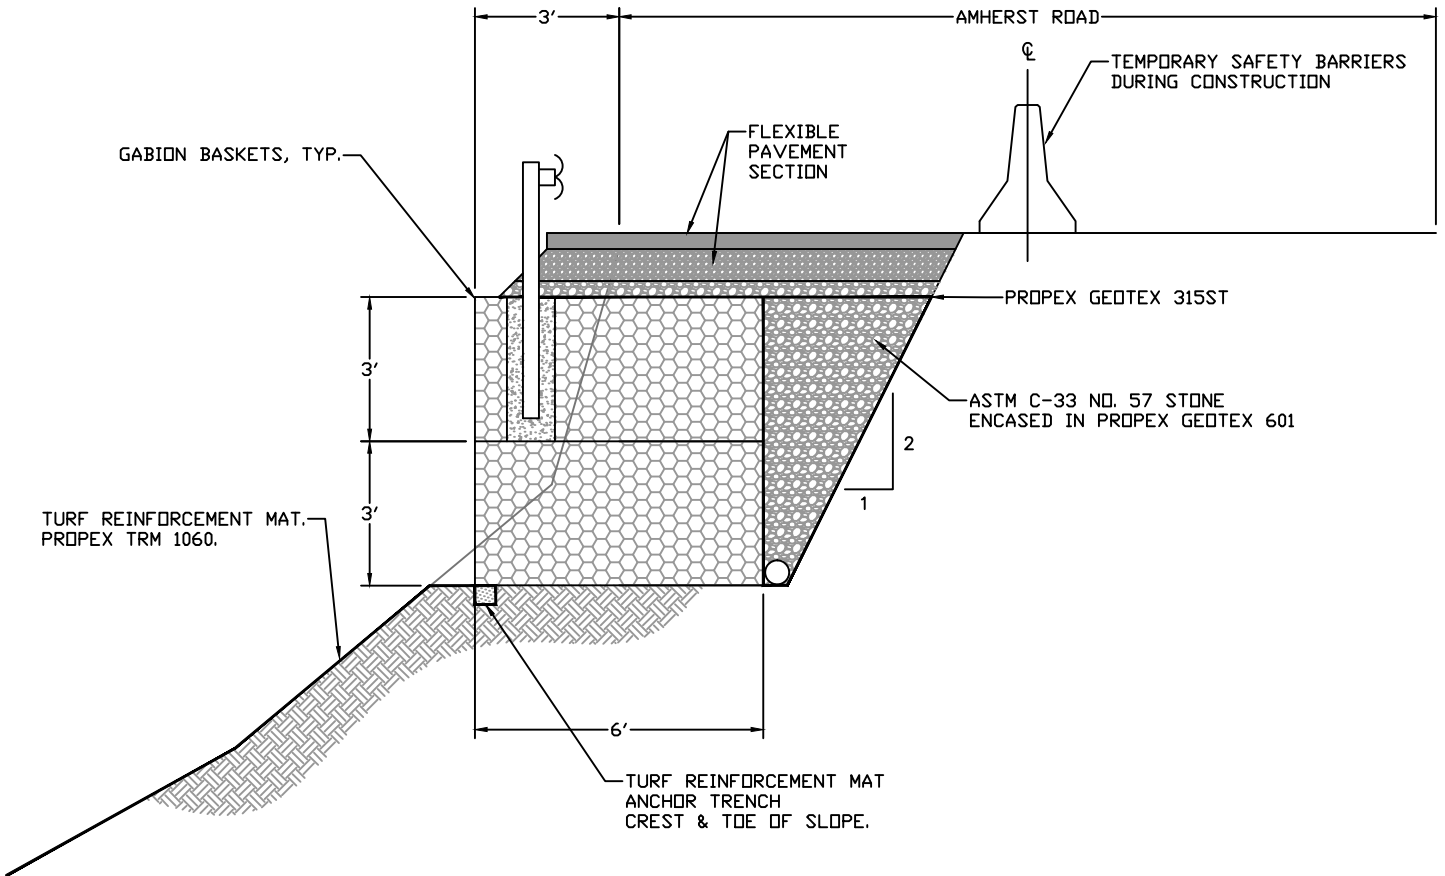
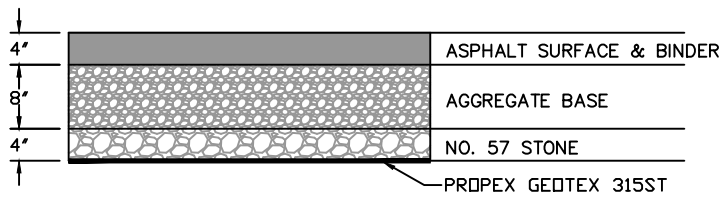
Typical Cross Section

FLEXIBLE PAVEMENT SECTION

TYPICAL CROSS SECTION

- The attached sketch graphically depicts the above outlined recommendations.

One system that was considered, and is recommended, is the use of Gabion Baskets placed at the crest of the slope to allow the roadway shoulder to be widened and a guard rail system to be constructed. The attached sketch graphically depicts our recommended stabilization technique.

We recommend that the roadway shoulder be widened and stabilized using Gabion baskets placed at the crest of the slope. A sketch that graphically depicts our recommended stabilization technique is included with this report.

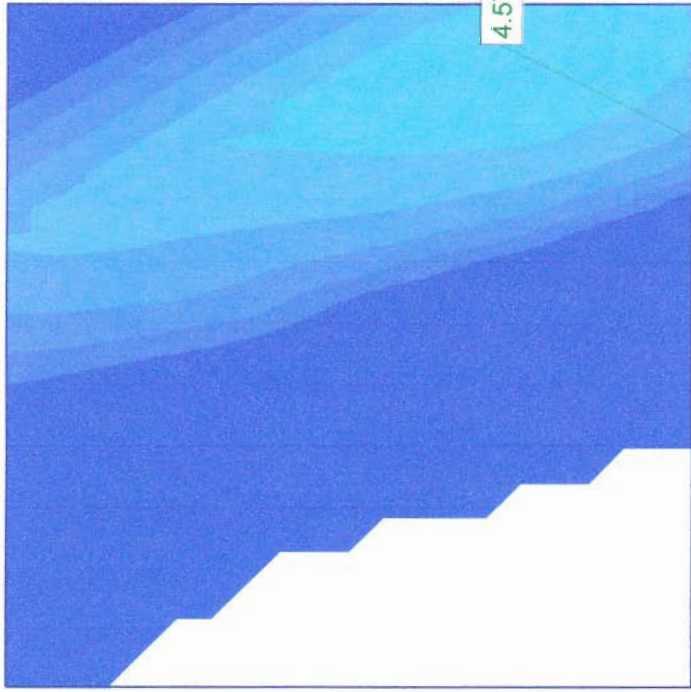
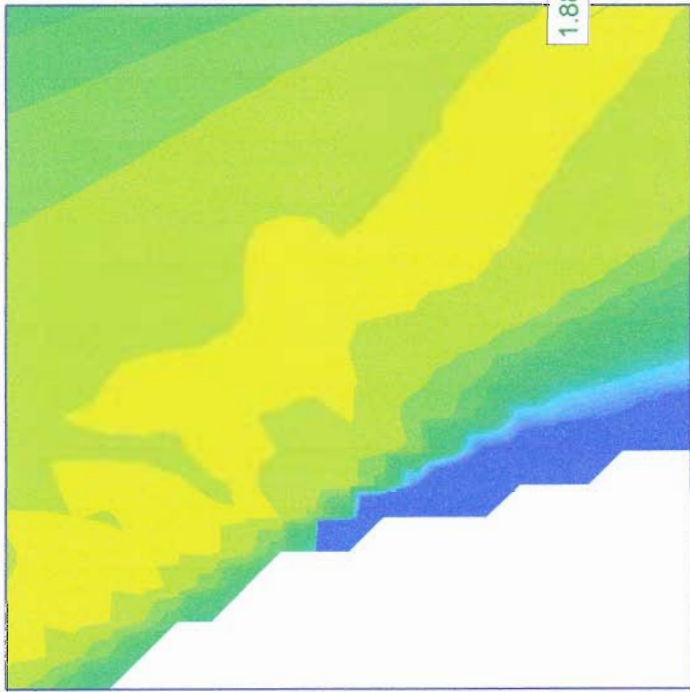
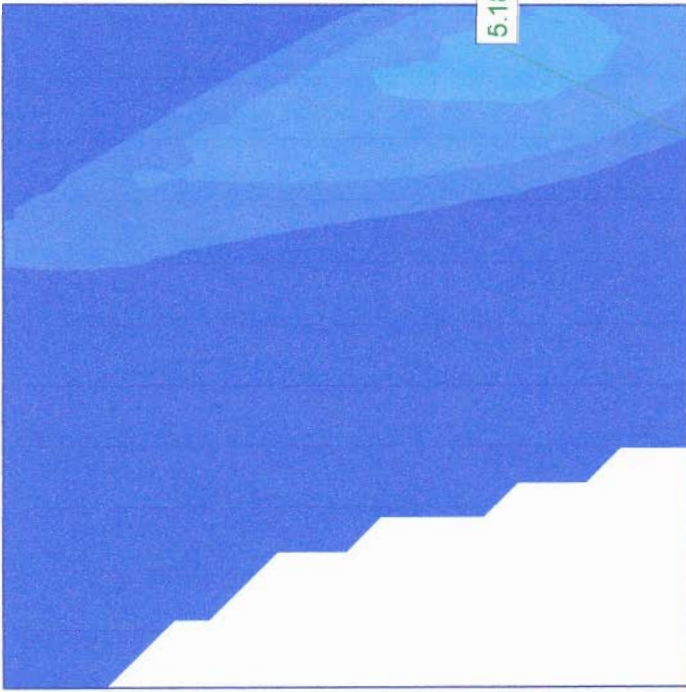
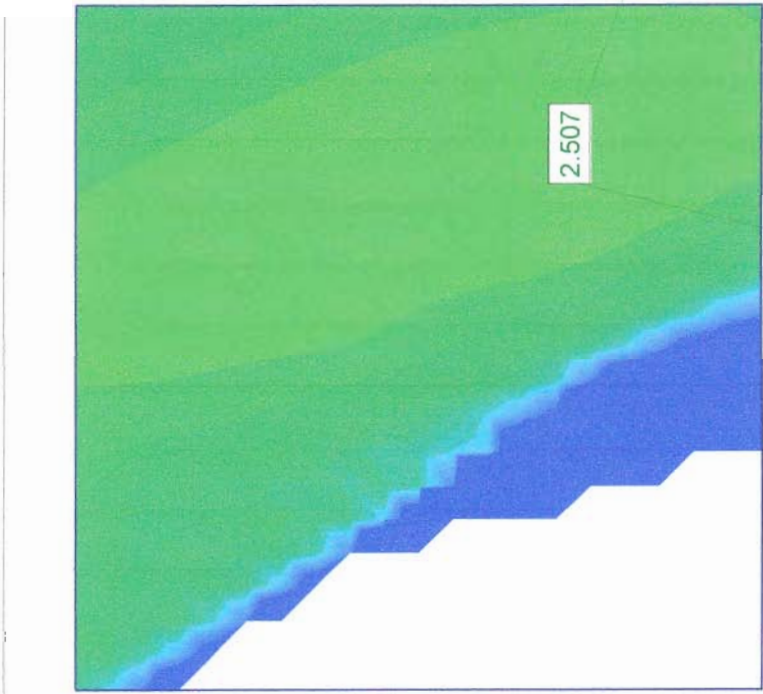
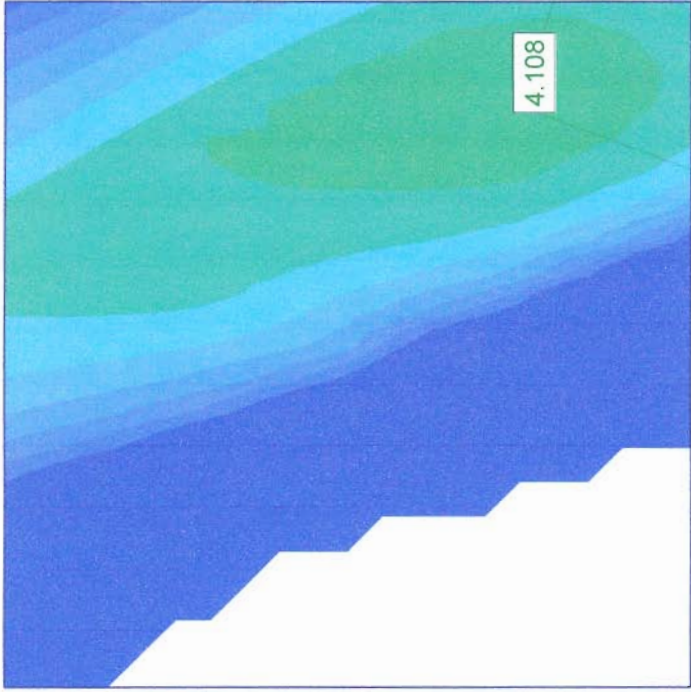
Slope Stability Analysis - Critical Cross Section  
 Amherst Road  
 Knoxville, Tennessee

The results of our stability analysis indicated factor of safety values with respect to global slope stability ranging from 1.883 to 5.186. In our professional opinion the results of the testing performed indicate that the slope is stable with respect to mass instability. A global slope failure is not predicted to occur. However, we did observe raveling and sluffing of the slope surface (slope face failures). There are sections where the shoulder and edge of the paved portion of the road have been lost. As such, while the slope is stable with regard to mass movement, loss of the roadway due to erosion and sluffing of the exposed outer surface material is occurring.

Based on the results of the testing performed, in our professional opinion the results of the testing performed indicate that the existing slope is stable with respect to mass instability. A global slope failure is not predicted to occur.

Based on the guidelines as outlined above, we recommend that a Factor of Safety of >1.5 be established as the minimum allowable slope stability. This recommendation also considers that the slope provides support to a roadway, and slope failure could encroach onto CSX rail lines.

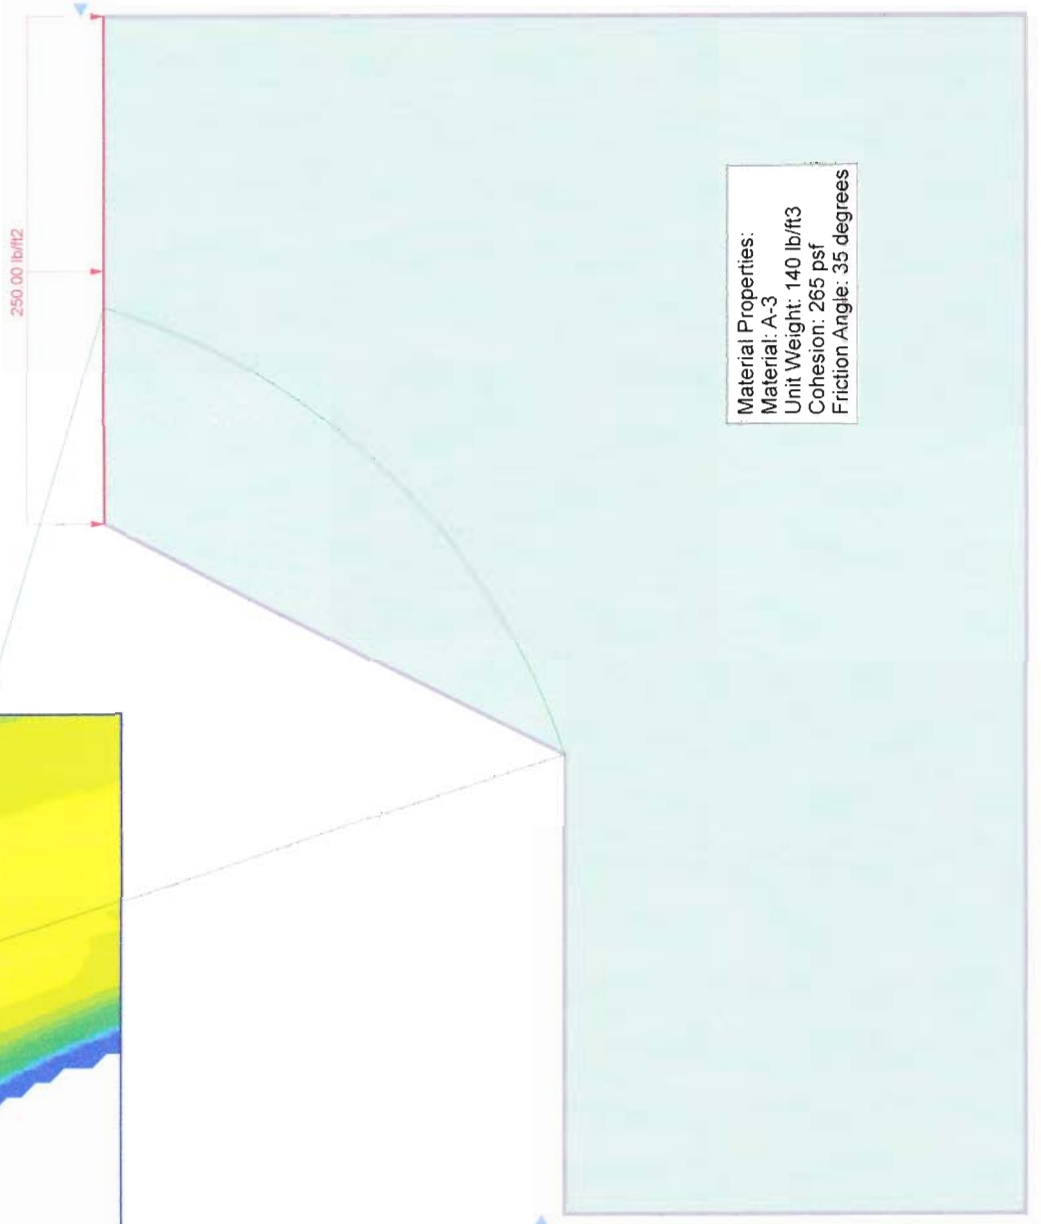
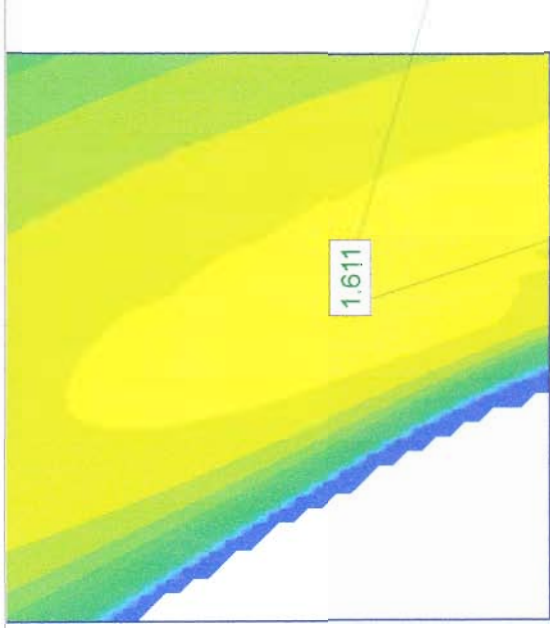
Slope Stability Analysis - Critical Soil Properties  
 0.5H:1V Temporary Construction Slope  
 Amherst Road  
 Knoxville, Tennessee

Material Properties:  
 Material: A-3  
 Unit Weight: 140 lb/ft<sup>3</sup>  
 Cohesion: 265 psf  
 Friction Angle: 35 degrees

The temporary construction excavation behind the wall should be sloped no steeper than 0.5H to 1V, or otherwise braced. The temporary construction slope should be constructed no taller than 8 feet vertically. Traffic barriers should be placed along the crest of the excavation. Truck traffic and other heavy loads should not be allowed behind the temporary construction excavation. We recommend that truck traffic and other heavy traffic loads be diverted around the construction area.

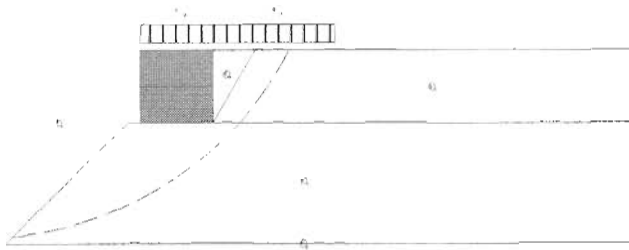
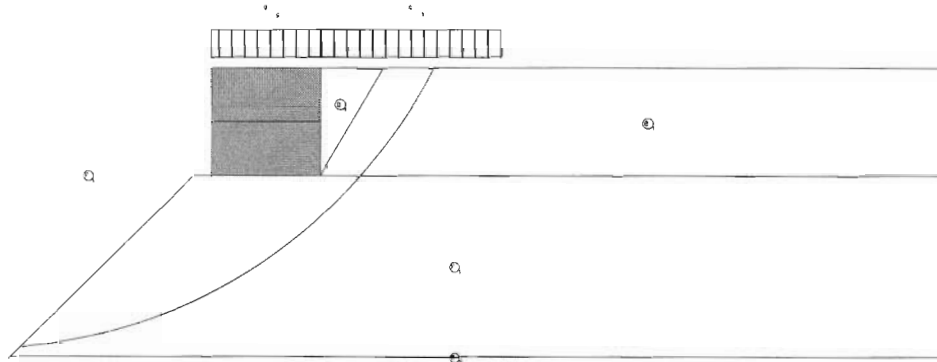
Gabion Wall Analysis – GawacWin 2003

Inclination of Stretch 1 : 0.00 deg  
 Length of stretch 1 : 10.00 ft  
 Inclination of Stretch 2 : 0.00 deg  
 Soil unit weight : 100.00 lb/ft<sup>3</sup>  
 Soil friction angle : 38.00 deg  
 Soil cohesion : 0.00 lb/ft<sup>2</sup>

Soil	$\gamma$ lb/ft <sup>3</sup>	c lb/ft <sup>2</sup>	$\phi$ deg	Soil	$\gamma$ lb/ft <sup>3</sup>	c lb/ft <sup>2</sup>	$\phi$ deg
B <sub>s</sub>	100.00	0.00	38.00	F <sub>s</sub>	120.00	500.00	16.00
B <sub>1</sub>	140.00	265.00	35.00	F <sub>1</sub>	140.00	265.00	35.00
				F <sub>2</sub>	150.00	20000.00	35.00

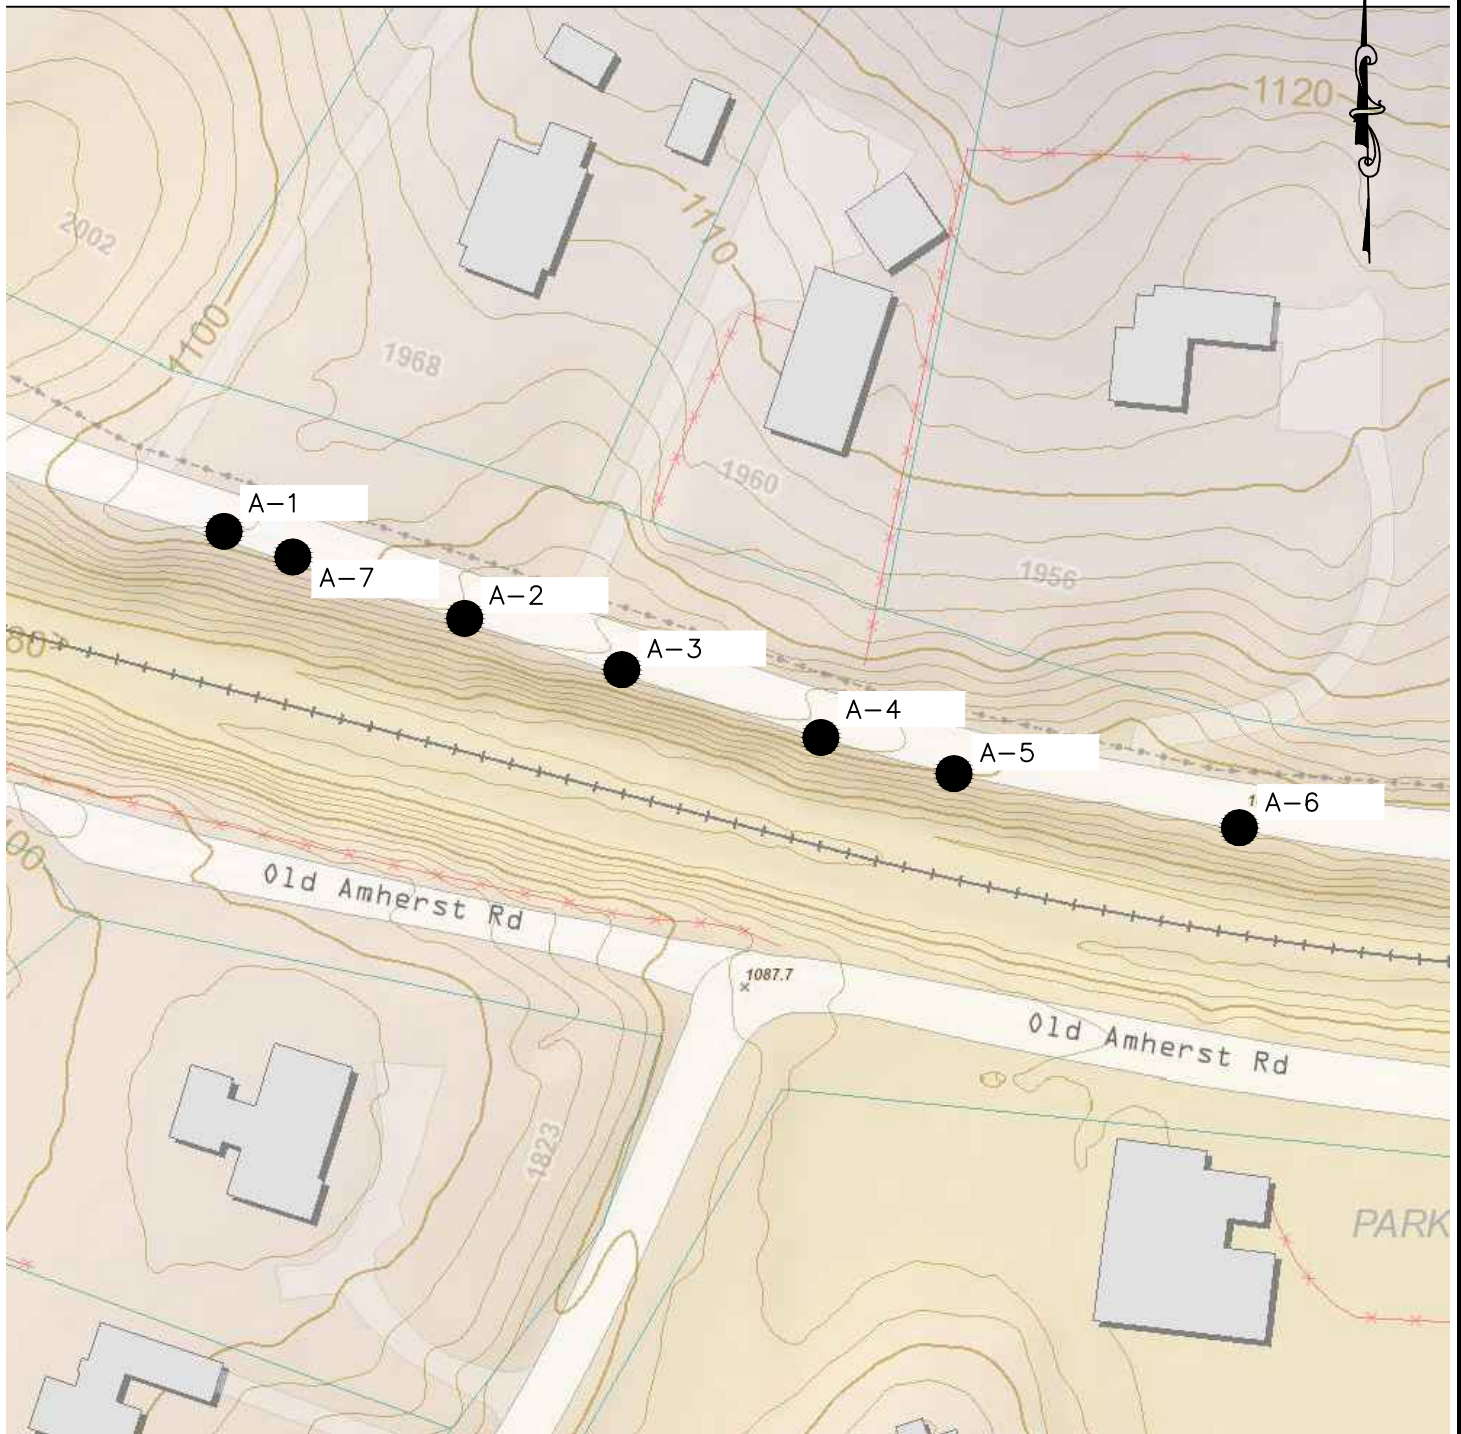
Boring Location Plan & Auger Boring Records

Seven (7) soil auger borings with Dynamic Cone Penetrometer (DCP) testing were used to investigate the section of Amherst Road where the south roadway shoulder and slope leading down to the CSX rail line have experienced surface failure and sluffing. The borings were placed at locations as selected by our personnel. The borings were drilled to depths of 25 to 30 feet below existing grade, or auger refusal. The approximate locations of the borings may be seen on the attached *Boring Location Plan*. Upon completion, the borings were backfilled with concrete.

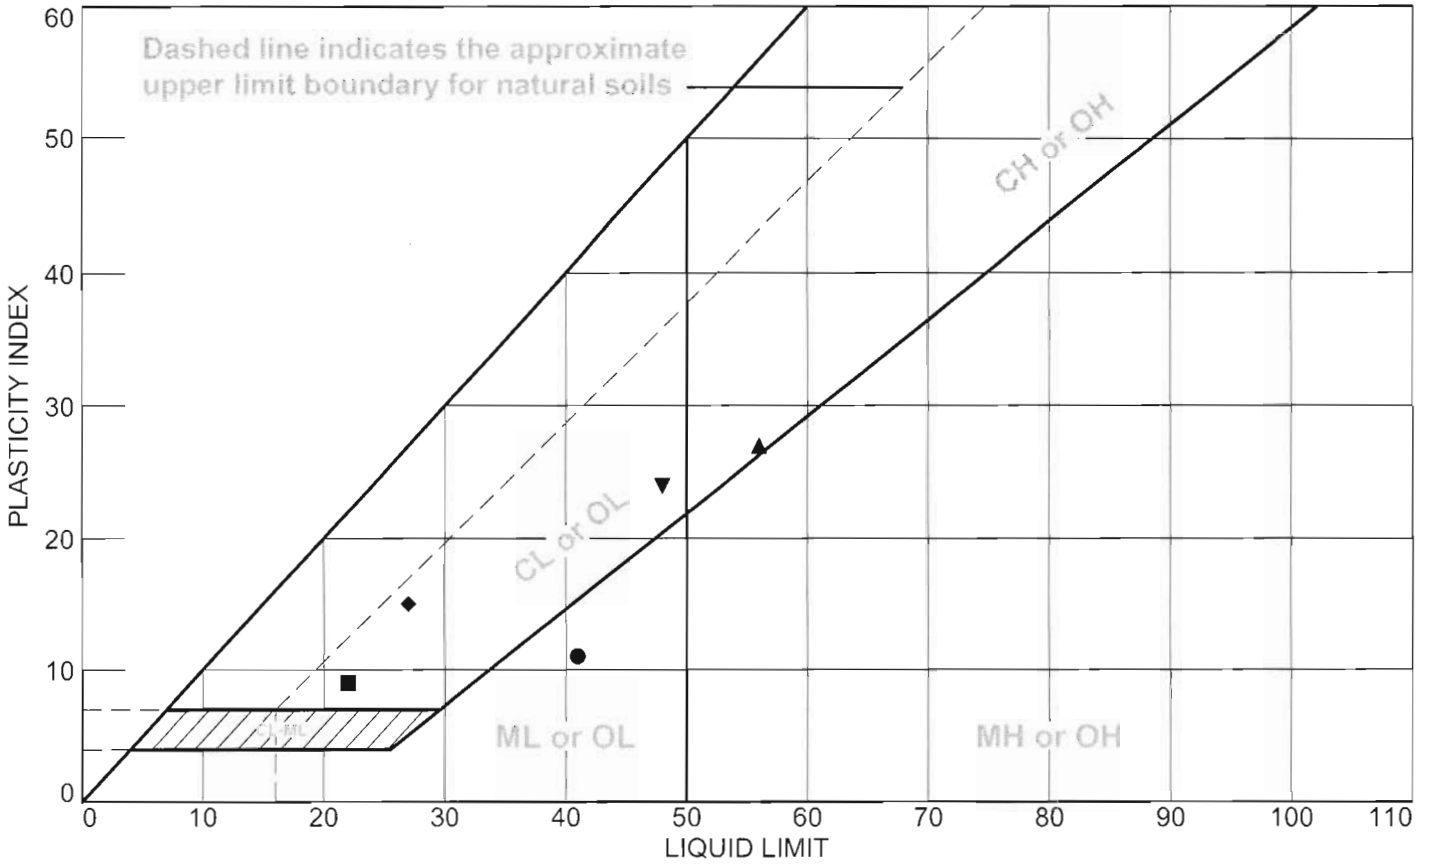
# LIQUID AND PLASTIC LIMITS TEST REPORT

SOURCE	SAMPLE NO.	DEPTH	NATURAL WATER CONTENT (%)	PLASTIC LIMIT (%)	LIQUID LIMIT (%)	PLASTICITY INDEX (%)	USCS
●	A-2		22.0-24.0'	32.7	30	41	11	ML
■	A-3		2.0-4.0'	12.2	13	22	9	CL
▲	A-5		18.0-20.0'	29.9	29	56	27	CH
◆	A-6		6.0-8.0'	16.9	12	27	15	CL
▼	A-7		13.0-15.0'	31.6	24	48	24	CL

The result of the Atterberg limits testing indicates that the soil liquid limit values for the samples selected for testing varied from approximately 22 percent to approximately 56 percent, with an average of approximately 39 percent. Soil plastic limit values varied from approximately 12 percent to approximately 30 percent, with an average soil plastic limit value of was approximately 22 percent. Soil natural moisture content values varied from approximately 11.4% to approximately 34.8%. The soil will typically flow as a heavy viscous fluid at the liquid limit. Soil strength values decrease rapidly as the soil moisture content exceeds the plastic limit.

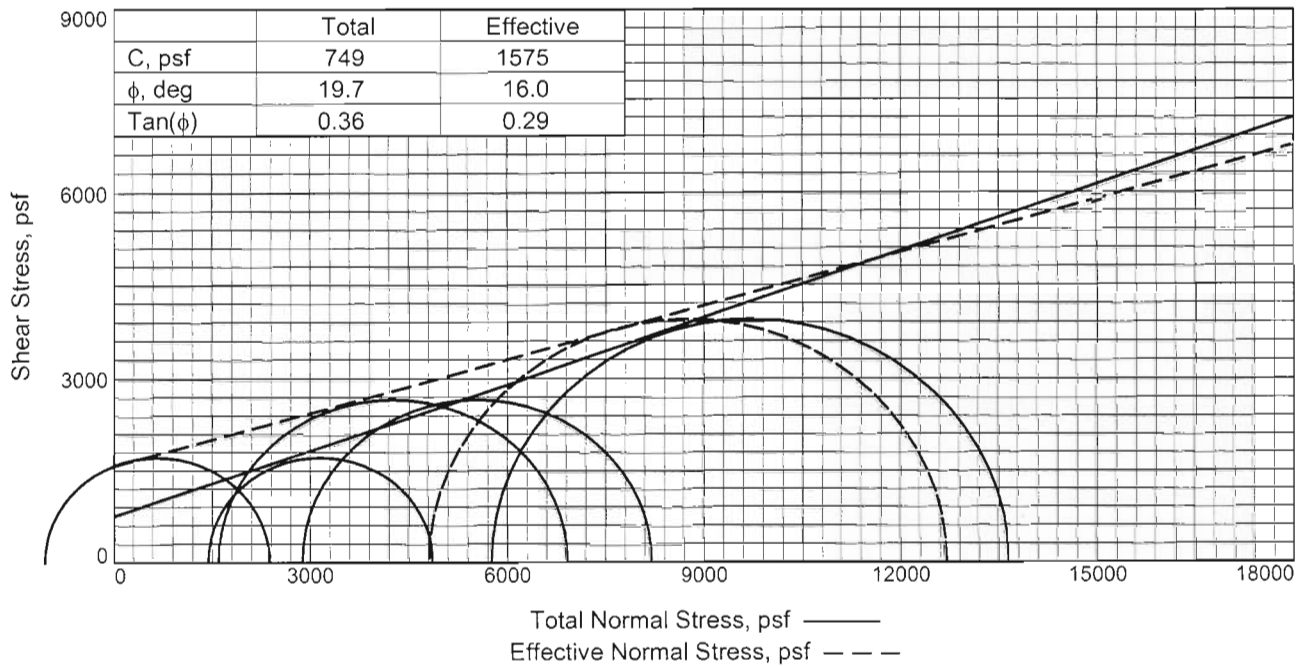
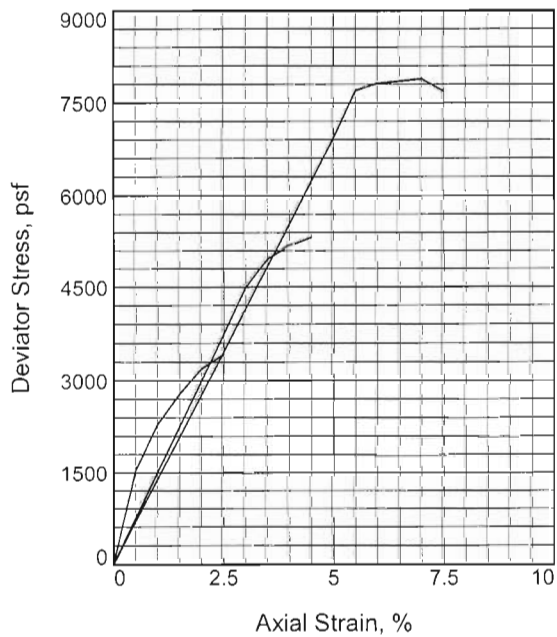
Figure 1

Sample No.	1	2	3
<b>Initial</b>			
Water Content, %	32.7	32.7	32.7
Dry Density, pcf	89.5	89.5	89.5
Saturation, %	100.0	100.0	100.0
Void Ratio	0.8841	0.8841	0.8841
Diameter, in.	1.85	1.85	1.85
Height, in.	3.70	3.70	3.70
<b>At Test</b>			
Water Content, %	32.7	32.7	32.7
Dry Density, pcf	89.5	89.5	89.5
Saturation, %	100.0	100.0	100.0
Void Ratio	0.8841	0.8841	0.8841
Diameter, in.	1.85	1.85	1.85
Height, in.	3.70	3.70	3.70
Strain rate, in./min.	1.00	1.00	1.00
Back Pressure, psi	80.00	80.00	80.00
Cell Pressure, psi	90.00	100.00	120.00
Fail. Stress, psf	3426	5321	7892
Total Pore Pr., psf	14011	12802	12470
Ult. Stress, psf			
Total Pore Pr., psf			
$\bar{\sigma}_1$ Failure, psf	2375	6919	12701
$\bar{\sigma}_3$ Failure, psf	-1051	1598	4810

Five (5) consolidated, drained, effective stress, triaxial shear tests were performed on undisturbed samples of soil encountered as the borings were advanced. The triaxial shear test samples were selected from samples collected during undisturbed Shelby tube sampling. The results of the triaxial shear testing may be seen in Table V of this report. Laboratory triaxial shear test data sheets may be found in the report appendix.

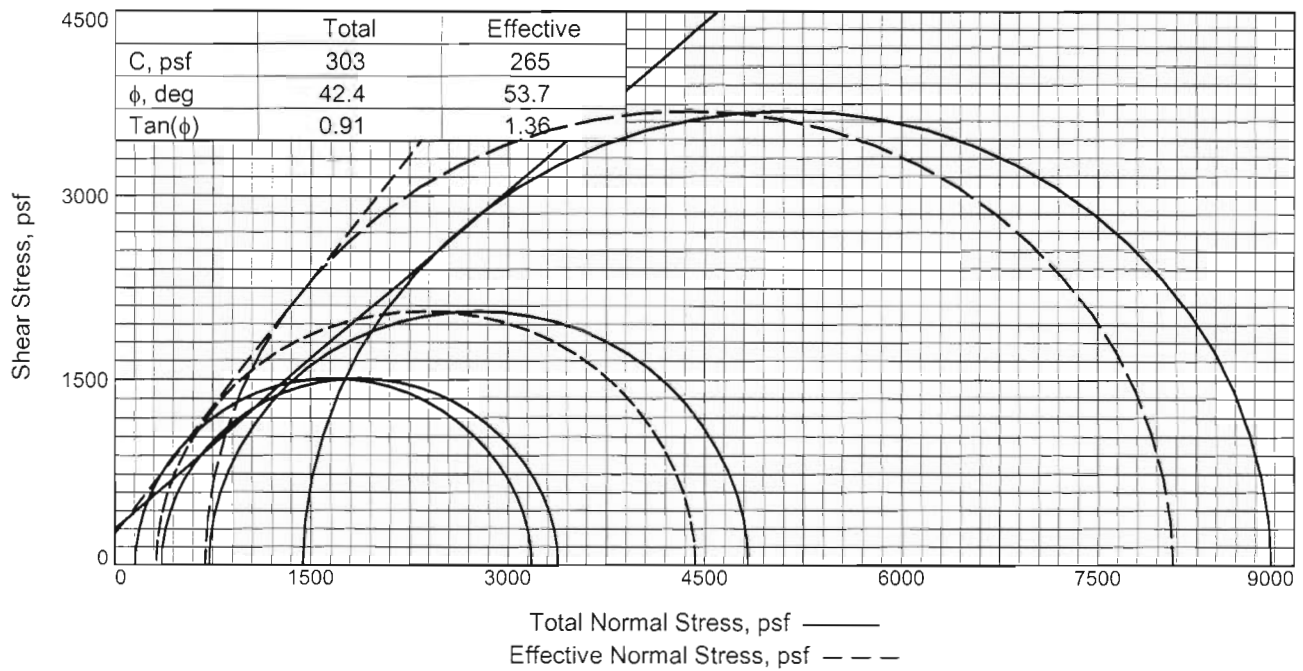
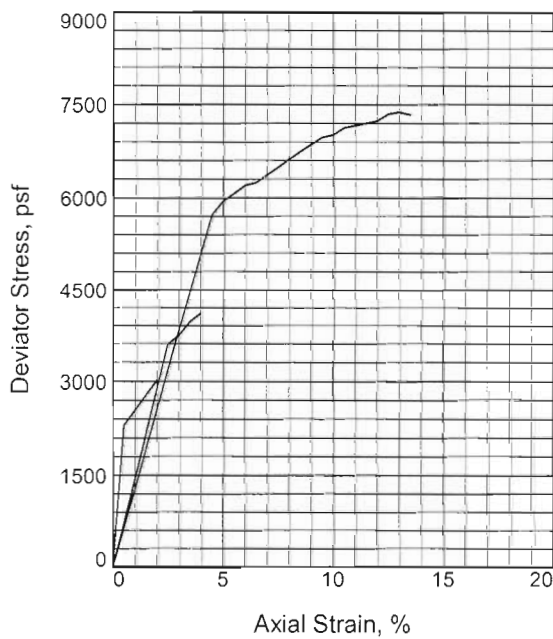
Figure 2

Sample No.	1	2	3
<b>Initial</b>			
Water Content, %	12.2	12.2	12.2
Dry Density, pcf	124.9	124.9	124.9
Saturation, %	99.9	99.9	99.9
Void Ratio	0.3244	0.3244	0.3244
Diameter, in.	1.85	1.85	1.85
Height, in.	3.70	3.70	3.70
<b>At Test</b>			
Water Content, %	12.2	12.2	12.2
Dry Density, pcf	124.9	124.9	124.9
Saturation, %	100.0	100.0	100.0
Void Ratio	0.3244	0.3244	0.3244
Diameter, in.	1.85	1.85	1.85
Height, in.	3.70	3.70	3.70
Strain rate, in./min.	1.00	1.00	1.00
Back Pressure, psi	90.00	90.00	90.00
Cell Pressure, psi	92.50	95.00	100.00
Fail. Stress, psf	3024	4114	7383
Total Pore Pr., psf	13162	13363	13709
Ult. Stress, psf			
Total Pore Pr., psf			
$\bar{\sigma}_1$ Failure, psf	3182	4431	8074
$\bar{\sigma}_3$ Failure, psf	158	317	691

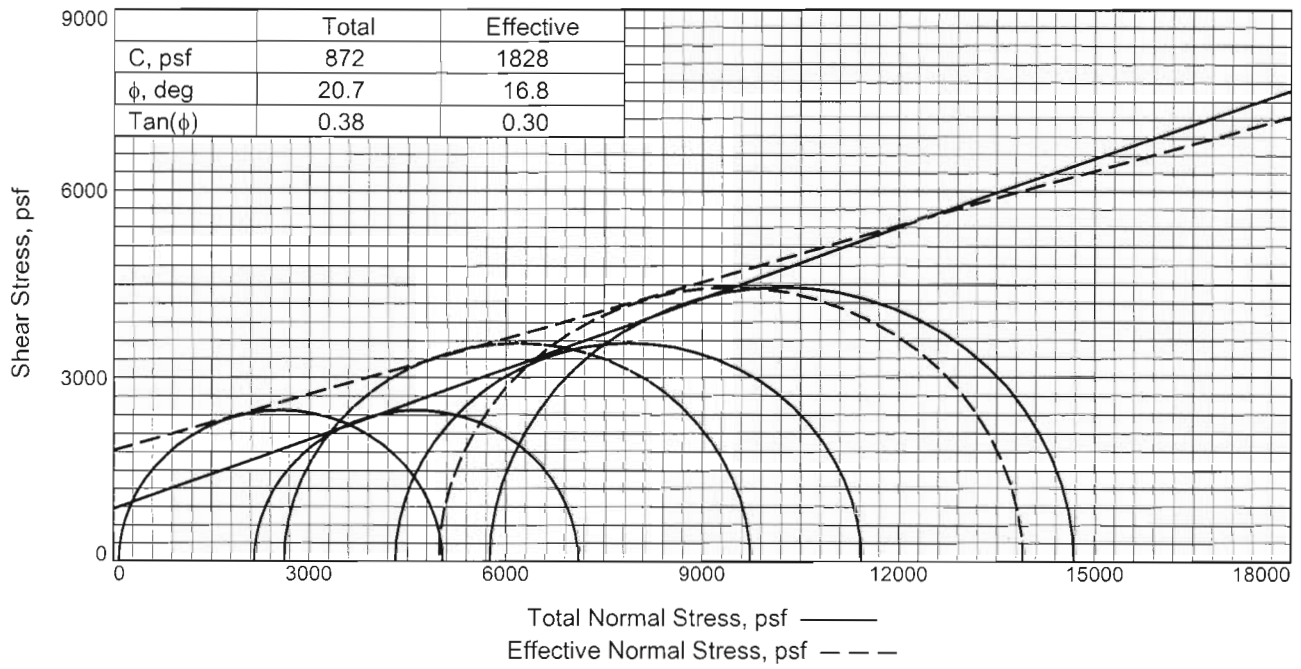
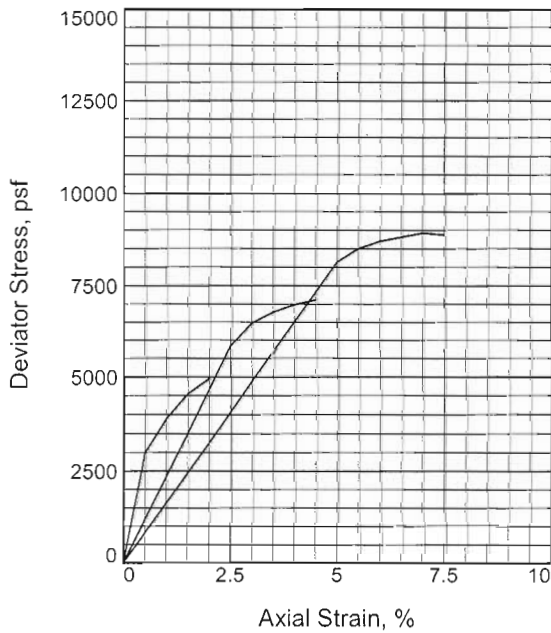
Figure 3

Sample No.		1	2	3
Initial	Water Content, %	29.9	29.9	29.9
	Dry Density, pcf	93.2	93.2	93.2
	Saturation, %	99.8	99.8	99.8
	Void Ratio	0.8088	0.8088	0.8088
	Diameter, in.	1.85	1.85	1.85
	Height, in.	3.70	3.70	3.70
At Test	Water Content, %	30.0	30.0	30.0
	Dry Density, pcf	93.2	93.2	93.2
	Saturation, %	100.0	100.0	100.0
	Void Ratio	0.8088	0.8088	0.8088
	Diameter, in.	1.85	1.85	1.85
	Height, in.	3.70	3.70	3.70
Strain rate, in./min.		1.00	1.00	1.00
Back Pressure, psi		80.00	80.00	80.00
Cell Pressure, psi		95.00	110.00	120.00
Fail. Stress, psf		4956	7122	8928
Total Pore Pr., psf		13594	13219	12298
Ult. Stress, psf				
Total Pore Pr., psf				
$\bar{\sigma}_1$ Failure, psf		5042	9742	13910
$\bar{\sigma}_3$ Failure, psf		86	2621	4982

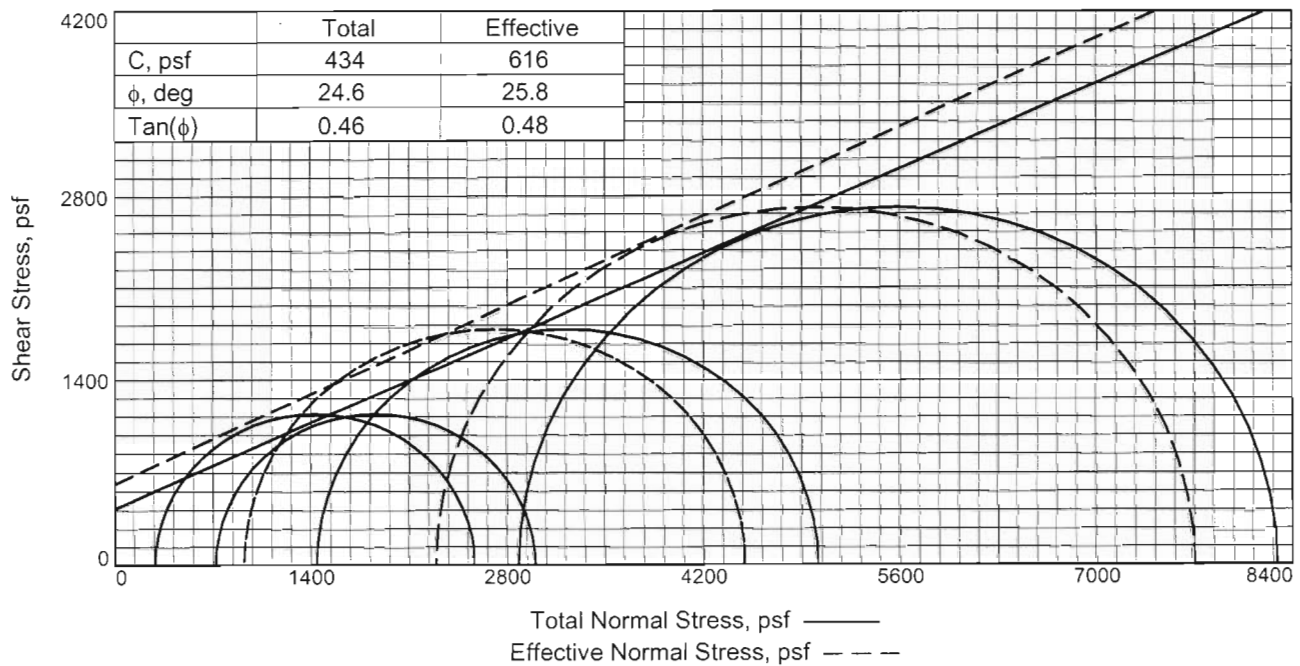
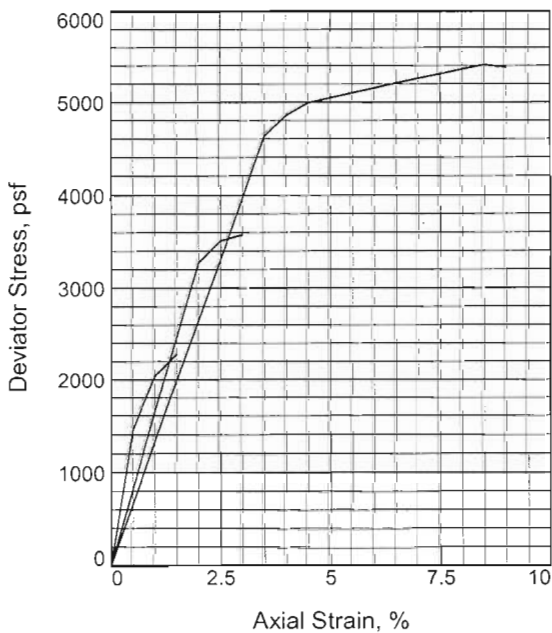
Figure 4

Sample No.		1	2	3
Initial	Water Content, %	16.9	16.9	16.9
	Dry Density, pcf	115.7	115.7	115.7
	Saturation, %	99.8	99.8	99.8
	Void Ratio	0.4573	0.4573	0.4573
	Diameter, in.	1.85	1.85	1.85
	Height, in.	3.70	3.70	3.70
At Test	Water Content, %	16.9	16.9	16.9
	Dry Density, pcf	115.7	115.7	115.7
	Saturation, %	100.0	100.0	100.0
	Void Ratio	0.4573	0.4573	0.4573
	Diameter, in.	1.85	1.85	1.85
	Height, in.	3.70	3.70	3.70
Strain rate, in./min.		1.00	1.00	1.00
Back Pressure, psi		90.00	90.00	90.00
Cell Pressure, psi		95.00	100.00	110.00
Fail. Stress, psf		2280	3575	5412
Total Pore Pr., psf		13392	13478	13550
Ult. Stress, psf				
Total Pore Pr., psf				
$\bar{\sigma}_1$ Failure, psf		2568	4497	7701
$\bar{\sigma}_3$ Failure, psf		288	922	2290

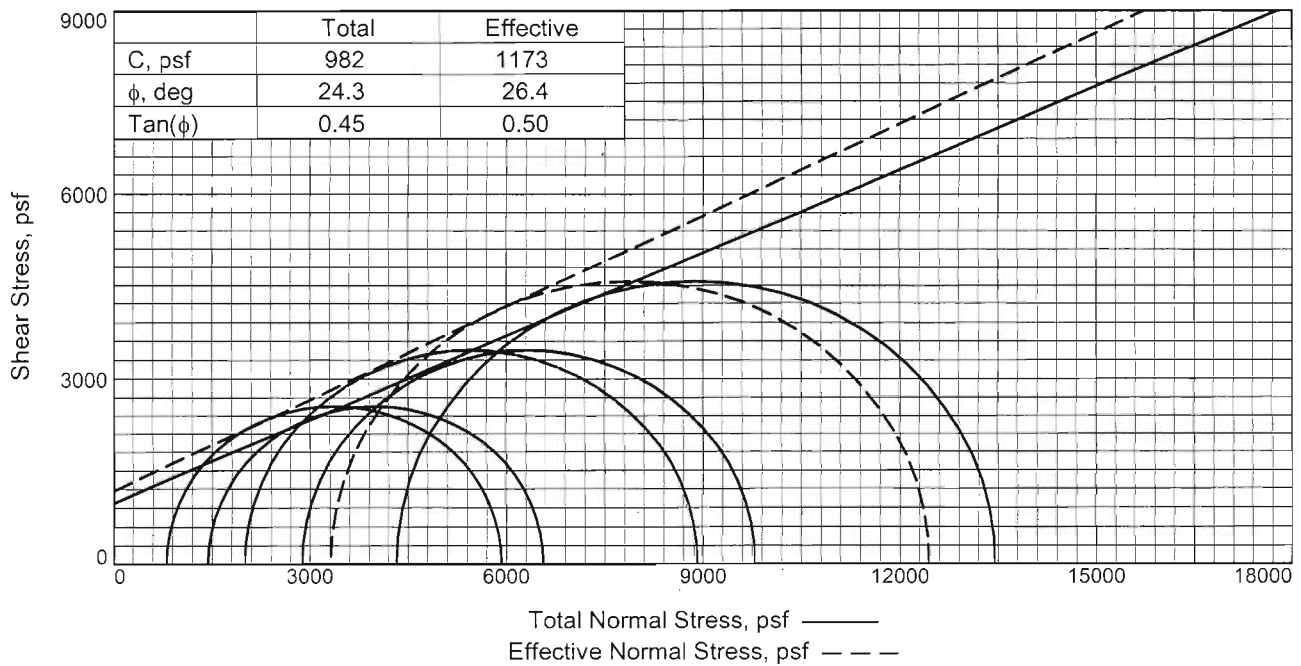
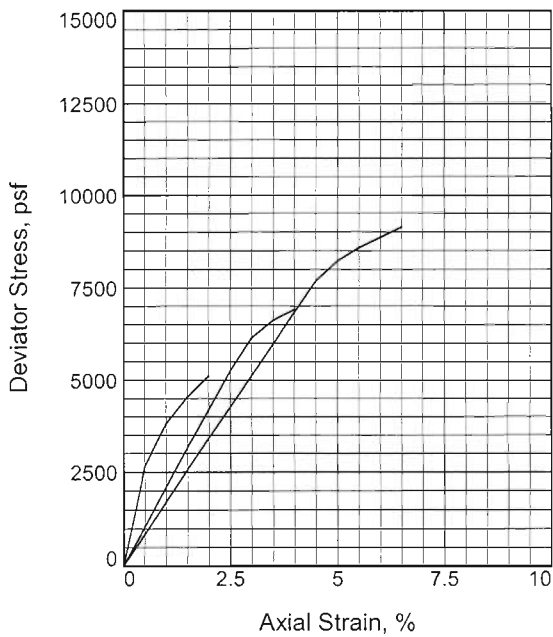
Figure 5

Sample No.		1	2	3
Initial	Water Content, %	31.6	31.6	31.6
	Dry Density, pcf	90.8	90.8	90.8
	Saturation, %	99.6	99.6	99.6
	Void Ratio	0.8555	0.8555	0.8555
	Diameter, in.	1.85	1.85	1.85
	Height, in.	3.70	3.70	3.70
At Test	Water Content, %	31.7	31.7	31.7
	Dry Density, pcf	90.8	90.8	90.8
	Saturation, %	100.0	100.0	100.0
	Void Ratio	0.8555	0.8555	0.8555
	Diameter, in.	1.85	1.85	1.85
	Height, in.	3.70	3.70	3.70
Strain rate, in./min.		1.00	1.00	1.00
Back Pressure, psi		90.00	90.00	90.00
Cell Pressure, psi		100.00	110.00	120.00
Fail. Stress, psf		5124	6912	9136
Total Pore Pr., psf		13594	13838	13968
Ult. Stress, psf				
Total Pore Pr., psf				
$\bar{\sigma}_1$ Failure, psf		5930	8914	12448
$\bar{\sigma}_3$ Failure, psf		806	2002	3312
