Subject: **REPORT OF GEOTECHNICAL EXPLORATION ADDENDUM**  
**Vermont Avenue Multi-Family Development**  
1800 & 1900 Vermont Avenue  
Knoxville, Tennessee  
GEOservices Project No. 21-23276

We are submitting this Addendum to our Report of *Geotechnical Exploration*, dated March 28, 2023, for the proposed development to be located off Vermont Avenue in Knoxville, Tennessee. This addendum report provides the results of the observation pits, and the laboratory test results from the previous exploration. This work was performed, as authorized by you, in accordance with our Proposal No. 11-23173, dated February 1, 2023.

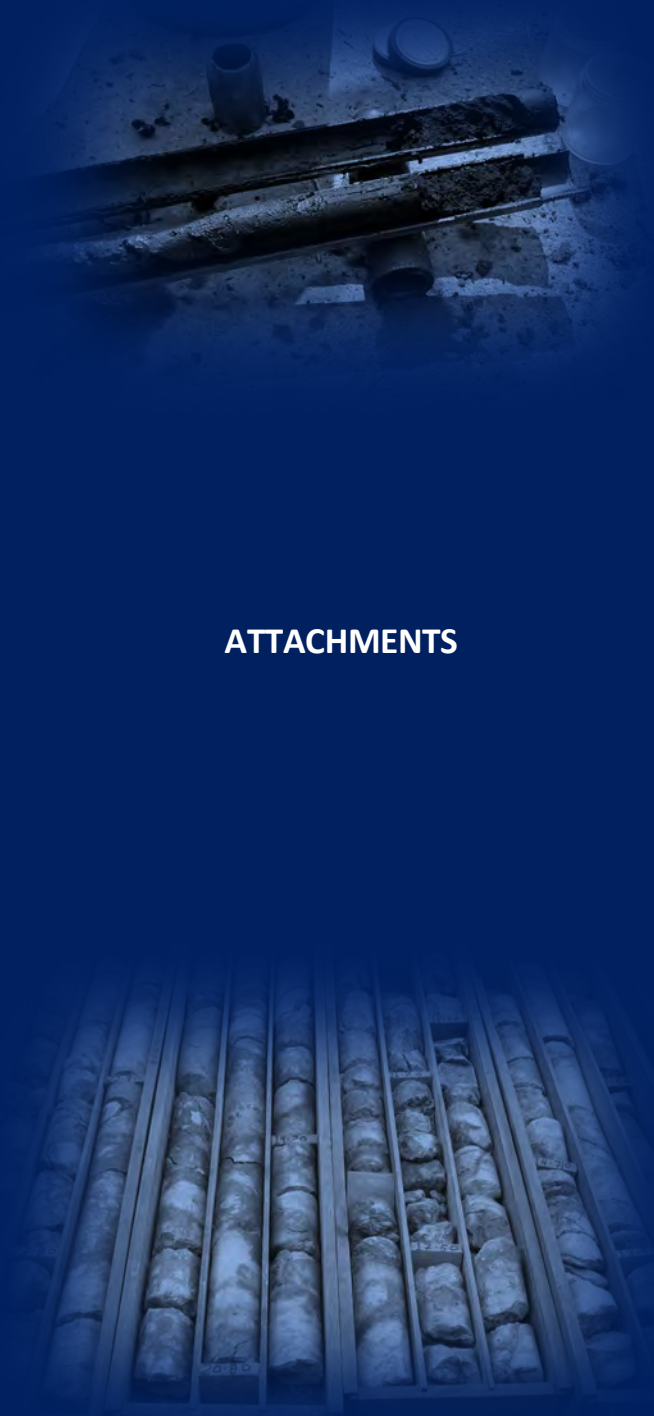
The site subsurface conditions were explored by excavating fifteen (15) observation across the proposed development. The observation pits were marked in the field by GEOservices personnel using a hand-held GPS unit. The approximate locations of the observation pits are shown in Figure 2 in the attachments of this

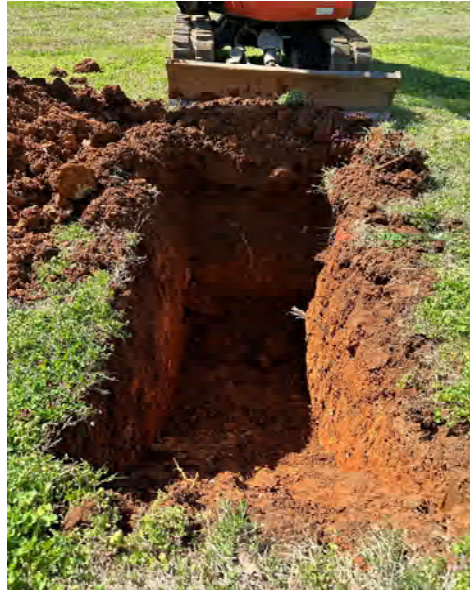
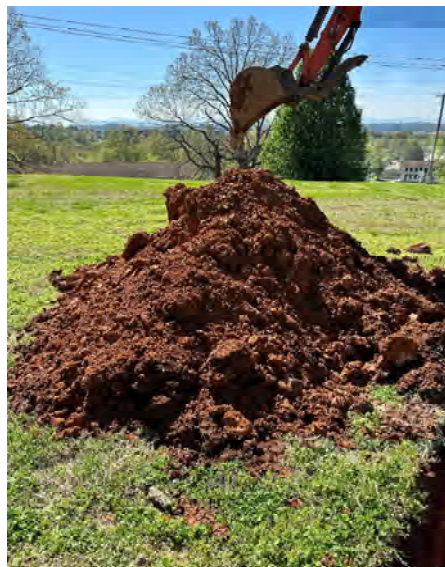
Location	Depth (ft.)		Material Type	Description	Comments
	from	to			
OP-1	0.0	0.2	Surficial	Topsoil with roots (2 inches)	
	0.2	4.0	Fill	Lean Clay (CL) - with bricks, rock fragments, and abandoned water and cable lines - Brown, reddish brown, and dark gray - Moist	Firm
	4.0	5.0	Residual	Fat Clay (CH) - with silt and chert fragments - Reddish brown, tan, and white - Moist	Stiff, terminated at 5.0 feet

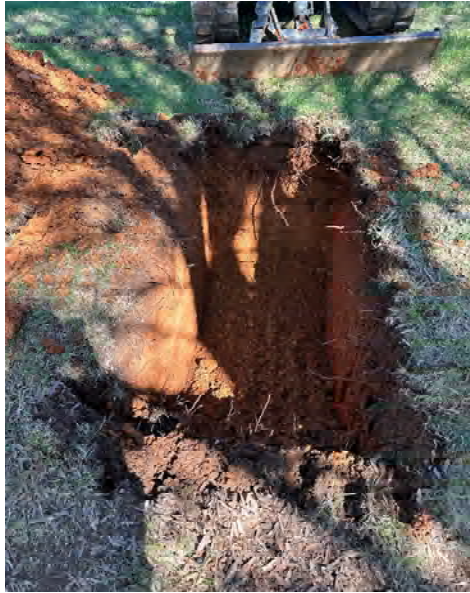
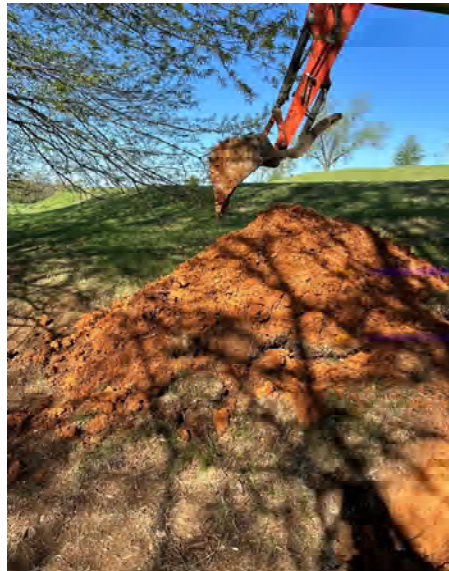
Location	Depth (ft.)		Material Type	Description	Comments
	from	to			
OP-2	0.0	0.3	Surficial	Topsoil with roots (4 inches)	
	0.3	4.0	Residual	Fat Clay (CH) - with silt and chert fragments - Reddish brown and tan - Moist	Stiff, terminated at 4.0 feet

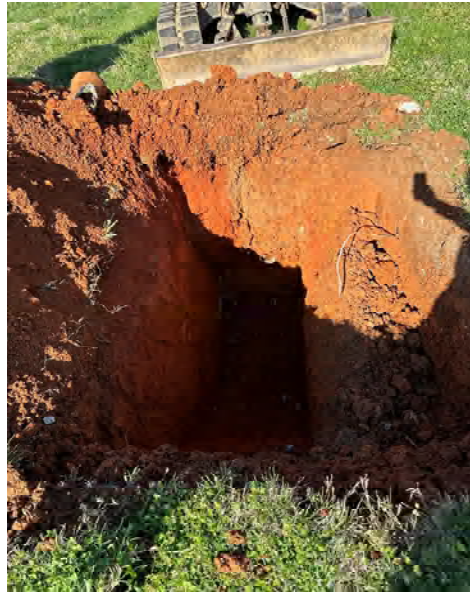
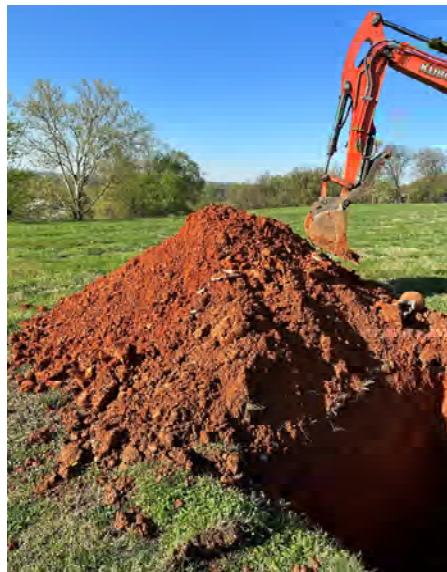
Location	Depth (ft.)		Material Type	Description	Comments
	from	to			
OP-3	0.0	0.2	Surficial	Topsoil (2 inches)	
	0.2	5.5	Fill	Lean Clay (CL) - with boulders, asphalt fragments, cables, glass, concrete fragments, pipes, and abandoned water, sewer, and phone lines - Brown, dark brown, and reddish brown - Moist	Firm
	5.5	9.5	Residual	Fat Clay (CH) - with silt, chert fragments, and weathered rock at depth - Reddish brown and tan - Moist	Firm to stiff, terminated at 9.5 feet

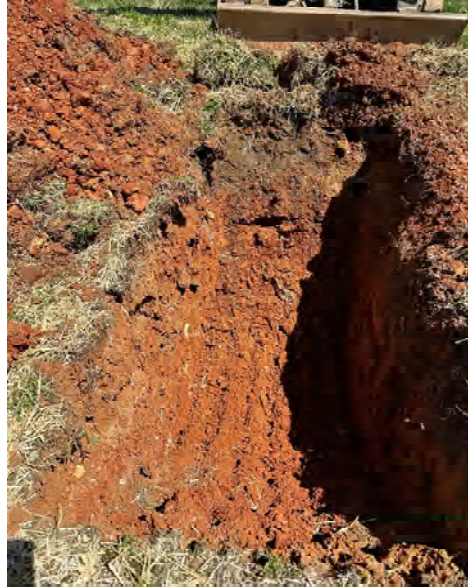
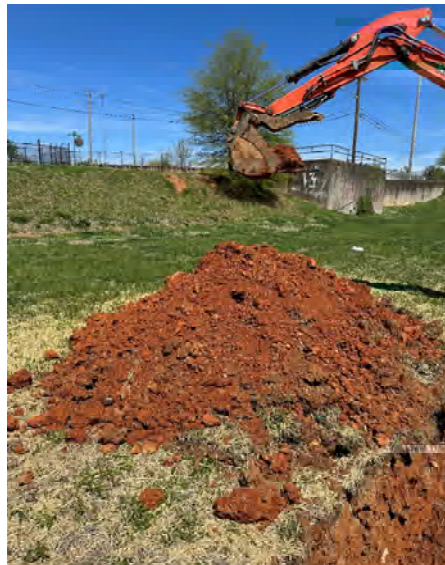
Location	Depth (ft.)		Material Type	Description	Comments
	from	to			
OP-4	0.0	0.2	Surficial	Topsoil (2 inches)	
	0.2	2.0	Fill	Lean Clay (CL) - with gravel, bricks, and concrete fragments - Brown, dark brown, and dark gray - Moist	Firm
	2.0	4.5	Residual	Lean Clay (CL) - with silt, chert fragments, and weathered rock - Reddish brown and white - Moist	Very stiff to hard, terminated at 4.5 feet

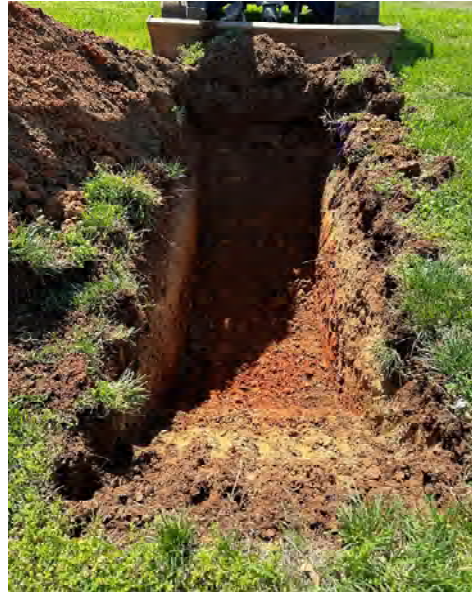
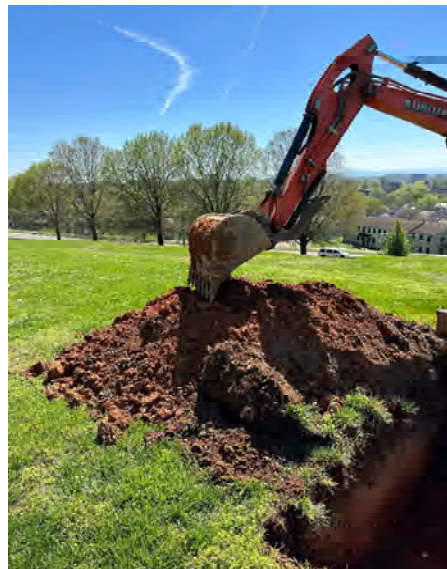
Location	Depth (ft.)		Material Type	Description	Comments
	from	to			
OP-5	0.0	0.2	Surficial	Topsoil (2 inches)	
	0.2	2.5	Fill	Lean Clay (CL) - with silt, bricks, and gravel - Brown and light brown - Moist	Firm
	2.5	4.5	Residual	Fat Clay (CH) - with silt and chert fragments - Reddish brown, tan, and white - Moist	Stiff, terminated at 4.5 feet

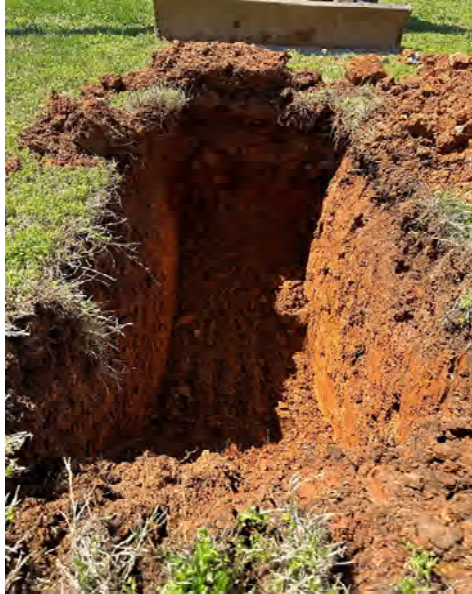
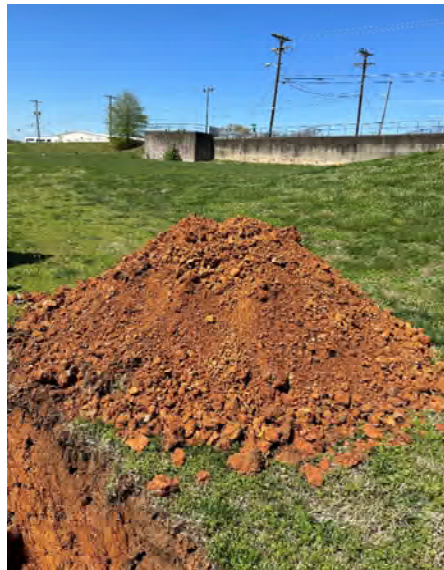
Location	Depth (ft.)		Material Type	Description	Comments
	from	to			
OP-6	0.0	0.4	Surficial	Topsoil (5 inches)	
	0.4	3.5	Fill	Lean Clay (CL) - with bricks, gravel, debris, and rock fragments - Brown, dark gray, and reddish brown - Moist	Stiff
	3.5	5.0	Residual	Fat Clay (CH) - with silt and chert fragments - Reddish brown and tan - Moist	Very stiff to hard, terminated at 5.0 feet

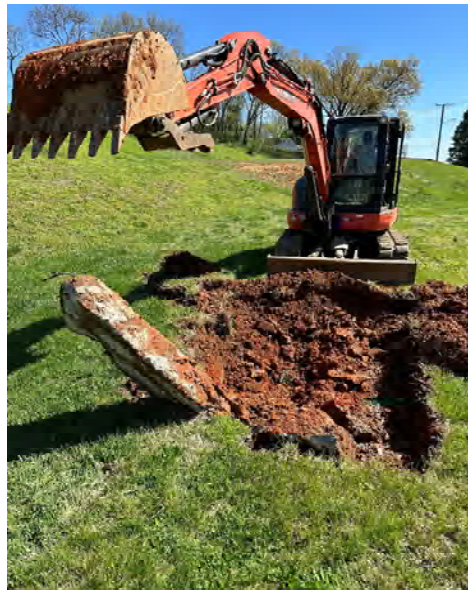
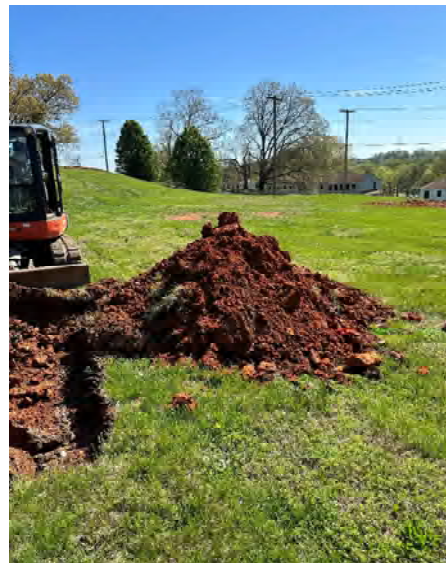
Location	Depth (ft.)		Material Type	Description	Comments
	from	to			
OP-7	0.0	0.2	Surficial	Topsoil (2 inches)	
	0.2	1.0	Fill	Lean Clay (CL) - with bricks and gravel - Brown and dark gray - Moist	Firm
	1.0	1.8	Fill	Reinforced concrete slab with attached sewer pipes (9 inches)	Hard
	1.8	2.5	Residual	Fat Clay (CH) - with silt and chert fragments - Reddish brown and tan - Moist	Stiff, terminated at 2.5 feet

During our exploration, we encountered building remnants and foundation elements from previous construction in at least one location. Based on our on site observations and given the historical use of the site, we expect that more foundation elements will be encountered during construction. Our previous report recommended the use of rammed aggregate piers. While still an option, the presence of large buried impenetrable materials, such as the foundation elements at this site, could present some difficulties during rammed aggregate pier installation and need to be removed prior to the construction of the piers.

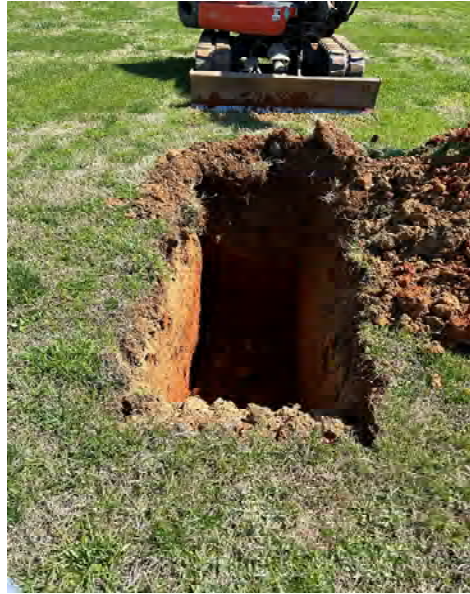
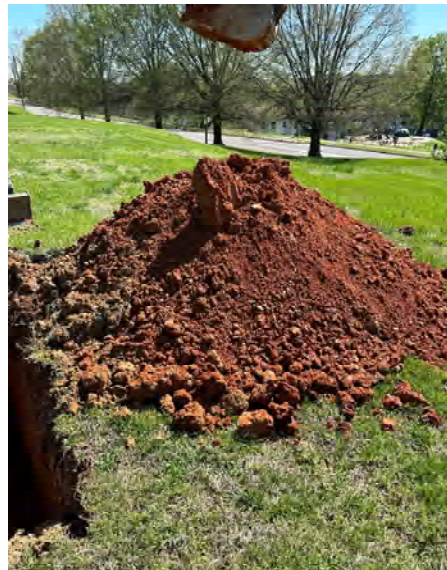
Location	Depth (ft.)		Material Type	Description	Comments
	from	to			
OP-8	0.0	0.2	Surficial	Topsoil (2 inches)	
	0.2	3.5	Fill	Lean Clay (CL) - with silt, bricks, and concrete fragments - Light brown, tan, reddish brown, and brown - Moist	Firm
	3.5	6.0	Residual	Fat Clay (CH) - with silt and chert fragments - Reddish brown and tan - Moist	Stiff, terminated at 6.0 feet

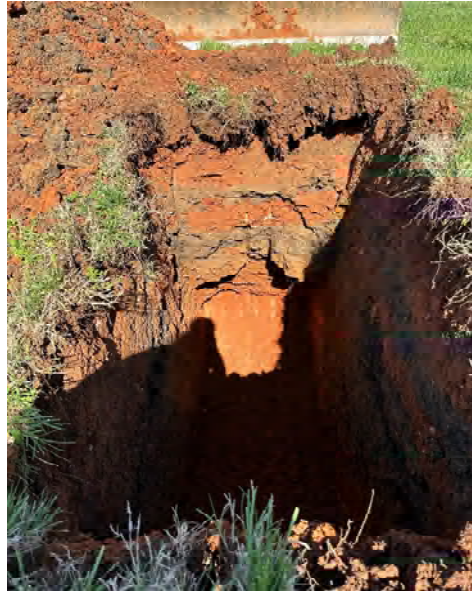
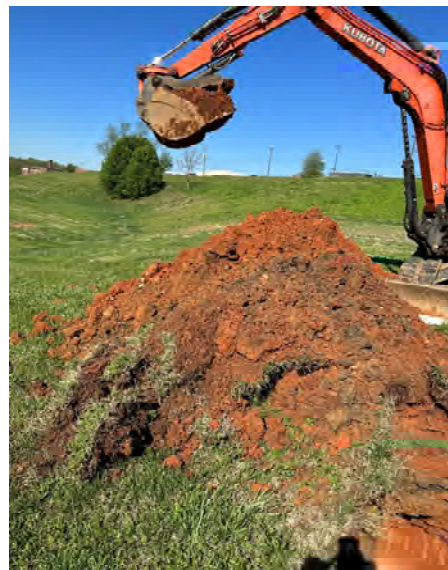
Location	Depth (ft.)		Material Type	Description	Comments
	from	to			
OP-9	0.0	0.3	Surficial	Topsoil (4 inches)	
	0.3	5.5	Fill	Lean Clay (CL) - with glass, pipes, and rock fragments - Brown, reddish brown, dark gray and black - Moist	Firm
	5.5	8.0	Residual	Lean Clay (CL) - with silt and chert fragments - Reddish brown - Moist	Firm to stiff, terminated at 8.0 feet

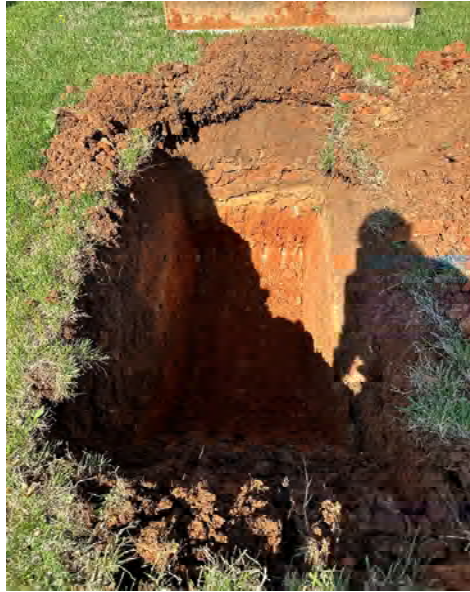
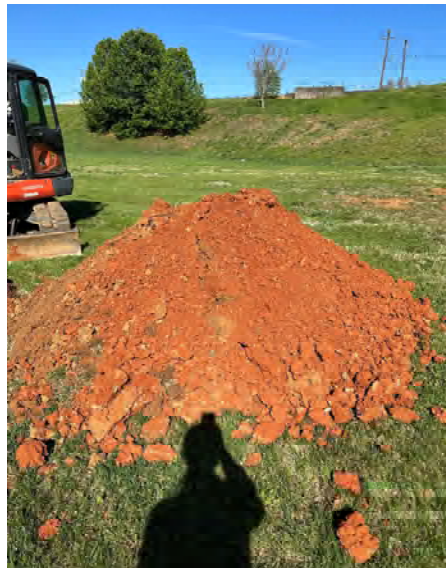
Location	Depth (ft.)		Material Type	Description	Comments
	from	to			
OP-10	0.0	0.2	Surficial	Topsoil (3 inches)	
	0.2	3.0	Fill	Lean Clay (CL) - with silt, silt fence fabric, and brick fragments - Dark gray, brown, tan, and reddish brown - Moist	Firm
	3.0	6.0	Residual	Fat Clay (CH) - with silt, significant chert fragments, and weathered rock at depth - Reddish brown, tan, and white - Moist	Stiff to very stiff, terminated at 6.0 feet

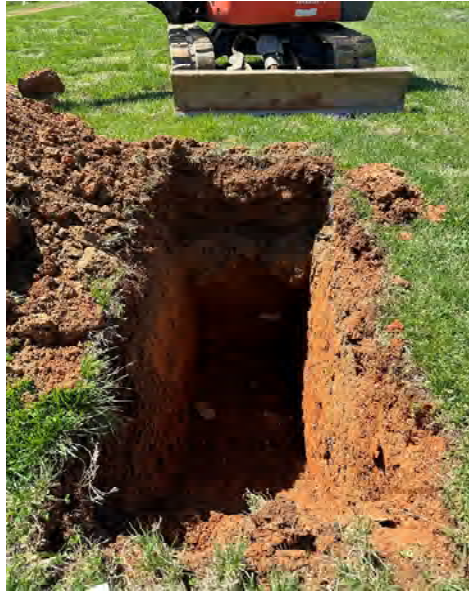
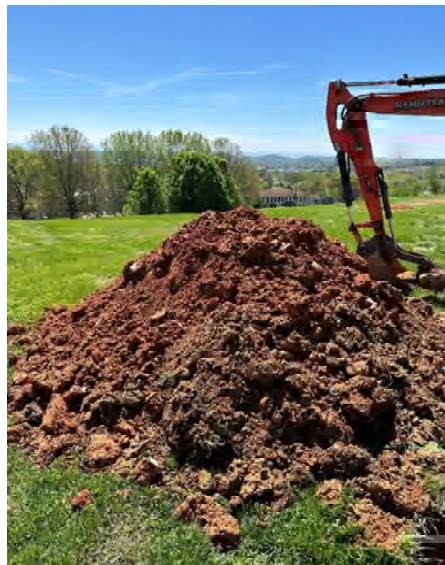
Location	Depth (ft.)		Material Type	Description	Comments
	from	to			
OP-11	0.0	0.3	Surficial	Topsoil (4 inches)	
	0.3	3.5	Fill	Lean Clay (CL) - with gravel, bricks, concrete fragments, and abandoned sewer line - Brown, light brown, and reddish brown - Moist	Stiff
	3.5	7.5	Residual	Lean Clay (CL) - with silt, chert fragments, and weathered rock - Reddish brown and white - Moist	Very stiff to hard, terminated at 7.5 feet

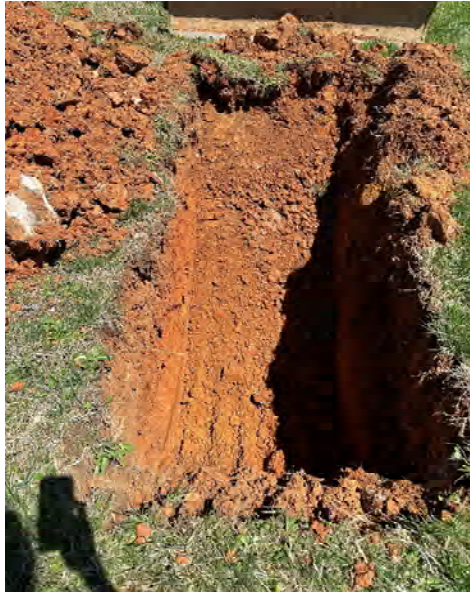
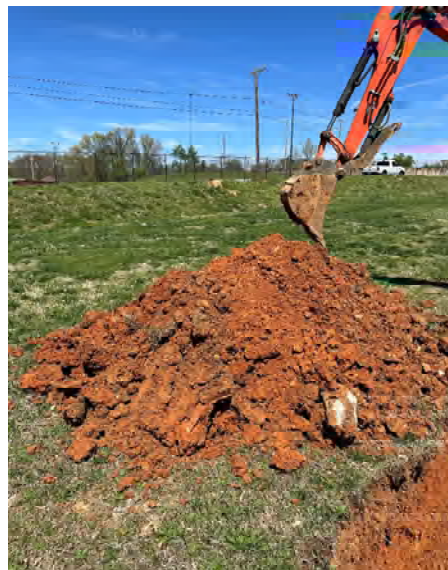
Location	Depth (ft.)		Material Type	Description	Comments
	from	to			
OP-12	0.0	0.2	Surficial	Topsoil (2 inches)	
	0.2	2.0	Fill	Lean Clay (CL) - with bricks, concrete fragments, and rock fragments - Brown, orangish brown, and gray - Moist	Stiff to very stiff
	2.0	4.5	Residual	Fat Clay (CH) - with silt, significant chert fragments, and weathered rock at depth - Reddish brown, tan, white, and red - Moist	Very stiff to hard, terminated at 4.5 feet

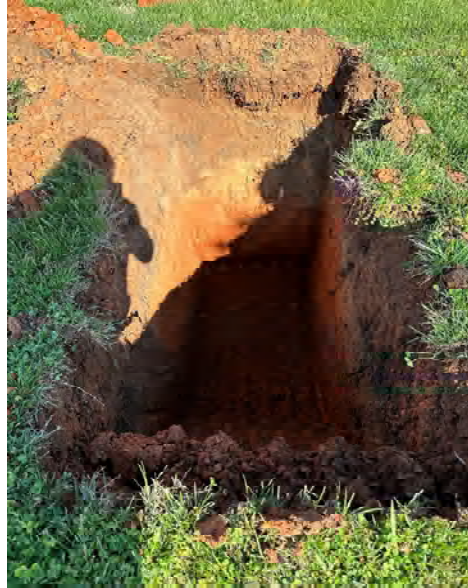
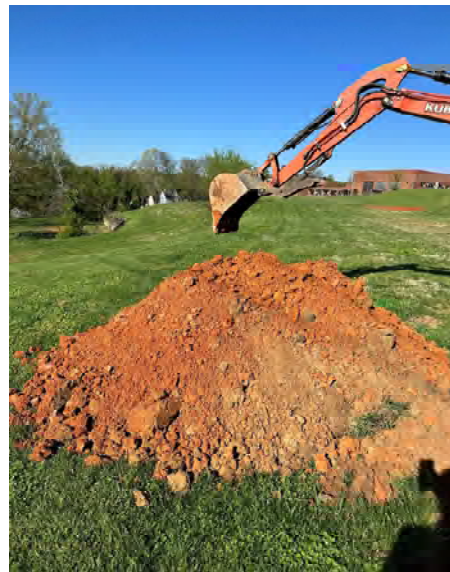
Location	Depth (ft.)		Material Type	Description	Comments
	from	to			
OP-13	0.0	0.3	Surficial	Topsoil (3 inches)	
	0.3	5.0	Fill	Lean Clay (CL) - with silt, bricks, glass, and rock fragments - Brown, tan, and orangish brown - Moist	Firm
	5.0	7.0	Residual	Fat Clay (CH) - with silt and chert fragments - Reddish brown and tan - Moist	Firm to stiff, terminated at 7.0 feet

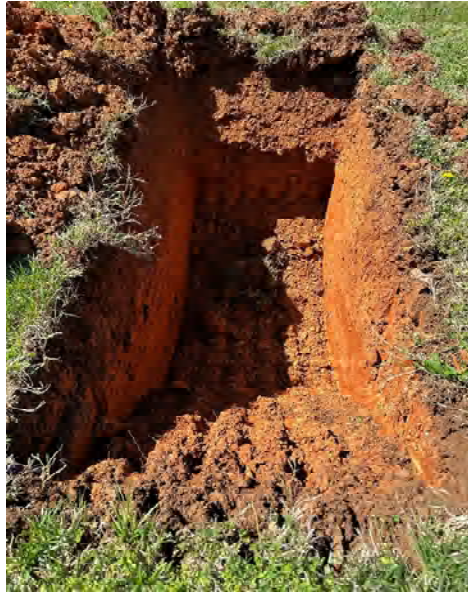
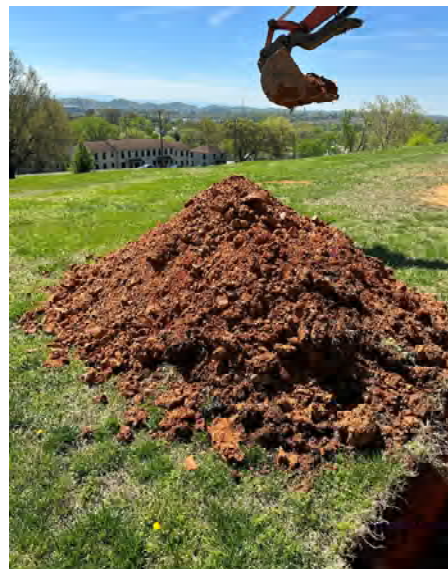
Location	Depth (ft.)		Material Type	Description	Comments
	from	to			
OP-14	0.0	0.3	Surficial	Topsoil (2 inches)	
	0.3	2.0	Fill	Lean Clay (CL) - with bricks, gravel, cobbles, and abandoned cable line - Brown and dark gray - Moist	Firm
	2.0	5.0	Residual	Fat Clay (CH) - with silt and chert fragments - Reddish brown, tan, and white - Moist	Stiff to very stiff, terminated at 5.0 feet

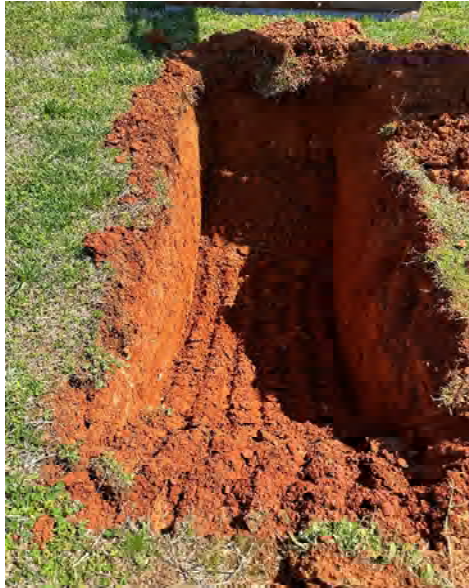
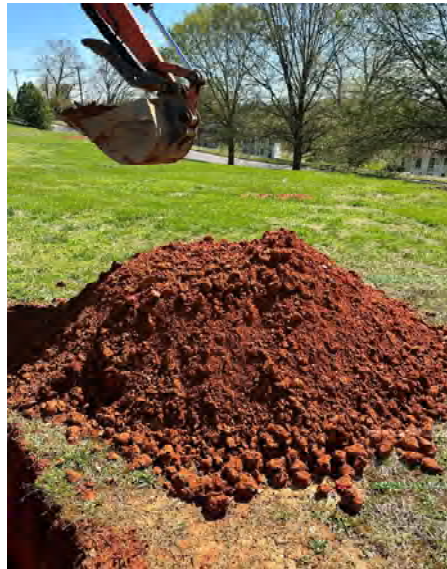
Location	Depth (ft.)		Material Type	Description	Comments
	from	to			
OP-15	0.0	0.2	Surficial	Topsoil (2 inches)	
	0.2	4.0	Residual	Fat Clay (CH) - with silt and chert fragments - Reddish brown and tan - Moist	Stiff to hard, terminated at 4.0 feet
