A WALL REPAIR .
 .SOCASTEE HIGH SCHOOL .
 .4900 SOCASTEE BLVD .
 .MYRTLE BEACH, SOUTH CAROLINA .

DRAWING DESCRIPTION:
 PROJECT REPAIR
 LOCATIONS/ELEVATION

DRAWING DESCRIPTION:
PROJECT REPAIR
DETAILS

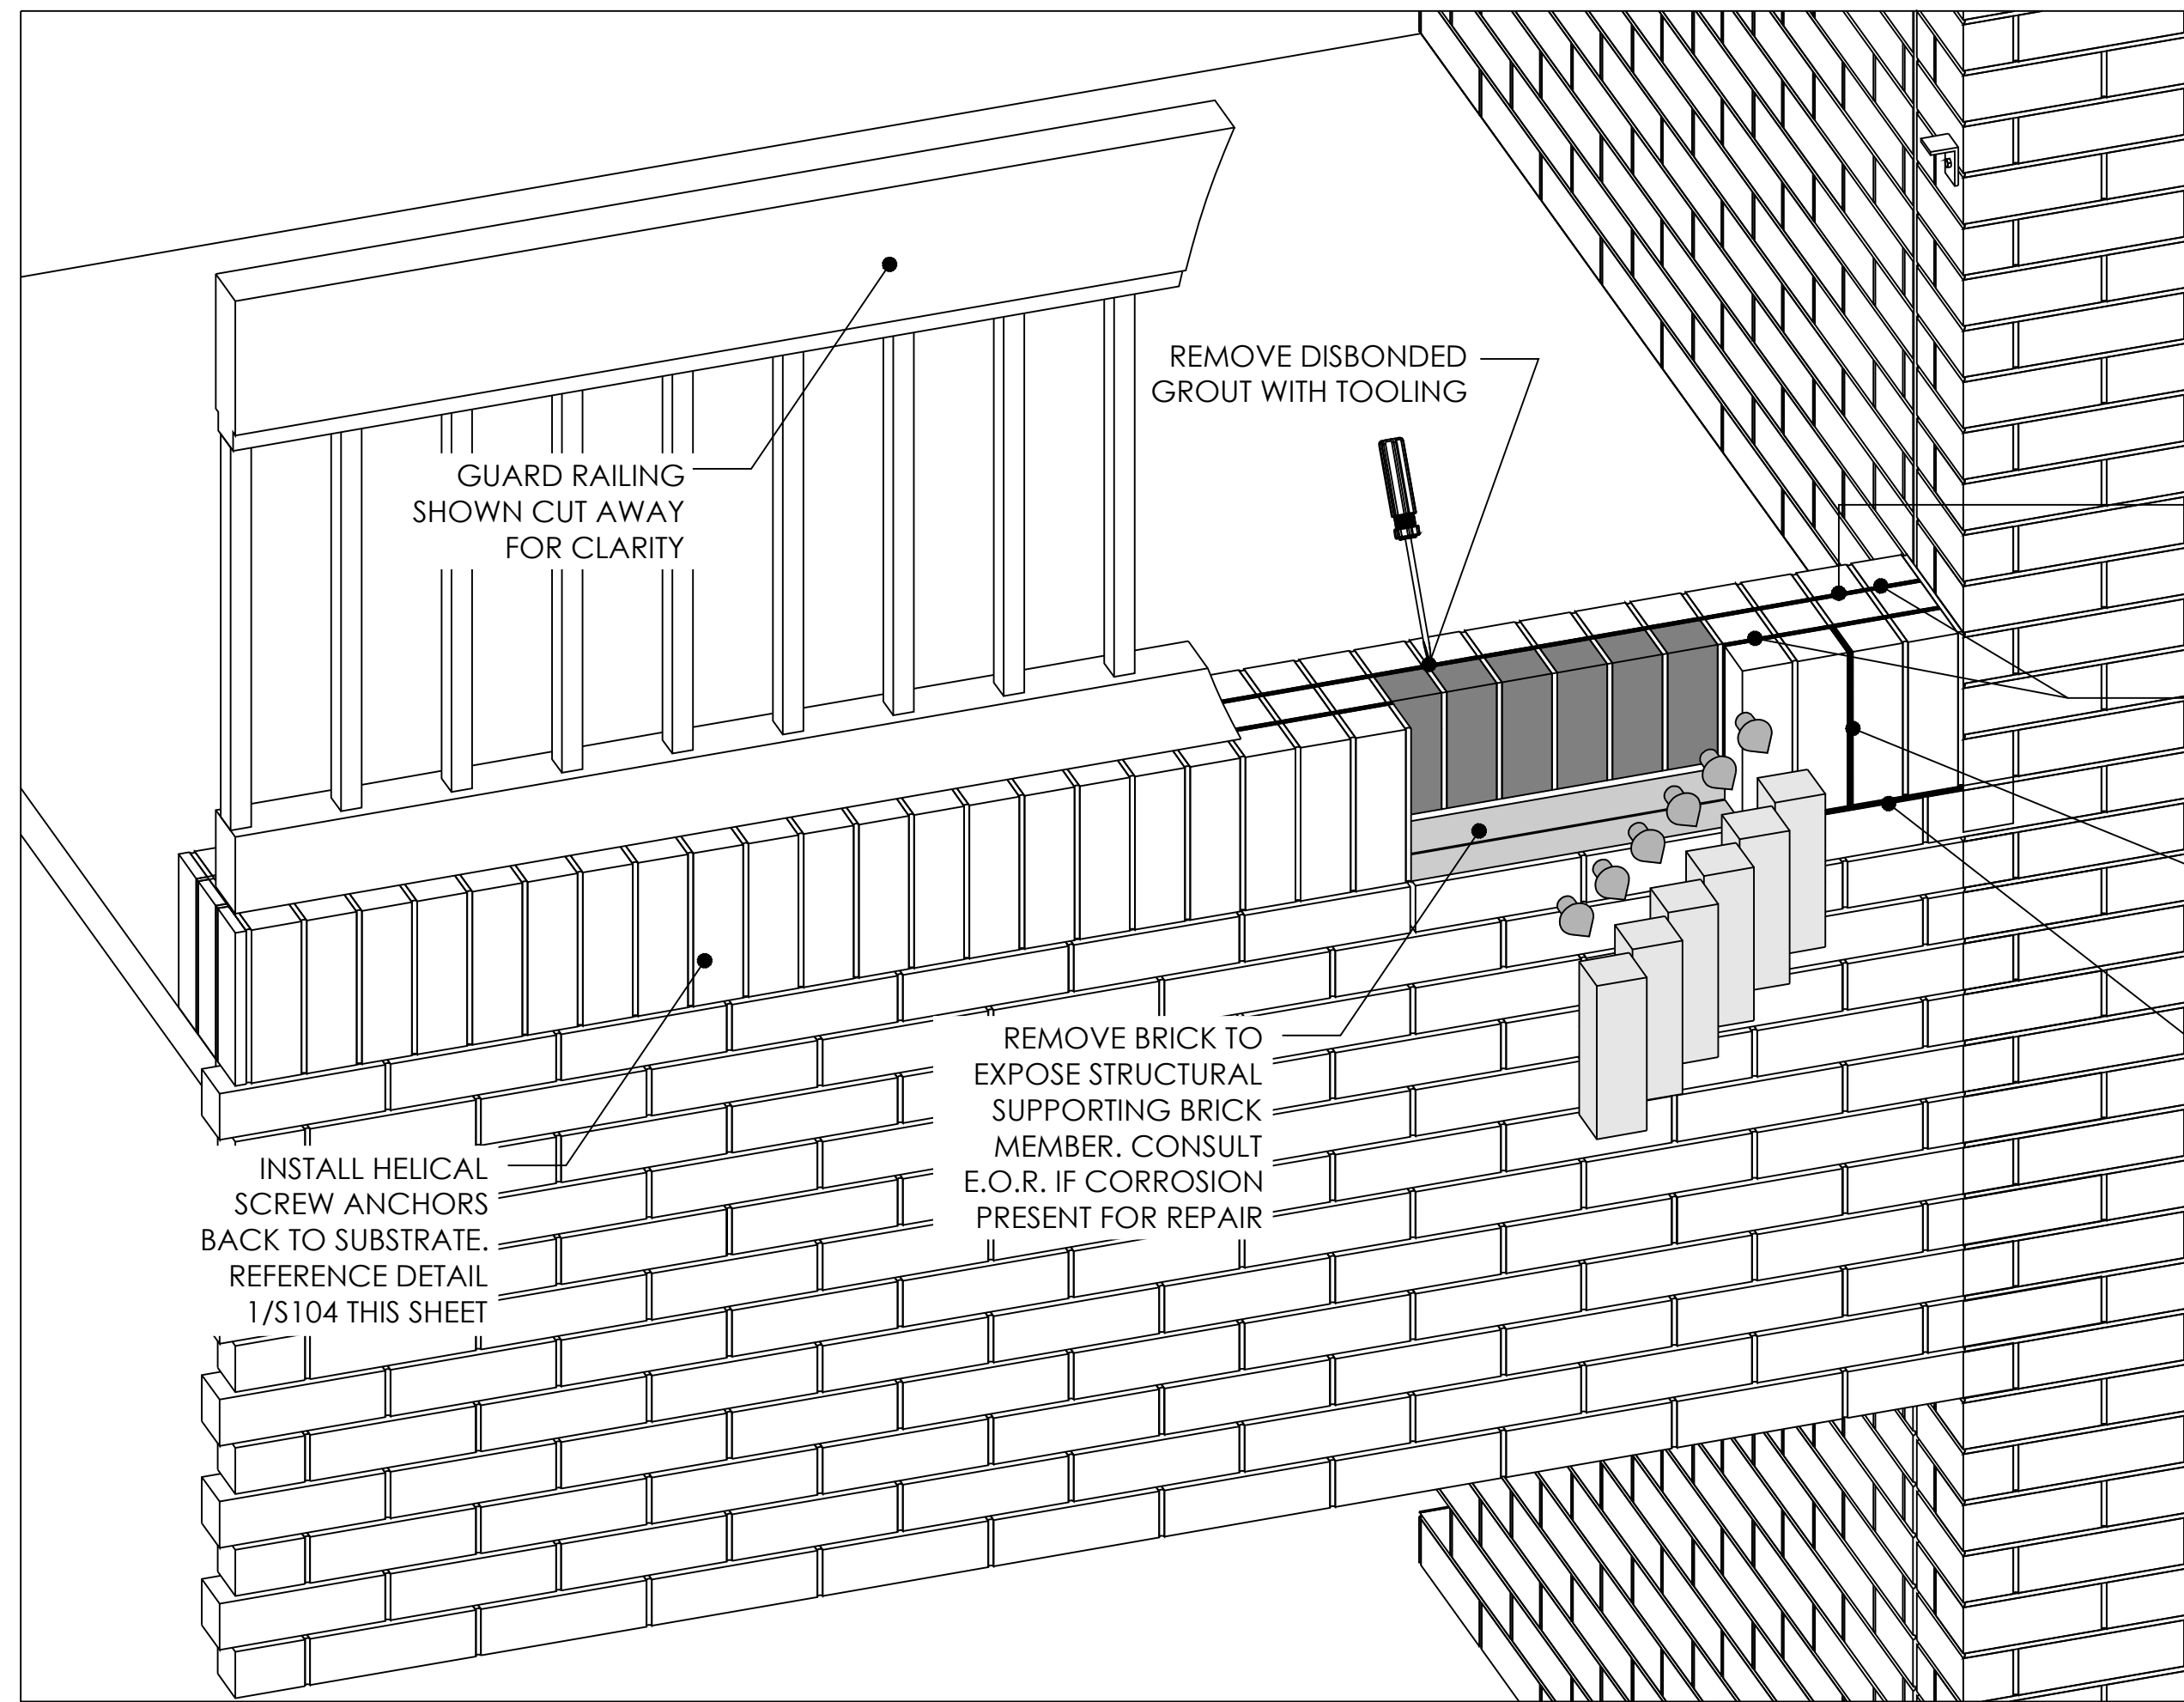
DETAIL - 1/S104
PARAPET KNEE WALL REPAIR OVER FRONT ENTRY
 N.T.S.

DRILL PILOT HOLES FOR RECEPTION OF NEW HELI-TIE BRICK ANCHORS. INSTALL AT 32" O.C. HORIZONTAL AND AT 16" O.C. VERTICAL. SEE DIAGRAM-1

TO PENETRATE SUBSTRATE BELOW COUNTER FLASHING

INSTALL 1/2" OR ACCEPTABLE BACKER ROD AT ROUTED JOINT

APPLY (2)-BEADS OF SIKA 2C EZ MIX AT TOP HORIZONTAL ROUTED JOINTS TYP.

APPLY SIKA HYFLEX 150 AT VERTICAL ROUTED JOINTS TYP.

APPLY A BEADS OF SIKA 2C EZ MIX AT HORIZONTAL ROUTED JOINTS TYP.
