Asbestos & Lead Based Paint Assessment

City of Spartanburg
147 Princeton Street
Spartanburg, South Carolina 29306

Project Number: 0120-17

February 10, 2020

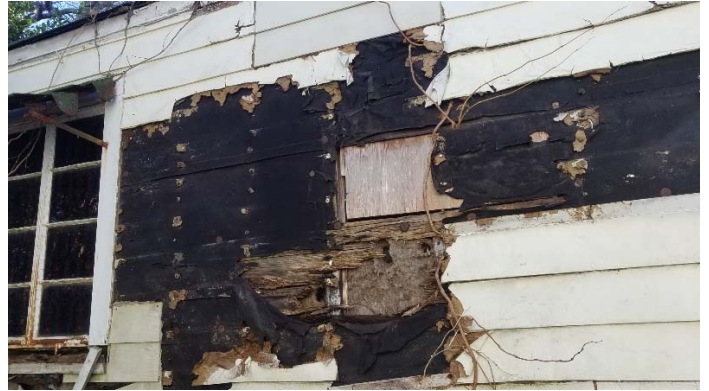
| Sample No. | Location | Sample Description | Analytical Results | Friable/Non Friable | Condition | Quantity |
|---|---|---|---|---|---|---|
| 10 | Ext. siding | Black felt | PLM - NAD | Non-friable | Good | 4,200 SF |

Photo 2 – Black felt under non-suspect exterior siding.

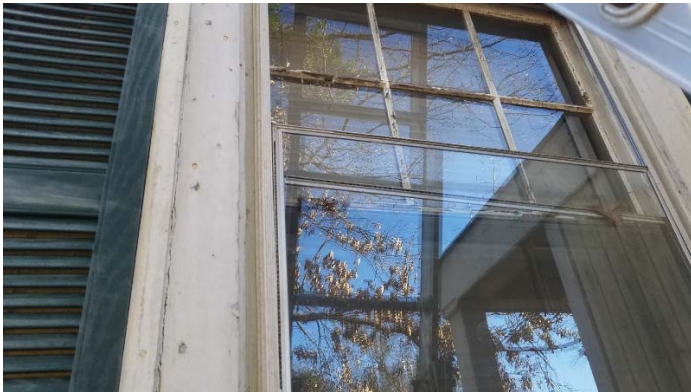
| Sample No. | Location | Sample Description | Analytical Results | Friable/Non Friable | Condition | Quantity |
|---|---|---|---|---|---|---|
| 7 | Windows | Glazing | PLM - NAD | Non-friable | Good | 12 EA |

Photo 3 – Exterior window glazing.

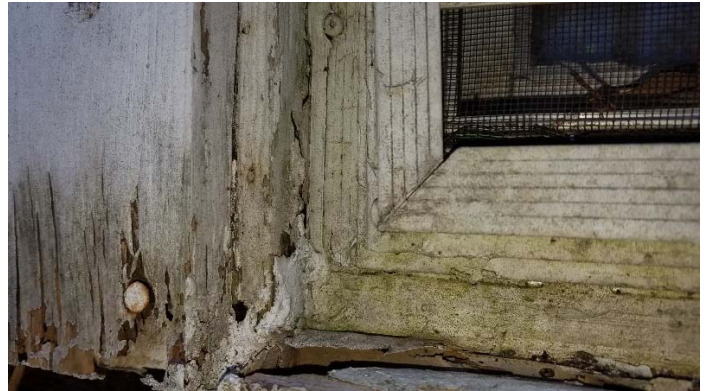
| Sample No. | Location | Sample Description | Analytical Results | Friable/Non Friable | Condition | Quantity |
|---|---|---|---|---|---|---|
| 4 | Windows | Caulk | PLM - NAD | Non-friable | Good | 12 EA |

Photo 4 – Exterior window caulk.

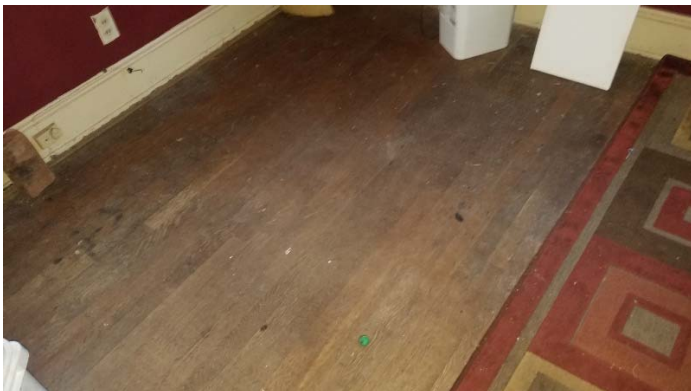
Photo 5 – Wood flooring.

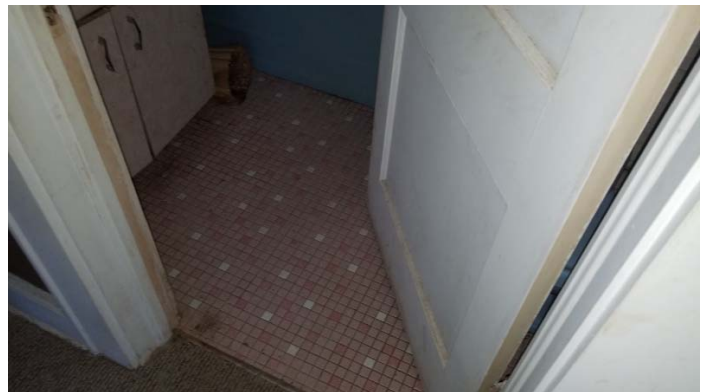
Photo 6 – Bathroom ceramic tile flooring.

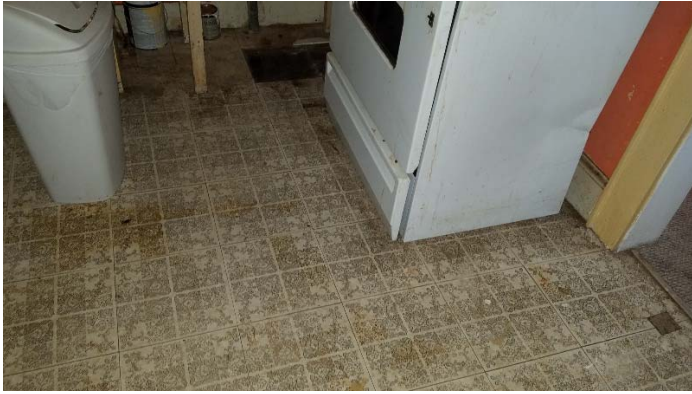
- Approximately 120 SF of 12"x12" grey self-stick floor tile in the kitchen.

| Sample No. | Location | Sample Description | Analytical Results | Friable/Non Friable | Condition | Quantity |
|---|---|---|---|---|---|---|
| 13 | Kitchen | 12"x12" grey self stick floor tile | PLM - 3% Chrysotile | Non-friable | Good | 120 SF |

Photo 7 – Kitchen self-stick floor tile.

1. Abate the asbestos containing materials in the structure prior to renovation or demolition.
2. Follow applicable asbestos regulations during renovation or demolition of the structure. You should be aware that stringent requirements are imposed upon anyone renovating or demolishing a structure in which ACM will be disturbed. This work must be performed in accordance with OSHA asbestos regulations, 29 CFR 1910 & 1926, and NESHAP asbestos regulations 40 CFR 61, subpart M. South Carolina regulations require the accreditation of personnel who work in the asbestos field and notification and permitting fees for asbestos removal projects. There is a 10 working day notification period required prior to abatement of asbestos in a facility. Failure to take proper precautions and actions to protect human health and the environment can result in penalties, danger to personnel, and construction delays.
