Subject: **REPORT OF GEOTECHNICAL EXPLORATION ADDENDUM**
Vermont Avenue Multi-Family Development
1800 & 1900 Vermont Avenue
Knoxville, Tennessee
GEOservices Project No. 21-23276

We are submitting this Addendum to our Report of *Geotechnical Exploration*, dated March 28, 2023, for the proposed development to be located off Vermont Avenue in Knoxville, Tennessee. This addendum report provides the results of the observation pits, and the laboratory test results from the previous exploration. This work was performed, as authorized by you, in accordance with our Proposal No. 11-23173, dated February 1, 2023.

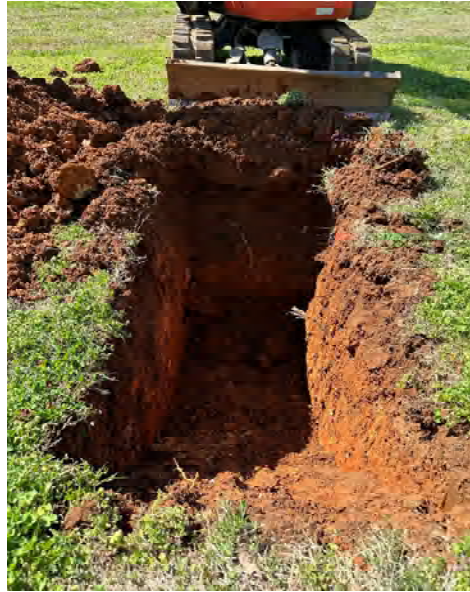
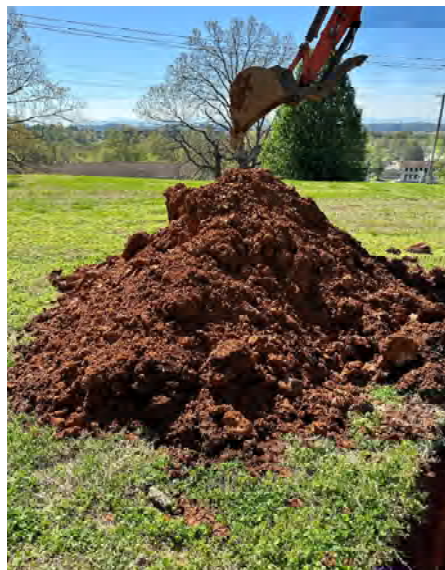
Location	Depth (ft.)		Material Type	Description	Comments
	from	to			
OP-1	0.0	0.2	Surficial	Topsoil with roots (2 inches)	
	0.2	4.0	Fill	Lean Clay (CL) - with bricks, rock fragments, and abandoned water and cable lines - Brown, reddish brown, and dark gray - Moist	Firm
	4.0	5.0	Residual	Fat Clay (CH) - with silt and chert fragments - Reddish brown, tan, and white - Moist	Stiff, terminated at 5.0 feet

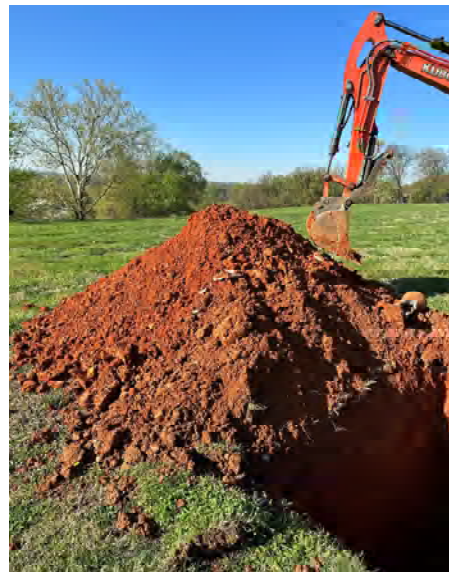
Location	Depth (ft.)		Material Type	Description	Comments
	from	to			
OP-3	0.0	0.2	Surficial	Topsoil (2 inches)	
	0.2	5.5	Fill	Lean Clay (CL) - with boulders, asphalt fragments, cables, glass, concrete fragments, pipes, and abandoned water, sewer, and phone lines - Brown, dark brown, and reddish brown - Moist	Firm
	5.5	9.5	Residual	Fat Clay (CH) - with silt, chert fragments, and weathered rock at depth - Reddish brown and tan - Moist	Firm to stiff, terminated at 9.5 feet

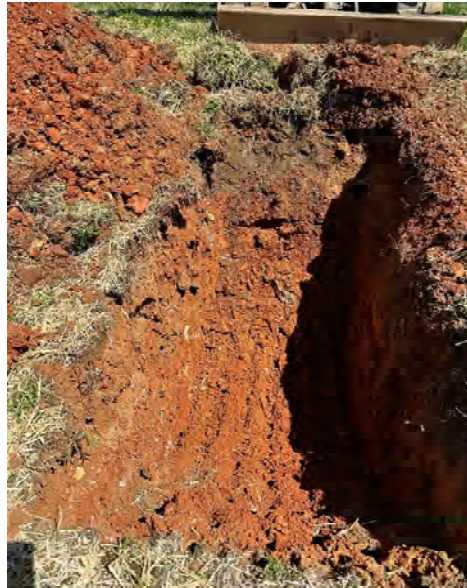
Location	Depth (ft.)		Material Type	Description	Comments
	from	to			
OP-4	0.0	0.2	Surficial	Topsoil (2 inches)	
	0.2	2.0	Fill	Lean Clay (CL) - with gravel, bricks, and concrete fragments - Brown, dark brown, and dark gray - Moist	Firm
	2.0	4.5	Residual	Lean Clay (CL) - with silt, chert fragments, and weathered rock - Reddish brown and white - Moist	Very stiff to hard, terminated at 4.5 feet

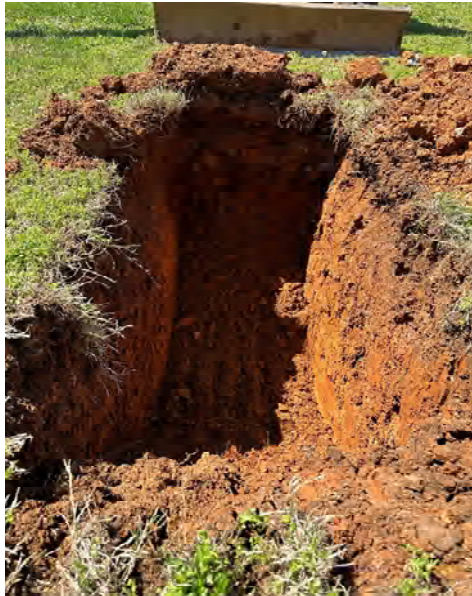
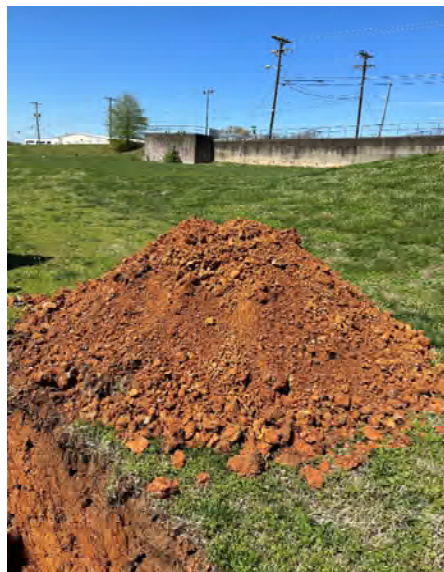
Location	Depth (ft.)		Material Type	Description	Comments
	from	to			
OP-6	0.0	0.4	Surficial	Topsoil (5 inches)	
	0.4	3.5	Fill	Lean Clay (CL) - with bricks, gravel, debris, and rock fragments - Brown, dark gray, and reddish brown - Moist	Stiff
	3.5	5.0	Residual	Fat Clay (CH) - with silt and chert fragments - Reddish brown and tan - Moist	Very stiff to hard, terminated at 5.0 feet

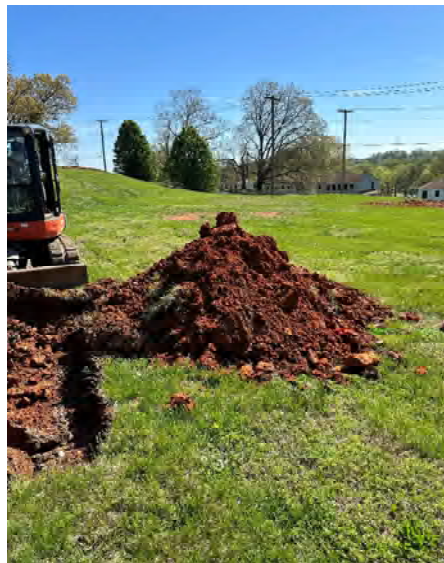
Location	Depth (ft.)		Material Type	Description	Comments
	from	to			
OP-7	0.0	0.2	Surficial	Topsoil (2 inches)	
	0.2	1.0	Fill	Lean Clay (CL) - with bricks and gravel - Brown and dark gray - Moist	Firm
	1.0	1.8	Fill	Reinforced concrete slab with attached sewer pipes (9 inches)	Hard
	1.8	2.5	Residual	Fat Clay (CH) - with silt and chert fragments - Reddish brown and tan - Moist	Stiff, terminated at 2.5 feet

During our exploration, we encountered building remnants and foundation elements from previous construction in at least one location. Based on our on site observations and given the historical use of the site, we expect that more foundation elements will be encountered during construction. Our previous report recommended the use of rammed aggregate piers. While still an option, the presence of large buried impenetrable materials, such as the foundation elements at this site, could present some difficulties during rammed aggregate pier installation and need to be removed prior to the construction of the piers.

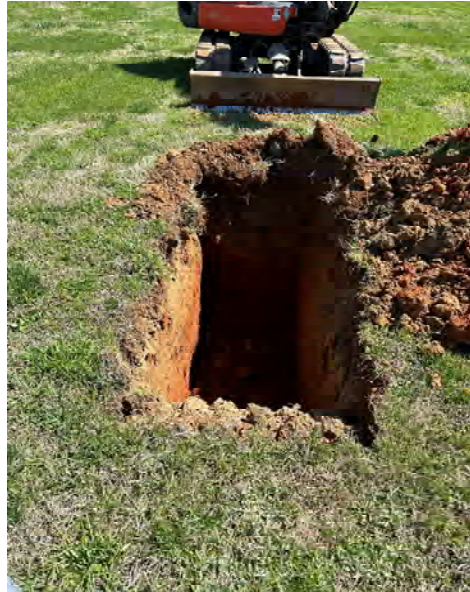
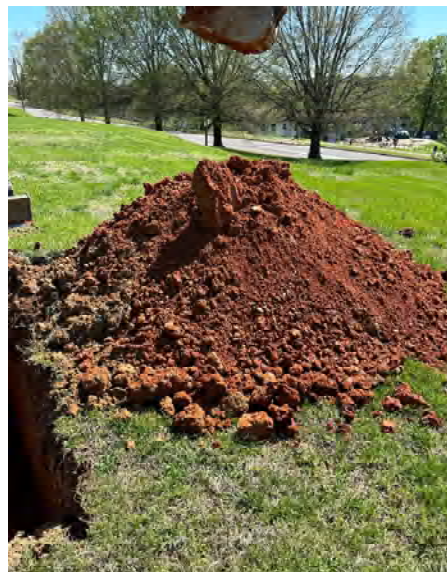
Location	Depth (ft.)		Material Type	Description	Comments
	from	to			
OP-8	0.0	0.2	Surficial	Topsoil (2 inches)	
	0.2	3.5	Fill	Lean Clay (CL) - with silt, bricks, and concrete fragments - Light brown, tan, reddish brown, and brown - Moist	Firm
	3.5	6.0	Residual	Fat Clay (CH) - with silt and chert fragments - Reddish brown and tan - Moist	Stiff, terminated at 6.0 feet

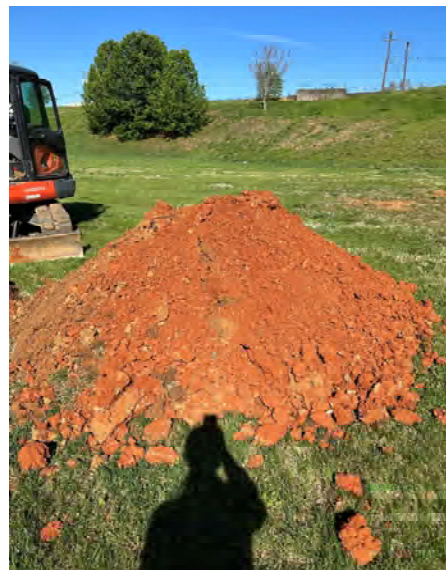
Location	Depth (ft.)		Material Type	Description	Comments
	from	to			
OP-10	0.0	0.2	Surficial	Topsoil (3 inches)	
	0.2	3.0	Fill	Lean Clay (CL) - with silt, silt fence fabric, and brick fragments - Dark gray, brown, tan, and reddish brown - Moist	Firm
	3.0	6.0	Residual	Fat Clay (CH) - with silt, significant chert fragments, and weathered rock at depth - Reddish brown, tan, and white - Moist	Stiff to very stiff, terminated at 6.0 feet

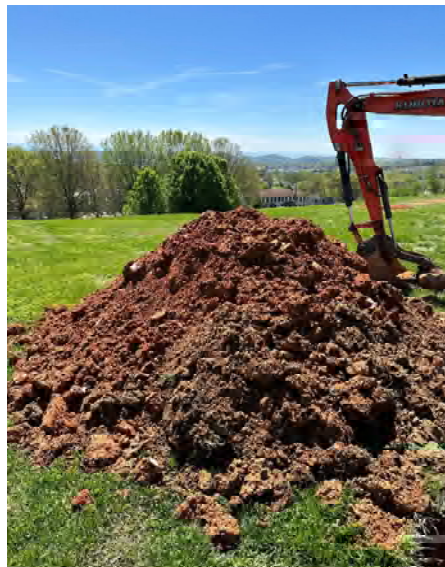
Location	Depth (ft.)		Material Type	Description	Comments
	from	to			
OP-11	0.0	0.3	Surficial	Topsoil (4 inches)	
	0.3	3.5	Fill	Lean Clay (CL) - with gravel, bricks, concrete fragments, and abandoned sewer line - Brown, light brown, and reddish brown - Moist	Stiff
	3.5	7.5	Residual	Lean Clay (CL) - with silt, chert fragments, and weathered rock - Reddish brown and white - Moist	Very stiff to hard, terminated at 7.5 feet

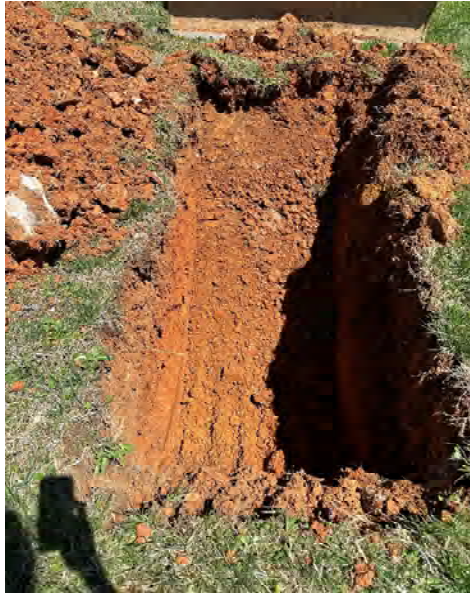
Location	Depth (ft.)		Material Type	Description	Comments
	from	to			
OP-12	0.0	0.2	Surficial	Topsoil (2 inches)	
	0.2	2.0	Fill	Lean Clay (CL) - with bricks, concrete fragments, and rock fragments - Brown, orangish brown, and gray - Moist	Stiff to very stiff
	2.0	4.5	Residual	Fat Clay (CH) - with silt, significant chert fragments, and weathered rock at depth - Reddish brown, tan, white, and red - Moist	Very stiff to hard, terminated at 4.5 feet

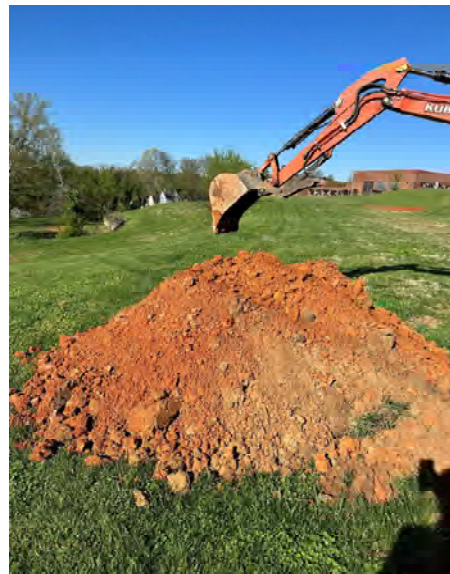
Location	Depth (ft.)		Material Type	Description	Comments
	from	to			
OP-13	0.0	0.3	Surficial	Topsoil (3 inches)	
	0.3	5.0	Fill	Lean Clay (CL) - with silt, bricks, glass, and rock fragments - Brown, tan, and orangish brown - Moist	Firm
	5.0	7.0	Residual	Fat Clay (CH) - with silt and chert fragments - Reddish brown and tan - Moist	Firm to stiff, terminated at 7.0 feet
