Re: QR 35567 – Tidal-Forested Freshwater Essential Fish Habitat – Trash and Debris Removal

EXHIBIT 5 — PHASE I ENVIRONMENTAL SITE ASSESSMENT

**FREEMAN PROPERTY
ST. JOHNS COUNTY, FLORIDA
LA 2017-029**

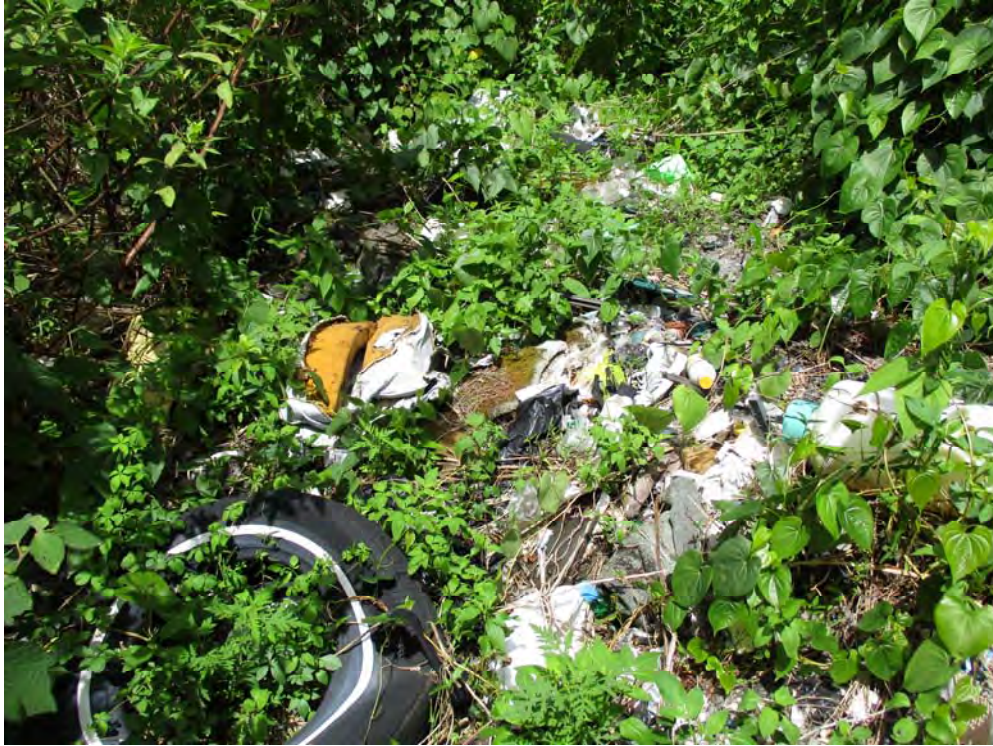
On-site concerns were noted from mounds of solid waste trash and debris including paper, glass, plastic, and waste tires observed on the northwestern portion of the site. Dense vegetation prevented a thorough assessment of the volume and types of products disposed. *De minimis* quantities of hazardous substances and/or petroleum products were observed in the surficial trash and debris; however, the potential exists for significant quantities of these types of materials to remain buried or otherwise concealed during the time of the inspection.

7) View of the solid waste trash and debris on the northwestern portion of the site.

Additionally, Aerostar recommends the removal and proper disposal of the solid waste trash and debris. No additional soil and groundwater sampling is recommended at this time, but further assessment may be warranted if evidence of the disposal of hazardous substances or petroleum products is observed during the removal activities. Aerostar understands that the site may consist of wetlands intended for restoration and conservation. If the area impacted by trash and debris consists of wetlands, additional restoration activities may be necessary depending on the extent of impacts to the area.

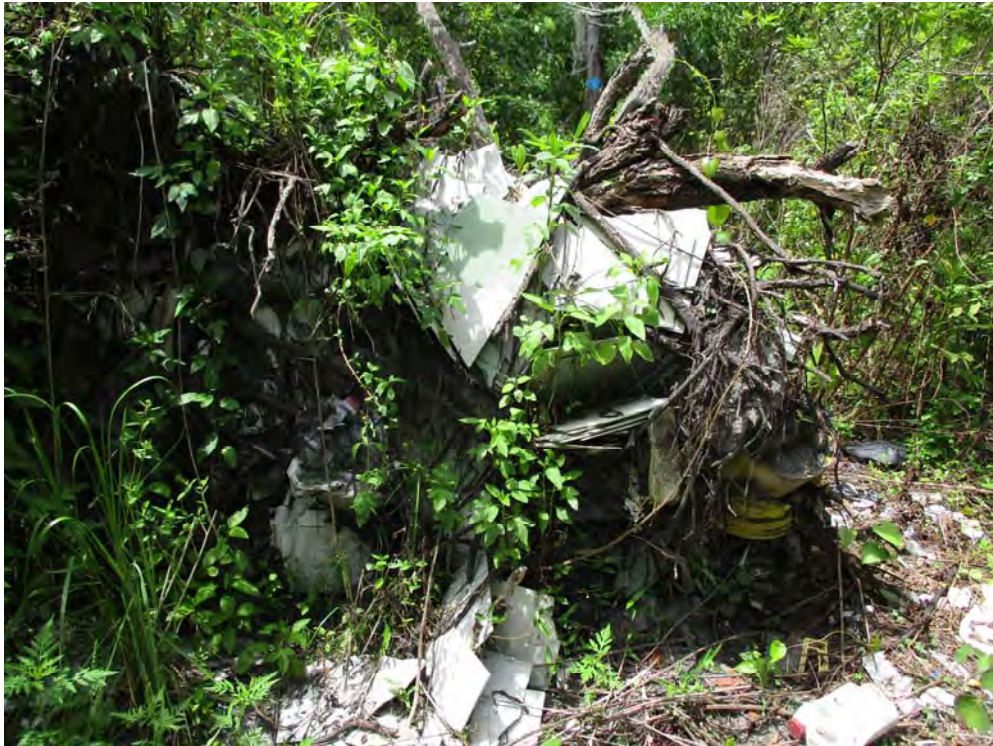
8) View of the solid waste trash and debris intergrown with roots and vegetation on the northwestern portion of the site.

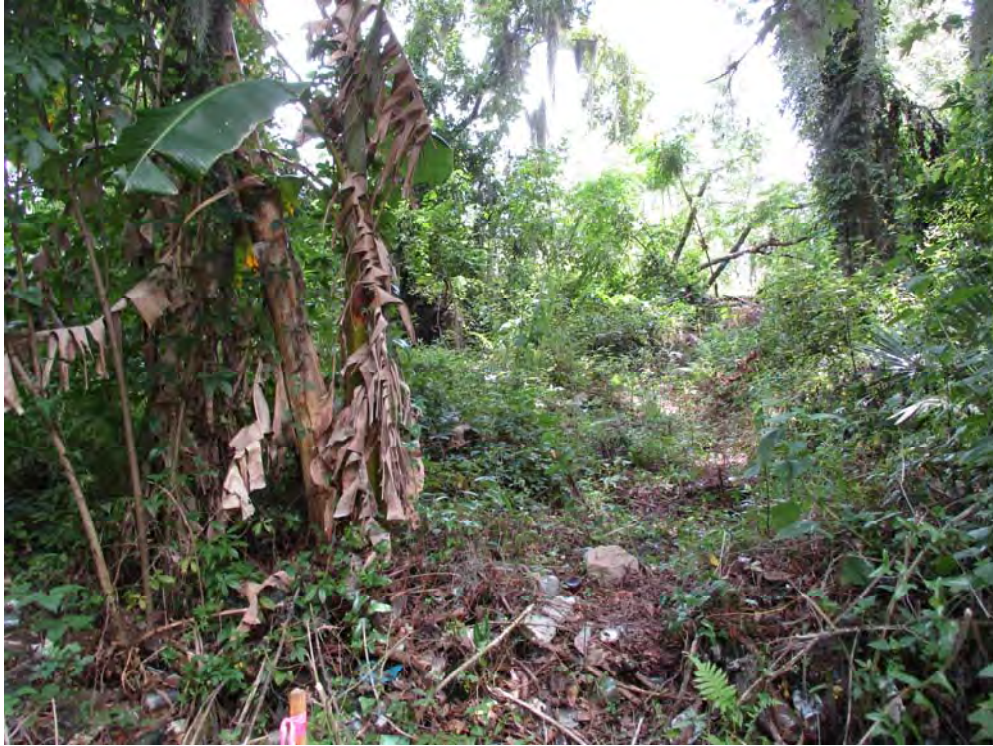
9) Looking south along the site boundary in the vicinity of the solid waste trash and debris.

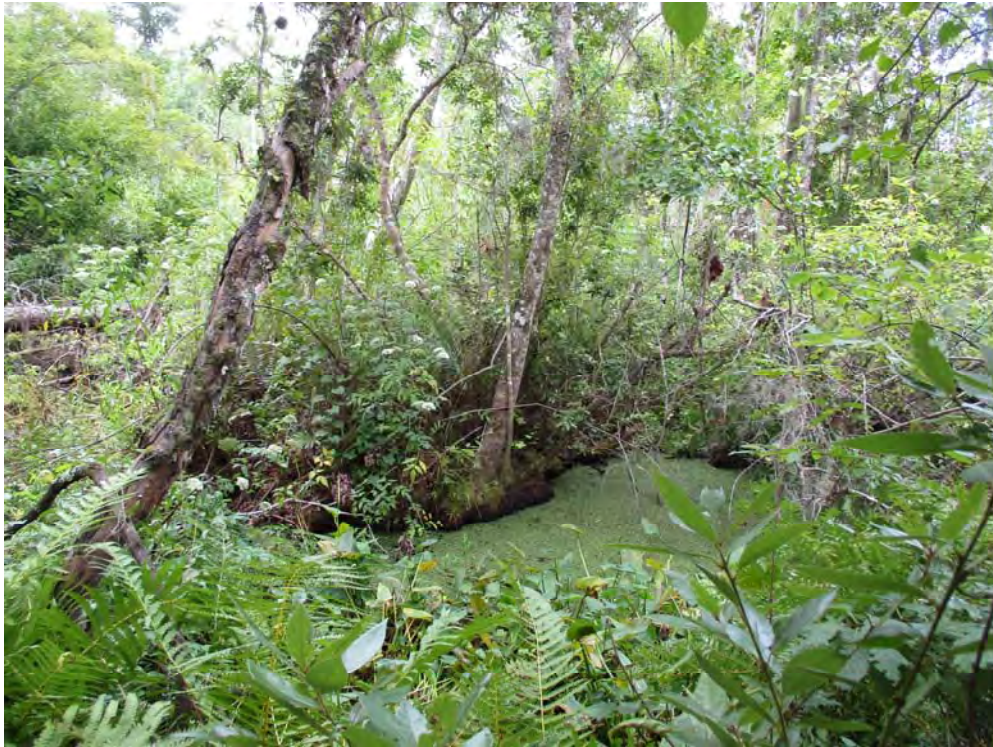
A canal was observed on site. According to Mr. Johnny Counts, Hastings Drainage District, and Mr. Leonard Freeman, site owner, stormwater runoff from thousands of acres of the surrounding agricultural land drains through the on-site canal to Deep Creek, located northeast of the site. On-site concerns were noted from the potential impact to the site from agriculture-related substances (herbicides and pesticides) in the stormwater runoff.

10) Looking east at the canal on the central portion of the site.

Based on the information reviewed as part of this investigation, further assessment of the site is recommended. Soil and groundwater samples should be collected from the former agricultural areas and analyzed for organochlorine pesticides by EPA Method 8081, organophosphorus pesticides by EPA Method 8141, chlorinated herbicides by EPA Method 8151, and arsenic and copper by EPA Method 6010. If future site activities include the possible disturbance of sediments in the on-site canals, Aerostar would also recommend the collection of sediment samples.

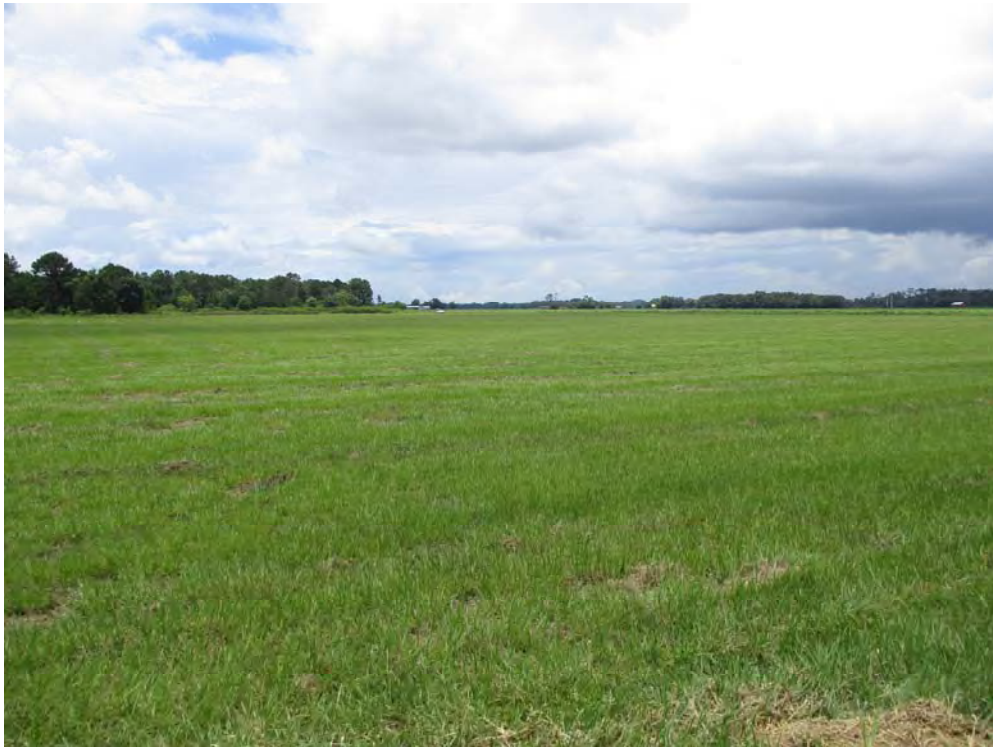
Off-site concerns were noted from the sod farms located on the northern, southern, and western adjoining properties. Typical operations associated with agricultural properties include the storage, handling, and application of herbicides and pesticides.

14) Looking southwest across the sod farm on the southern adjoining property.

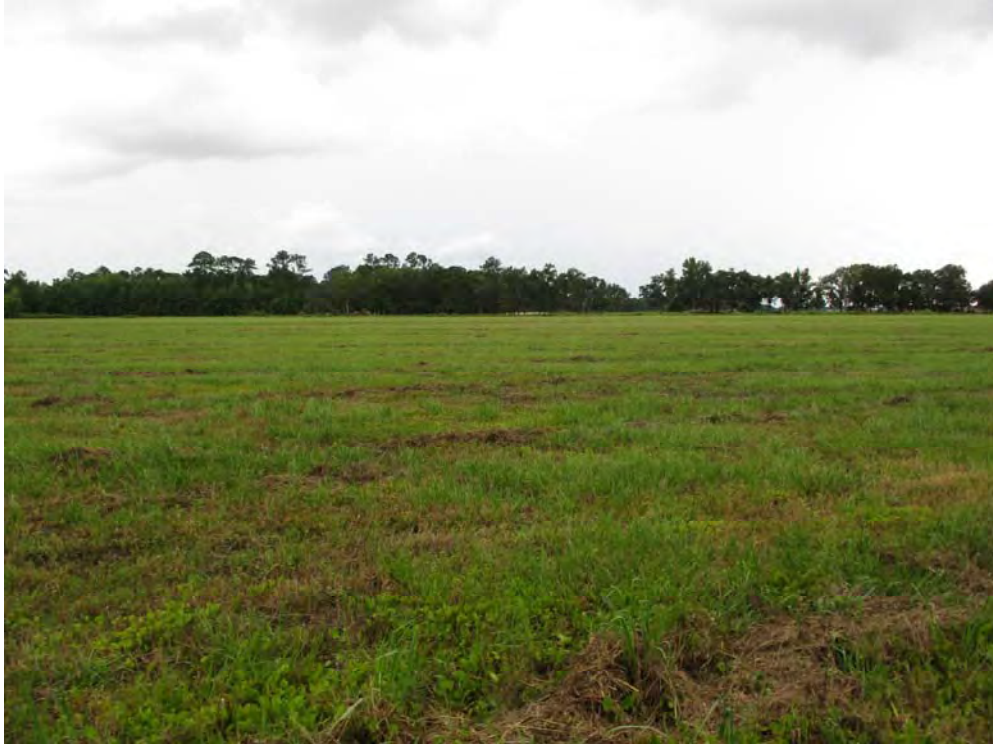
15) Looking south across the sod farm on the western adjoining property.
