## Phase I Environmental Site Assessment

**West Government Street Property  
401 West Government Street  
Pensacola, Florida 32502**

Escambia County Engineering  
3363 West Park Place  
Pensacola, Florida 32502

February 12, 2019

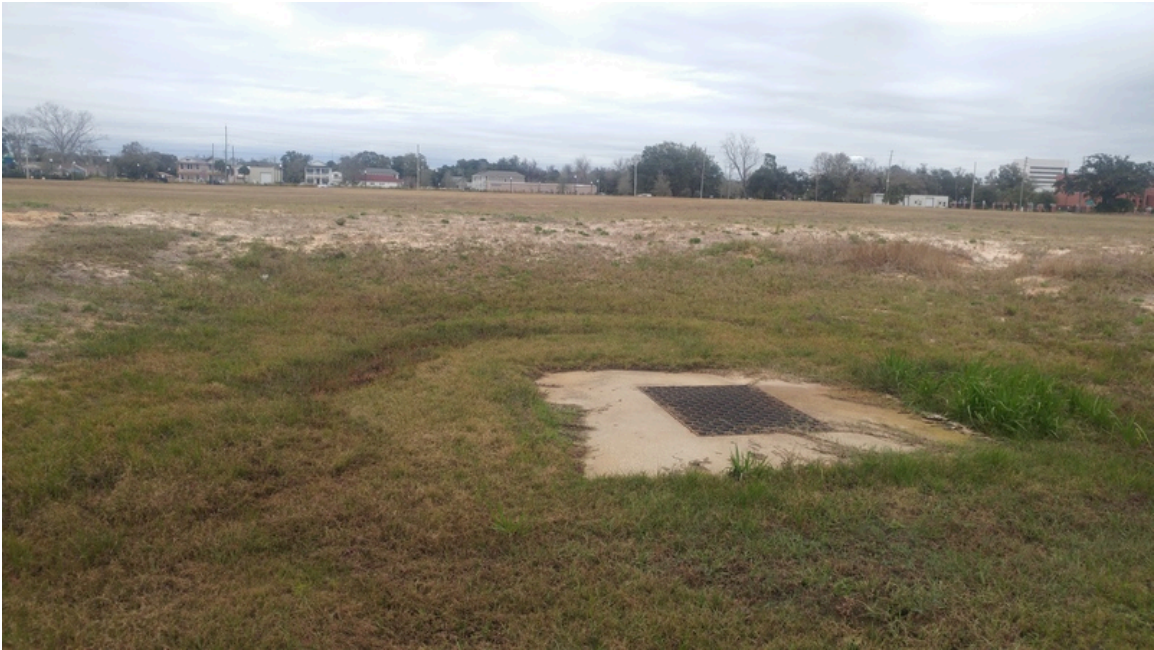
PSI observed a storm drain on the south central portion of the subject property. PSI did not observe evidence of unusual staining or improper disposal in connection with the observed storm drains, and the storm drains appeared to be in a generally good condition. The drain appear to flow into Washerwoman Creek which ultimately drains into Pensacola Bay. Based on this information, the observed storm drain is not considered to be evidence of a REC in connection with the subject property.

Photo 8: VIEW OF SUBJECT PROPERTY, NOTE STORM DRAIN.

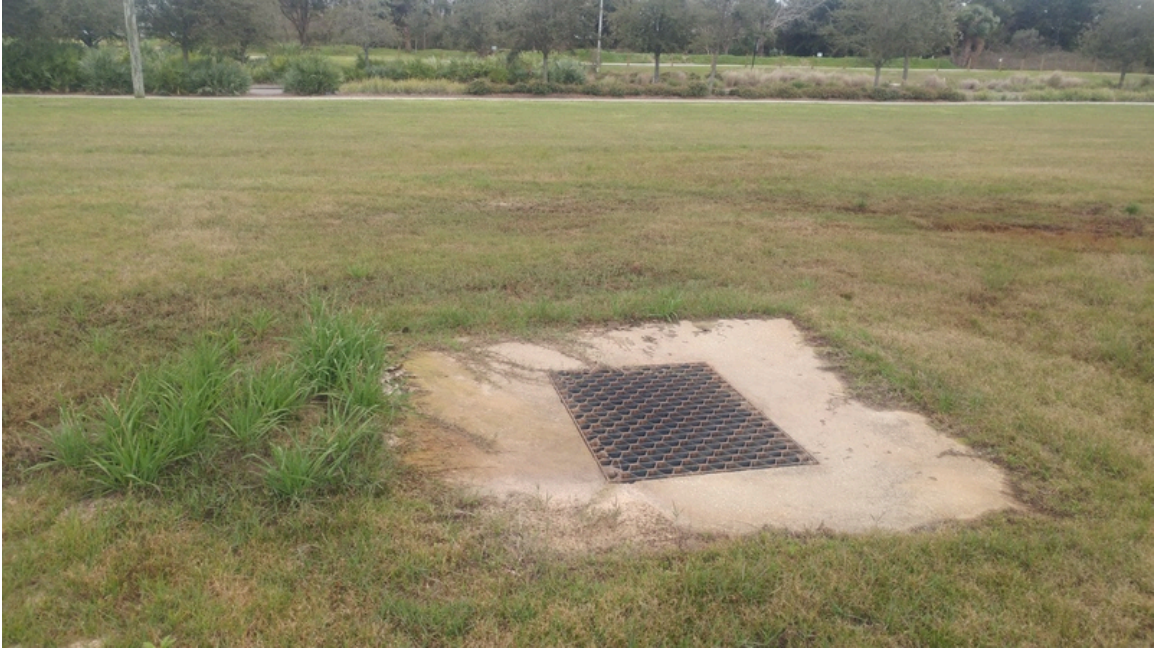
Photo 9: VIEW OF SUBJECT PROPERTY, NOTE STORM DRAIN.

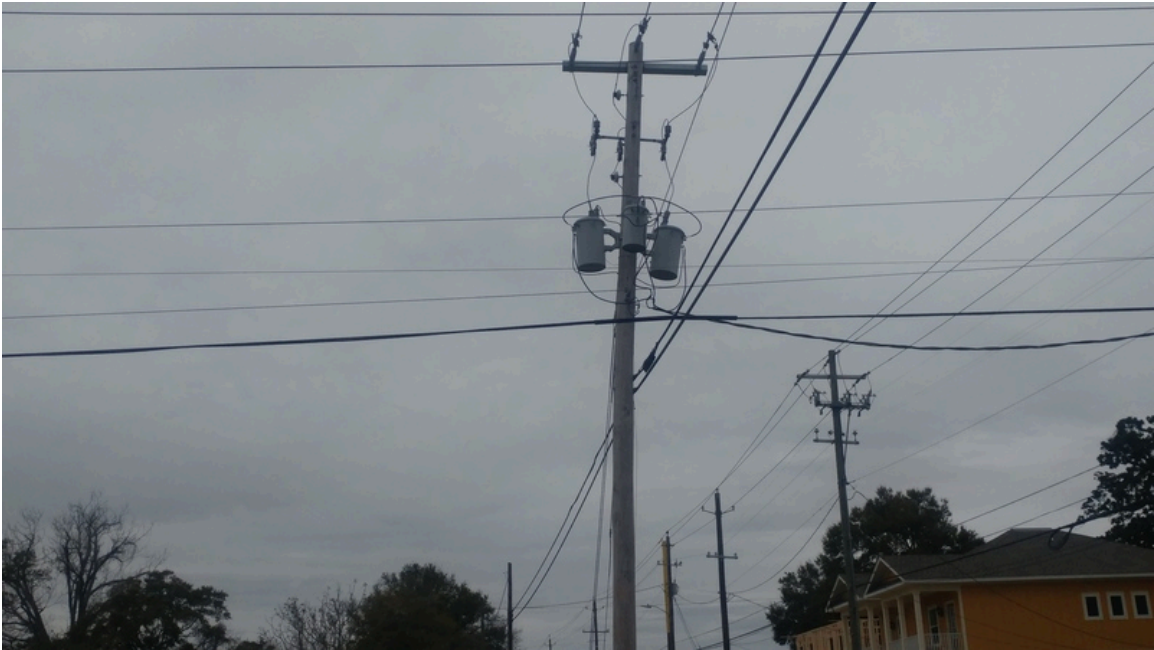
Three pole-mounted electrical transformers were observed on the north adjoining property. PSI did not observe non-PCB labeling on the transformers at the time of the site reconnaissance. PSI believes the electrical equipment is the property and responsibility of Gulf Power, the local electrical utility company, who would be responsible for cleanup related to the equipment that could not be attributed to tenant negligence. The identified electrical equipment appeared to be in good condition, with no apparent evidence of staining, leakage, or corrosion noted. Based on their observed condition and the local utility ownership, the observed transformers are not considered to be evidence of a REC in connection with the subject property.

Photo 22: VIEW OF NORTH ADJOINING PROPERTY, POLE-MOUNTED TRANSFORMER.

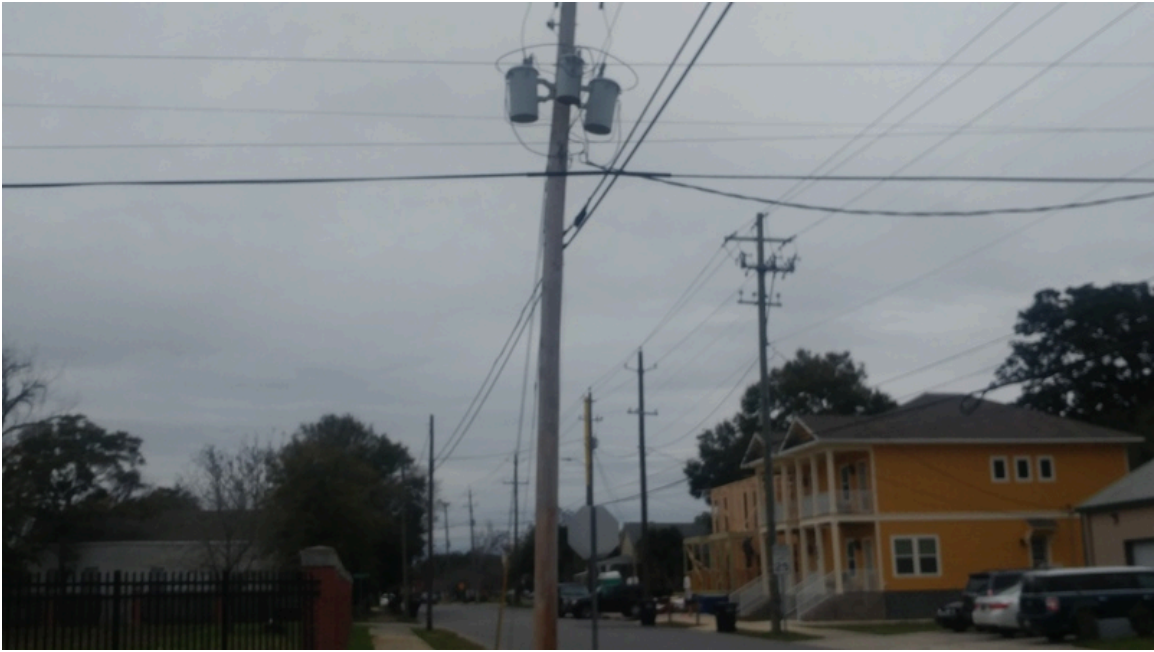
Photo 23: VIEW OF NORTH ADJOINING PROPERTY, POLE-MOUNTED TRANSFORMER.
