Award To/Lessee: TAYLOR ENGINEERING, INC.

Description of: ENGINEERING & ARCHITECTURAL CONSULTING SERVICES

Eastern Destin Fifteen-Year Post-Construction
Monitoring Report
Okaloosa County, FL

Western Destin Nine-Year Post-Construction
Monitoring Report
Okaloosa County, FL

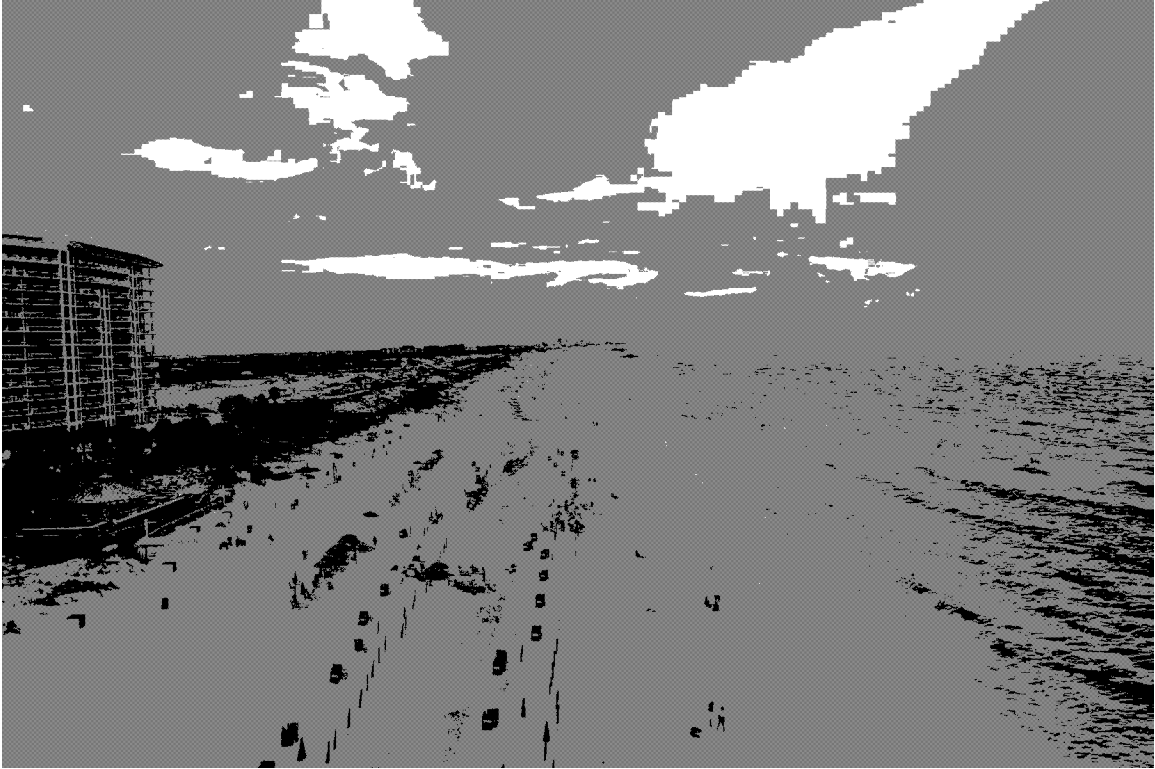
Figure 1: Okaloosa County near R-32 looking East (6/29/2022)

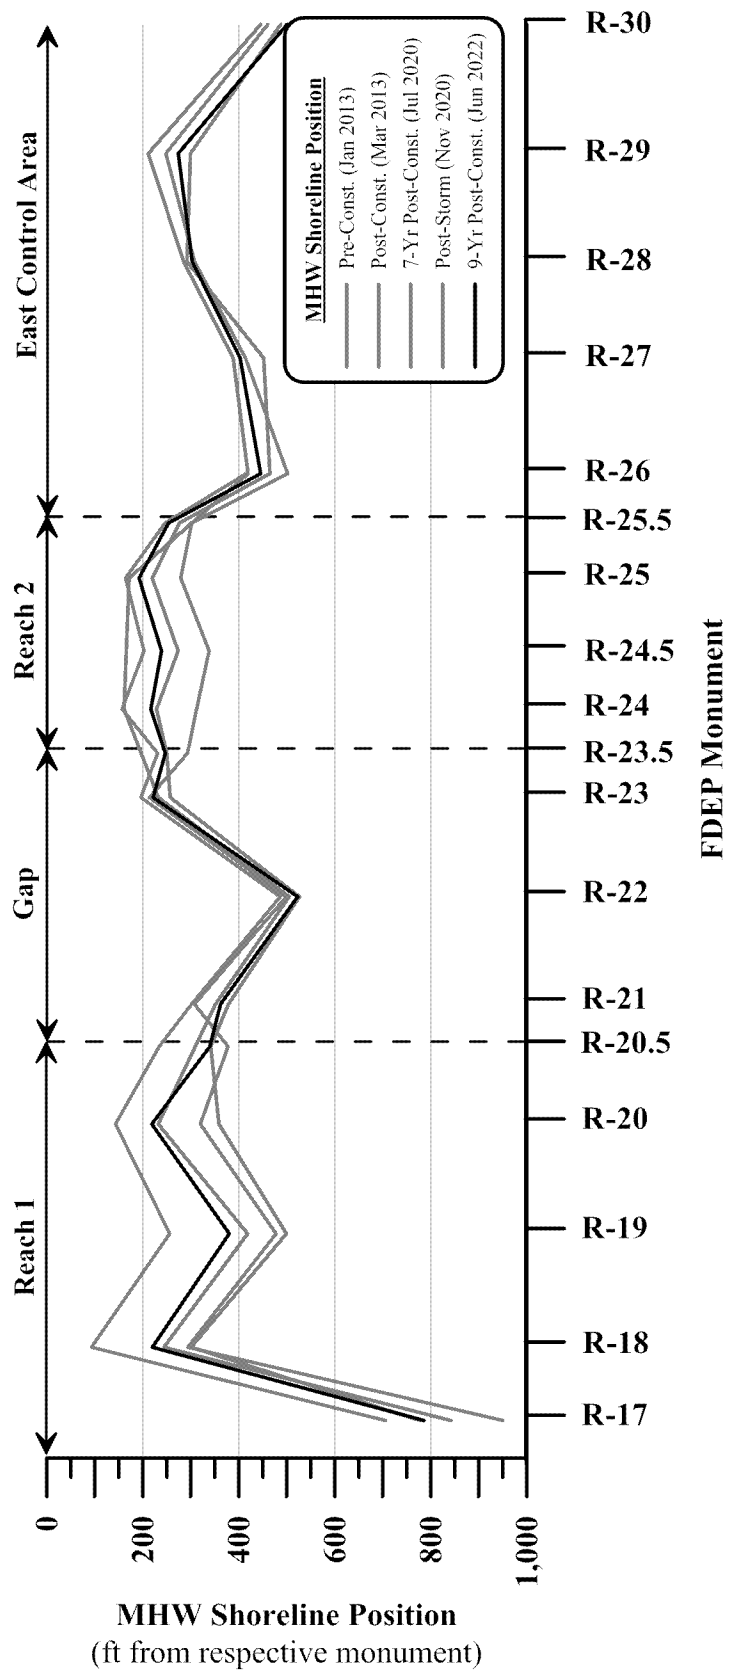
Figure 3.1 MHW Shoreline Position

Table 3.1 and **Figure 3.1** present the surveyed mean high water (MHW elevation = 0.77 ft- NAVD) shoreline position as a function of distance from each monument for the 2013 pre-construction, 2013 post-construction, 2020 seven-year post-construction, 2020 post-storm, and 2022 nine-year post-construction conditions. **Table 3.2** and **Figure 3.2** present the MHW shoreline changes for the above-mentioned comparison periods. Straight lines connect the MHW positions between reference

monuments. As noted in Section 2.2, the post-storm November 2020 survey did not include data at half monument locations, therefore, straight lines connect the MHW positions between the nearest whole monuments for the November 2020 survey. A positive change in shoreline position indicates seaward shoreline advance while a negative change indicates landward shoreline retreat.

The gap area MHW shoreline advanced seaward an average of 28.5 ft with a maximum advance of 54.2 ft at R-21 and a minimum of 7.6 ft at R-23. Longshore diffusion from the 2013 project in Reach 1 and Reach 2 and the 2020 dredging event in Reach 1 likely caused the shoreline advances within the gap area.

Reach 2 experienced average shoreline retreat of -23.1 ft, with a maximum retreat of -34.6 ft (R-24.5) and a minimum retreat of -3.0 ft (R-23.5). The recession in Reach 2 during this monitoring period could be a result of increased tropical storm activity. The shoreline retreats in Reach 2 are in similar magnitude to the adjacent gap area and east control area changes (discussed below), indicating this section of the shoreline may be at or approaching an equilibrated condition.

Comparisons between the 2020 post-storm (November 2020) and 2022 nine-year post-construction (June 2022) surveys reveal shoreline changes one and a half years following Hurricane Sally. The monitoring area shoreline experienced retreat in Reach 1, minor average advance in the gap area, and advance in Reach 2 and the east control area. As noted in Section 2.2, the post-storm November 2020 survey did not include data at half monument locations (R-20.5, R-23.5, R-24.5, and R-25.5). The increased longshore resolution provided by the half monuments is not possible in the post-storm data set.

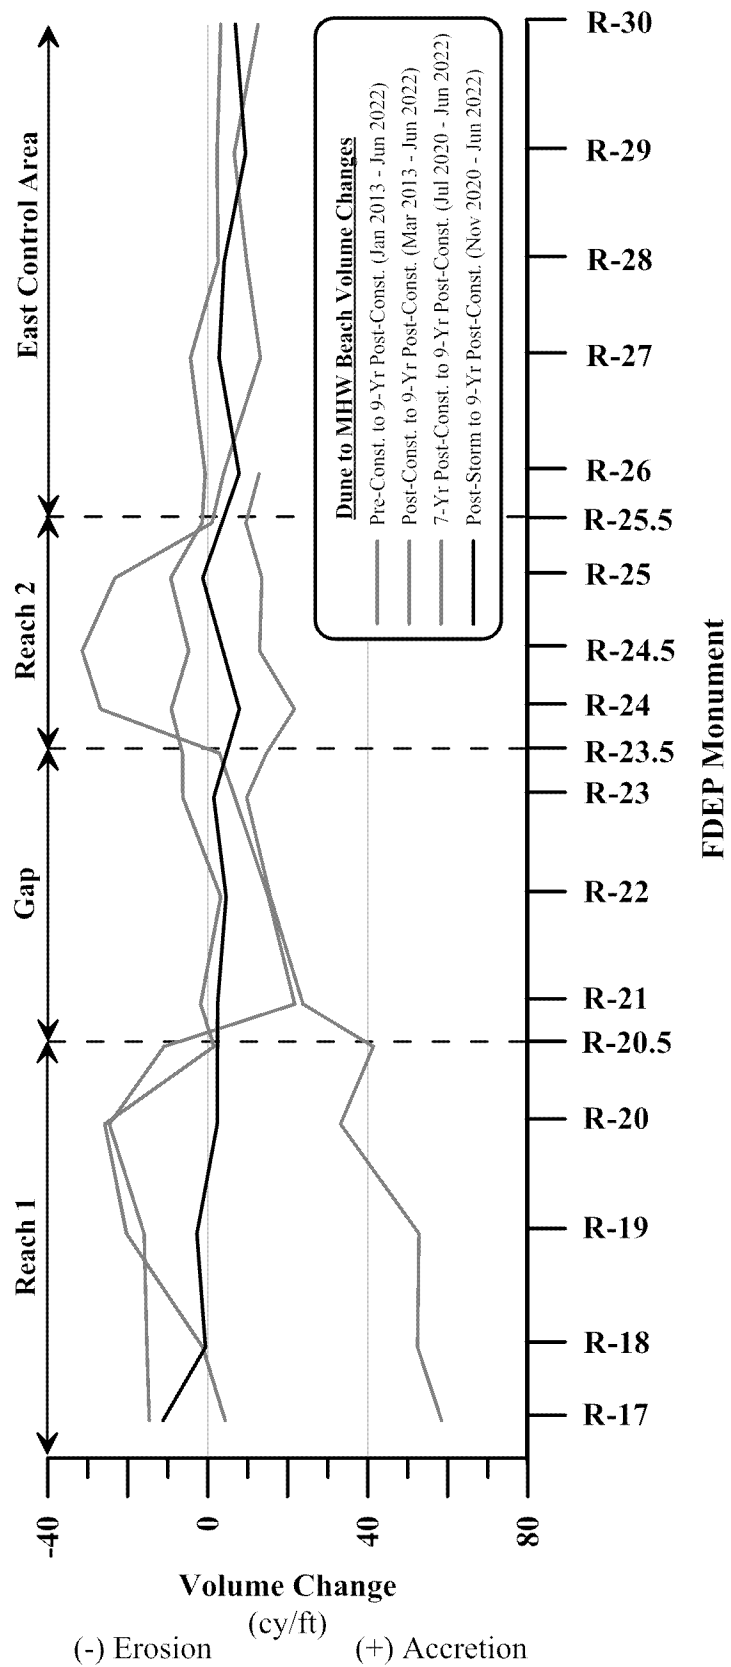
Figure 3.3 Dune to MHW Beach Volume Changes (cy/ft)

The beach monitoring area consists of the two project areas (Reach 1 and Reach 2), the gap area and the east control area. **Table 3.3 – Table 3.10** and **Figure 3.3 – Figure 3.9** present beach volume changes in the above-mentioned compartments at each reference monument location. Straight lines connect the volume changes between reference monuments. As noted in Section 2.2, the post-storm November 2020 survey did not include data at half monument locations, therefore, straight lines connect the volume changes between the nearest whole monuments for the November 2020 survey. With the beach volume changes rounded to tenths for cubic yard/foot (cy/ft) values and to hundreds for cubic yard (cy) values, some of the reported integrated values may not match exactly.

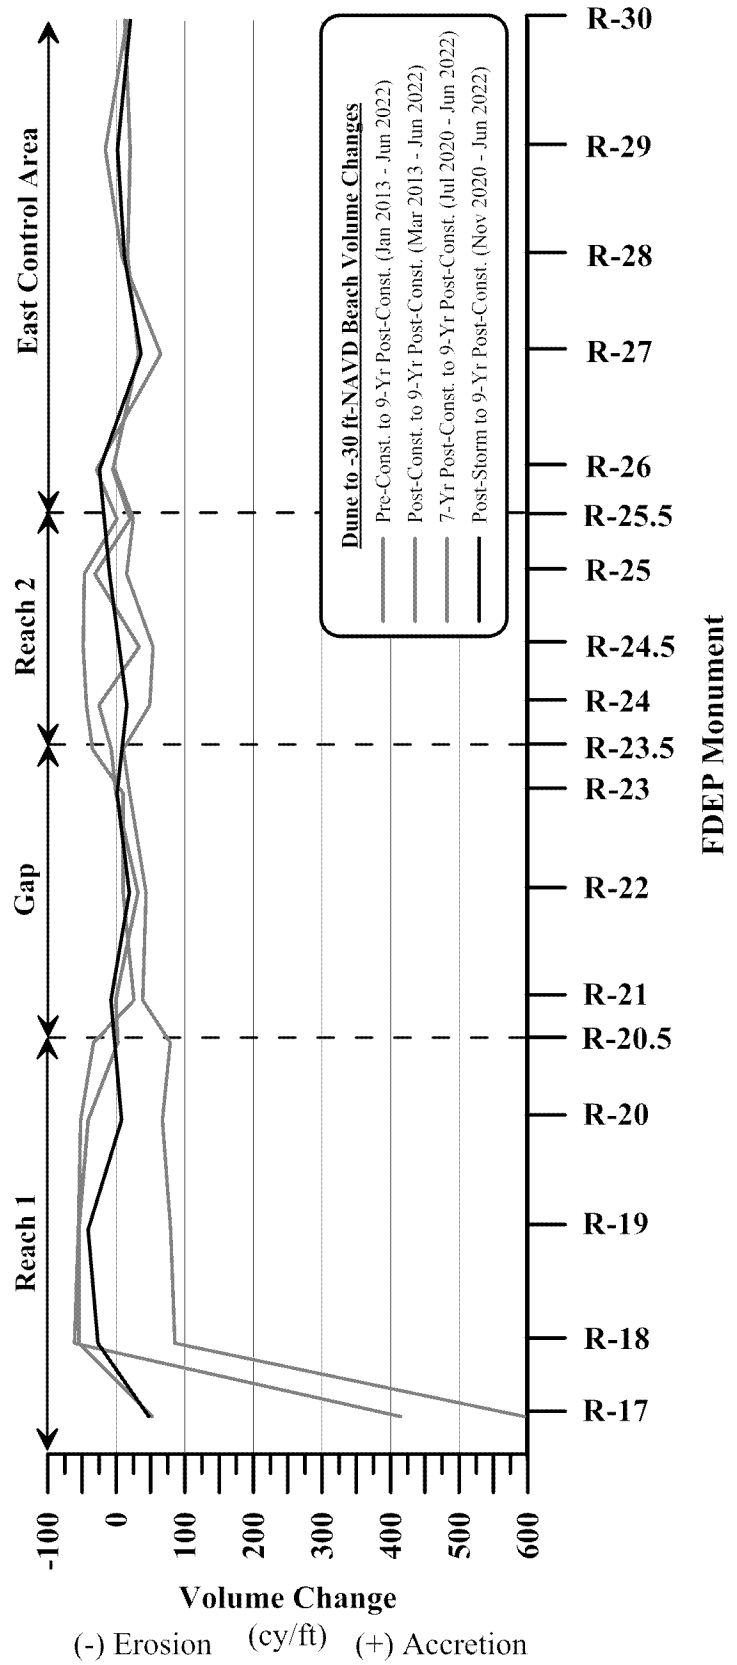
Figure 3.8 Dune to -30 ft-NAVD Beach Volume Changes (cy/ft)

The overall Reach 1 volume changes (dune to -30 ft-NAVD), on a monument-by-monument basis, show accretion across the project area with a trend of increasing accretion to the west (except for a slight decrease in accretion at R-20) and noticeably larger increases at R-17. Likely causes of the accretion trend include the larger fill volumes placed in the western portion of the 2013 project and placement mid-reach in 2020, the littoral barrier to the west (the East Pass jetty) reducing westerly longshore dispersion of the fill, and losses of the 2013 project fill at the east end from eastward longshore dispersion of the fill into the gap area. However, the volume change tables indicate noticeably larger accretion rates at reference monument R-17 as compared to the overall Reach 1 project area. Similar to the previous monitoring results, the profile plots of R-17 (**Appendix A**) clearly indicate the large volume changes between MLW and -20 ft-NAVD result from ebb shoal growth offshore of the project area and the nine-year post-construction survey reveals increased ebb shoal changes below -20 ft-NAVD. While a portion of the ebb shoal growth may result from offshore transport of the beach restoration project, determining the root causes of the ebb shoal changes requires further in-depth analyses of the entire ebb shoal and inlet system. As documented in previous monitoring reports, the ebb shoal growth likely results from the ebb-tide dominance of the inlet and the increased rain events in the local area over the past years transporting additional sediments from the bay and inlet system offshore; however, a portion of the sand accumulation along the eastern edge of the ebb shoal may result from longshore and offshore transport from the project area. While **Table 3.3 – Table 3.10** present overall beach volume changes and include ebb shoal changes, **Appendix D** summarizes the beach volume changes excluding these ebb shoal changes at R-17 (~1,200 to 3,500 ft offshore).

The east control area experienced a net gain of 76,000 cy (average 15.6 cy/ft) above -30 ft-NAVD. The control area shows a mix of minor accretion and erosion above MLW with noticeably higher accretion from R-27 to R-30 between MLW and -20 ft-NAVD. Mixed minor accretion and erosion occurs again between -20 and -30 ft-NAVD, while predominantly accretion occurs between -30 and -50 ft-NAVD. Overall, and above -20 ft-NAVD, the east control gained 78,000 cy, predominantly due to noticeably larger accretion at R-27. As noted above, these large accretion volumes above -20 ft-NAVD possibly result from easterly longshore dispersion of the Reach 2 beach fill and largely influence the overall volume changes for the east control area. As documented in previous monitoring reports, the continued easterly movement of large accretional areas likely indicates further easterly transport from the Reach 2 project area, and possibly a transport nodal point (easterly transport from the Reach 2 project area combining with westerly longshore transport from areas further to the east). The current results indicate the project continues to have a significant positive effect to overcome the erosion previously occurring along these areas.

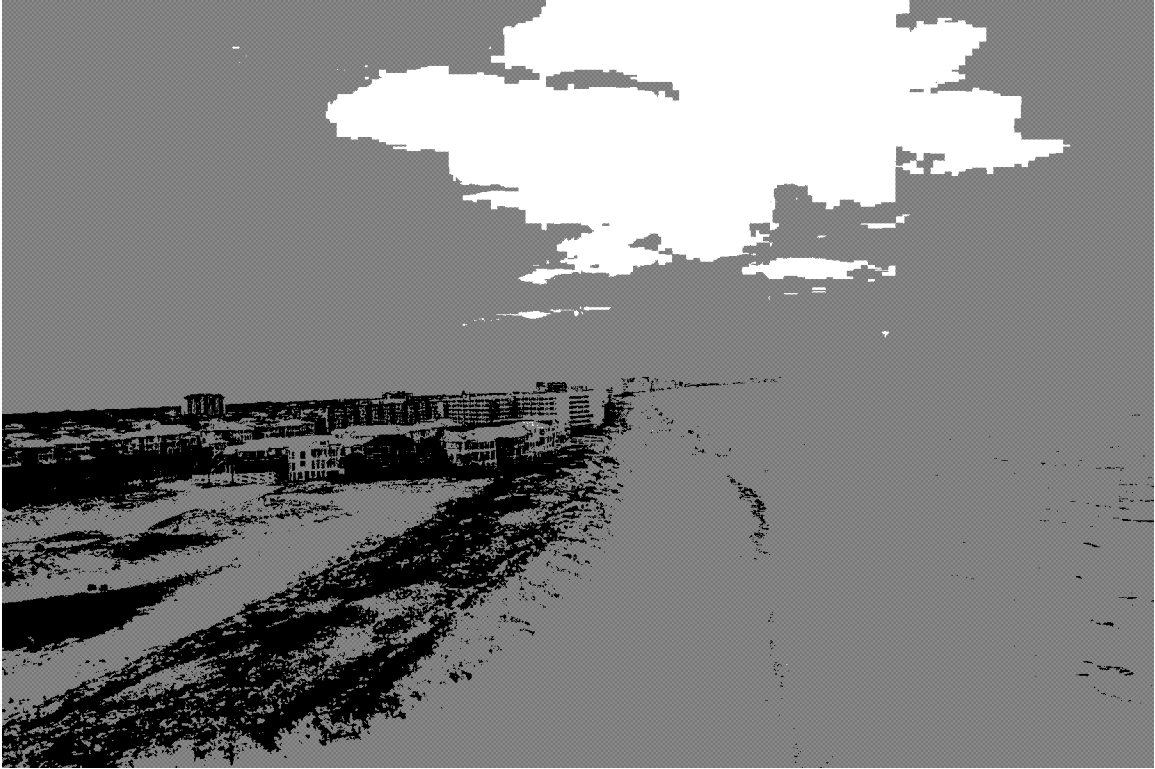
Figure 1: Okaloosa County near East Pass Jetty (R-17) looking East (6/29/2022)
