# Arlington County Water Pollution Control Plant

## *Hazardous Materials Survey*

## *Asbestos & Lead-Based Paint Inspection*

**May 2003**

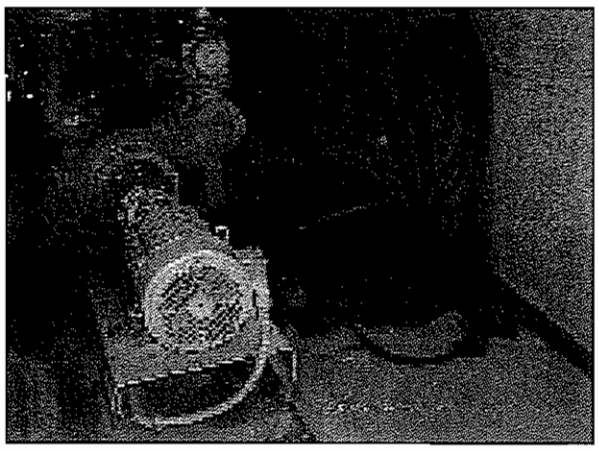
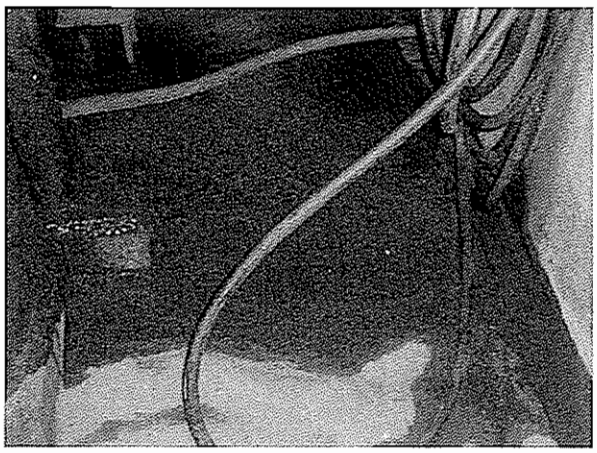
**LTR 1B**

**All of the Second Step Area Line Reactor Tank Pumps (LTRs) were scanned.**

**(representative of the 5 LTRs that were scanned)**

**It was noted that there was visible sludge spilled on the floor around each LTR. This was also scanned.**

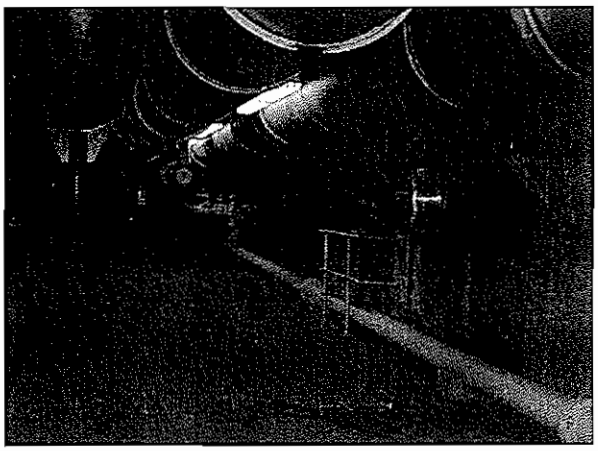
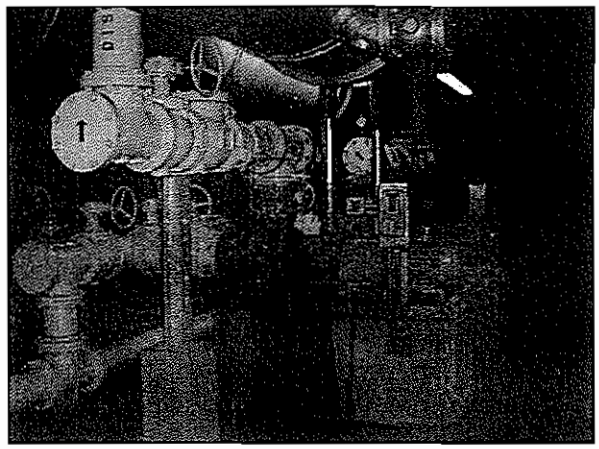
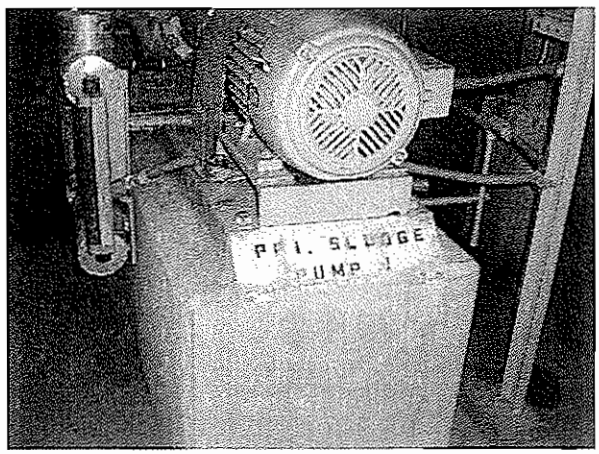
## Primary Sludge Pumps

**All pipe joints and pipes were scanned and were found to demonstrate Low Activity.**

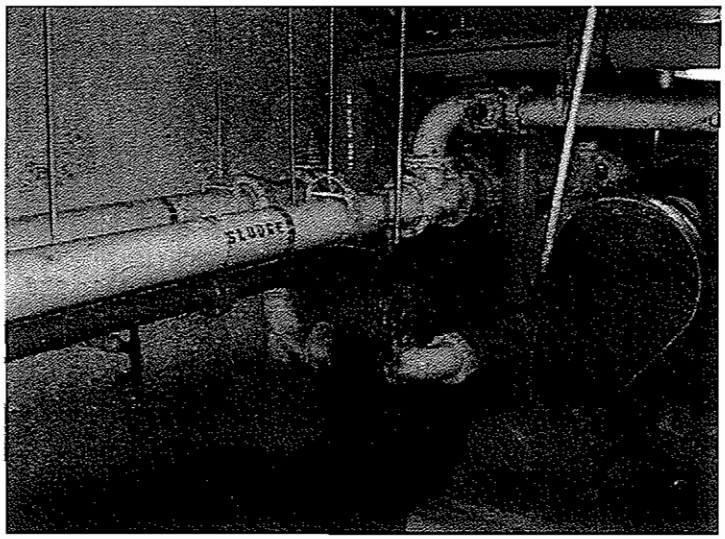
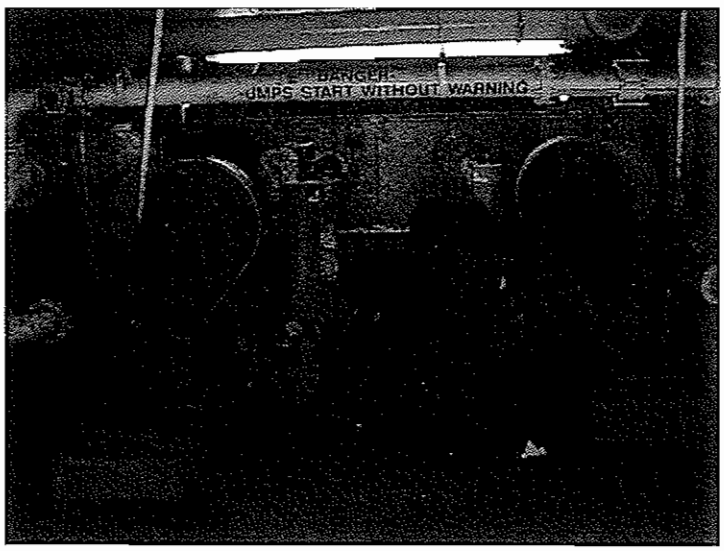
## Flotation Thickener Building

**Pipes and pipe joints were scanned and were found to demonstrate Low Activity.**

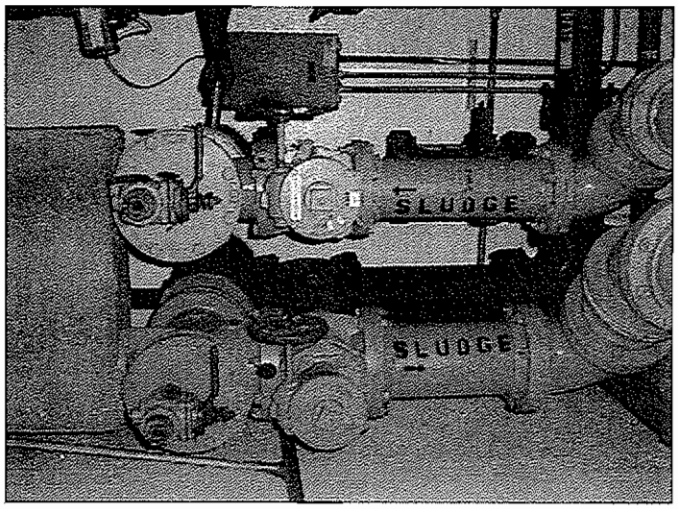
## Dewatering Building

**These pipes contain sludge from the primary and secondary systems as well as AWT (Advanced Waste Treatment) Sludge.**

**Sludge samples were taken from the pipes in the Dewatering Building and sent to the laboratory for analysis.**
