July 26, 2019

Re: Geotechnical Engineering Services – Pavement Evaluation Report
Stryker Road Resurfacing from North Olivia Drive to US-27
Highlands County, Florida
Highlands County Project No.: 18008
TSF File No. 7111-19-206

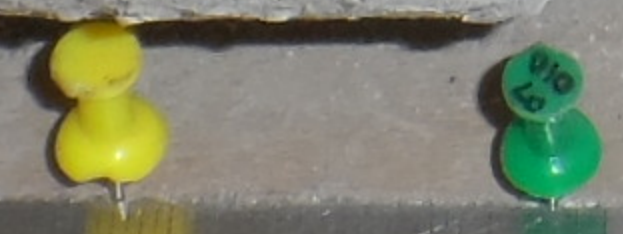
PAVEMENT CORE
PC-5

Project#	7111-19-206
Core #	PC-5
Layer 1	1.8
Layer 2	1.5
Layer 3	
Layer 4	
Layer 5	
Layer 6	
by: TSF
