ADDENDA# 2

**RFQ NO. 3001-0-2019, ARCHITECTURAL/ENGINEERING DESIGN SERVICES
RFQ NO. 3002-0-2019, CONSTRUCTION MANAGEMENT AT RISK SERVICES
REPLACE MARTIN COUNTY SCHOOL DISTRICT'S JENSEN BEACH (JBES) &
PALM CITY ELEMENTARY (PCES) SCHOOLS**

2017 AHERA RE-INSPECTION
Jensen Beach Elementary
2525 NE Savannah Road
Jensen Beach, Florida
S&ME Project No. 4484-17-070-B

2525 NE Savannah Road
Jensen Beach, Florida 34957
January, 2018

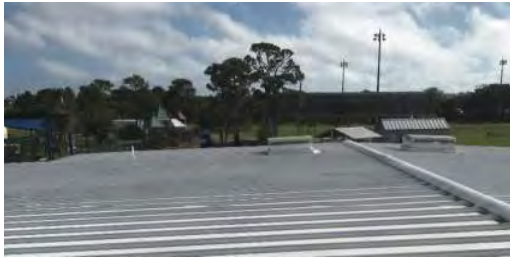
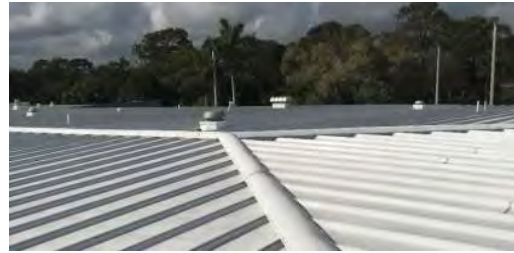
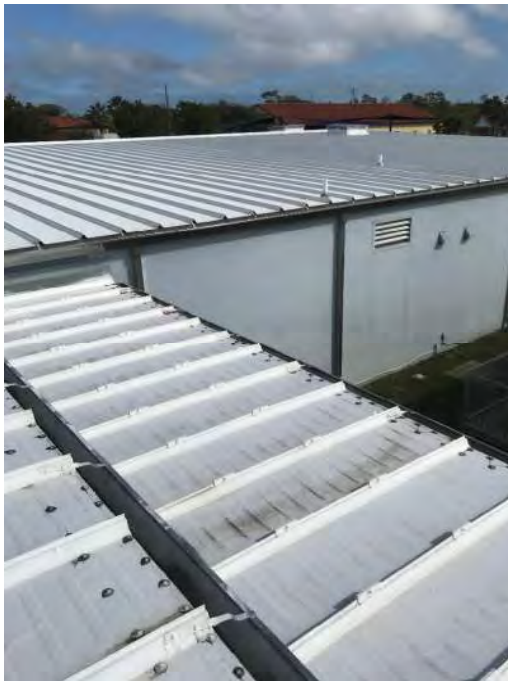
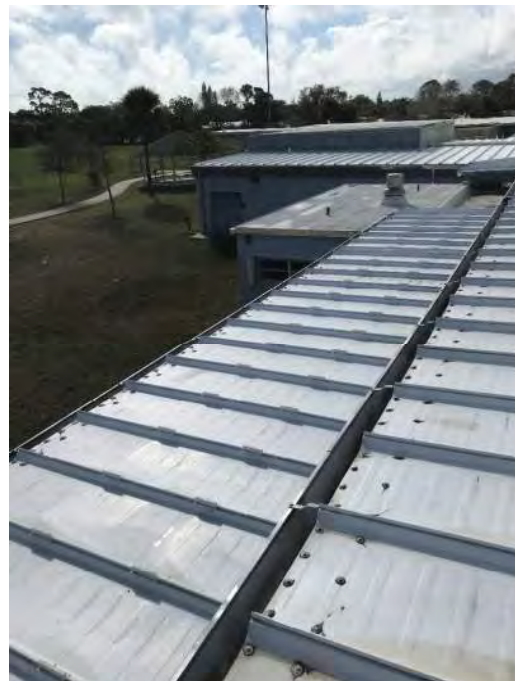
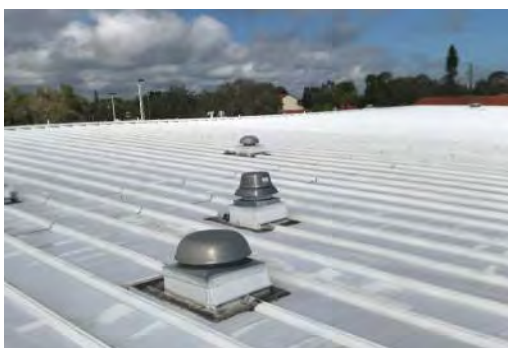
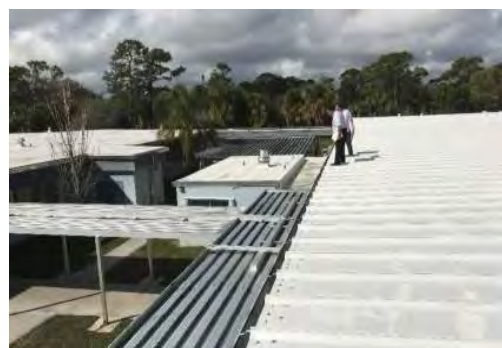
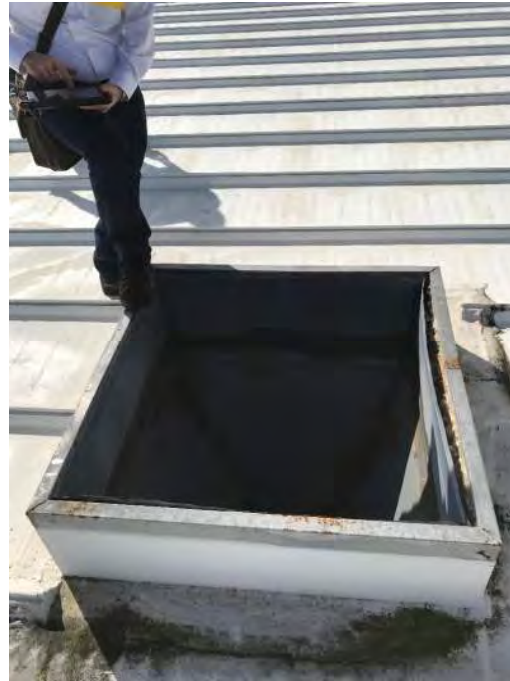
Building 2, 3 and 5's roofing system does not meet current Energy Code requirements and current Florida Building Code (FBC), given its age. The existing steel deck would not meet the 2017 edition of the FBC. The lower roofs located at the perimeter of these buildings would also have to be replaced. The roofs do not meet current FBC wind load requirements.

The roofing system, as was noted earlier, for these buildings covers 3 buildings; Building 2, Building 3 and Building 5. All roof areas are sloped to the perimeter 1/2" per foot. All the roof areas have a roof ridge that divides each roof area down the middle and have the same slope on both sides. The storm drainage is handled by metal gutters and metal downspouts. Some, but not all of the downspouts are connected to an underground storm sewer system. Many of the downspouts drain directly on sidewalks and paved areas.

Buildings 2, 3 and 5 are recommended to be demolished and replaced with a new facility that would serve the current student capacity and same demographics as is reported in the 01 10 18 FISH Inventory Report.

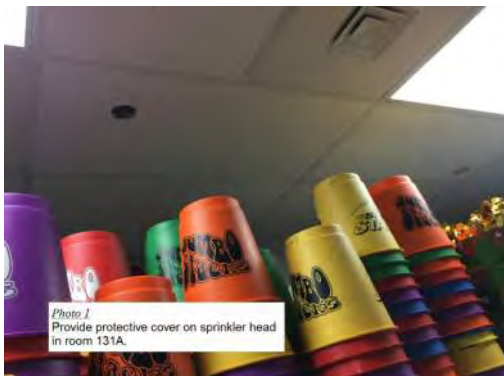
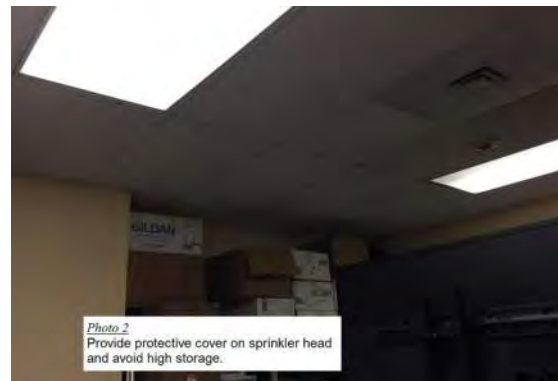
- Protective cover on sprinkler head needs to be re-installed and avoid high storage.

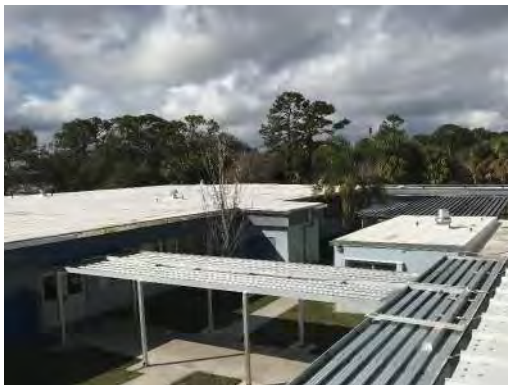
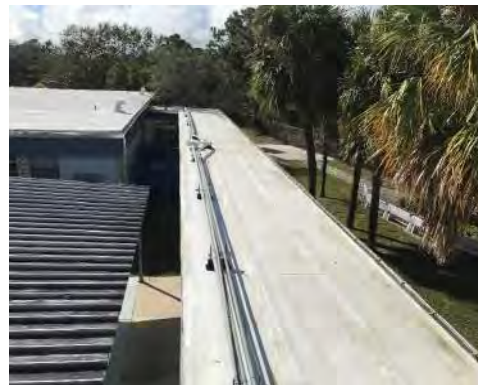
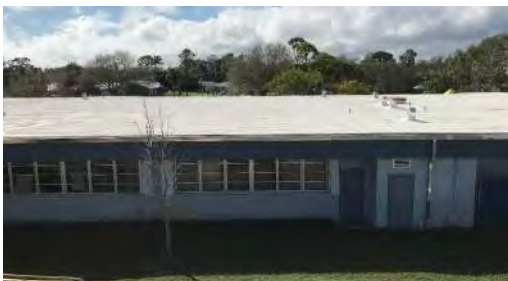
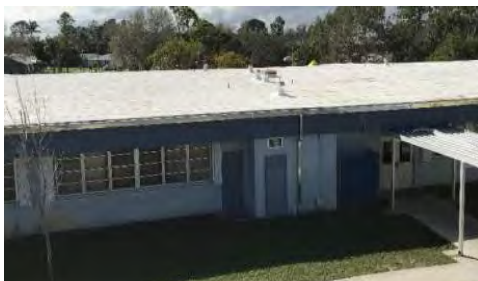
In rooms with exposed ceilings, where the metal deck could reviewed without destructive investigation. Some minor corrosion and signs of water infiltration were observed. The steel joists also had signs of minor corrosion along the top cord.

Building 9's roofing system does not meet current Energy Code requirements and current Florida Building Code (FBC). The existing steel deck would not meet the 2017 edition of the FBC. The roof would also not meet FBC current wind load requirements.

All roof areas are sloped to the perimeter 1/4" per foot. The roof has a ridge that divides each roof area down the middle running east to west with hip like construction on the east and west ends. The storm drainage is handled by metal gutters and metal downspouts. The downspouts are connected to an underground storm sewer system.

Asbestos testing on roofs is recommended in order to determine material content of the roofing system. Refer to Attachment 1 for Asbestos Report.

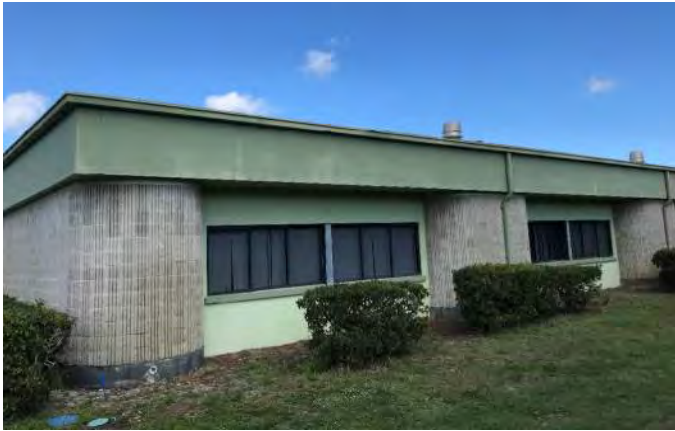
Primary and Secondary Exterior Wall Types

Primary and secondary existing exterior wall construction types exist for Building 1. The primary wall type is unreinforced 8" concrete masonry units (CMU) with a 4" fluted concrete masonry veneer. No weeps or vents were observed on the exterior face of any of the buildings nor were they noted on an as built wall section. Without weeps and vents being provided in exterior walls moisture will be trapped within the airspace of the building envelope. As there is not vertical reinforcement in the exterior CMU wall, resistance to lateral wind loads or loads imparted by windows and doors is minimal.

The secondary wall type is wall type is 8" unreinforced concrete masonry units (CMU) with a stucco finish. Also no weeps or vents were observed on the exterior face of any of the buildings nor were they noted on an as built wall section. Without weeps and vents being provided in exterior walls moisture will be trapped within the airspace of the building envelope. As there is not vertical reinforcement in the exterior CMU wall, resistance to lateral wind loads or loads imparted by windows and doors is minimal.

Evidence of water infiltration and the resulting black mold was present on the exterior of this building and most of the buildings. Additional information confirming that water infiltration is occurring in this building's exterior wall is that the steel angle supporting the ribbed CMU veneer located at the base of the wall was extremely corroded and requires replacement. Given the degree of decay of this structural support it is uncertain how long the veneer will remain intact and certainly does not meet the Florida Building Code wind load requirements. The Facility's Maintenance Service Manager showed the Castaldi team a video of an exterior wall being repaired that while filming failed completely and collapsed leaving the interior space of the wall exposed.

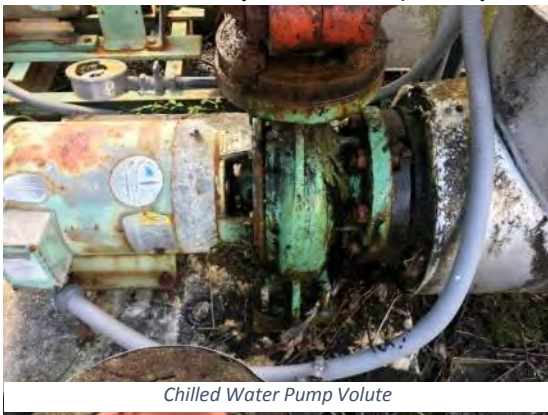
Chilled water loop uses a primary / secondary pumping configuration. Exterior chilled water pumps show significant surface age and corrosion and do not meet modern efficiency standards. These likely still have five to ten years of service life remaining. Interior (secondary) pumps are in excellent condition and likely still have 10 to 15 years of service life remaining. Exterior chilled water insulation needs to be replaced at the pump volutes but is otherwise in good condition. Building HVAC uses an antiquated pneumatic control system. System would need to be replaced with modern BACNet architecture as part of any upgrade. No

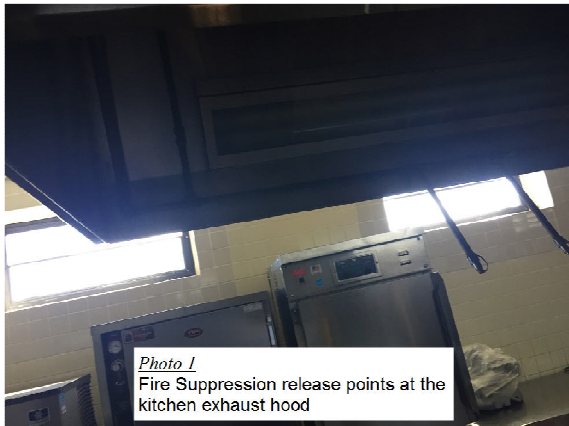
Photo 1
Fire Suppression release points at the kitchen exhaust hood

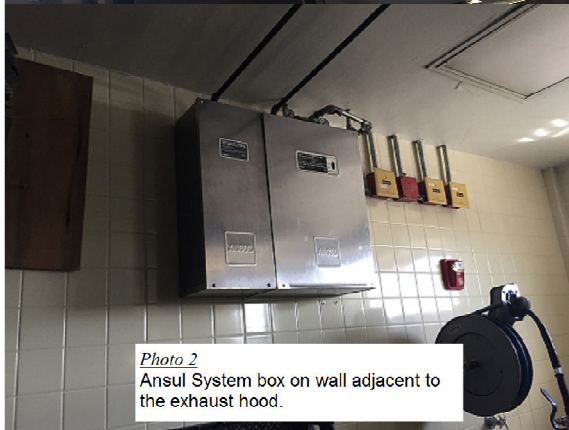
Photo 2
Ansul System box on wall adjacent to the exhaust hood.

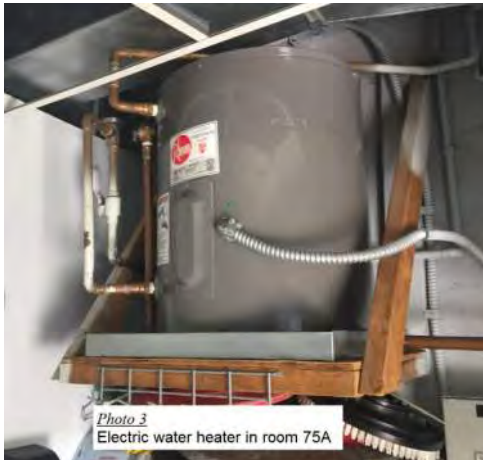
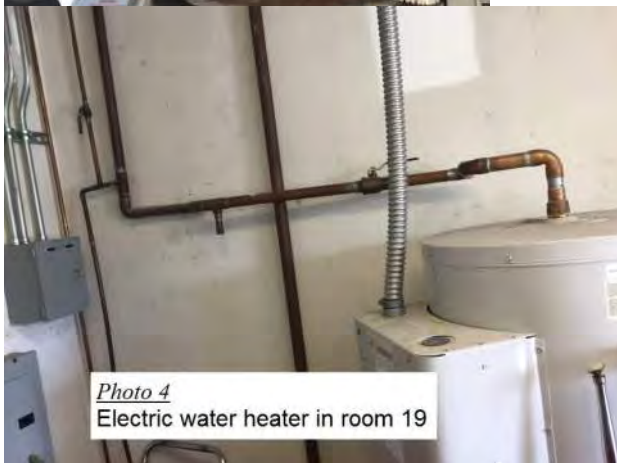
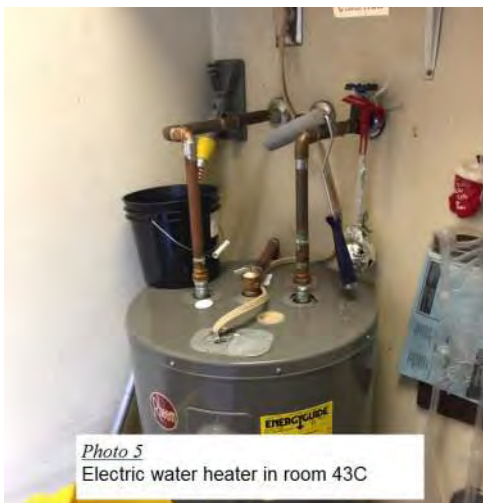
- The age of the water heater(s) varies, one made in 2005 (13 years old), one made in 2012 (6 years old), another about the same time. As water heaters age, their efficiency decreases.
- The majority of the visible hot water piping was not insulated, which is a loss of energy and does not meet the current Florida Energy requirements.
- The water heaters are not piped according to the current plumbing code requirements (see 2017 FPC, sections 502, 503, 504 and, section 607).
- Hot water recirculating system piping does not exist and therefore does not meet the plumbing code requirements, where applicable. (See 2017 FPC section 607.2).

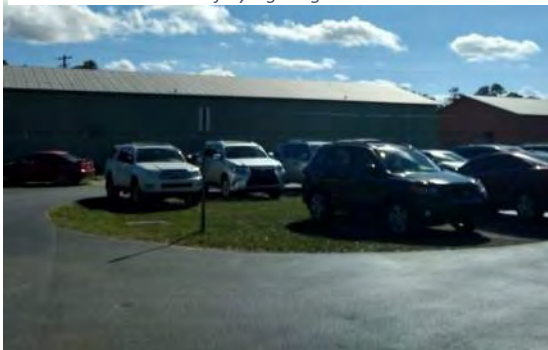
No Safety Lighting Installed
