July 15, 2019

Ms. Kenya M. Anderson, MSP
Highlands County Board of County Commissioners
Engineering Department
505 South Commerce Avenue
Sebring, Florida 33870

Subject: Pavement Evaluation
CR 623 (Kenilworth Boulevard)
Between Haywood Taylor Boulevard and Mini Ranch Road
Sebring, Florida

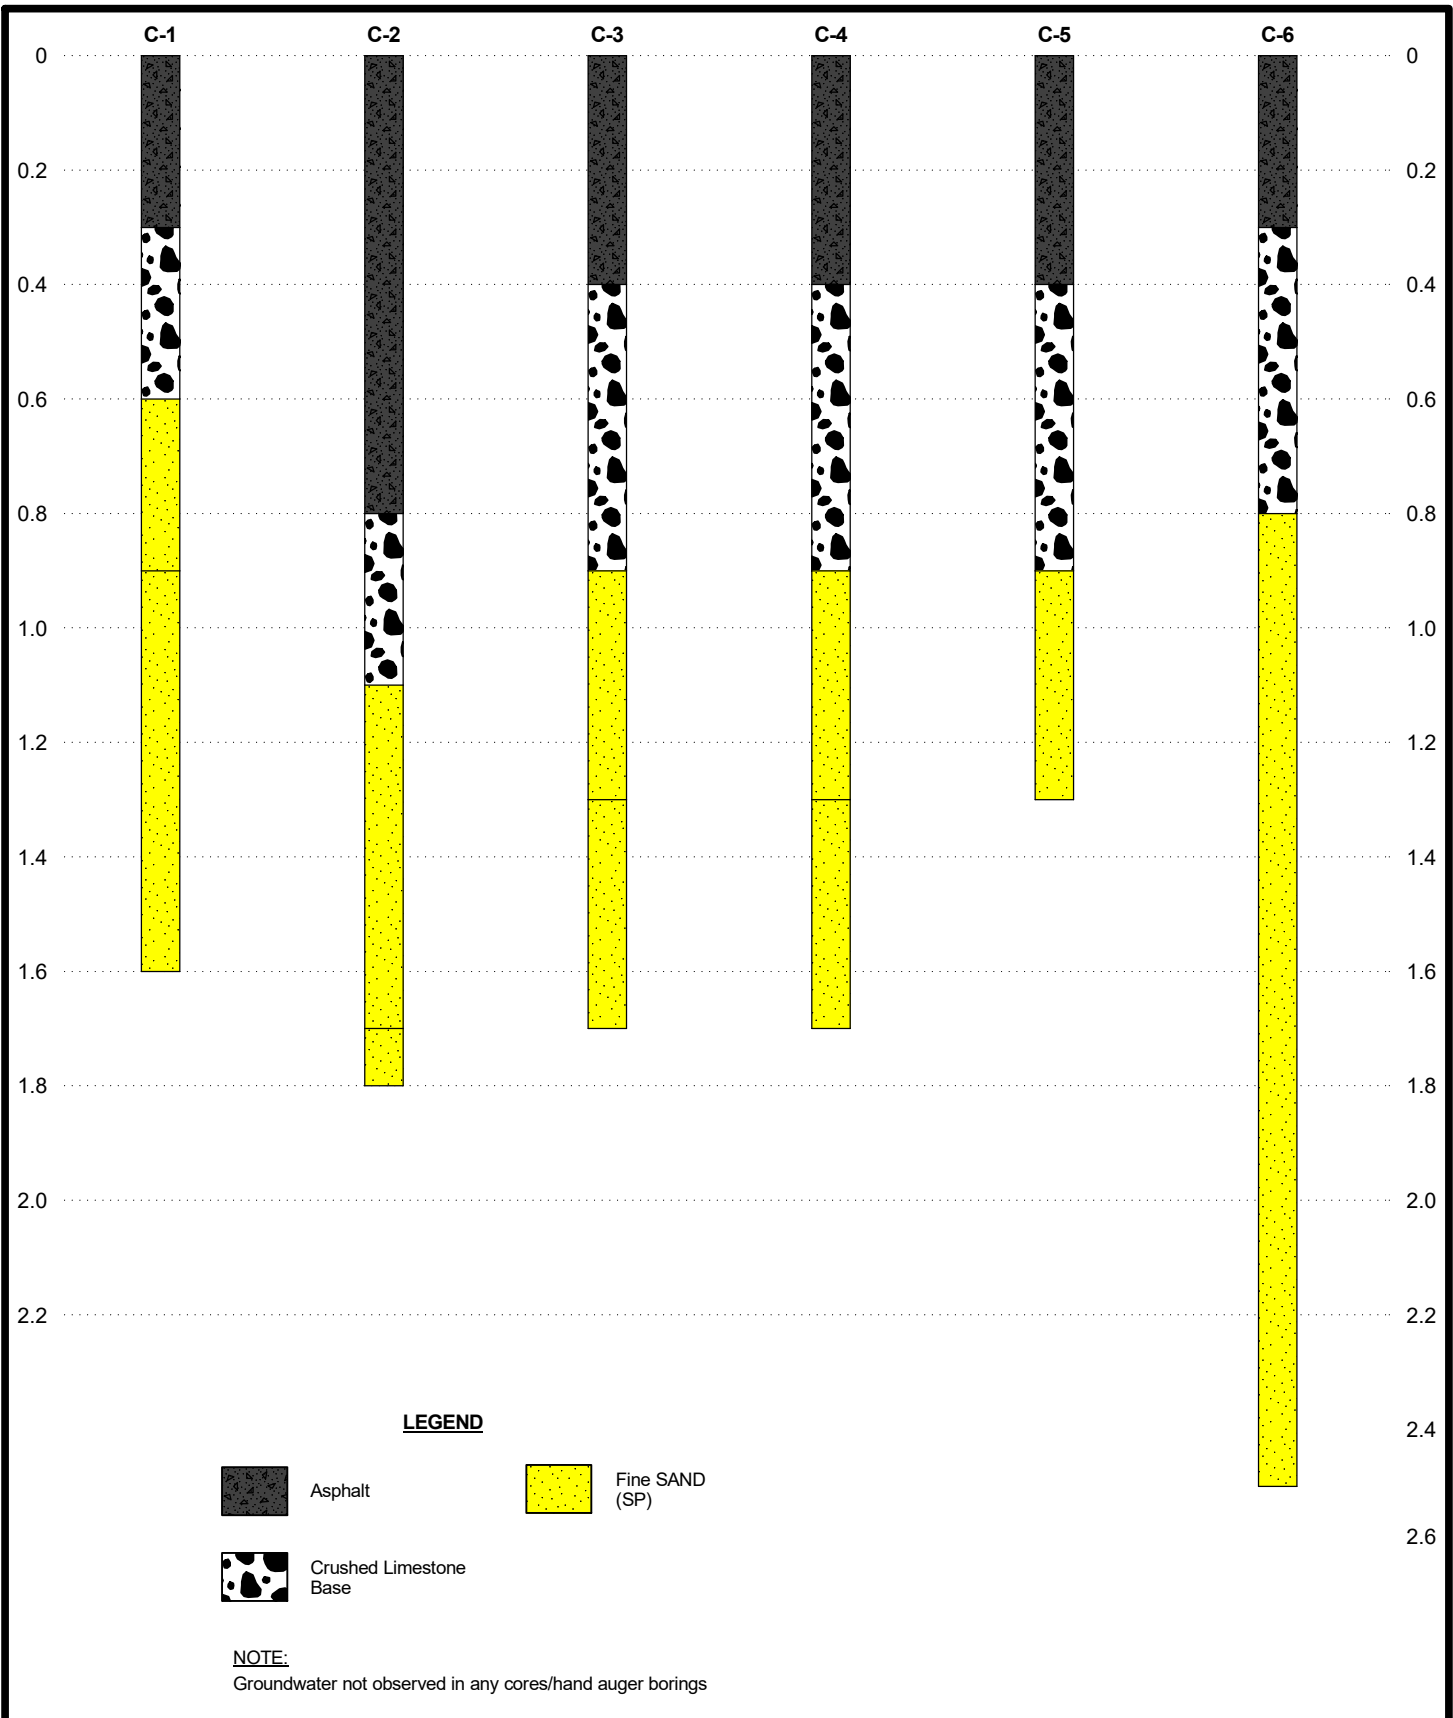
5602 Thompson Center Court, Suite 405 Tampa, Florida 33634	Pavement Evaluation, Kenilworth Blvd, Sebring, FL		
	Highlands County Engineering Department	SUBSURFACE PROFILE ATC Project No: Z520840001	Figure 3 Drill Date: 6/26/2019

To aid in characterizing the pavement section, hand auger borings were completed at each asphalt core location. The overall thickness of asphalt, limestone base and subgrade composition is shown in Figure 3. Table 2 provides a summary of shallow subsurface conditions.

The thickness of the asphalt pavement was found to vary from 3.5 to 8.5 inches, see Table 2 and Photo 1. This is a wide range in thickness for a relatively short distance of 1.2 miles of roadway and likely reflects the many repairs that have been performed on the roadway. There is no correlation between the quality of the asphalt and its thickness. As stated earlier, many of the asphalt overlays are a weakly bonded asphaltic matrix with random shell fragments. This asphalt has substandard strength and at some time during the life of the pavement was placed to compensate for roadway settlement indicative of deep seated problems.

The base course found in all cores is crushed limestone. The base course thickness varied from 3.0 to 6.5 inches in thickness. In all cases the base course was found to be dense and is not a cause for roadway distress.

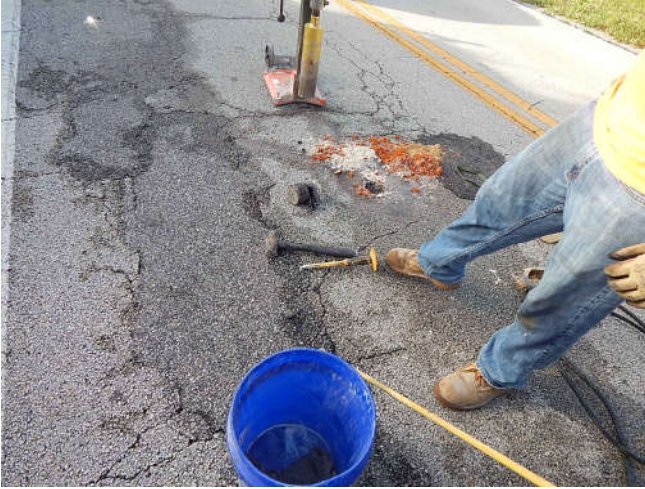
Photo 7: Core drill equipment
