STRUCTURAL ENGINEERING ASSESSMENTS, PC
A STRUCTURAL CONSULTING / FORENSIC ENGINEERING FIRM

Re: Circle Drive Warehouse
226 Circle Drive
Gatlinburg, Tennessee 37738
SEA Project #: 240-16

As requested, Structural Engineering Assessments, PC made a site visit on December 15, 2016, to the referenced location to provide a visual assessment regarding potential fire or fire related structural damage to the steel framed structure.

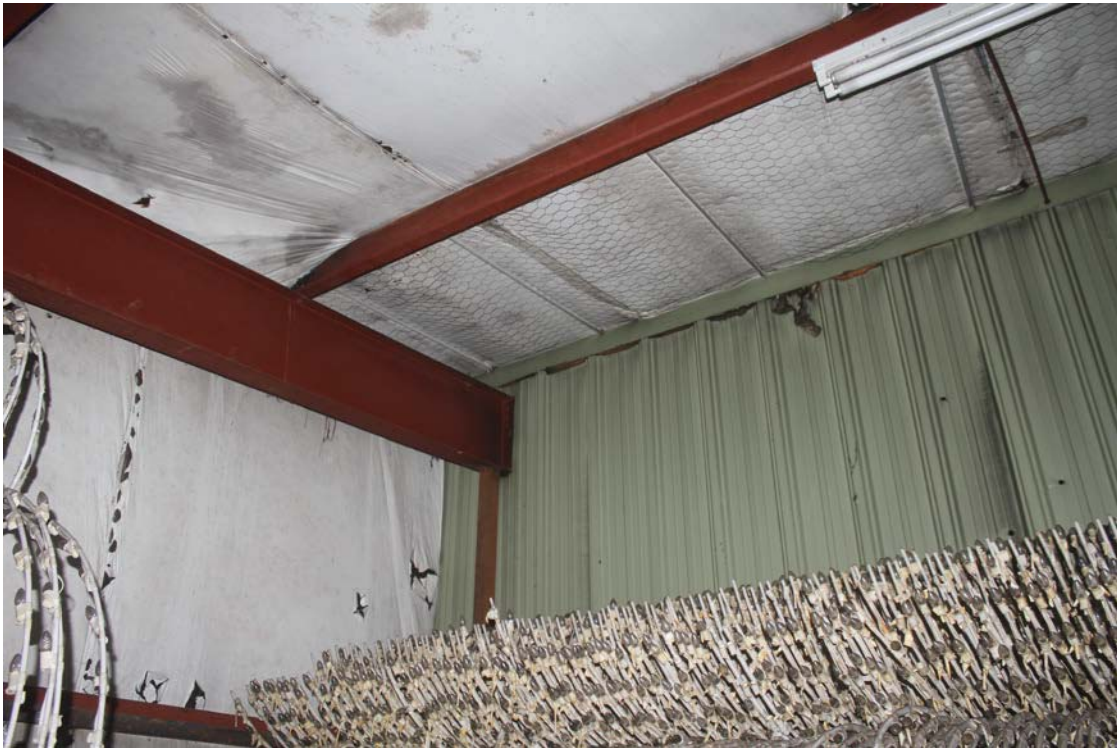
Photograph #15

3. The metal wall panels (See Photographs #11 and #12) on the east end of the building displayed significant heat related damage, but the wall girts (See Photographs #13 and #14) did not appear to suffer any loss of structural integrity from the heat of the fire.
4. The metal roof panels, the steel purlins and pre-engineered steel moment frames (See Photographs #15 and #16) above the east end of the building did not appear to suffer heat related damage or suffer any loss of structural integrity from the heat of the fire.

Based on the noted observations, the fire related damage appears to be localized to the exterior metal panels and secondary structural components. We recommend replacing the steel wall girts on the west end of the building, adjacent to the northwest corner of the building. The exterior metal wall panels and roof panels should be removed and replaced with new panels.
