“City of Havelock
Request for Engineering Services: Woodhaven Drive”
Addendum 1
July 30, 2019

Addition to bid: Inspection report of storm culvert listed in project description.

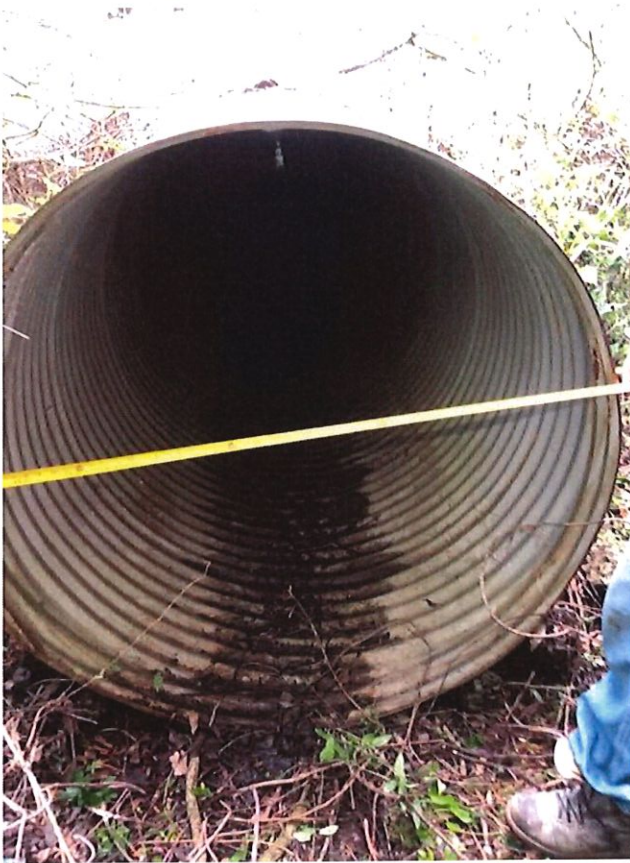
Photo 1

This pipe is 97.5' long x 54" in diameter. Each joint has been photographed (both sides); however, all the joints and bands/collars appear to be in good shape. There was minor rusting around the joints, however no leaking to be seen. The invert was in good, sound condition. Overall the pipe is in good shape and no repairs are suggested or recommended.

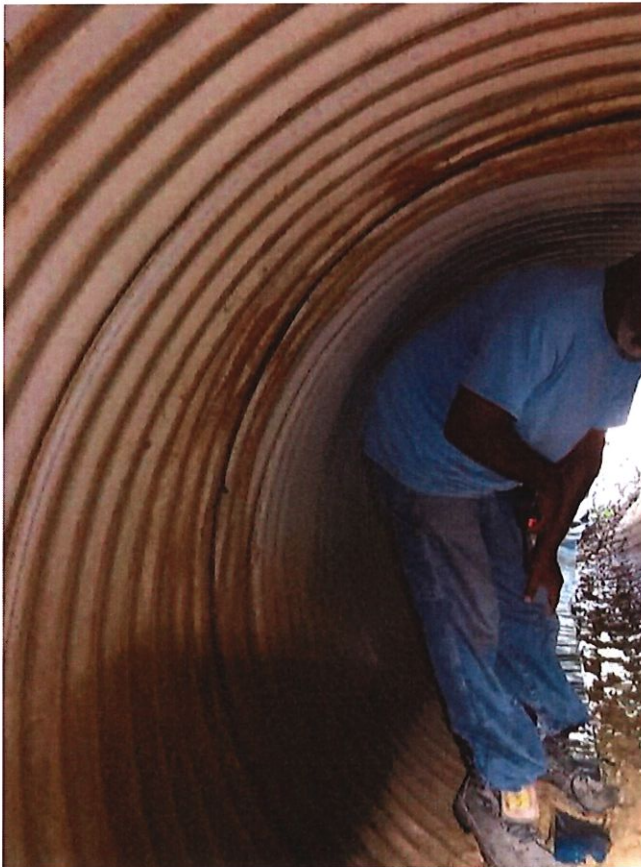
Photo 13

This pipe is 91' 9" long x 54" in diameter. Each joint has been photographed and all joints and bands/collars appear to be in good shape. There is some minor rusting, however, there are no signs of leaking or infiltration. There are two circumferential cracks in the pipe, as well as a hole in the invert towards the downstream end. They have been photographed and measured.

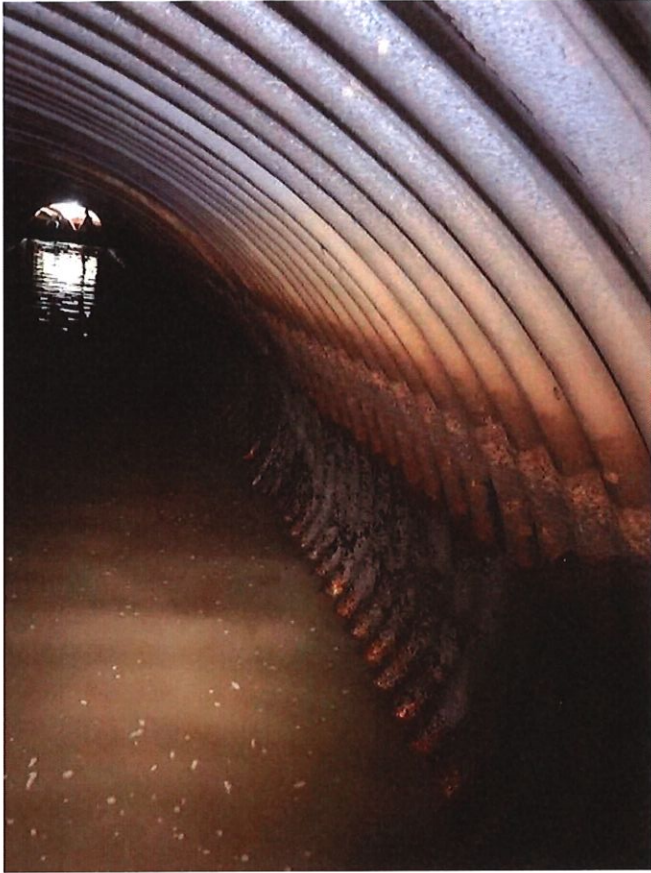
Photo 1

This pipe is 100' 2" long, with only 4 joints, which 3 are separated and leaking severely. In addition, the pipe is rusting from the invert to the midpoint of the pipe, and signs of severe rusting above that. Also, there are 2 circumferential cracks located between Joint 1 and Joint 2; they 2.5' and 3.5' long.

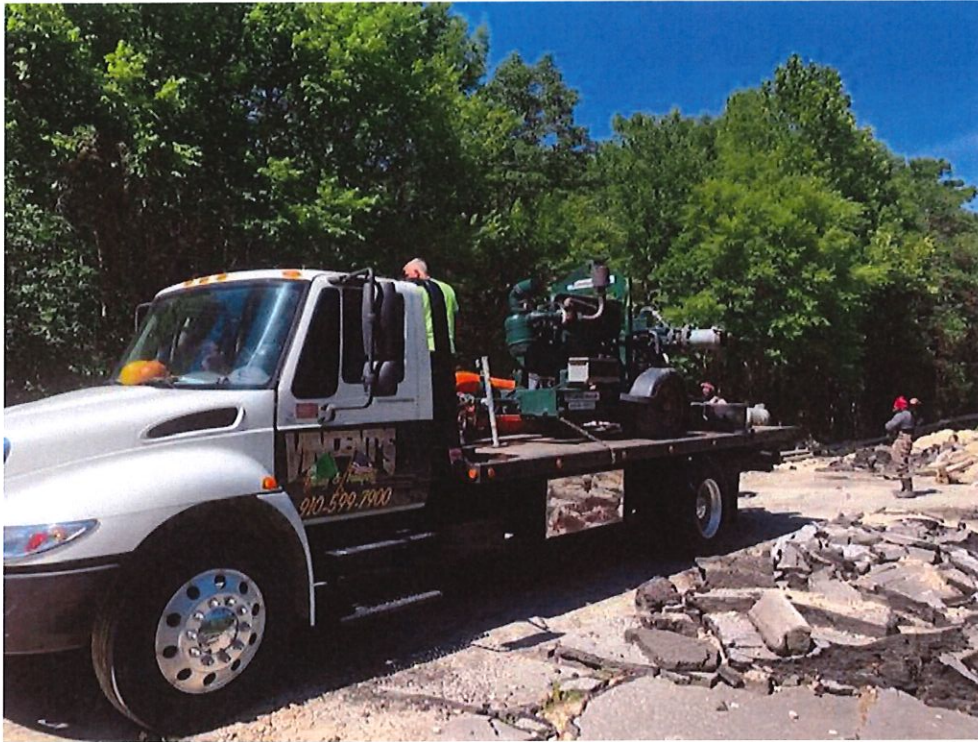
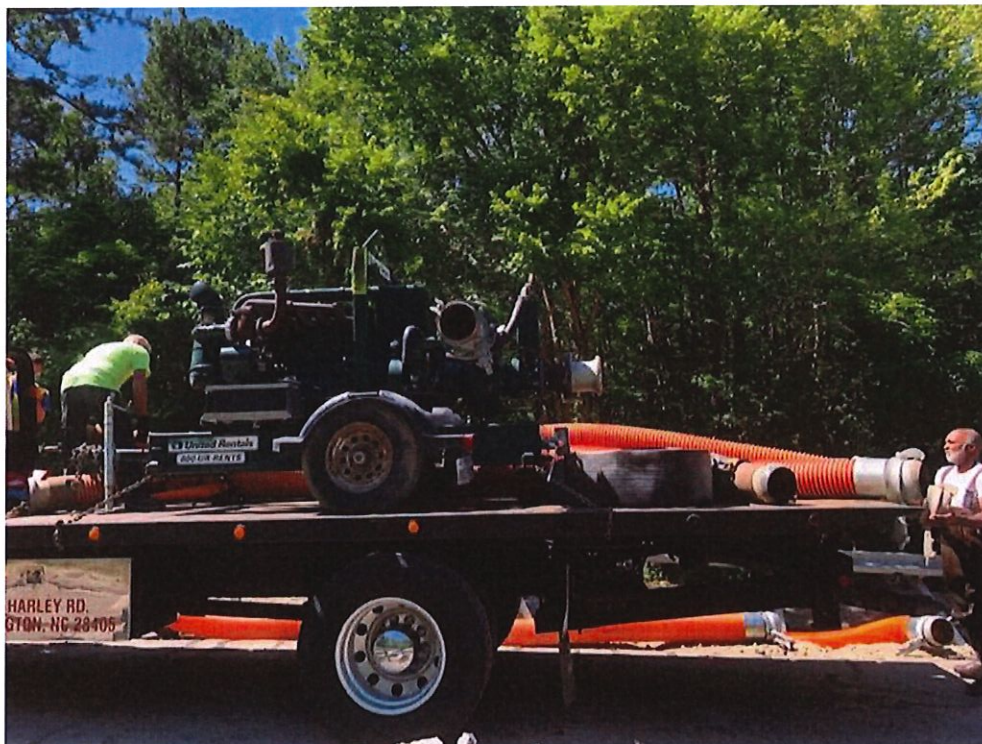
8" Hydraulic Pump / Suction Hose / Discharge Hose

As you can see from the photos, upstream and downstream dams were constructed using sandbags and plywood; however, the I&I at the joints did not allow the water level to decrease. We were able to incorporate a Super Max 6" hydraulic pump (rented from United Rentals). It included 50' of 8" discharge hose and 100' of suction hose. Even with this equipment, the I&I was greater than the discharge and we were only able to reduce the water level to about 1.5'. This did show the rusting, which was more severe at higher levels on the pipe - this is due to the fluctuating water level. Typically, the pipe will rust faster if there is intermittent flow. It exposes the pipe to the elements, which accelerates the rusting.
