Contract #15-047, Detention Center Building Condition Assessment

Final Assessment

GEORGETOWN COUNTY DETENTION CENTER

EXECUTIVE SUMMARY

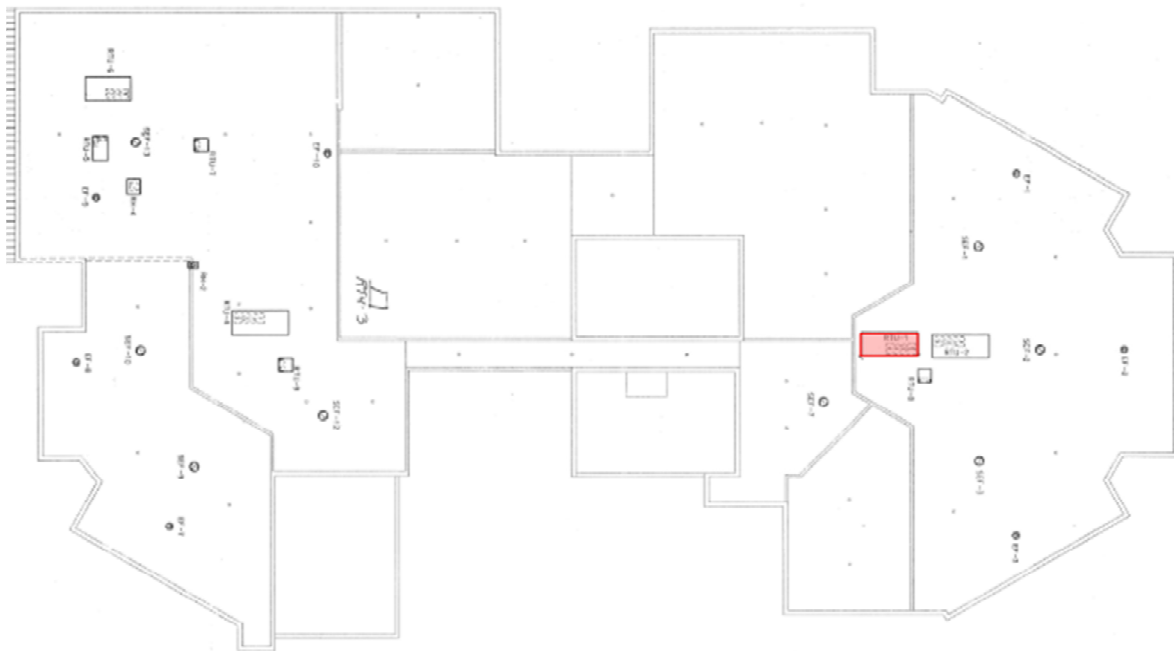
RTU-1 (UNIT 4)

RTU-1 is highlighted on the roof plan above in red.

The unit is 9 years old and in poor condition. There is rust and microbial growth visible on the exterior of the unit. Condensation within the unit has allowed the unit to corrode in a short amount of time, and has caused the insulation inside the unit to delaminate. Where the insulation is damaged, more condensation will occur, resulting in more rust. Areas with delaminated or saturated insulation have visible microbial growth. Temperature readings from the FLIR show the rooftop unit's surface temperature is above dew point.

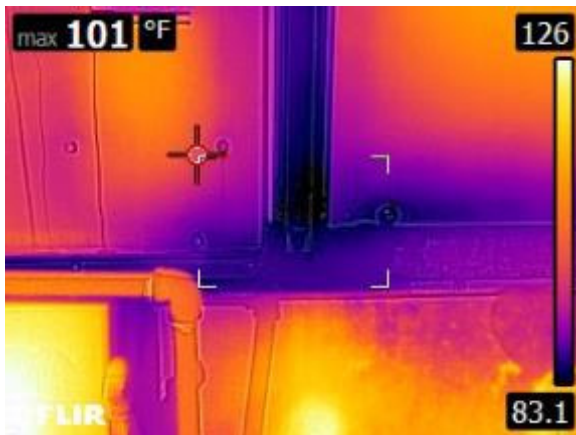
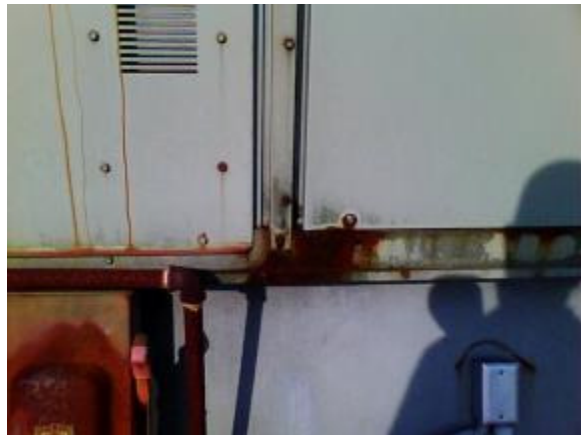
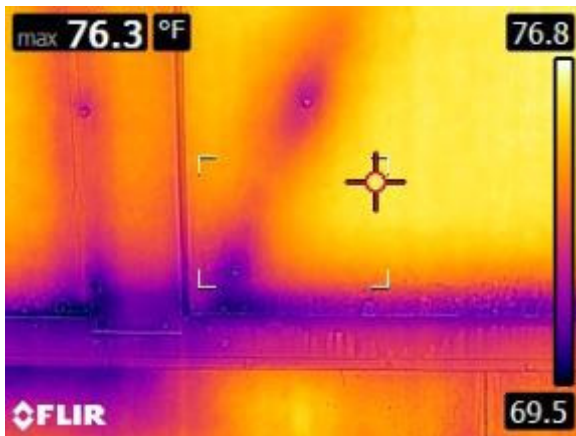
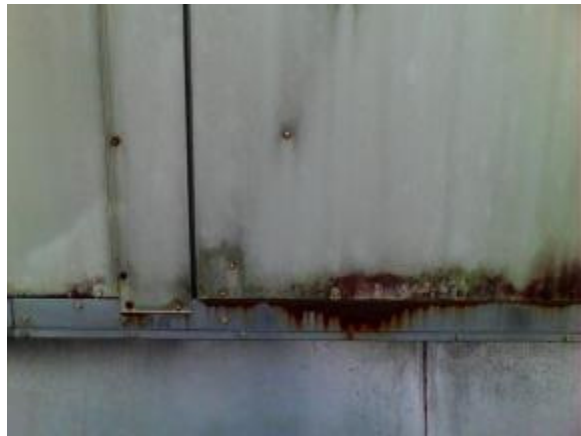
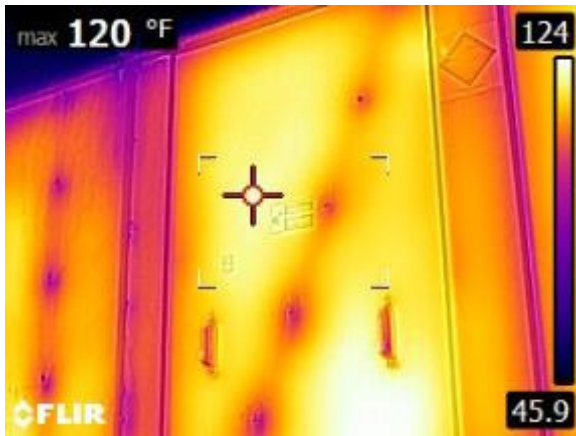
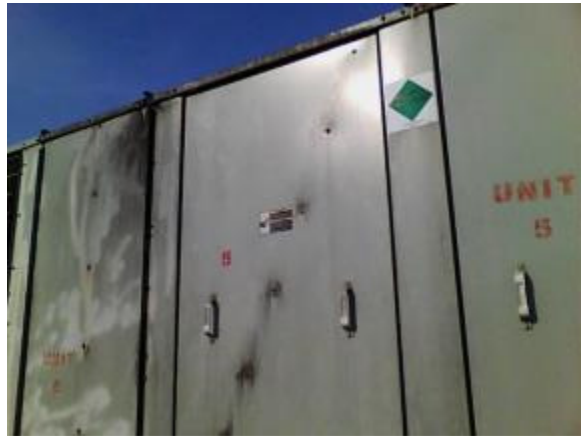
Temperature readings were recorded using the FLIR. The temperature readings on the exterior of the unit vary by about 40°F due to sunlight in addition to insulation delamination. The temperature of the unit should be uniform on the exterior and above the dew point. The moisture, microbial growth, and rust are occurring at the coldest parts of the unit.

Above are side by side comparisons of the unit.

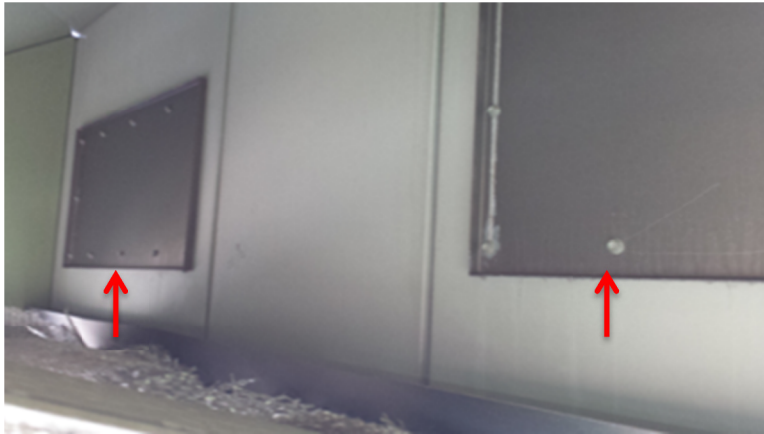
The unit has the capability of bringing in outside air through louvers. However, the louvers have been blanked-off completely; therefore they do not bring in any outside air.

Pictured above are blanked-off louvers to RTU-1.

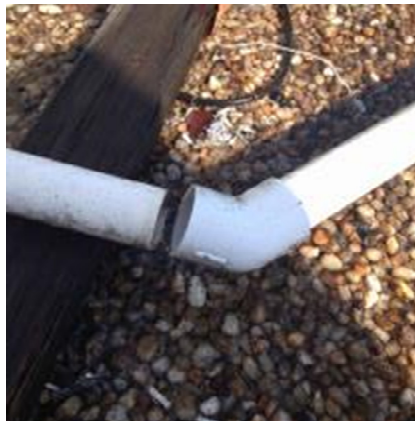
The condensate piping is disconnected and is dispensing directly on the roof.

Condensate piping is disconnected.

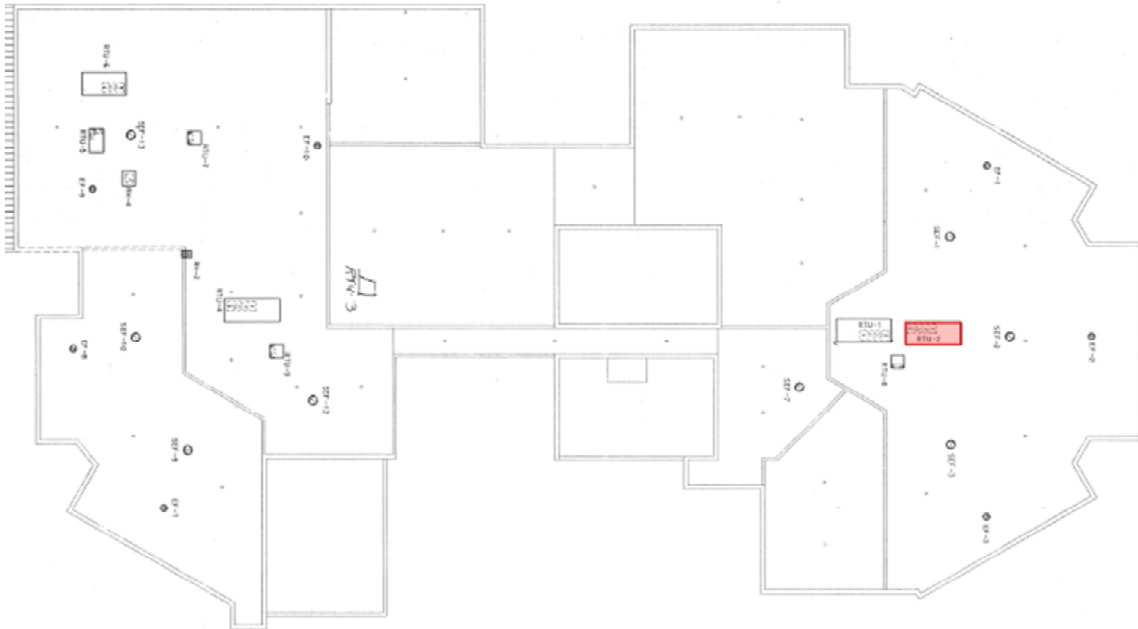
RTU-2 (UNIT 5)

RTU-2 is highlighted on the roof plan above in red.

The unit is 10 years old and in poor condition. There is rust and microbial growth visible on the exterior of the unit. Condensation within the unit has allowed the unit to corrode in a short amount of time, and has caused the insulation inside the unit to delaminate. The condensation has caused the insulation to delaminate. Where the insulation is damaged, more condensation can occur, resulting in more rust. Areas with delaminated or saturated insulation have visible microbial growth.

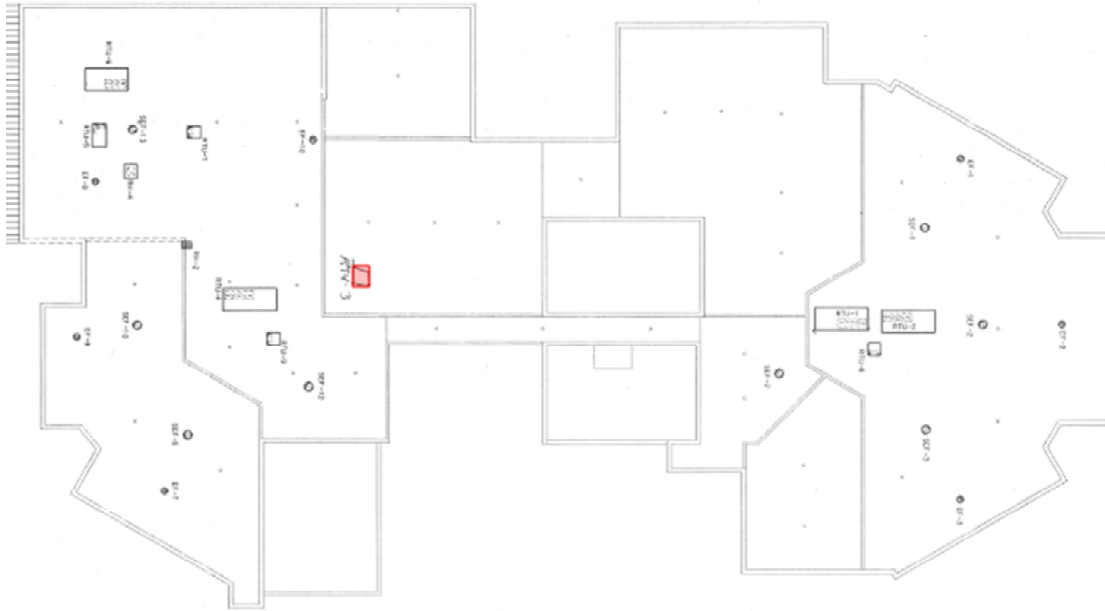
RTU-3 (UNIT 6)

RTU-3 is highlighted on the roof plan above in red.

The unit was installed on June 8, 2015. The new unit was placed on the existing roof curb, which is oversized and corroded. The roof curb is likely not seismically braced/restrained.

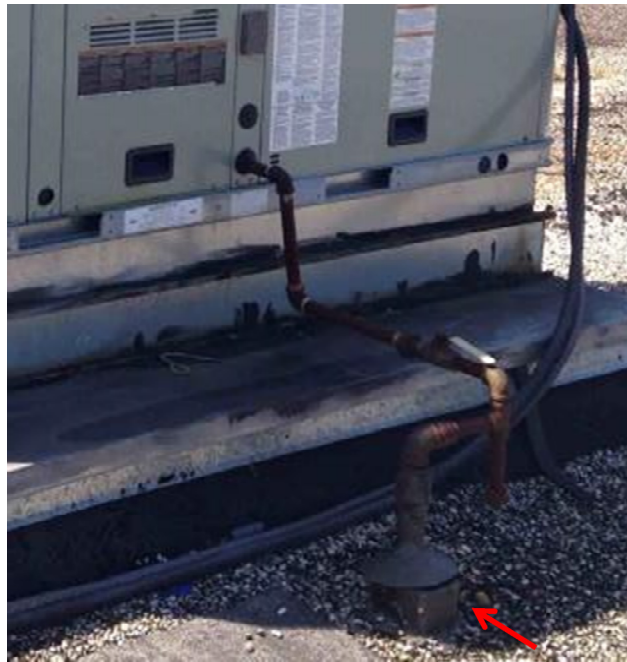
The gas piping penetration enters the building by a pitch pocket.

This is an example of a correct gas pipe penetration.

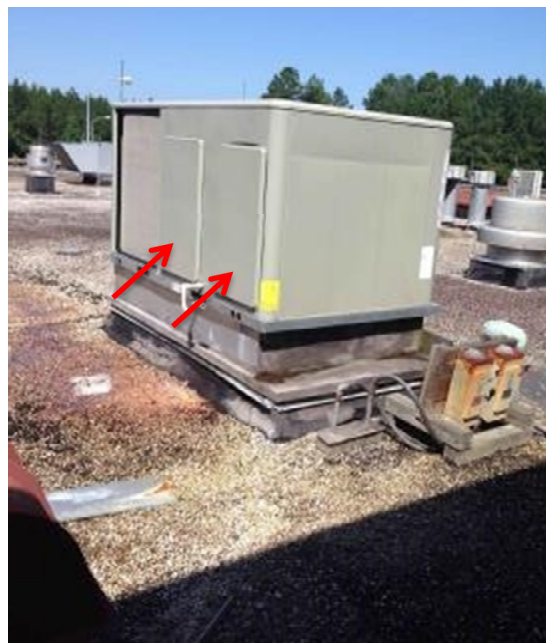
The unit does not have louvers to bring in outside air; therefore, no outside air is entering RTU-3.

No outside air is entering RTU-3.

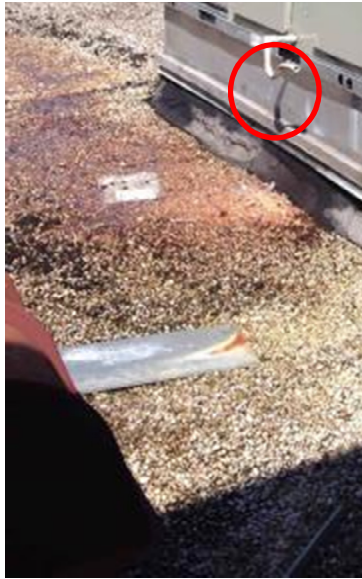
The condensate is not piped to a roof drain and is dispensing directly on the roof.

Condensate is not piped to a roof drain.

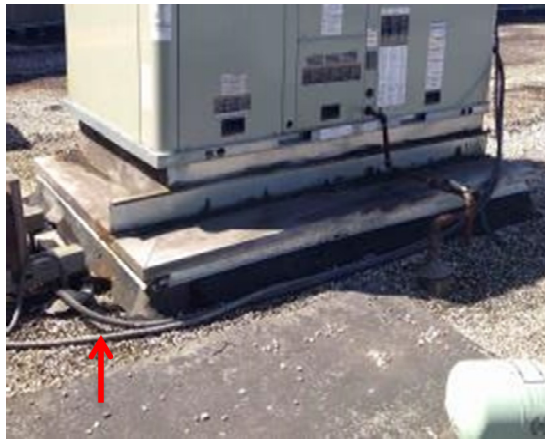
The electrical conduit is not properly supported and is resting on the roof.

Electrical conduit is resting on the roof.

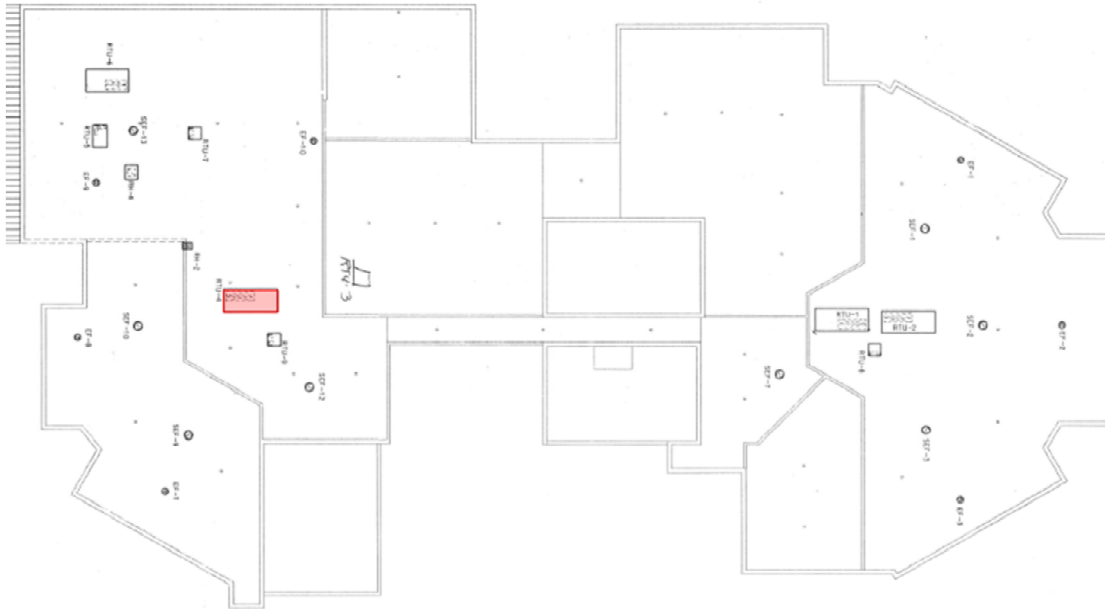
RTU-4 (UNIT 3)

RTU-4 is highlighted on the roof plan above in red.

The unit is 7 years old and in poor condition. There is rust and microbial growth visible on the exterior of the unit. The rooftop equipment has been installed on the original roof curb without proper modifications. When the new equipment was installed, the supply and return air ductwork connections did not align with the existing curb. A rusted electrical disconnect is attached to the unit. Condensation within the unit has allowed the unit to corrode in a short amount of time, and has caused the insulation inside the unit to delaminate. The condensation has caused the insulation inside the unit to delaminate. Where the insulation is damaged, more condensation can occur, resulting in more rust. Areas with delaminated or saturated insulation have visible microbial growth.

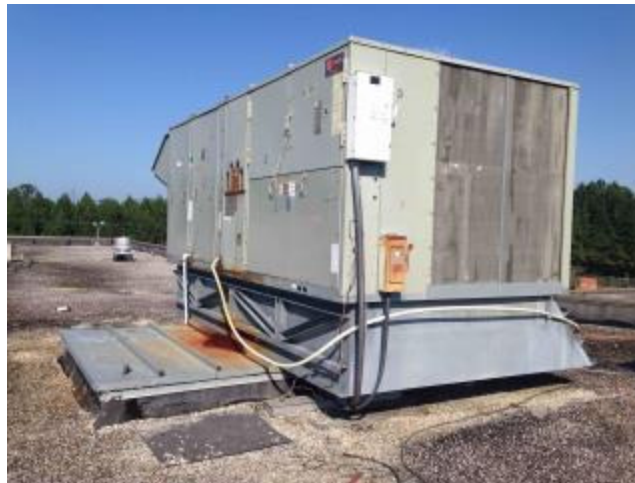
RTU-4 has rust and microbial growth.

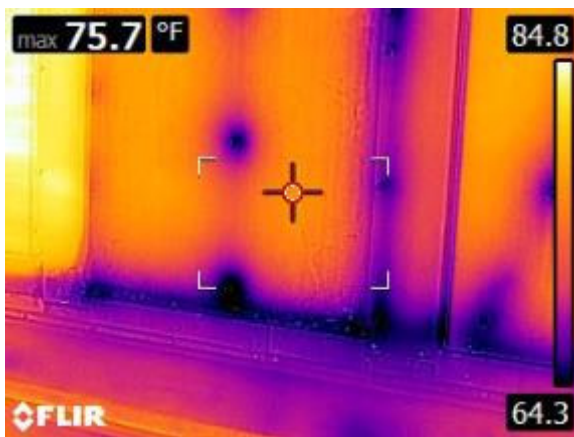
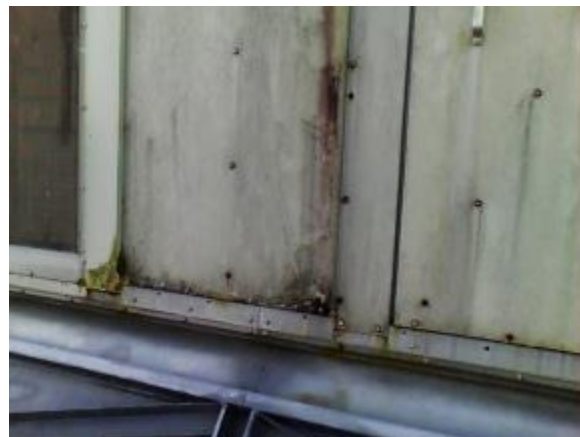
Temperature readings were recorded using the FLIR. Temperature readings from the FLIR show the rooftop unit's surface temperature is above dew point. The temperature readings on the exterior of the unit vary by about 20°F due to sunlight in addition to insulation delamination. The temperature of the unit should be uniform on the exterior and below dew point. The moisture, microbial growth, and rust are occurring at the coldest parts of the unit.

Above is a side by side comparison of the unit.

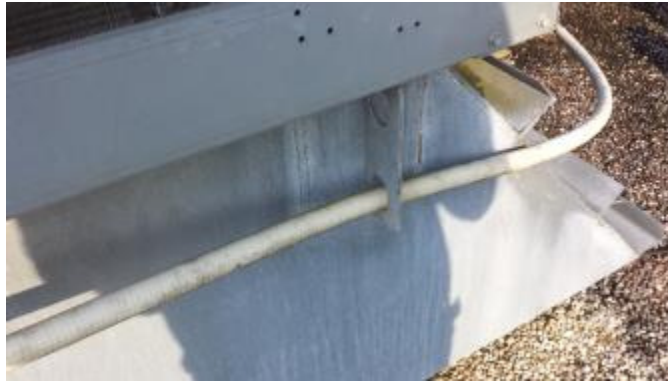
Corrugated metal gas piping is used to connect to the rooftop unit. The gas piping penetrations enter the building by pitch pockets. Gas piping has been routed through lifting lugs, which is an incorrect installation.

The gas piping is piped through the lifting lugs which is an incorrect installation.

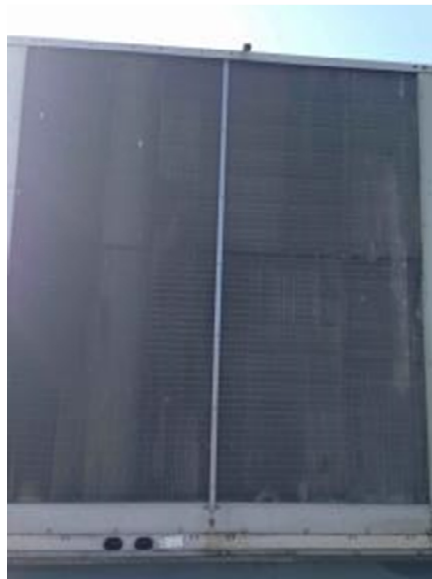
The fins are torn and delaminating.

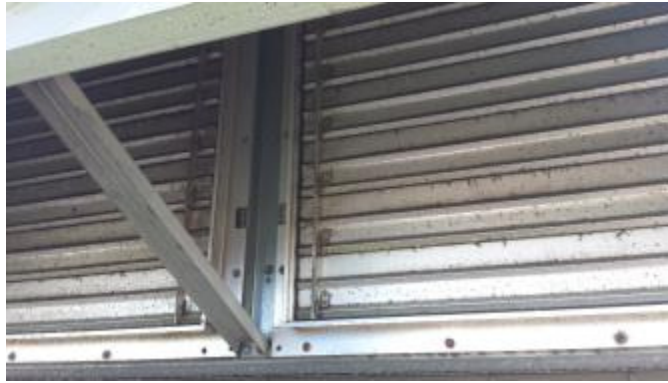
The unit has the capability of bringing in outside air through louvers. However, the louvers have been closed; therefore they do not bring in any outside air.

Pictured above are closed louvers to RTU-4.

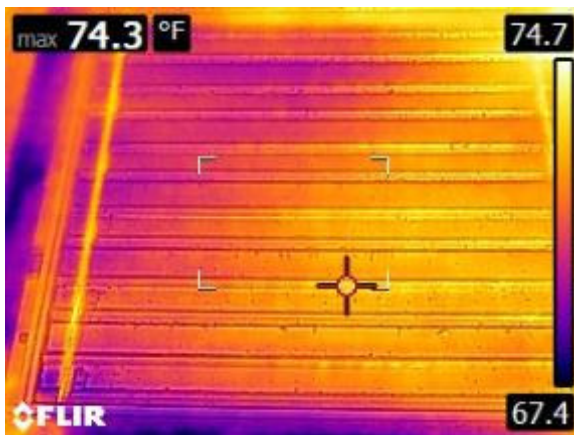
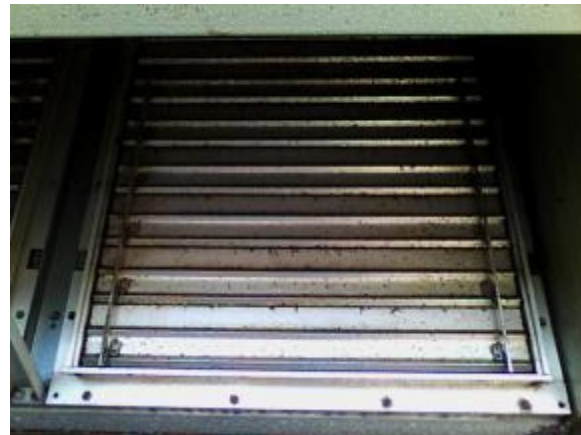
Temperature readings were recorded on the closed louver using the FLIR.

Above is a side by side comparison of the closed louver.

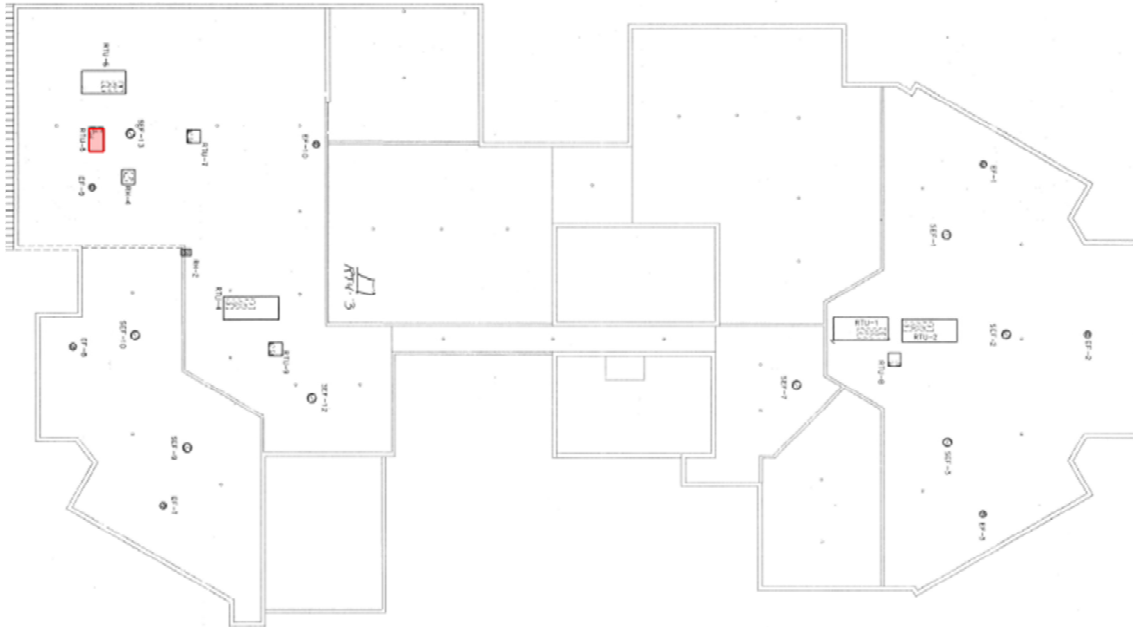
RTU-5 (UNIT 2)

RTU-5 is highlighted on the roof plan above in red.

The unit is 6 years old and in poor condition. There is rust and microbial growth visible on the exterior of the unit. The rooftop equipment has been installed on the existing roof curb, which is rotting. Condensation within the unit has allowed the unit to corrode in a short amount of time, and has caused the insulation inside the unit to delaminate. The condensation has caused the insulation to delaminate. Where the insulation is damaged, more condensation can occur, resulting in more rust. Areas with delaminated or saturated insulation have microbial growth.

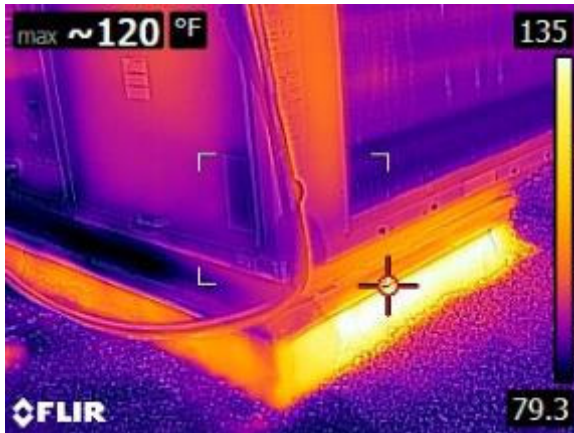
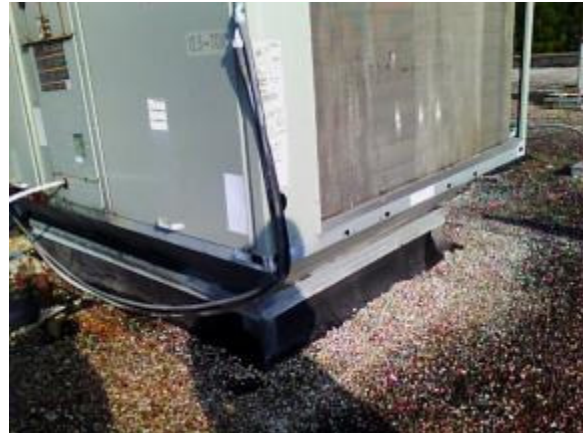
The roof curb temperature is about 120°F, much hotter than the rest of the unit.

The roof curb temperature is about 120°F.

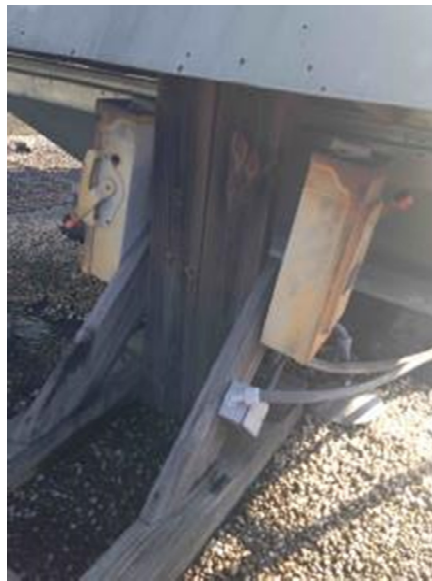
The original, rusted electrical disconnects are being reused and are mounted on wood next to the unit.

The corroded disconnects are mounted to wood.

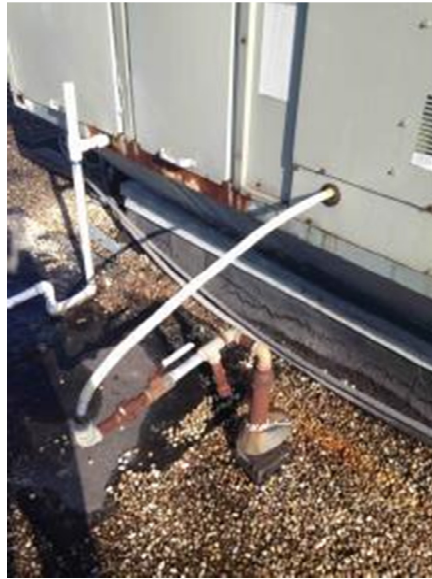
Corrugated metal gas piping is used to connect to the rooftop unit. The gas piping penetration enters the building by a pitch pocket. The pitch pocket is damaged.

The pitch pocket is damaged.

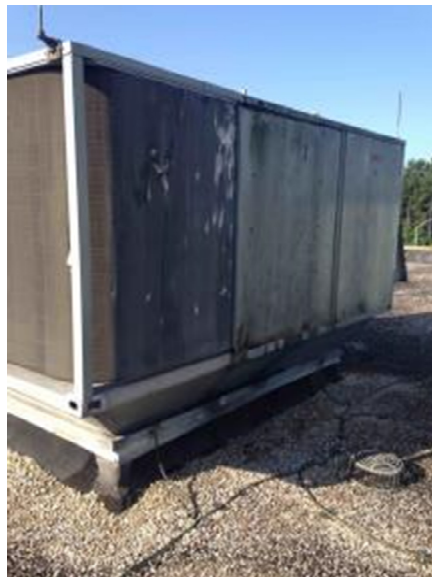
The fins are torn and delaminating.

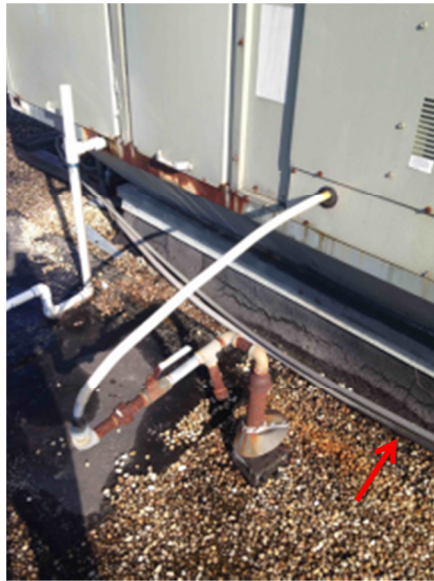
The electrical conduit is not properly supported and is resting on the roof.

Electrical conduit is resting on the roof.

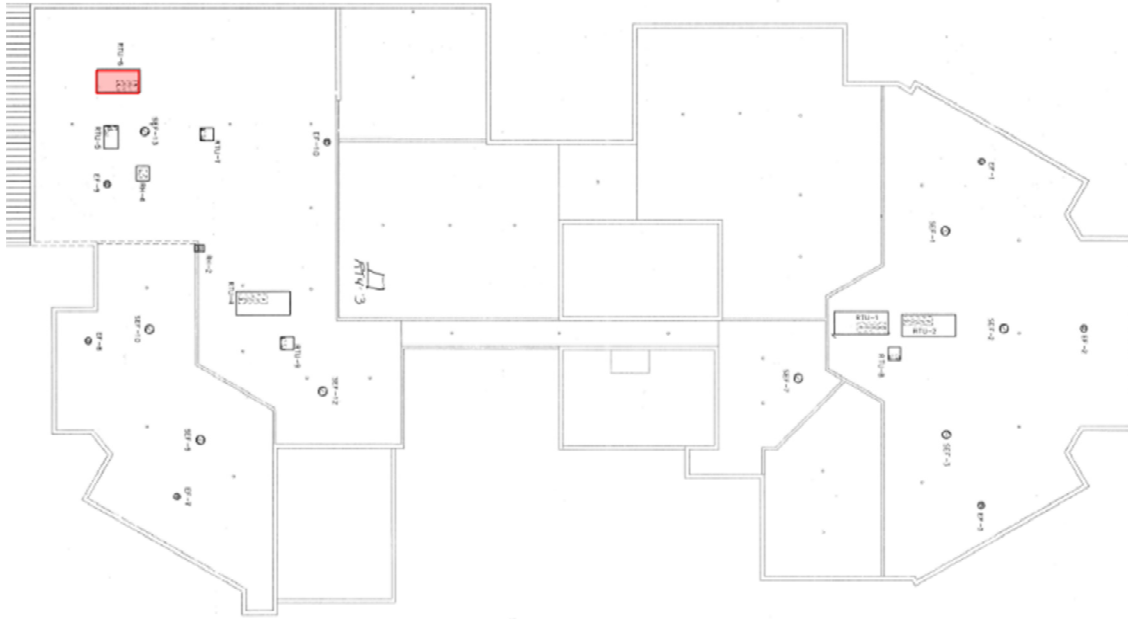
RTU-6 (UNIT 1)

RTU-6 is highlighted on the roof plan above in red.

The unit is 10 years old and in poor condition. There is rust and microbial growth visible on the exterior of the unit. Condensation within the unit has allowed the unit to corrode in a short amount of time, and has caused the insulation inside to delaminate. Where the insulation is damaged, more condensation can occur, resulting in more rust. Areas with delaminated or saturated insulation have visible microbial growth.

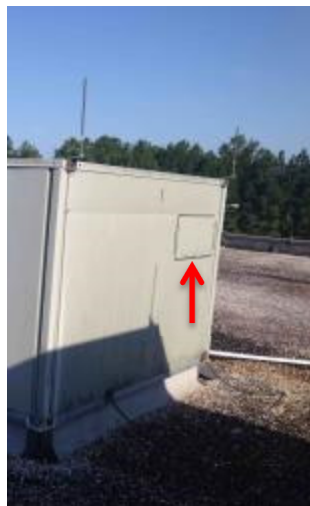
The unit does not have the capability of bringing in outside air through louvers. If it did the opening shown would not be sealed. No outside air is entering RTU-6.

No outside air is entering RTU-6.

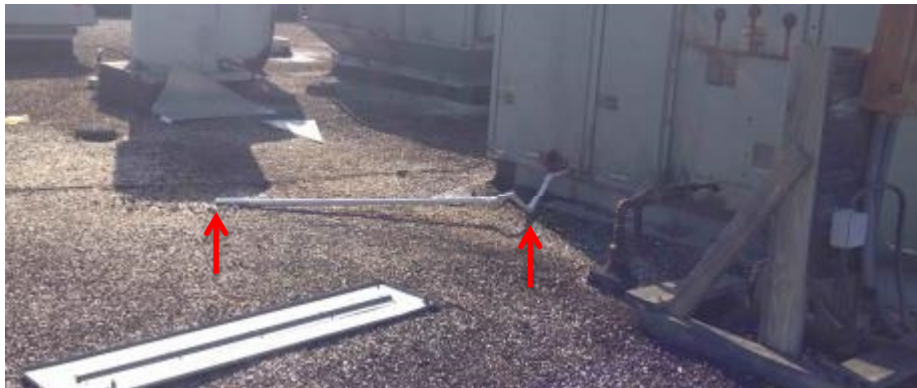
The condensate is not piped to a roof drain and is dispensing directly on the roof. Additionally, the condensate is not trapped properly.

Condensate is not piped to a roof drain.

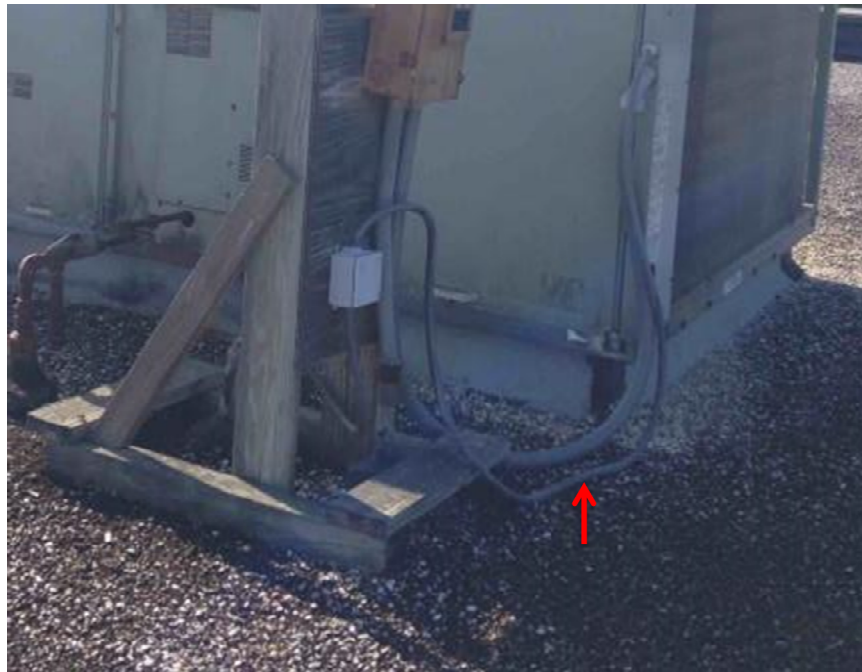
The electrical conduit is not properly supported and is resting on the roof.

Electrical conduit is resting on the roof.

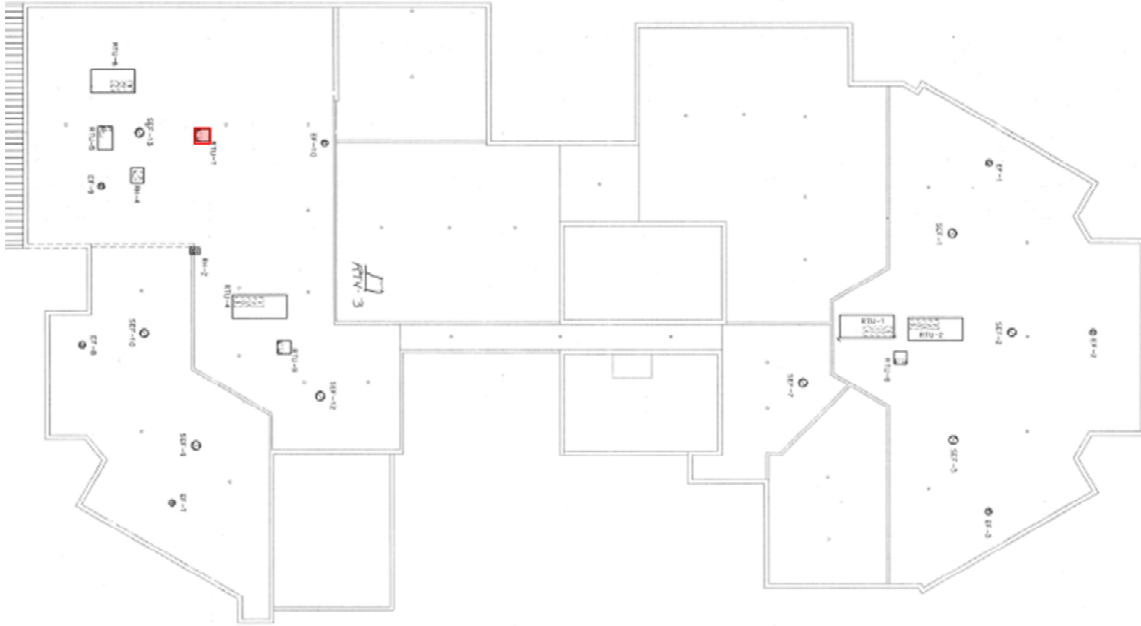
RTU-7 (UNIT 7)

RTU-7 is highlighted on the roof plan above in red.

The unit is 8 years old and in poor condition. There is rust and microbial growth visible on the exterior of the unit. Condensation within the unit has allowed the unit to corrode in a short amount of time, and has cause the insulation inside the unit to delaminate. The condensation has caused microbial growth.

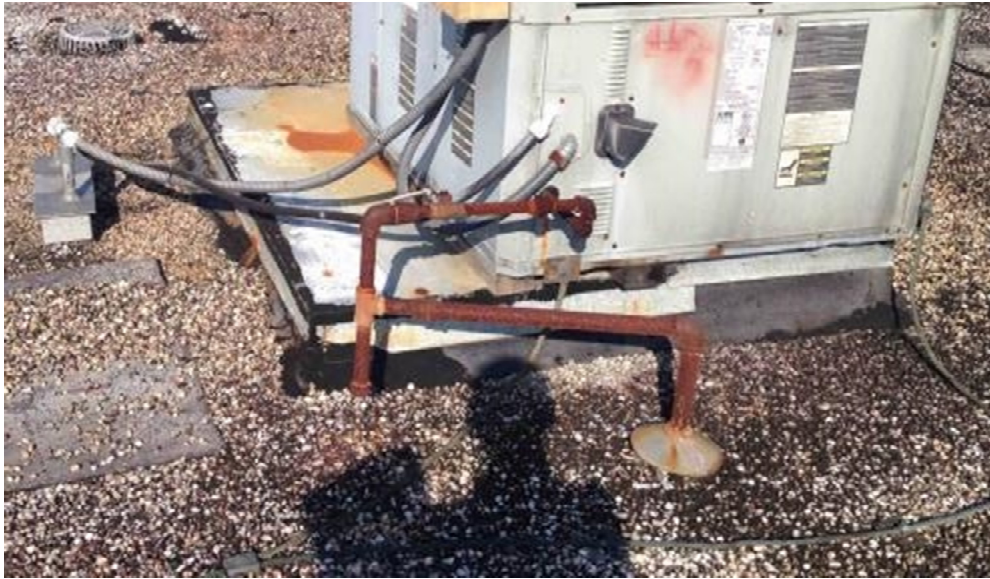
The gas piping penetration enters the building by a pitch pocket.

This is an example of a correct gas pipe penetration.

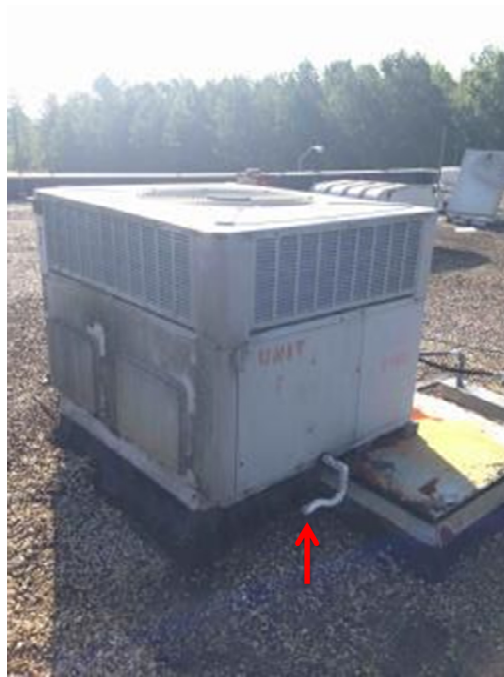
The condensate is not piped to a roof drain and is dispensing directly on the roof.

Condensate is not piped to a roof drain.

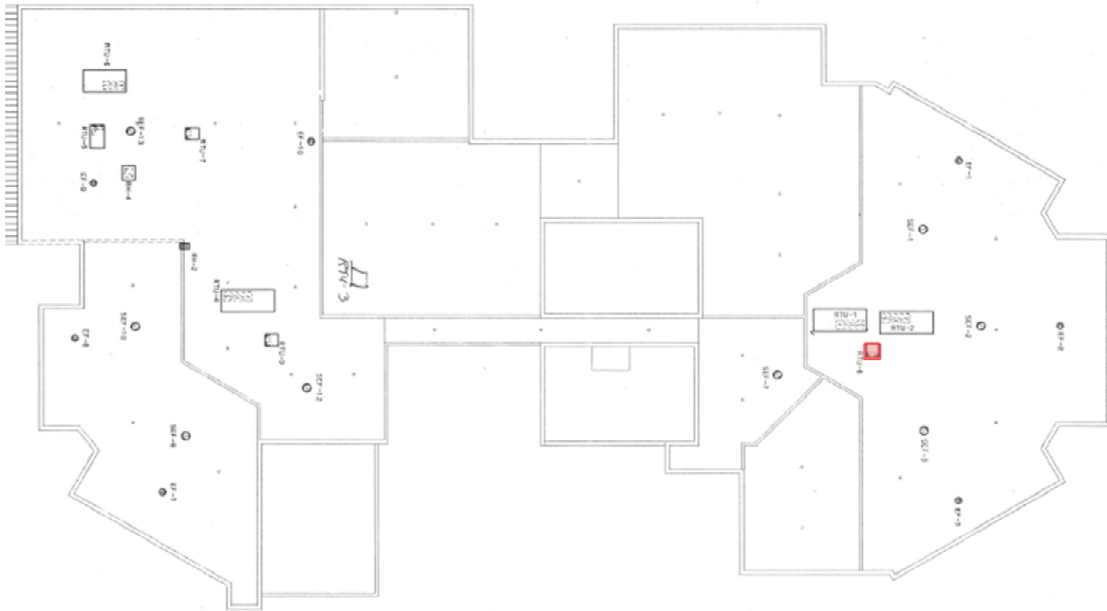
RTU-8 (UNIT 9)

RTU-8 is highlighted on the roof plan above in red.

The unit is 8 years old and in poor condition. There is rust and microbial growth visible on the exterior of the unit. Condensation within the unit has allowed the unit to corrode in a short amount of time, and has caused the insulation inside the unit to delaminate. The condensation has caused microbial growth.

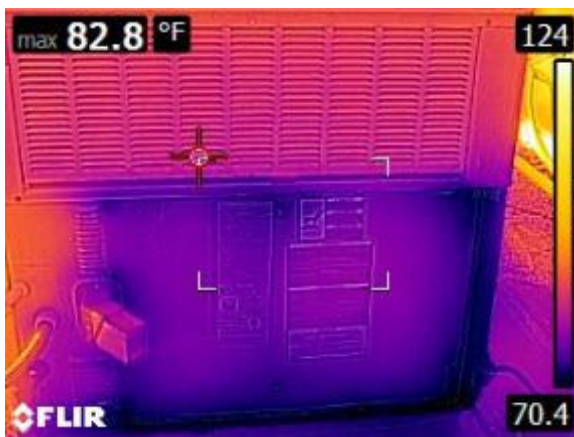
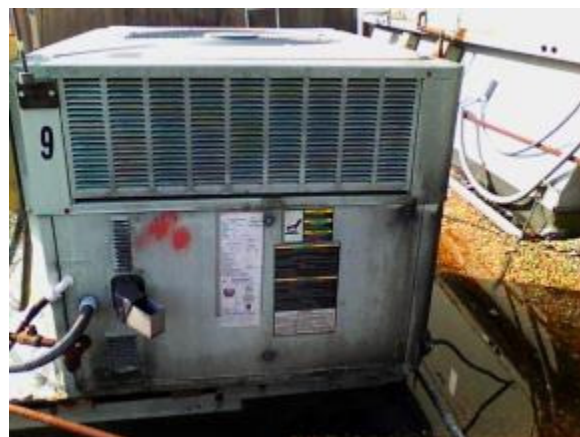
Temperature readings were recorded using the FLIR. The temperature readings on the exterior of the unit vary by about 20°F due to sunlight in addition to insulation delamination. The temperature of the unit should be uniform on the exterior and below dew point. The moisture, microbial growth, and rust are occurring at the coldest parts of the unit.

Above is a side by side comparison of the unit.

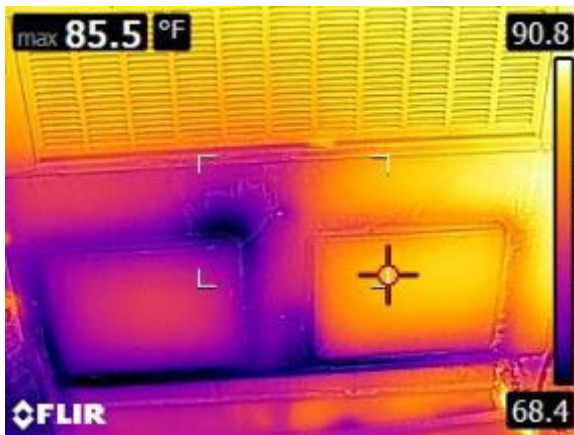
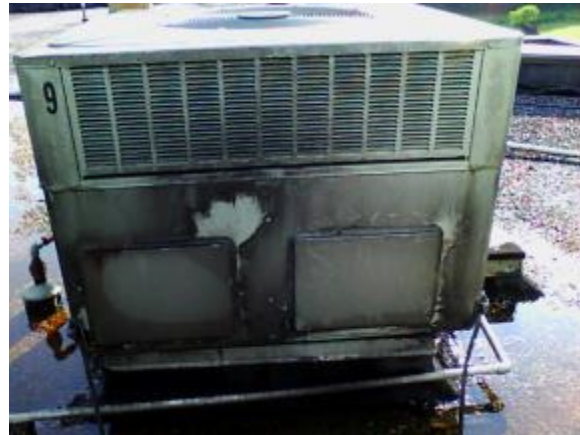
The left would be the relief opening and the right would be the intake.

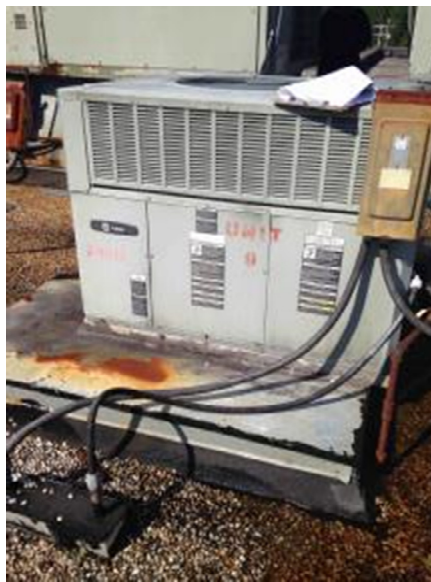
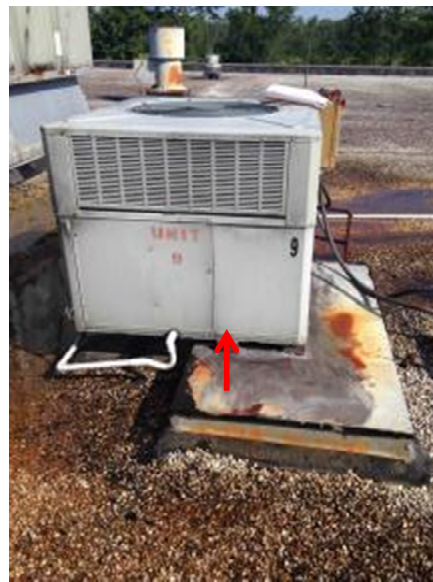
The rooftop unit has been installed on the original roof curb without proper modifications and a roof adaptor curb. When the new equipment was installed, the supply and return air ductwork connections did not align with the existing curb. In lieu of a roof curb, wood blocks are currently being used under the unit. This does not meet code requirements. Wood is never considered a proper support.

RTU-8 was placed on the existing roof curb.

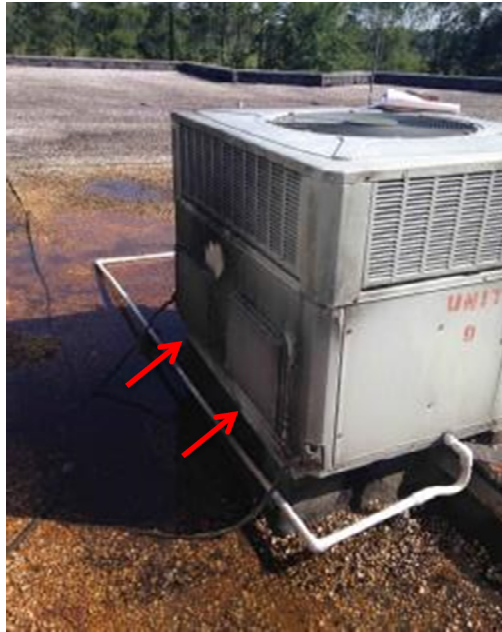
The unit does not have the capability of bringing in outside air through louvers. If it did the openings shown would not be sealed. No outside air is entering RTU-8.

No outside air is entering RTU-8.

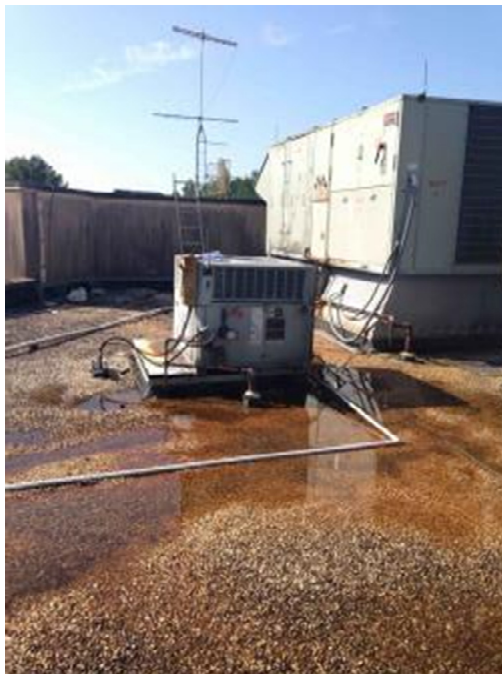
The condensate piping is not properly supported. Additionally, the unit is surrounded by standing water.

RTU-8 is surrounded by standing water.

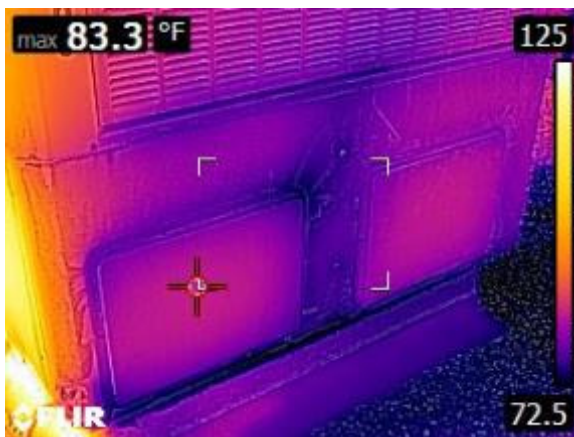
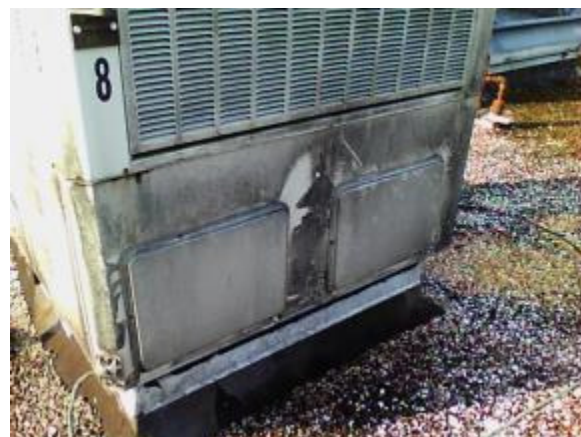
Temperature readings were recorded using the FLIR. The temperature readings on the exterior of the unit vary by about 20°F due to sunlight in addition to insulation delamination. The temperature of the unit should be uniform on the exterior and below dew point. The moisture, microbial growth, and rust are occurring at the coldest parts of the unit.

Above is a side by side comparison of the unit.

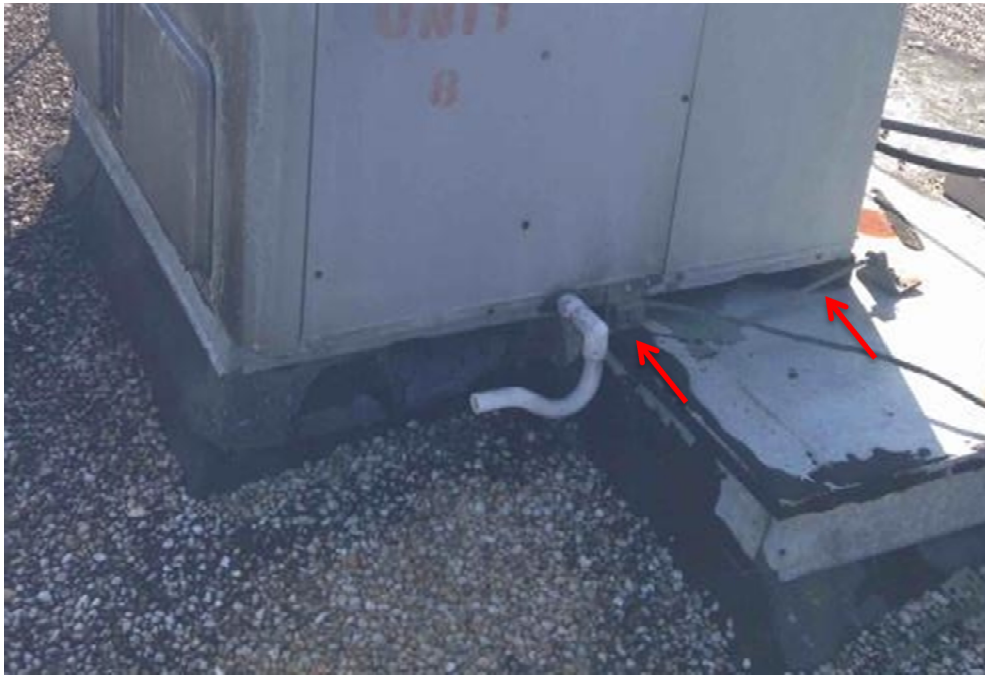
The rooftop unit has been installed on the original roof curb without proper modifications and a roof adaptor curb. When the new equipment was installed, the supply and return air ductwork connections did not align with the existing curb. In lieu of a roof curb, wood blocks are currently being used under the unit. This does not meet code requirements. Wood is never considered a proper support.

RTU-9 was placed on the existing roof curb.

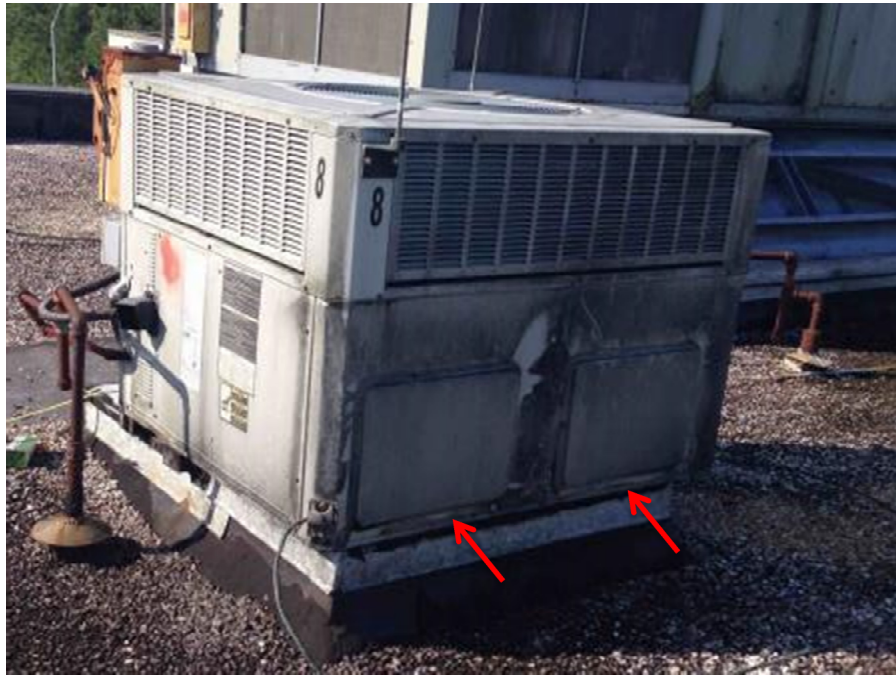
The unit does not have the capability of bringing in outside air through louvers. If it did the openings shown would not be sealed. No outside air is entering RTU-9.

No outside air is entering RTU-9.

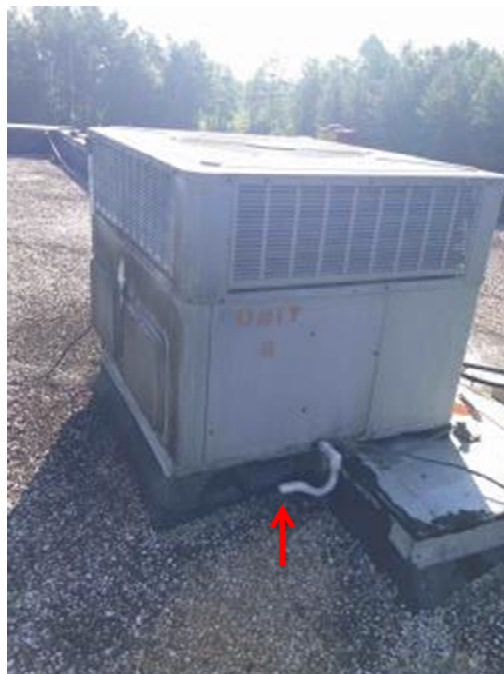
The condensate is not piped to a roof drain and is dispensing directly on the roof.

Condensate is not piped to a roof drain.

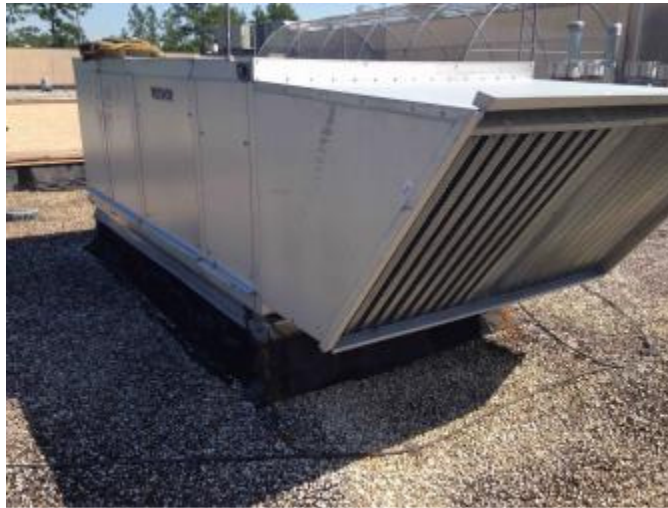
MAU-2 serves Food Service 140.

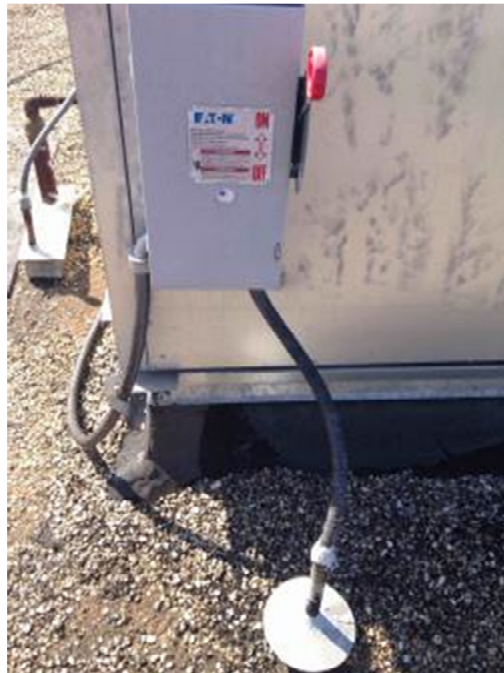
The electrical disconnect is mounted on the unit.
