Contract #15-047, Detention Center Building Condition Assessment

Final Assessment

GEORGETOWN COUNTY DETENTION CENTER

EXECUTIVE SUMMARY

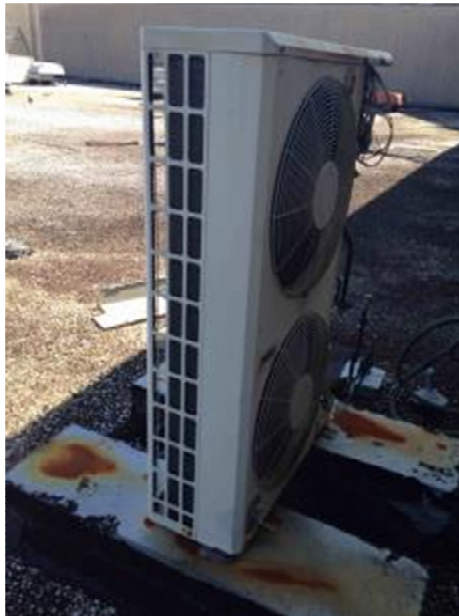
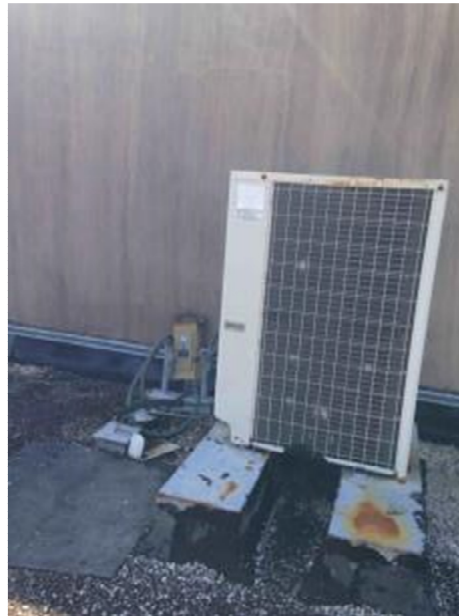
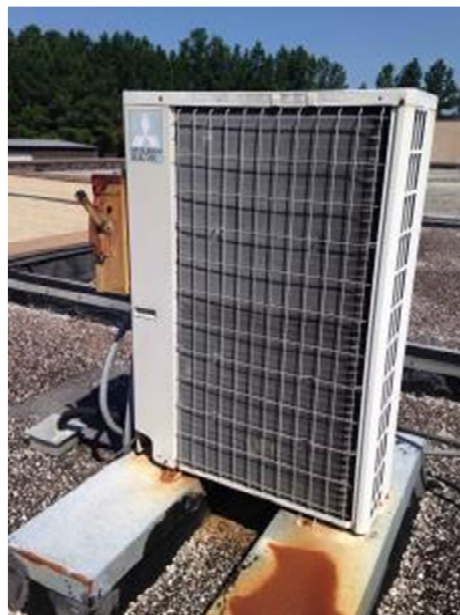
There are 2 split systems on the lower roof. Neither split system is equipped with tie downs for wind or seismic support. The mini split serving the elevator machine room is inoperable. Parts have been removed from the split system serving the elevator machine room to replace parts on the running split system. The running split system serves Telecomm 156.

Split systems are currently installed without wind or seismic supports.

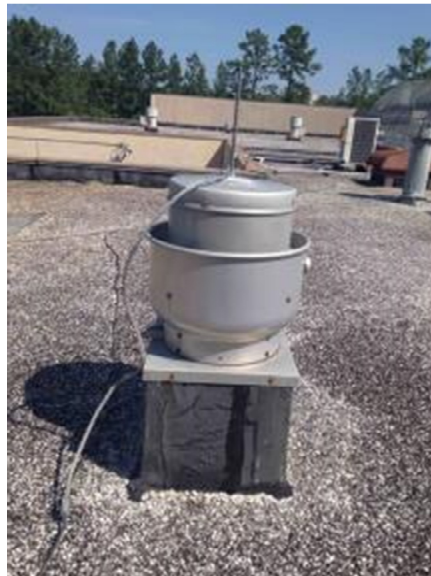
There are 15 Greenheck roof mounted, belt driven, upblast exhaust fans labeled on the existing drawings as "EF-X". Exhaust rates vary by unit and range from 515cfm to 8100cfm. The units are aged and corroded.

The roof mounted Greenheck exhaust fans are aged and corroded.

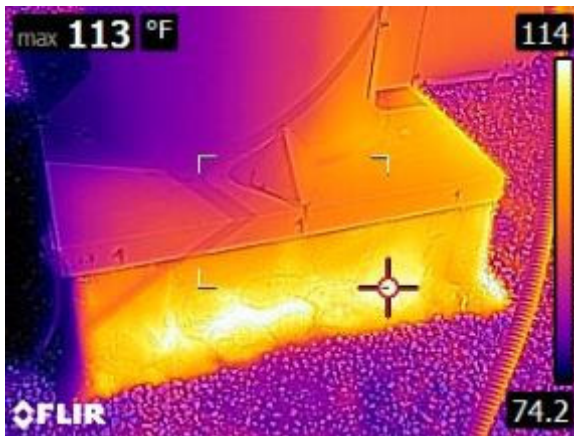
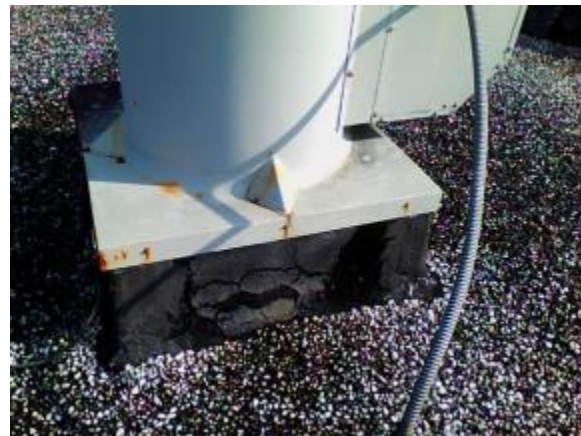
The damaged roof curb temperature is about 113°F, much hotter than the rest of the unit.

The roof curb temperature is about 113°F.

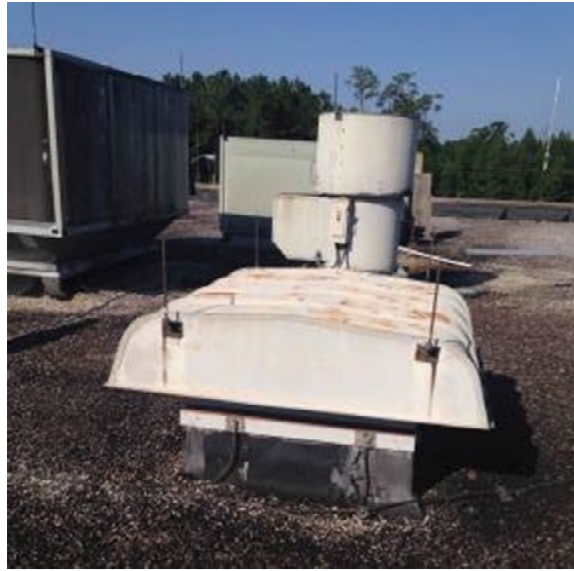
Roof Hoods

Conditioned air is exiting the building through 5 roof hoods that are dispersed throughout the roof.

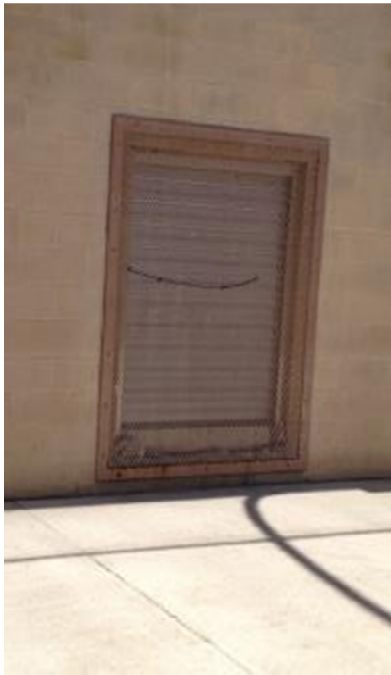
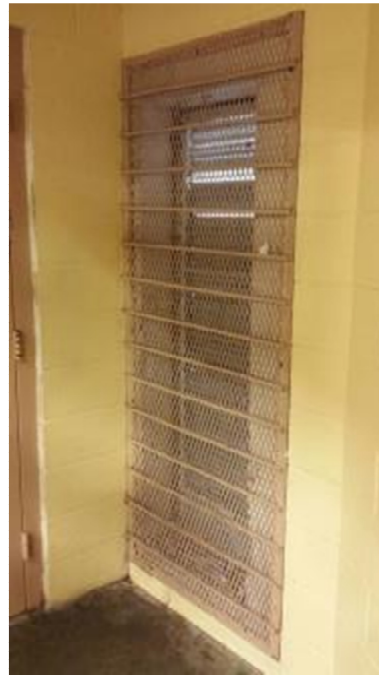
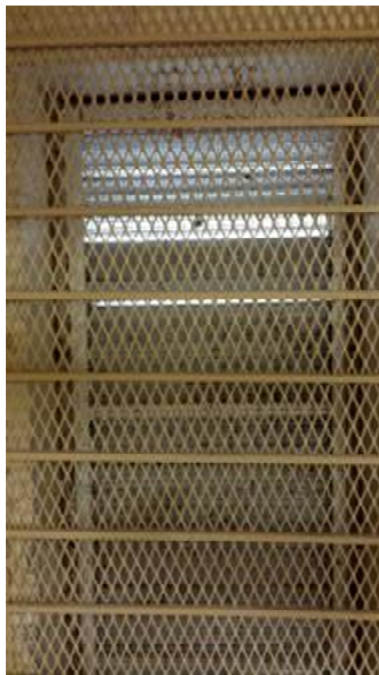
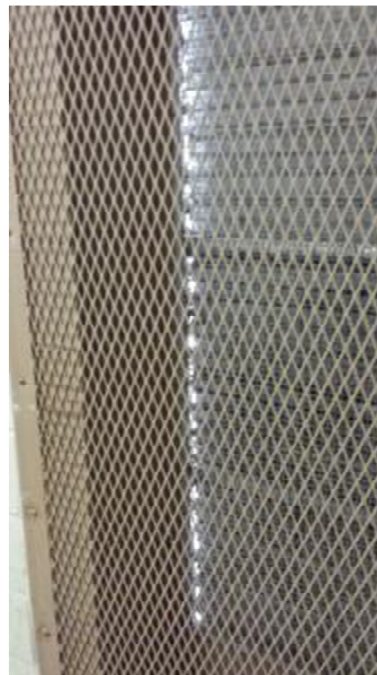
There are large, uninsulated, louvers in the housing blocks allowing uncontrolled infiltration. Unconditioned, humid air enters through the louvers frequently when the exhaust system is running. These large outdoor air louvers are used frequently to pull in raw outside air when the general exhaust system is operating to remove odors from the space.

There is uncontrolled infiltration through the large louvers in the housing blocks.

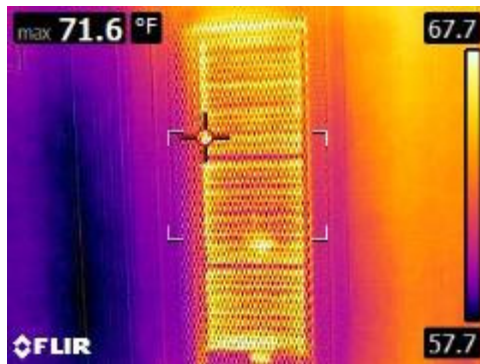
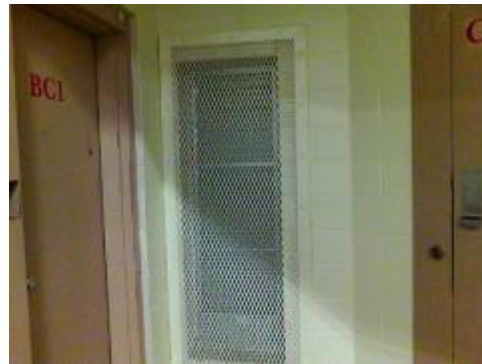
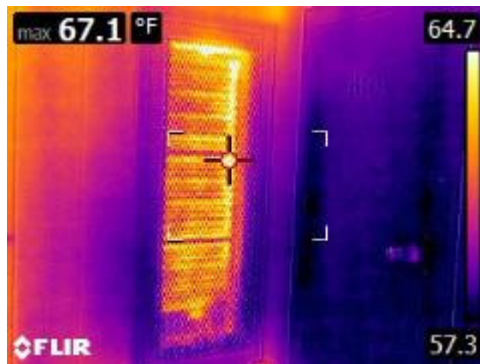
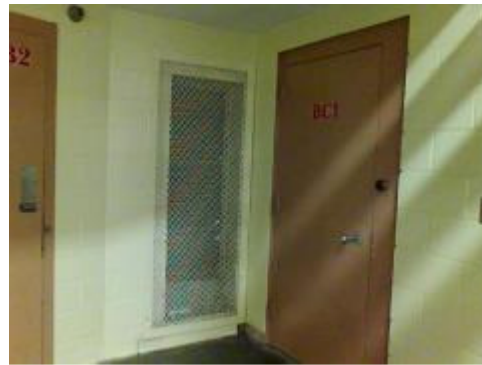
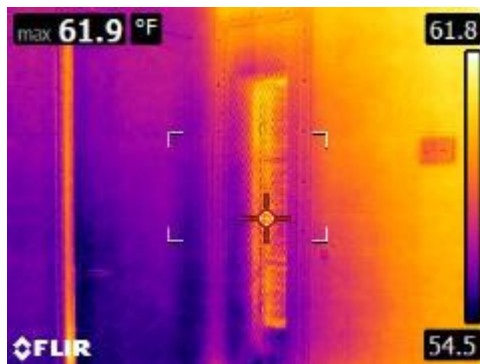
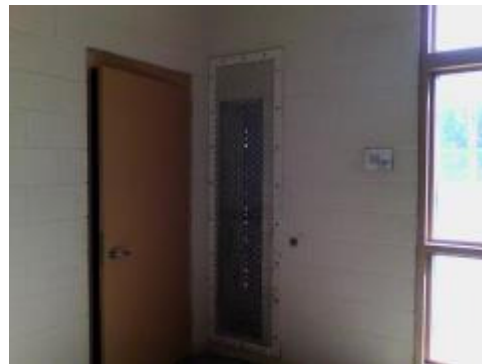
These are uninsulated outdoor air intakes (louvers).

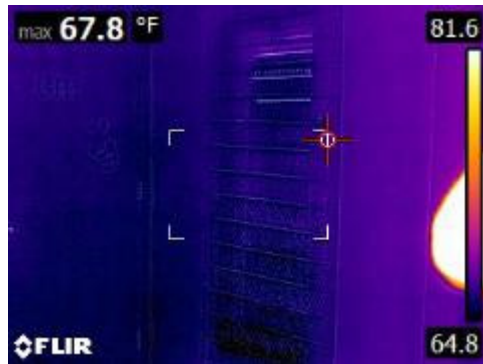
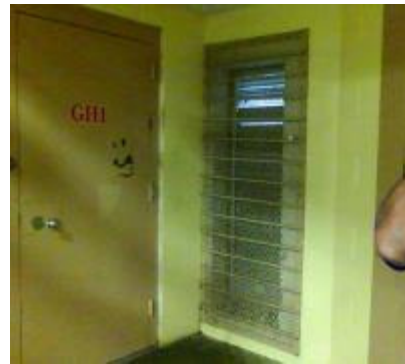
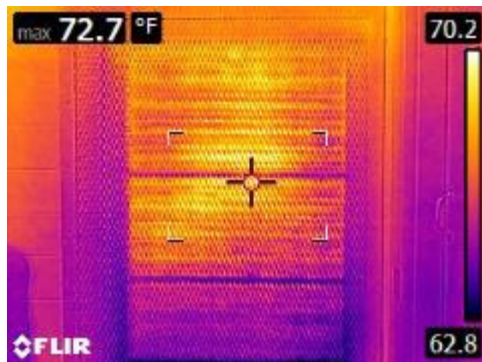
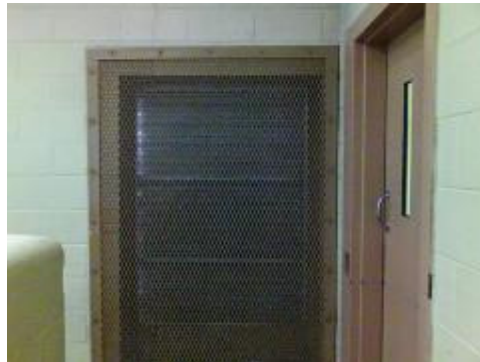
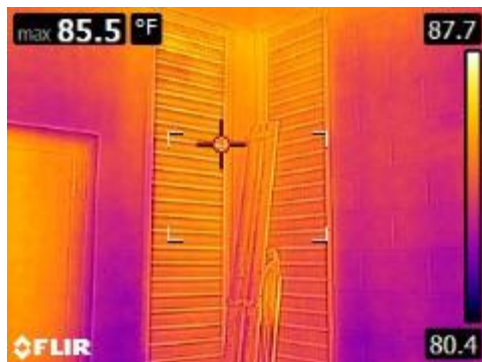
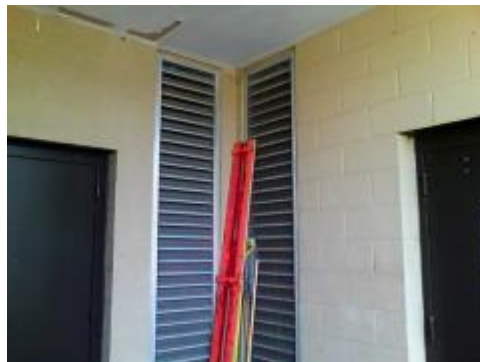
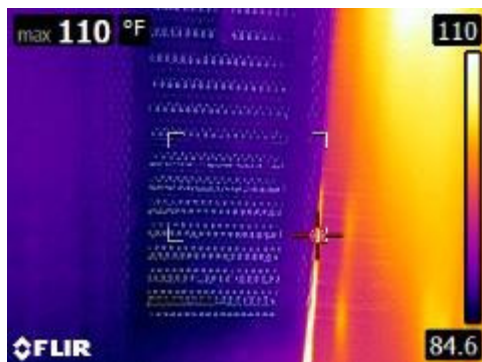
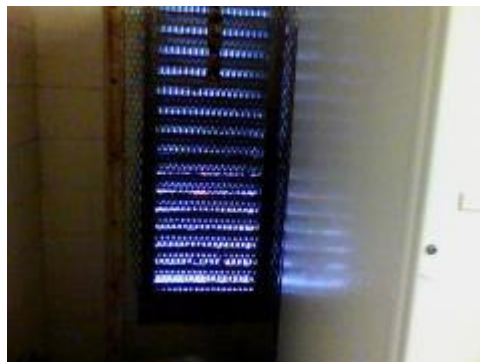
These are uninsulated outdoor air intakes (louvers).

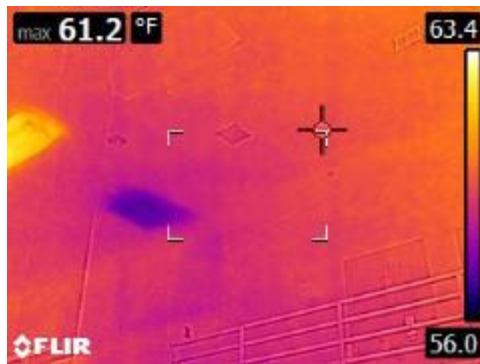
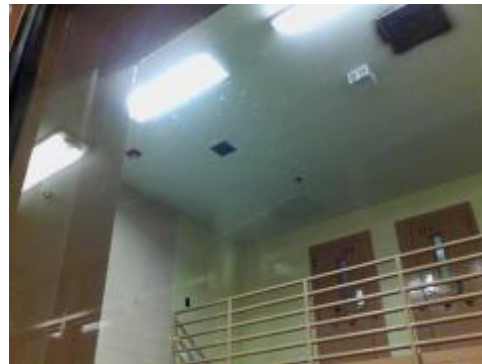
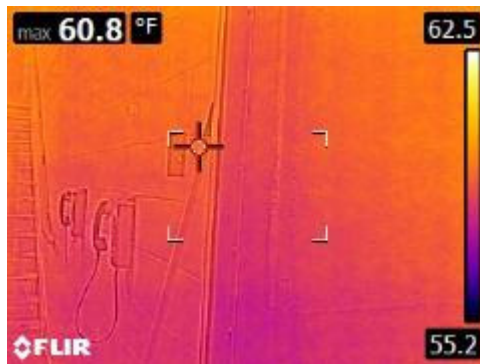
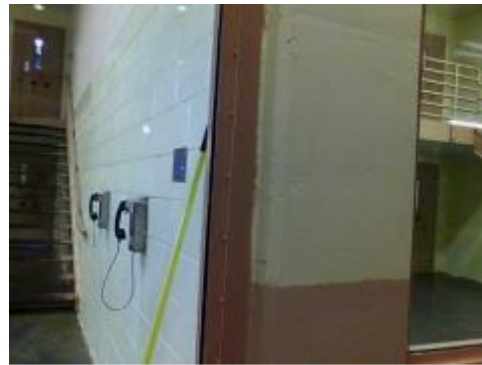
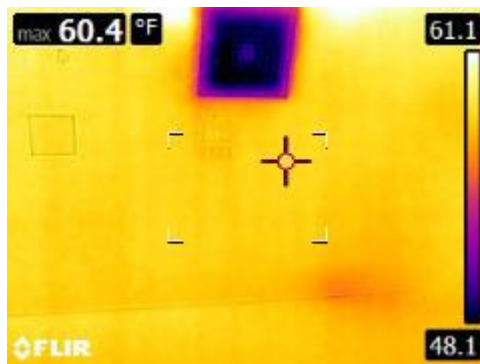
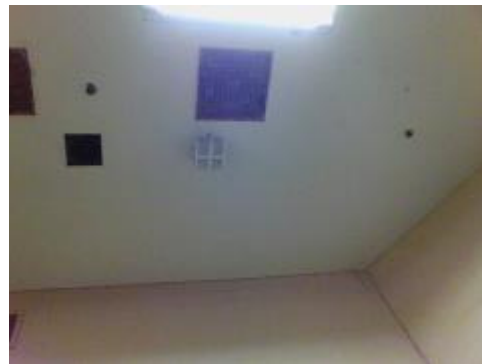
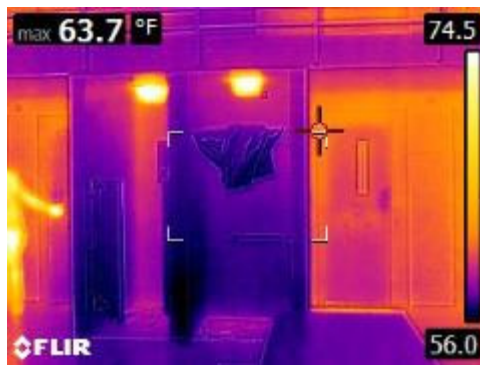
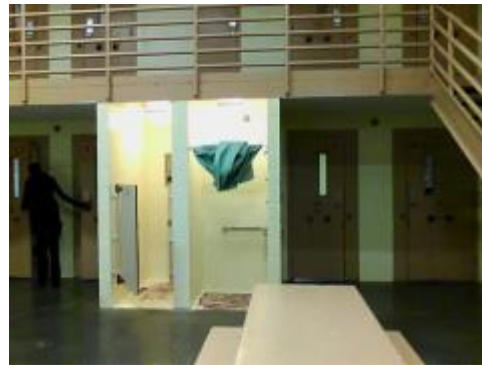
The housing units have temperatures as low as 50°F.

Above are temperature recordings throughout the housing units.

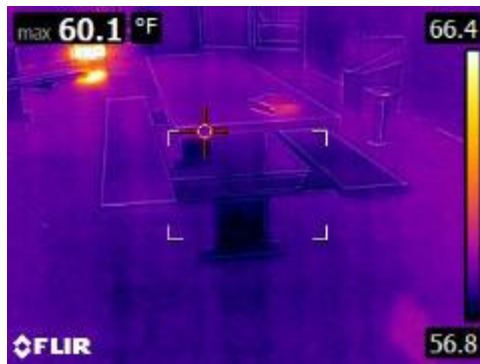
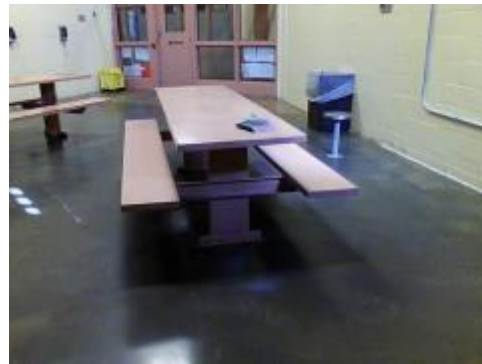
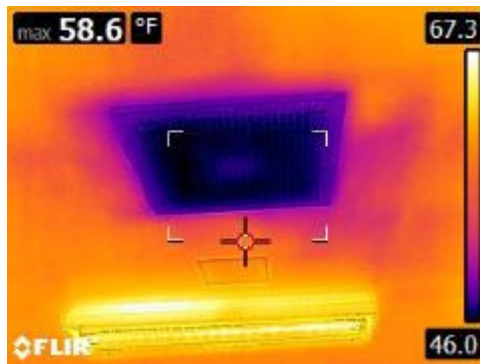
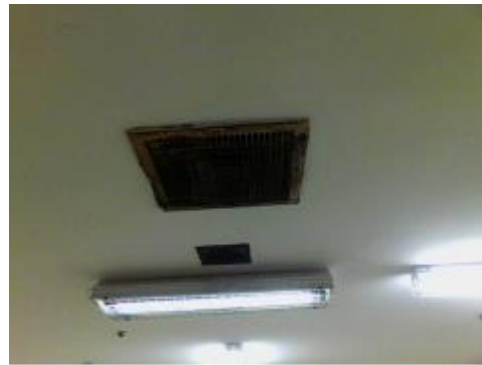
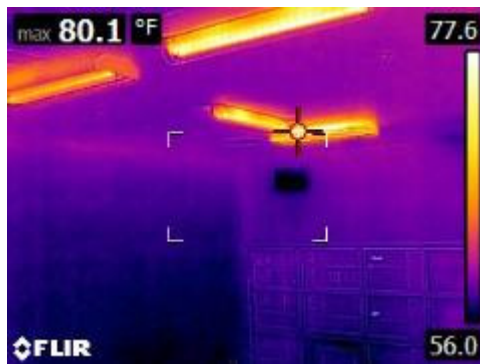
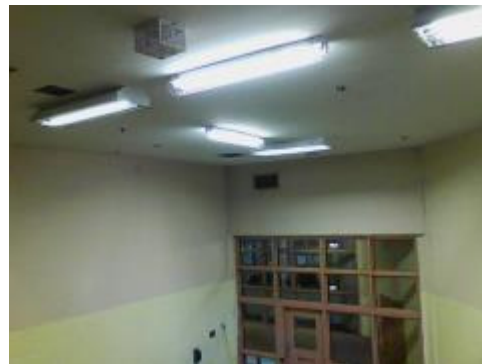
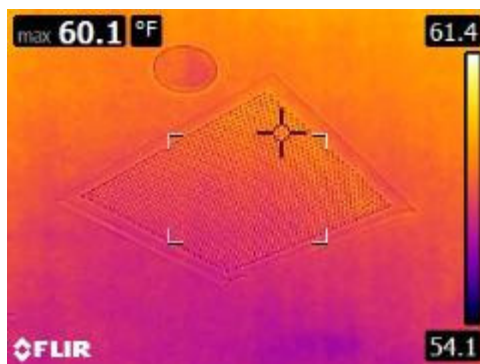
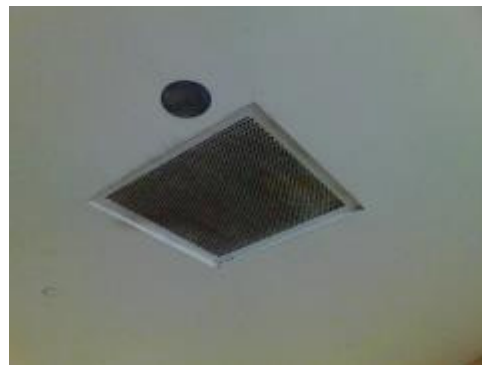
Above are temperature recordings throughout the housing units.

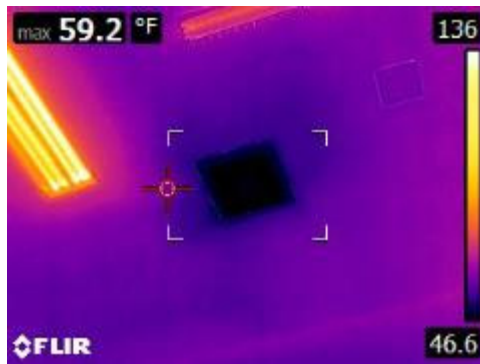
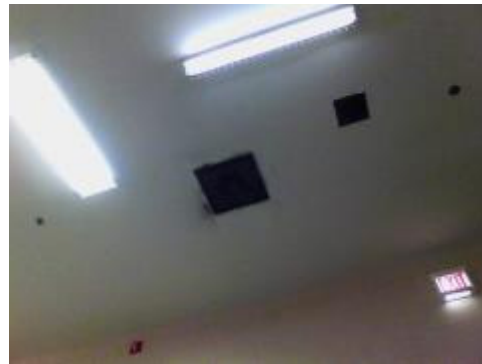
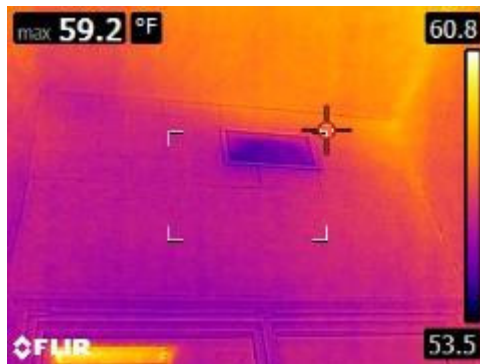
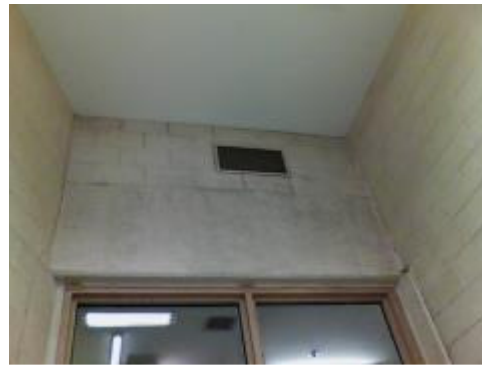
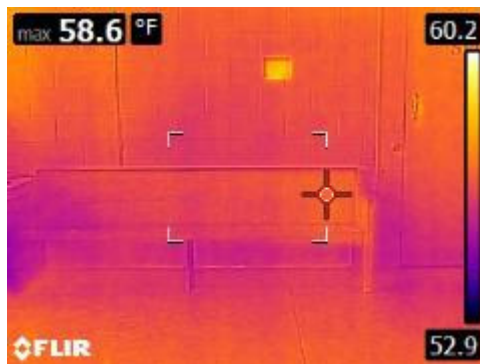
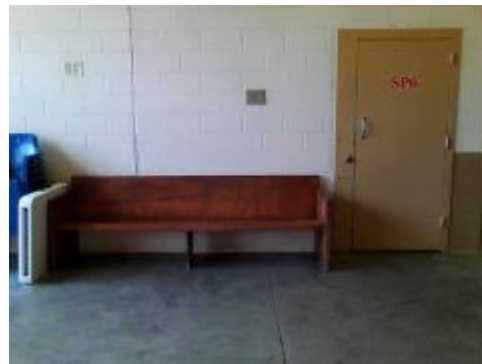
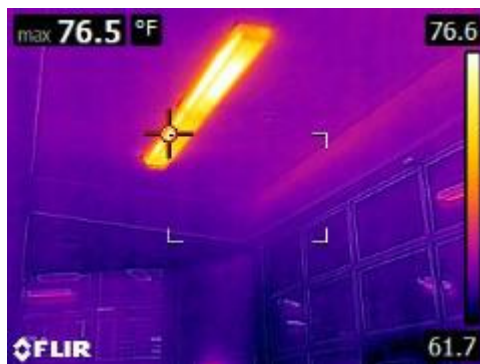
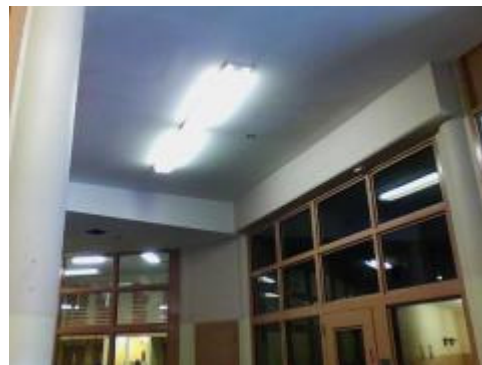
Above are temperature recordings throughout the housing units.

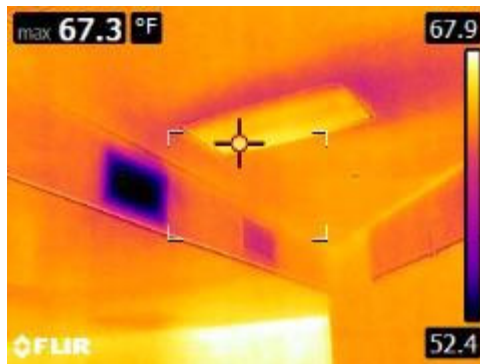
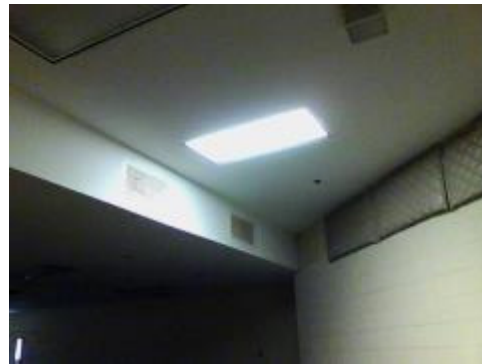
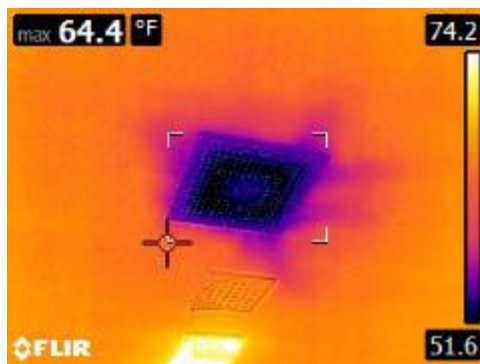
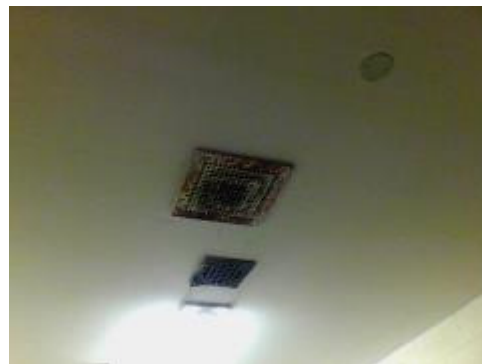
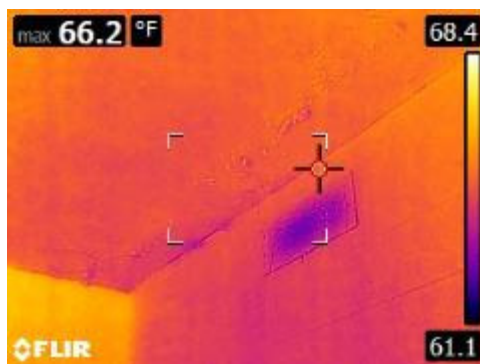
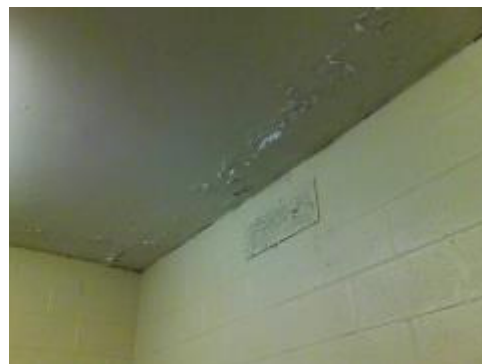
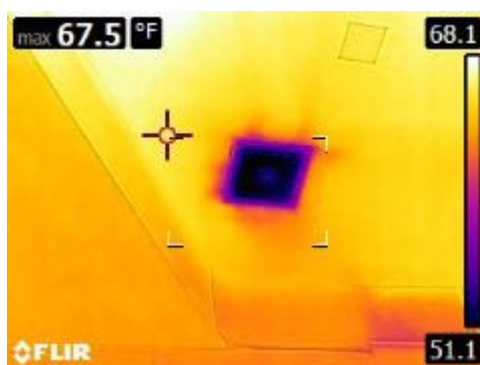
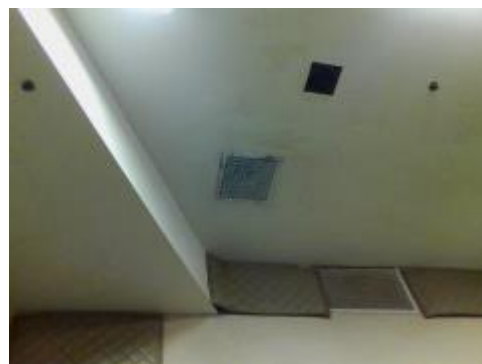
Above are temperature recordings throughout the housing units.

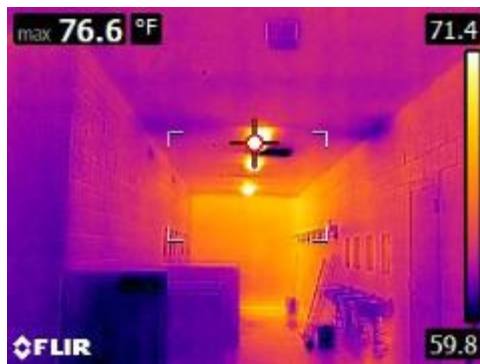
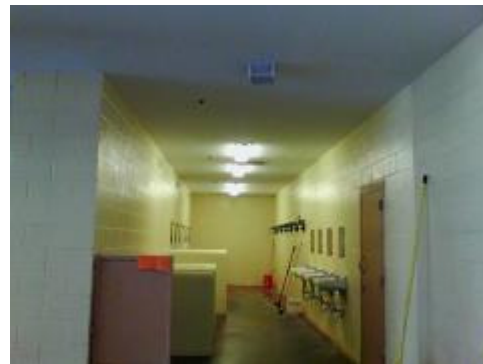
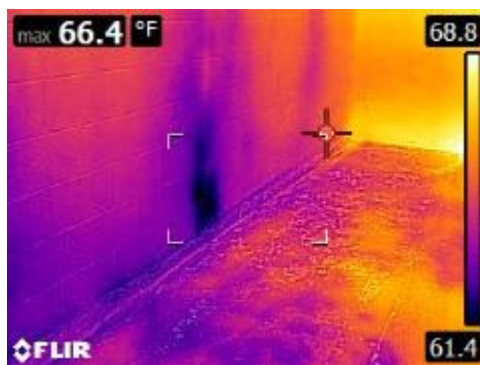
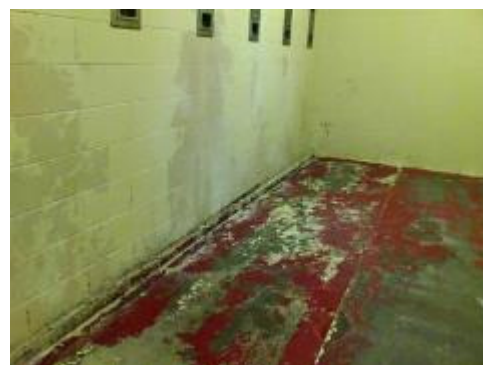
Above are temperature recordings throughout the housing units.

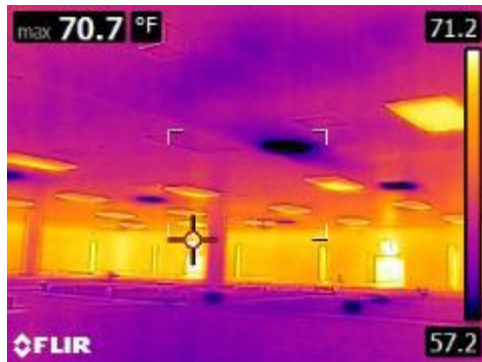
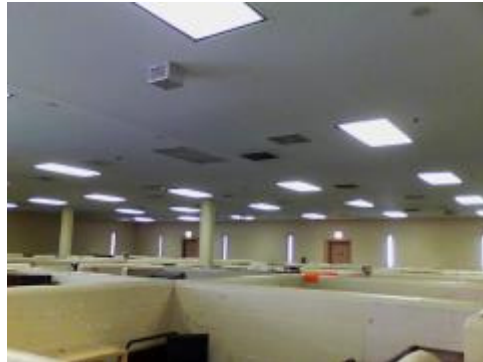
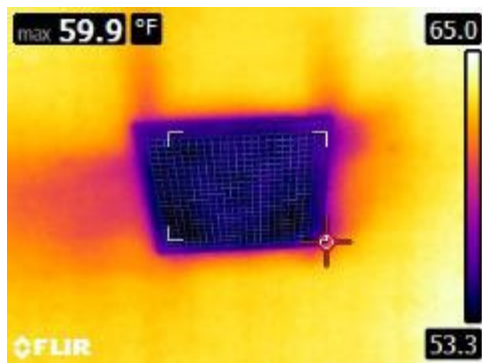
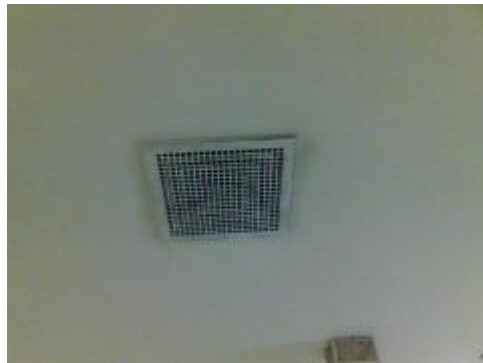
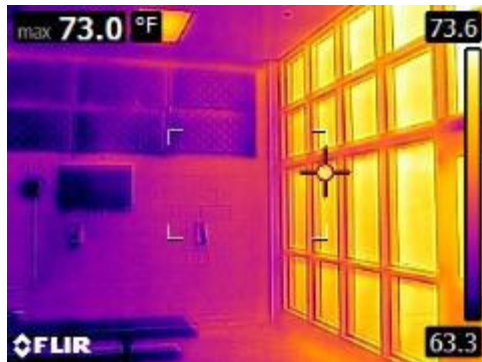
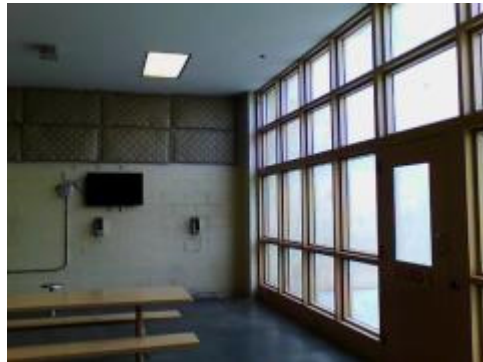
Above are temperature recordings throughout Room F102 and Room F103.

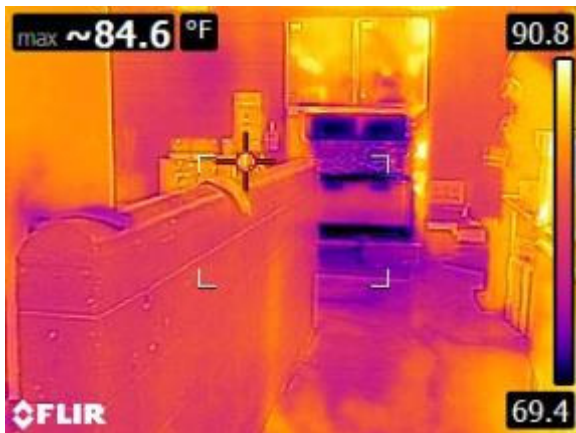
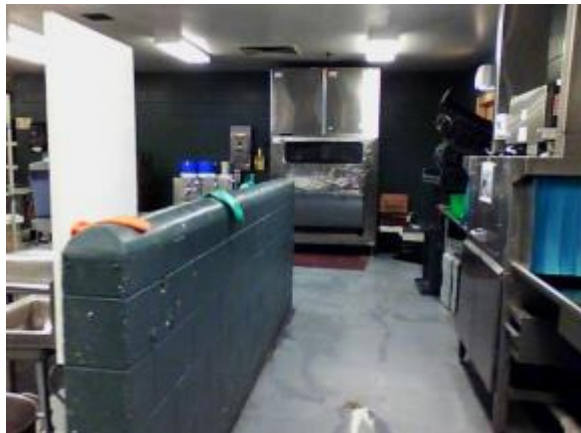
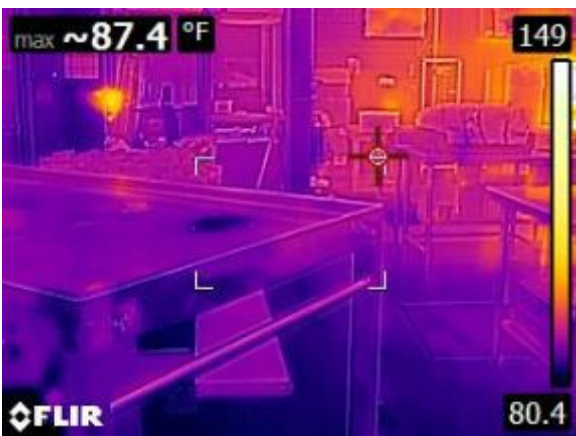
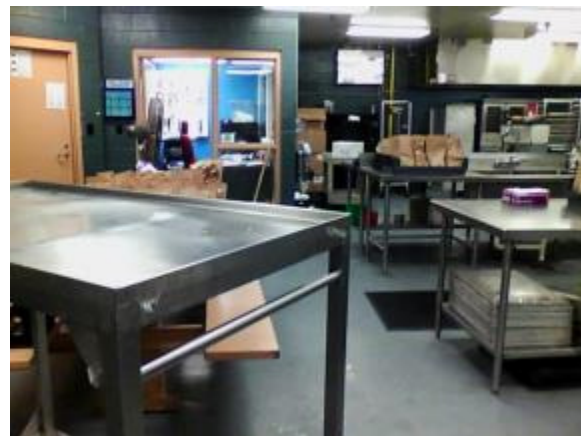
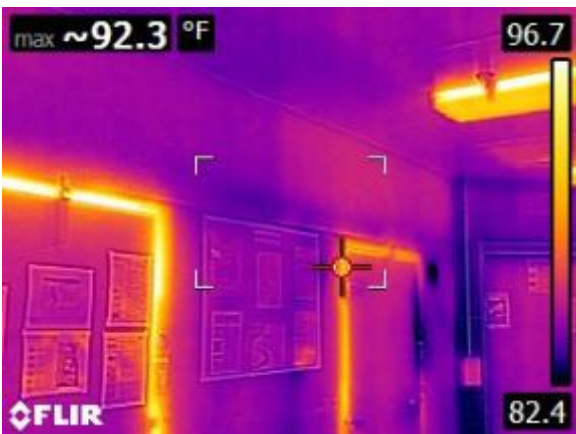
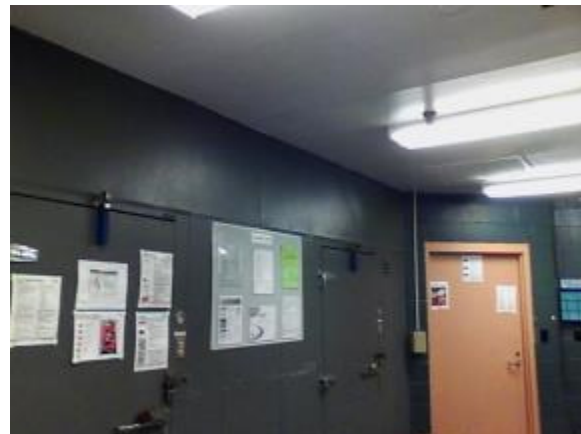
There is currently no cooling in the kitchen area and the space is uncomfortable for occupants. The makeup air systems that serve the kitchen space only provide heating. Recorded temperature readings were extremely high in this area.

Above are temperature recordings from the kitchen.

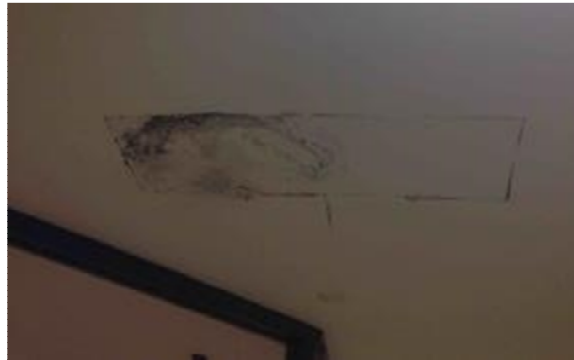
The ceiling in Intake 103 in the booking area shown above has microbial growth.

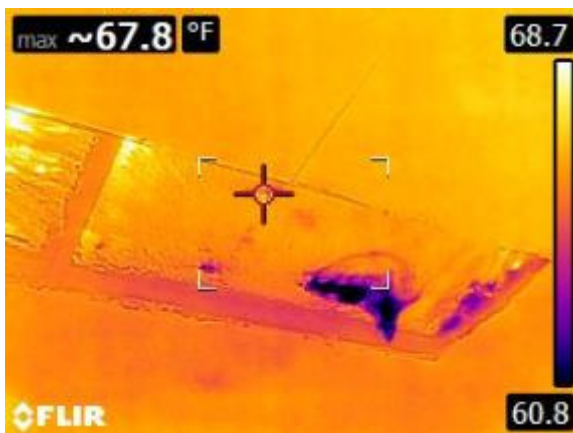
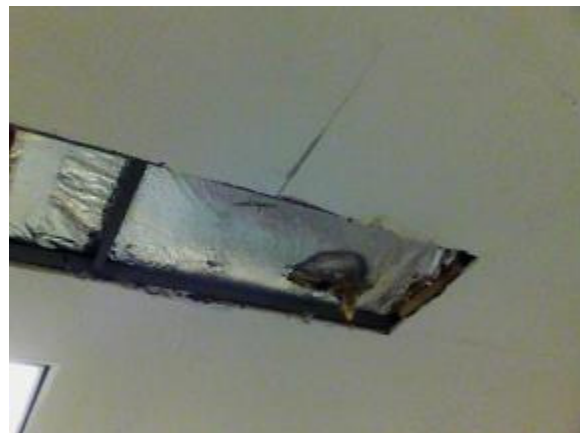
The drywall is being replaced due to condensation. The ductwork also has microbial growth.

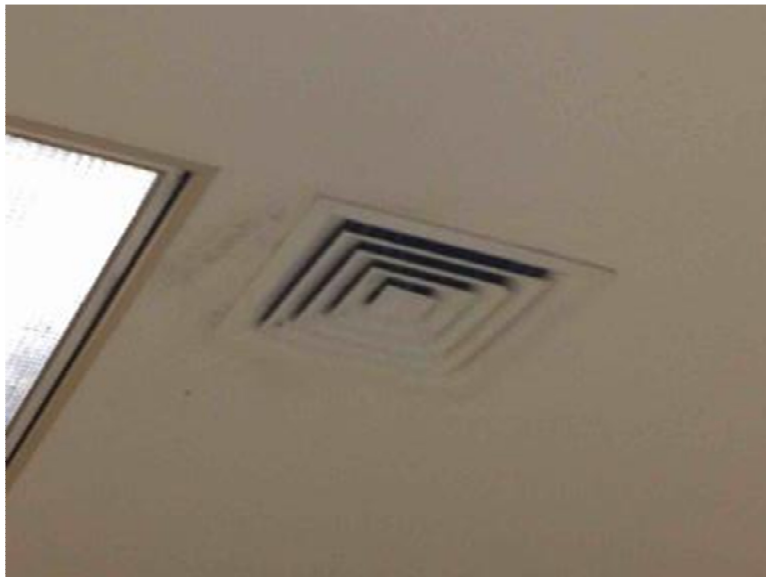
The ceiling in Booking Area 114 has microbial growth.

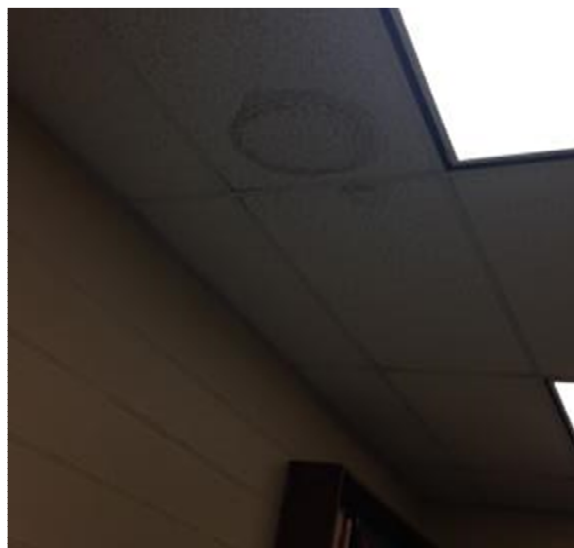
There is visible damage in the ceiling of the Segment A office area on the first floor.

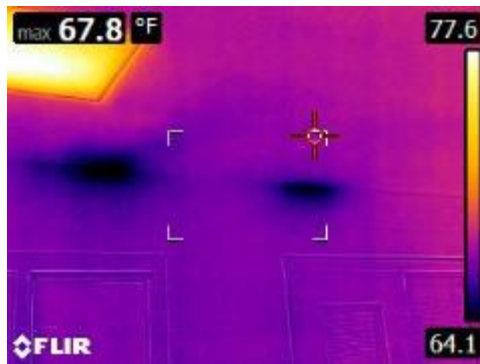
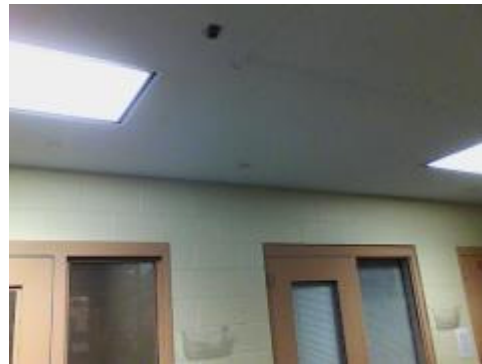
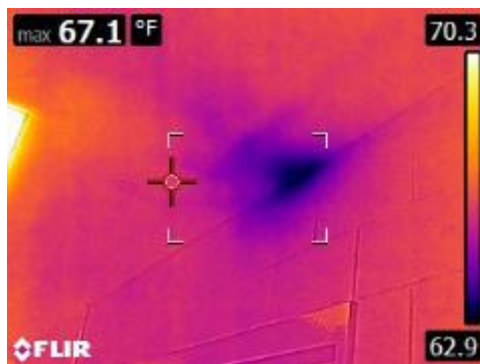
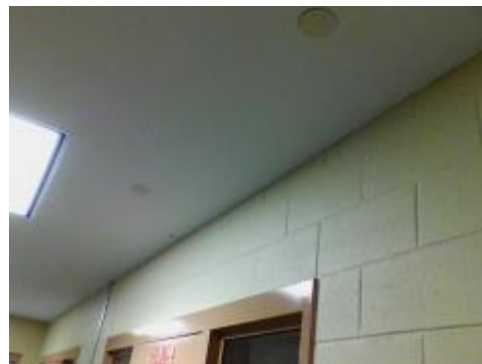
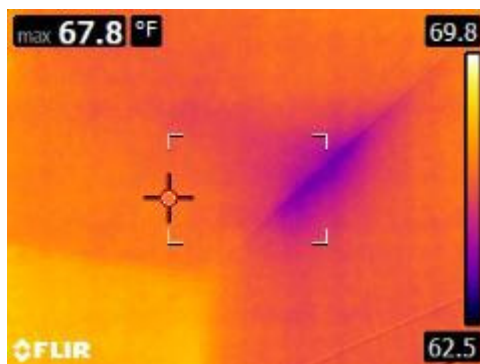
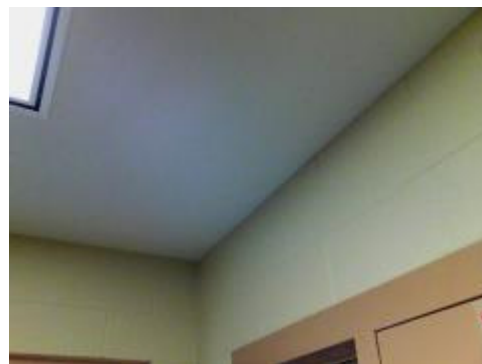
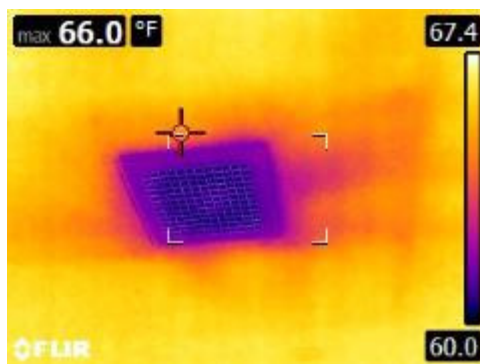
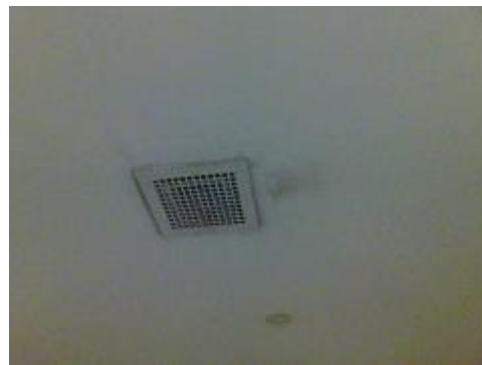
The dark spots in the images above indicate a water issue in the booking area. The supply air temperature is 60°F.

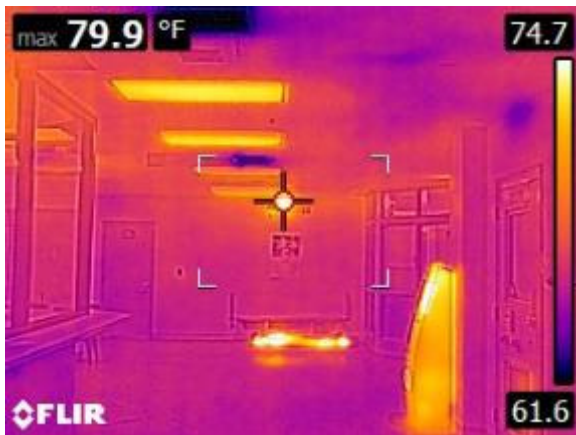
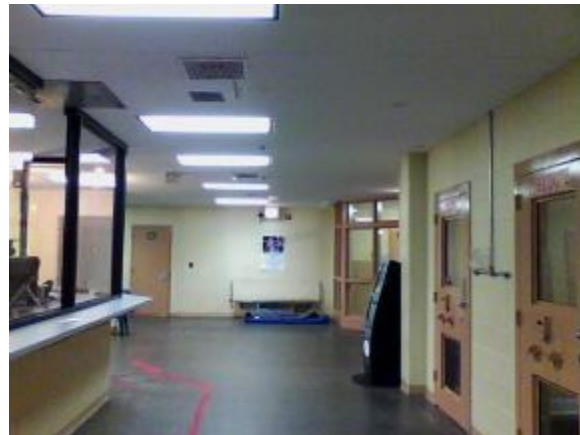
This is an overall view of the temperature difference in the booking area.

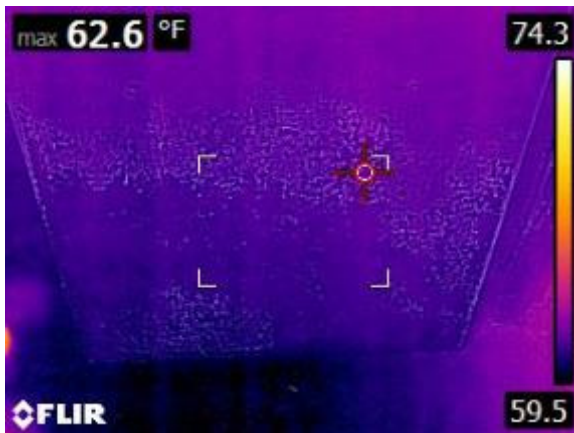
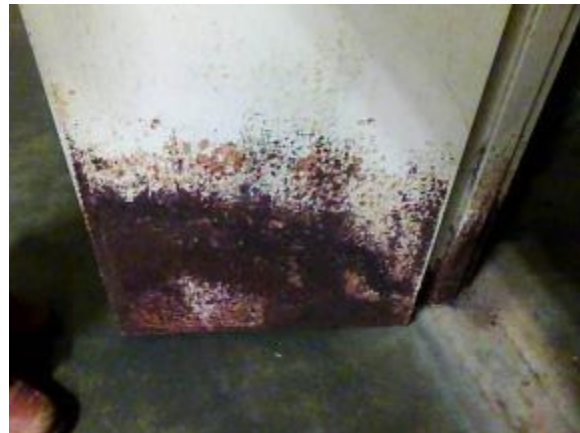
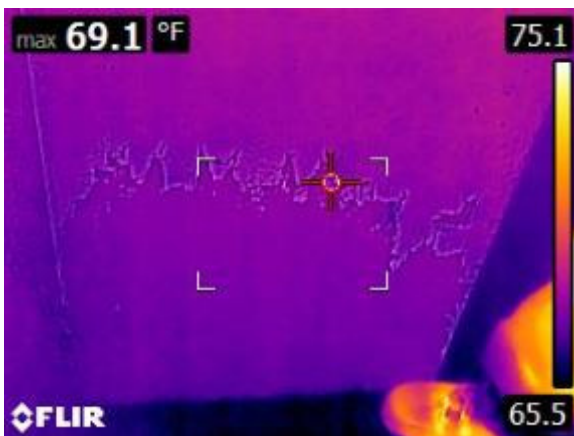
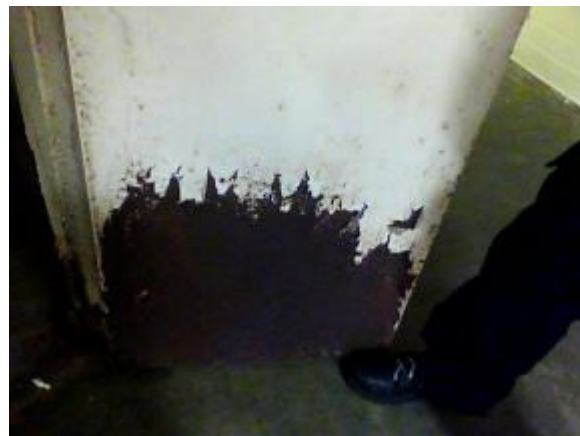
The area rusting on the doors to the plumbing chases is the coldest part of the door suggesting water intrusion.

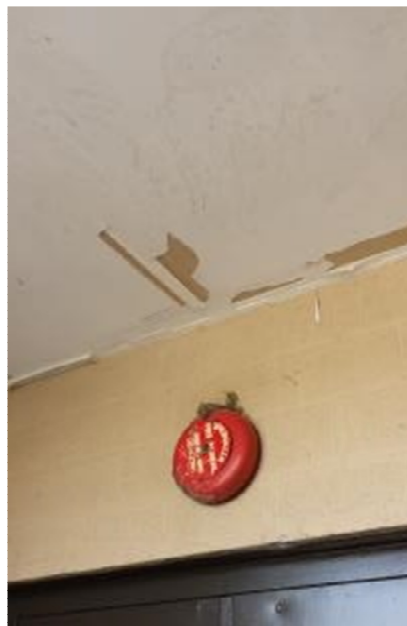
The paint is coming off the drywall at the boiler room entrance.

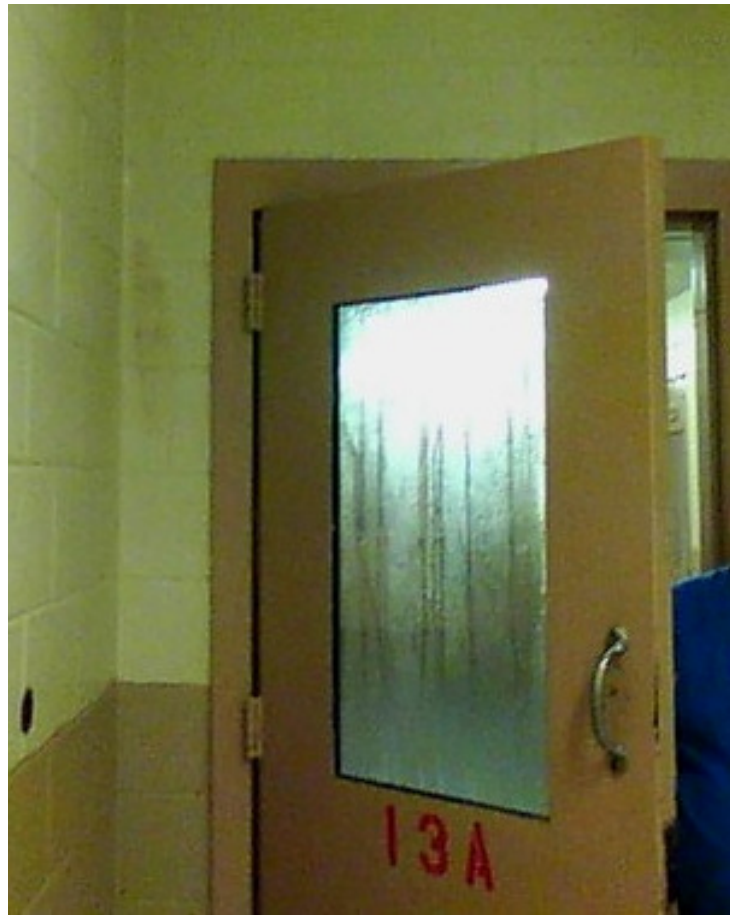
The glass is sweating in the door of the corridor connecting to the kitchen.

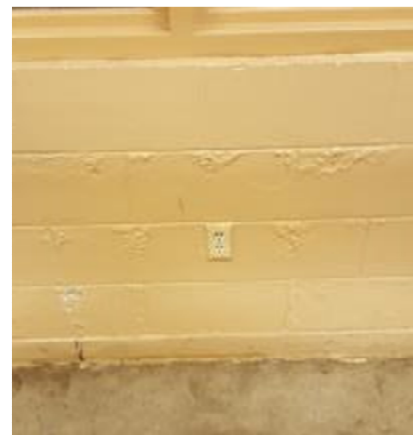
The paint is delaminating due to apparent migration moisture from the CMU block.

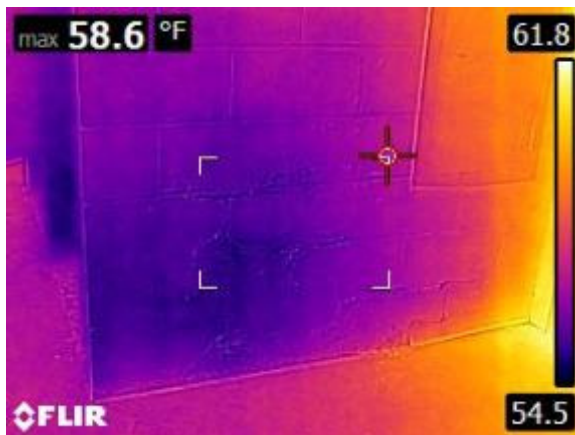
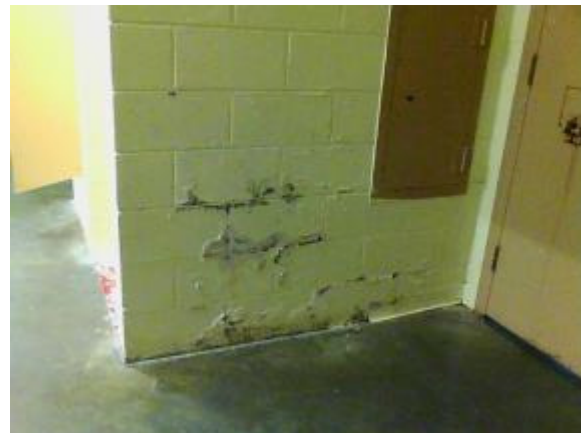
The paint is delaminating due to apparent migration moisture from the CMU block. Temperatures at this wall are as low as 54.5°F.

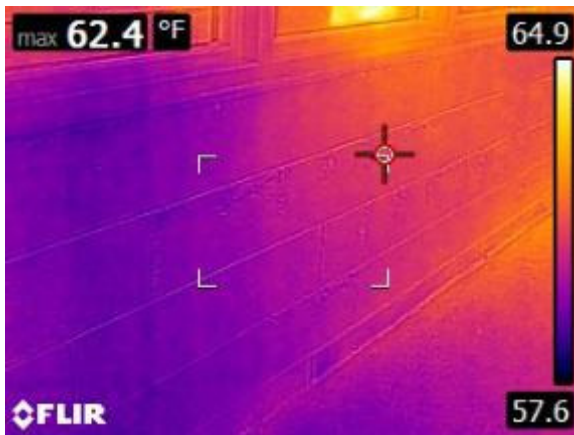
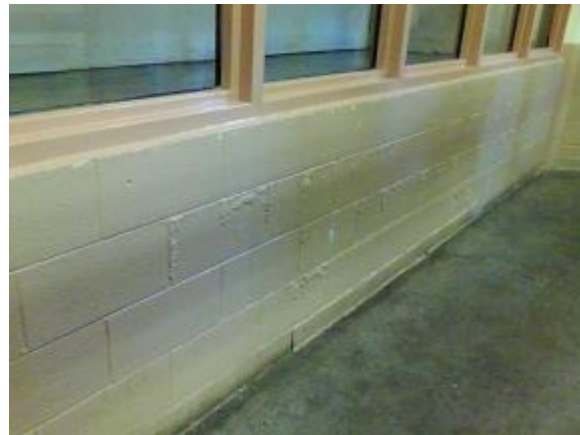
The paint is delaminating due to apparent migration moisture from the CMU block. Temperatures at this wall are as low as 57°F.

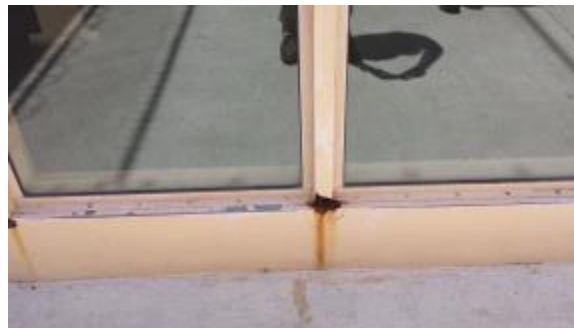
There is rust on the exterior of the building.

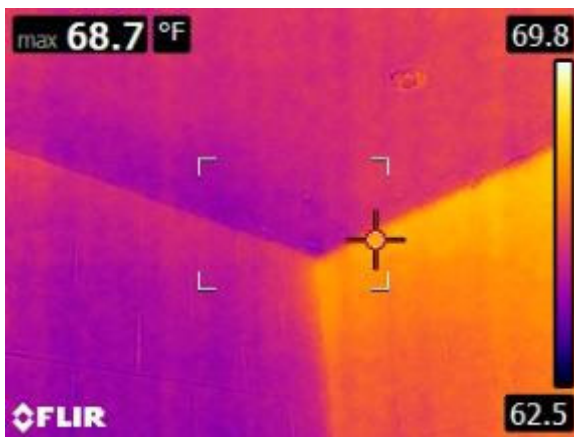
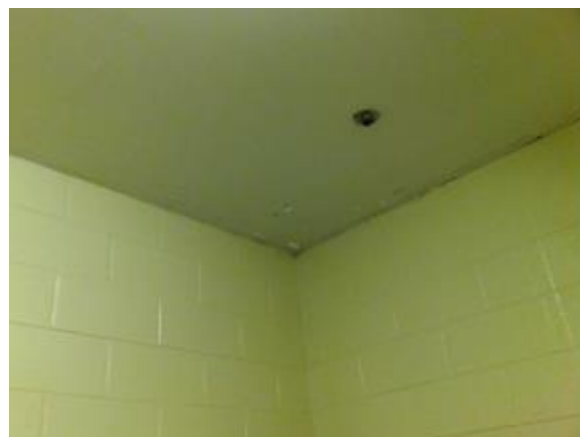
The FLIR temperature reading from the group restroom in the Dormitory Dayroom indicates the building is not insulated. The exterior walls are hot and the interior walls are cold.

The exterior wall is hot and the interior wall is cold.

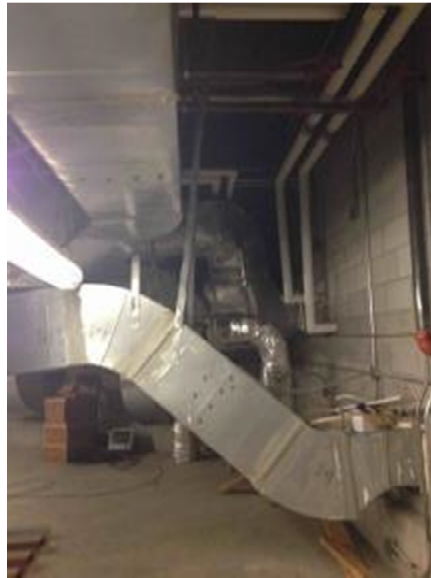
The ductwork chase accessed through Electrical Room 252 is in overall good condition. The ductwork and piping insulation is not showing signs of moisture in the space. Piping should be labeled.

This is inside the ductwork/plumbing chase next to Electrical Room 252.
