Contract #15-047, Detention Center Building Condition Assessment

Final Assessment

GEORGETOWN COUNTY DETENTION CENTER

EXECUTIVE SUMMARY

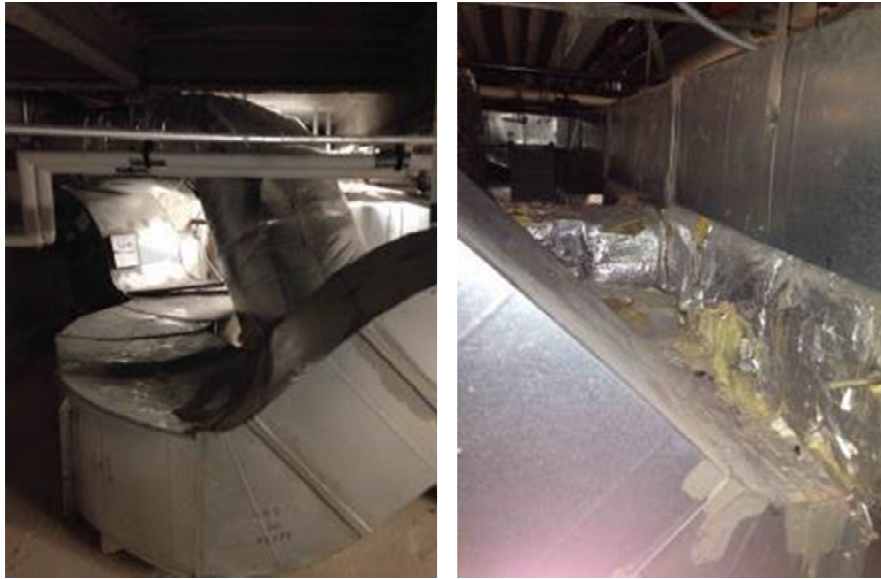
The ductwork chase accessed through Mechanical Room 255 is in overall good condition. The ductwork and piping are not showing signs of moisture in the space. Piping should be labeled. The ductwork insulation needs repair.

This is the piping and ductwork inside the sprinkler room accessed by Mechanical Room 255.

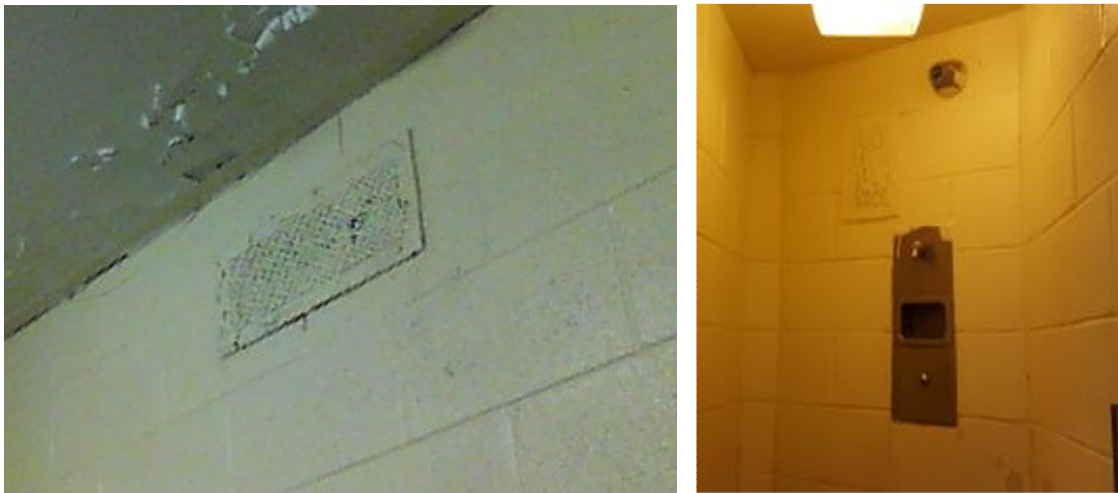
In general, air devices need to be cleaned. Grilles have been painted over and therefore are likely not functioning as designed.

Above are typical examples of grilles that have been painted over which impedes the airflow.

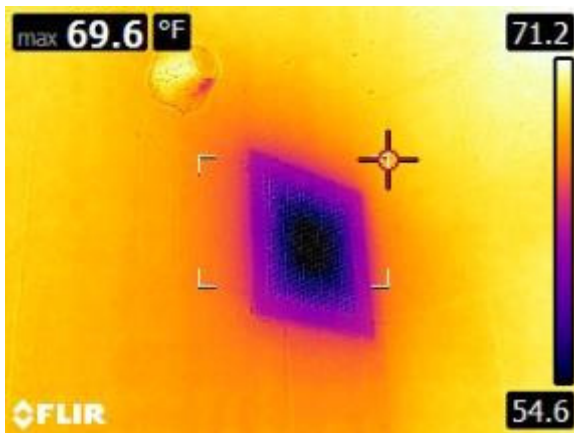
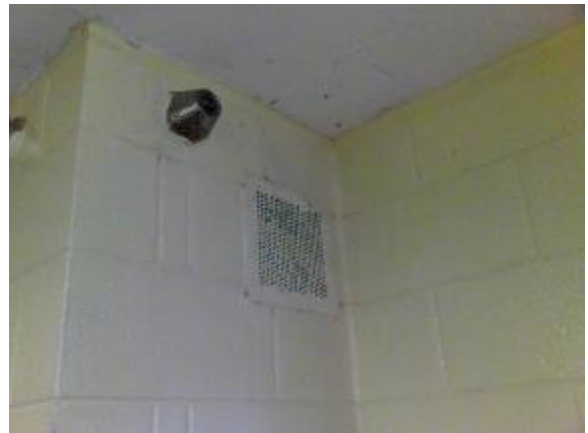
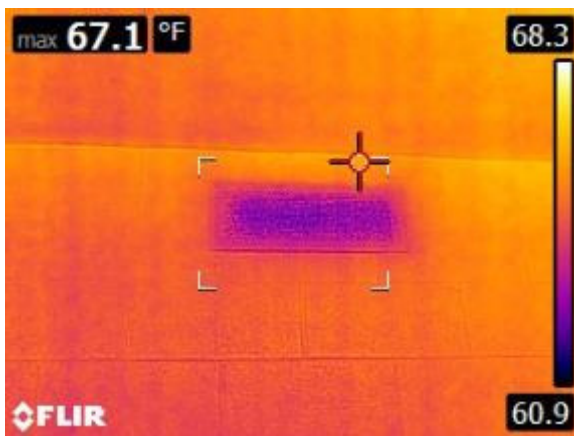
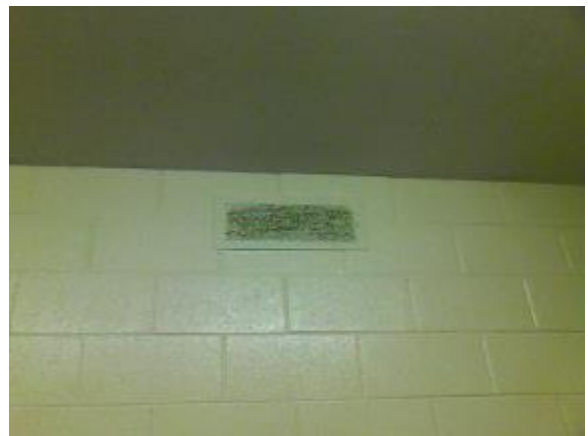
The supply grilles above have been painted over.

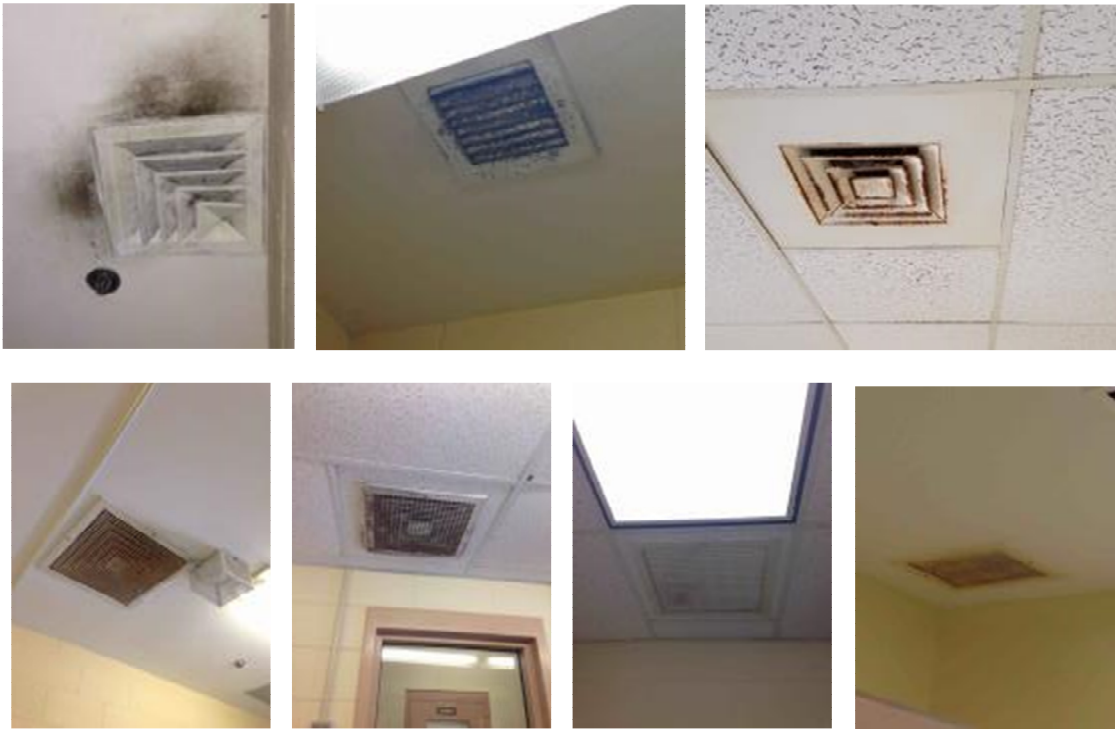
There are many instances of dirty air devices throughout the building.

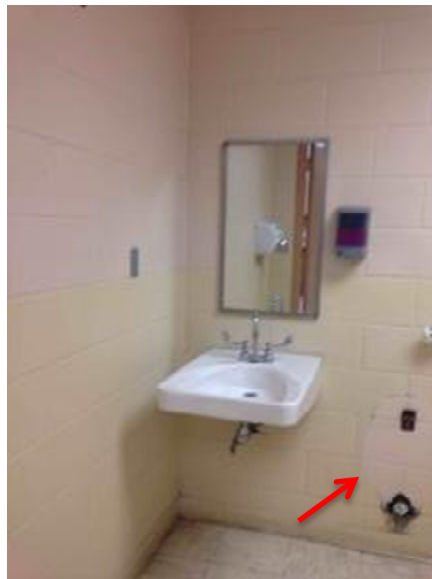
The urinal has been removed in Men's 202.

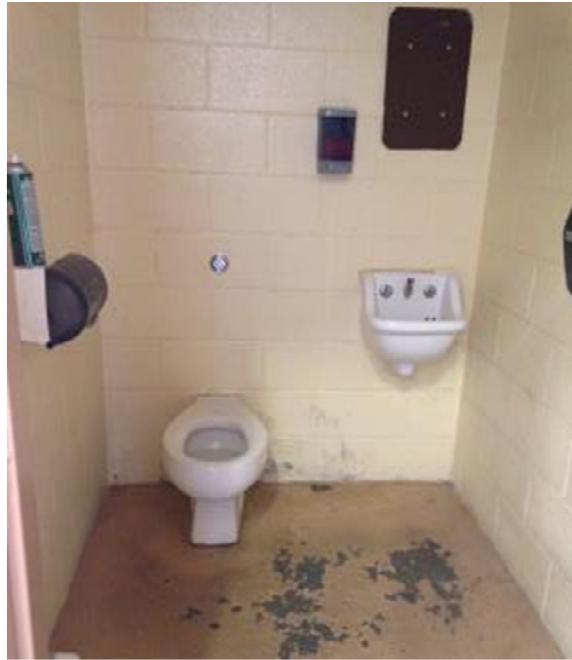
The vitreous china fixtures installed are used by inmates in the visitor area. This allows inmates to purposely flood the toilet.

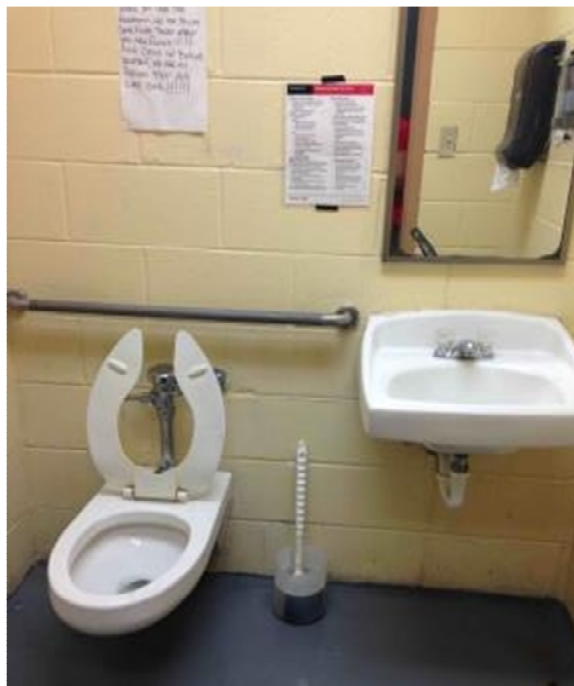
The vitreous china fixtures installed are used by inmates working in the kitchen. Additionally, a glass mirror is installed that is subject to breakage and theft.

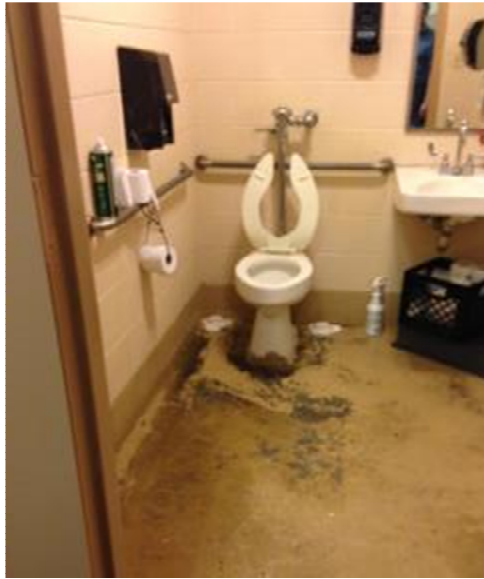
The vitreous china fixtures installed are used by inmates in the medical area. Additionally, a glass mirror is installed that is subject to breakage and theft.

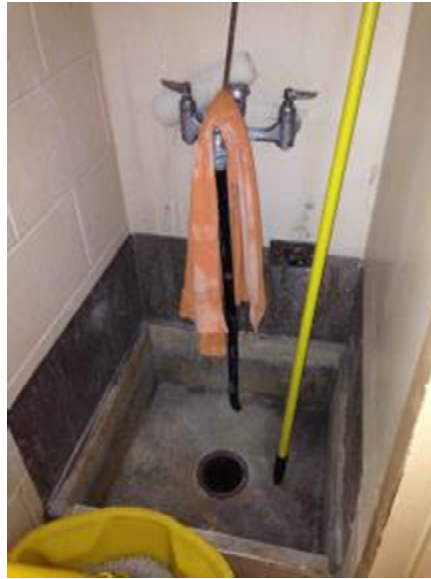
The mop sink in Janitor 233 is rusting and poor condition.

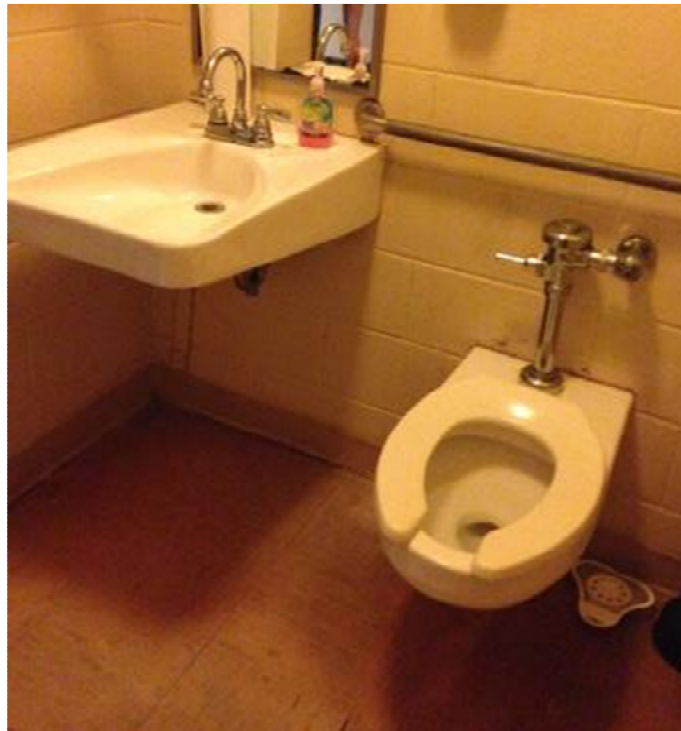
Several of the current restrooms do not meet ADA requirements – Rooms 106, 113, 172, and J101. ADA compliant grab bars, fixtures, fixture heights, pipe insulation, clearances, and faucets are required.

The lavatory does not have ADA compliant insulation on the piping below the lavatory in Room 113.

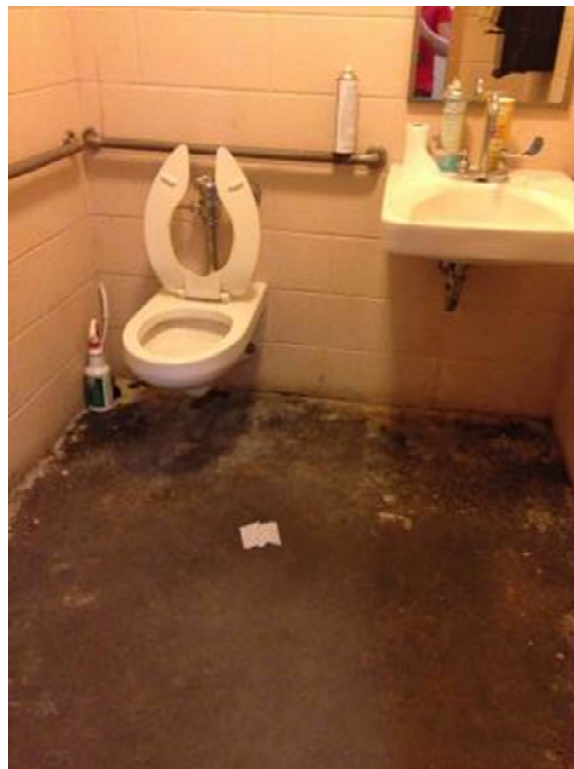
The lavatory does not have ADA compliant insulation on the piping below the lavatory in Room 106.

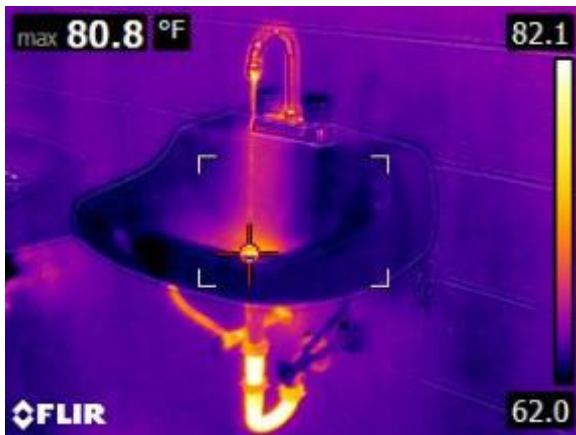
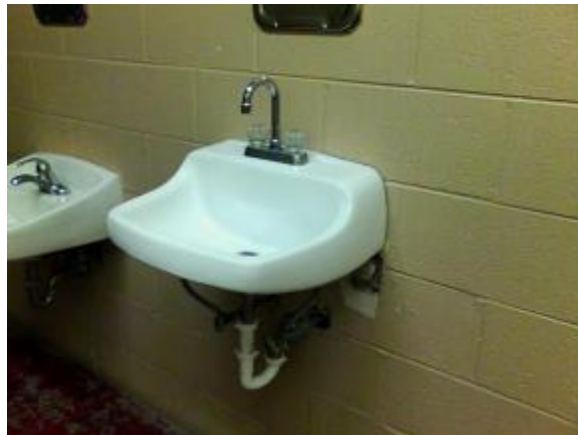
The lavatory intended for wheelchair users does not have an ADA compliant faucet or ADA compliant insulation.

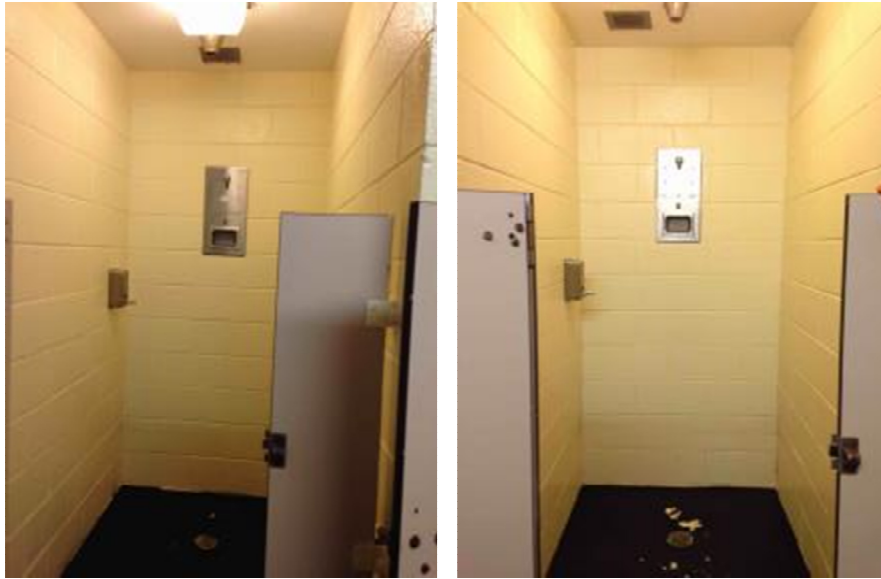
Penal fixtures have been provided in Shower 118 and 119 in the booking area. These showers do not meet ADA requirements.

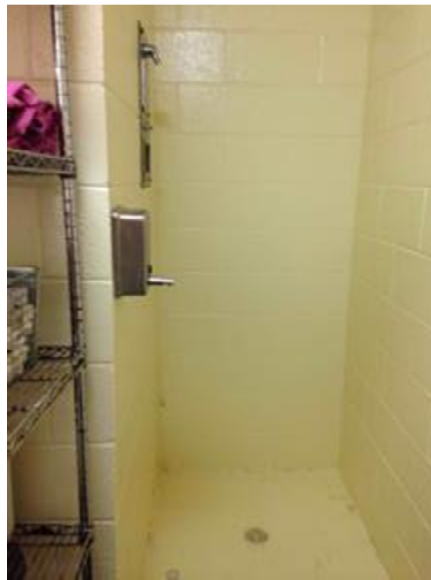
A penal fixture has been provided in Shower 123 in the booking area. This shower does not meet ADA requirements.

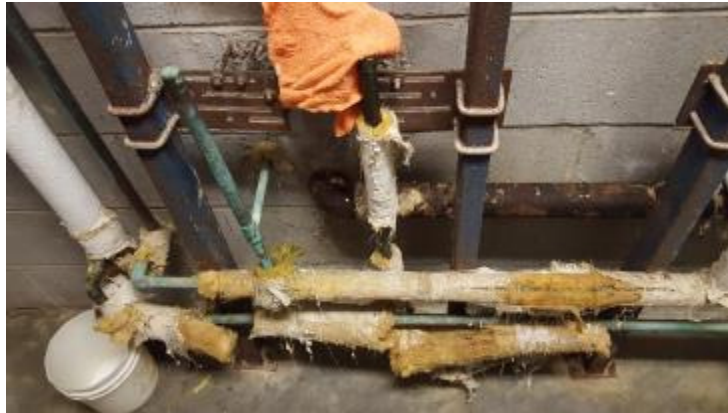
Piping insulation is in poor condition in plumbing chases. The existing insulation is torn and/or missing on piping. Additionally, there is a leak and a bucket has been placed below it as a temporary provision.

This is torn and damaged insulation on the piping serving the group restroom lavatories with a bucket placed below a leak.

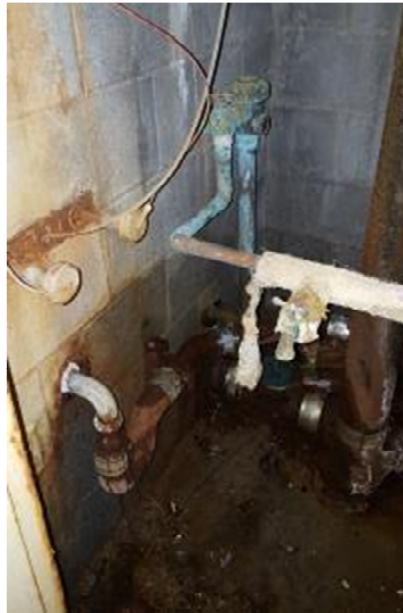
There is torn and damaged insulation on the piping serving the housing cells.

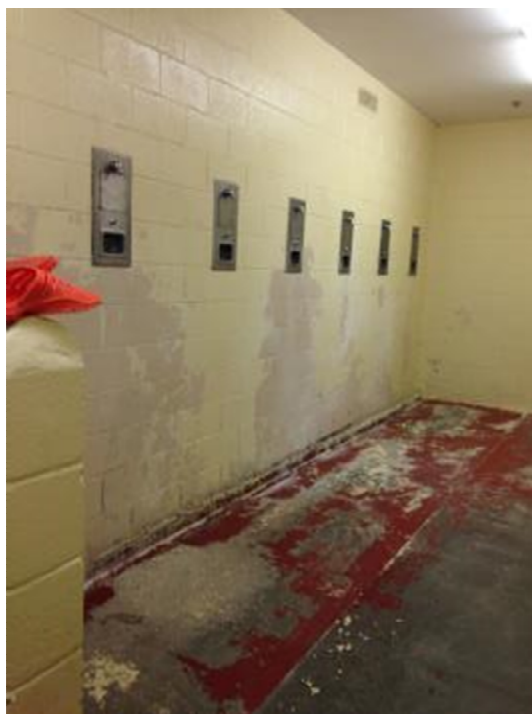
The current group restroom shower is not in accordance with PREA because there are no shower partitions installed.

The group shower does not have privacy partitions installed.

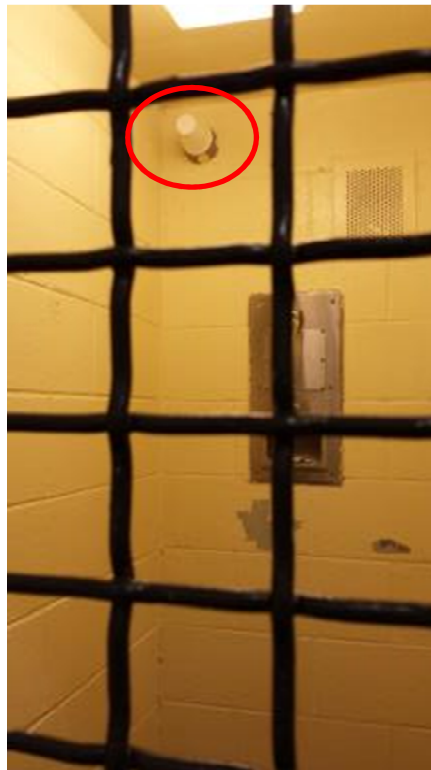
The sprinkler head in the shower stall above is currently covered with a cup.

All sprinkler heads should be exposed to function as intended.

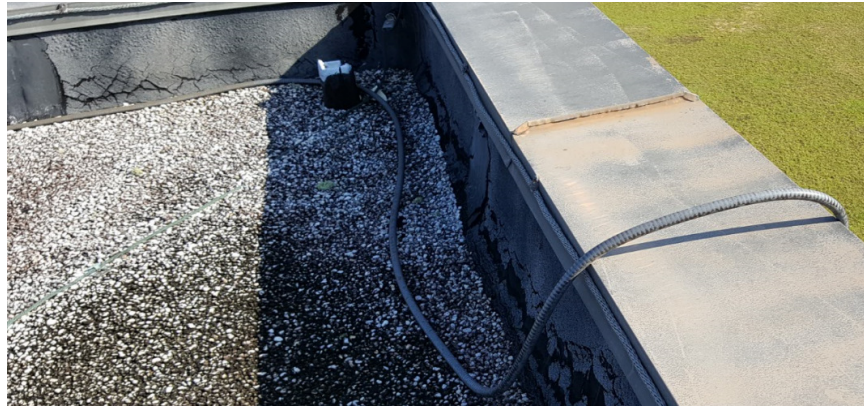
There is a significant amount of electrical conduit laying directly on the roof surface and is not properly supported.

This flexible non-metallic conduit is connected to a security camera that is mounted below on the building wall.

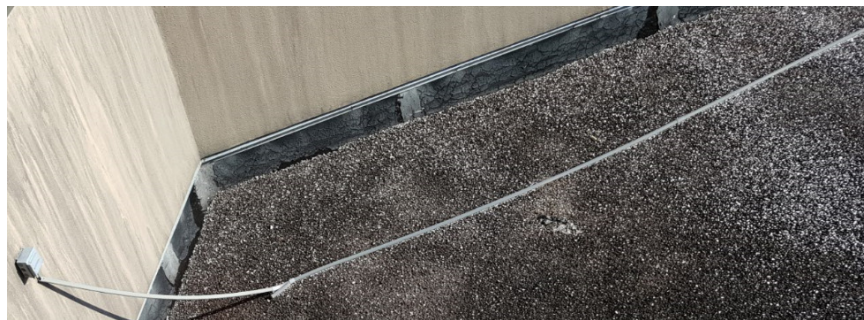
This rigid non-metallic conduit has disconnected from the receptacle box and wires are exposed.

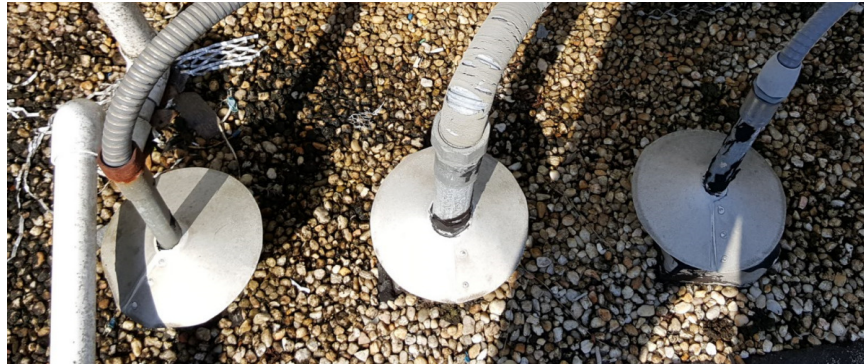
This left most flexible non-metallic conduit connection does not have a proper connection where it is connected to the rigid conduit. The PVC coated flexible metal conduit (center) is showing signs of extensive deterioration to the outside coated.

Conduit penetrations should include connectors, be properly sealed and provided with pitch pockets.

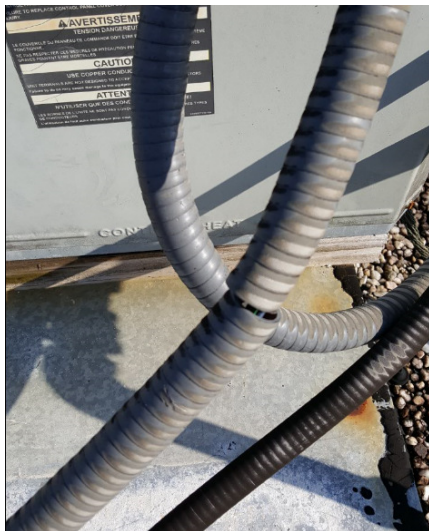
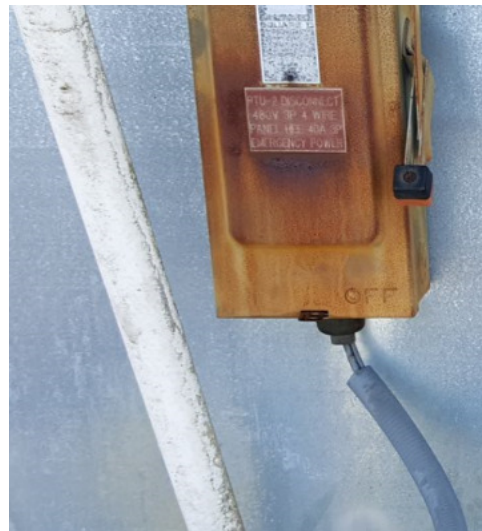
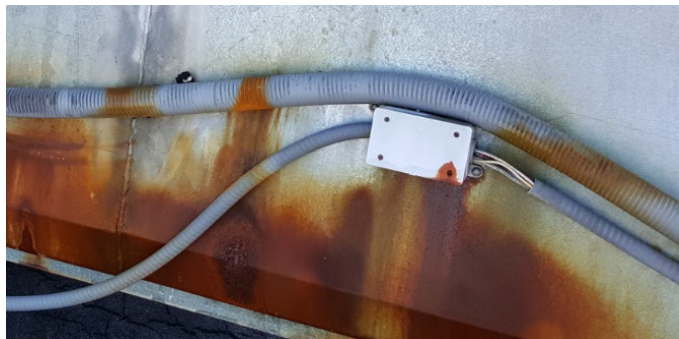
In several locations the electrical conduit is cracked and damaged and has separated from its connectors.

This electrical conduit has broken or has disconnected from termination point.

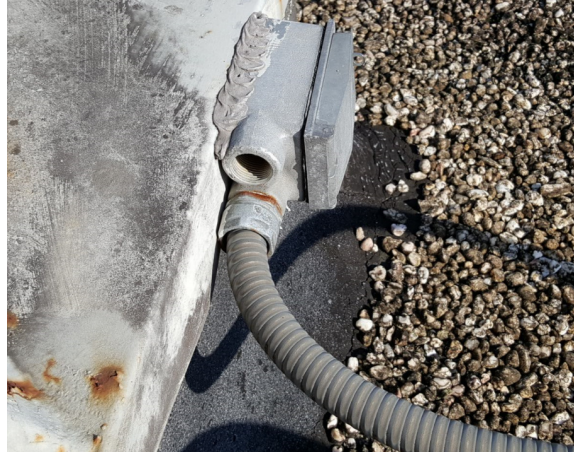
Wiring device knockouts are exposed allowing for water to enter the box and raceway.

This receptacle does not have a cover on the knock-out opening.

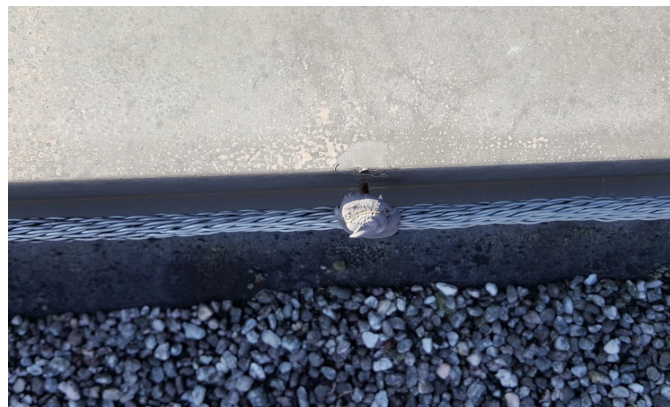
The lightning protection system does not appear to be in proper working order.

Lightning protection cable attachment has become dislodged from the parapet wall.

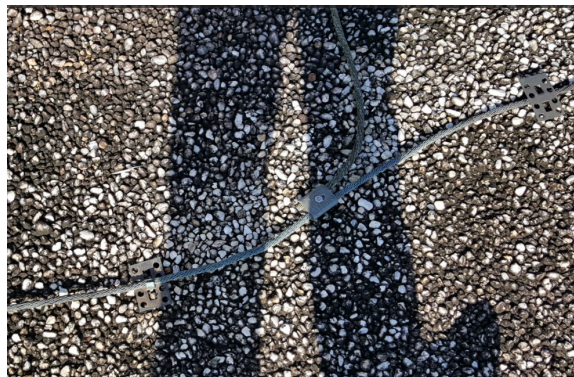
Lightning protection cable is laying on the roof surface and not permanently attached.

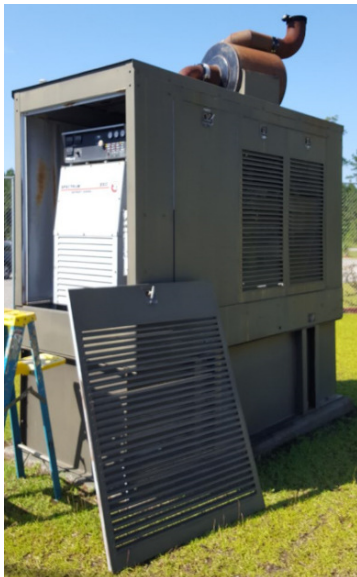
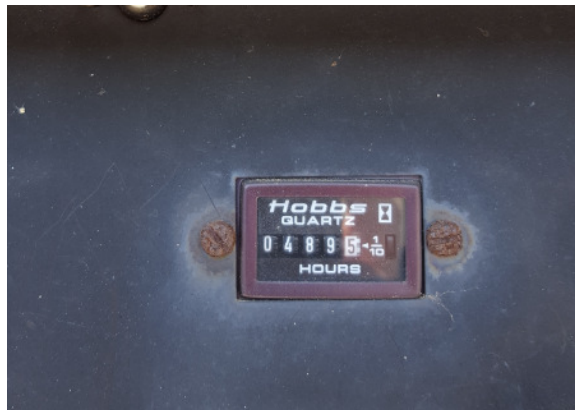
The exterior emergency generator is nearing 5,000 hours of runtime.

This is the 350kW / 438kVA emergency generator.

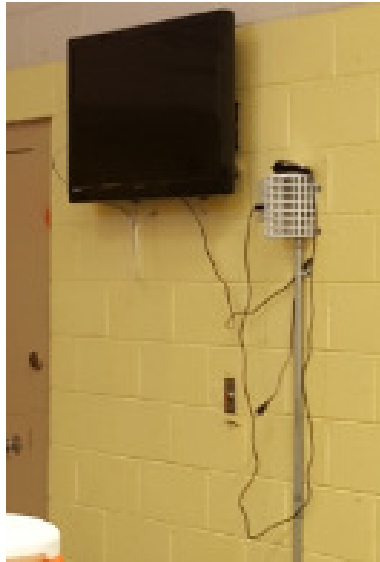
This is in A Block.

At several wall mounted television locations, cables are hanging to within reach of inmates.

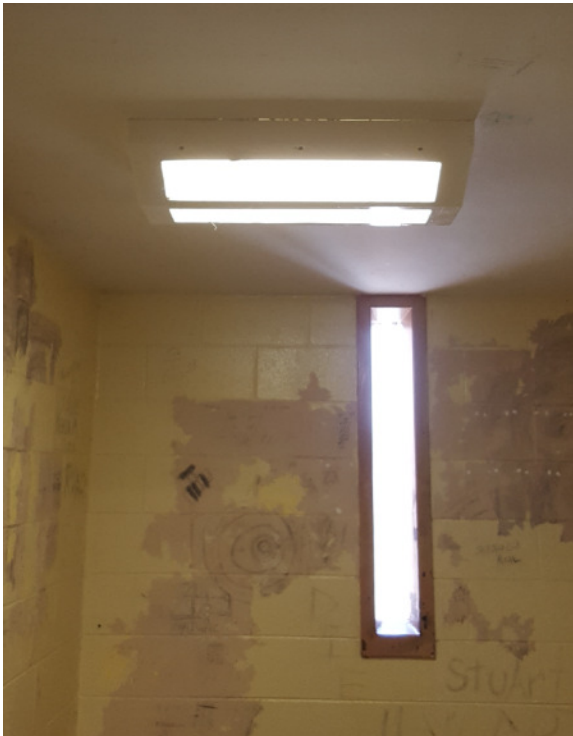
This is in D Block.

Ceiling mounted surface light fixtures are not tight to the ceiling.

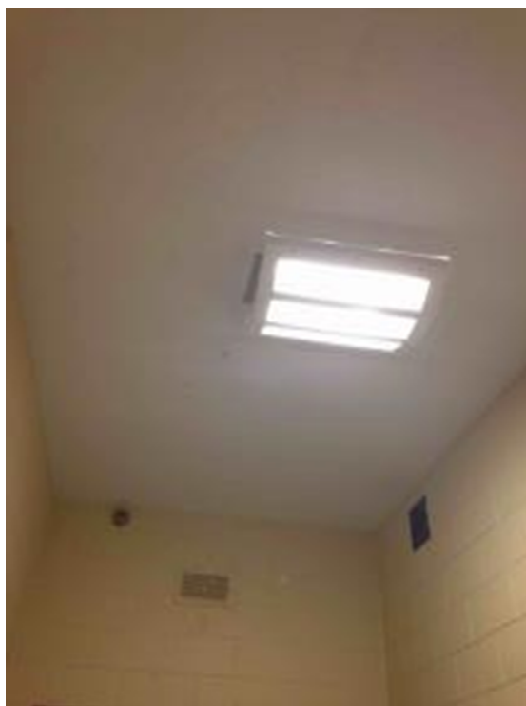
Light fixture is not penal type in Juvenile Holding 112.

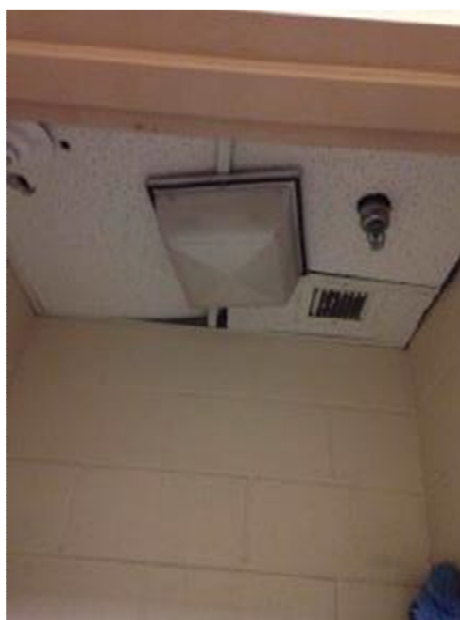
Light fixture is not properly installed in Janitor 233

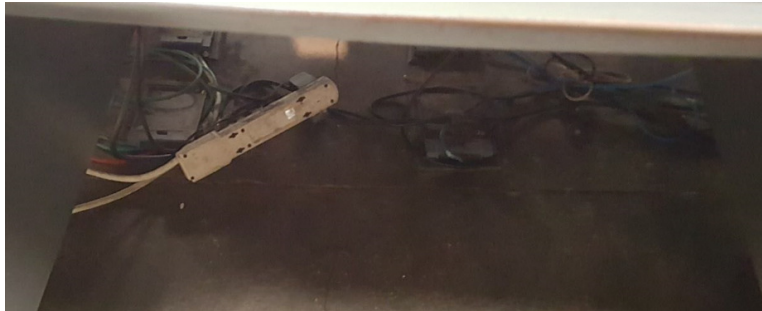
This is under the center desk in the Booking area.

Multi-outlet plugstrips are being used in administration areas. Extension cords are not a means of permanent wiring per NEC 240.5.

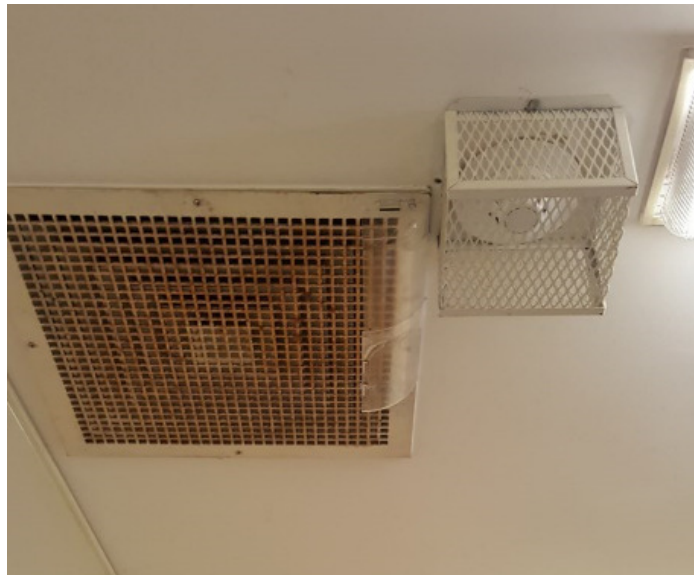
This is in the Booking area.

Plastic guards have been installed on ceiling air devices that are located near fire alarm smoke detectors.

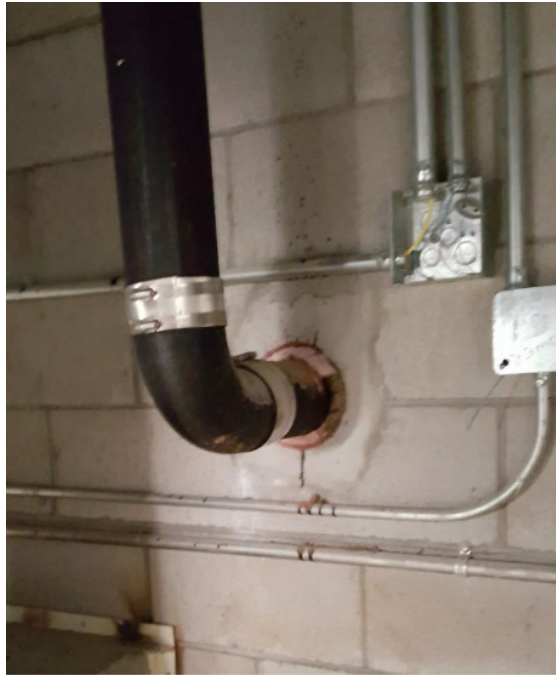
Coverplate needed on junction box in mechanical chase.

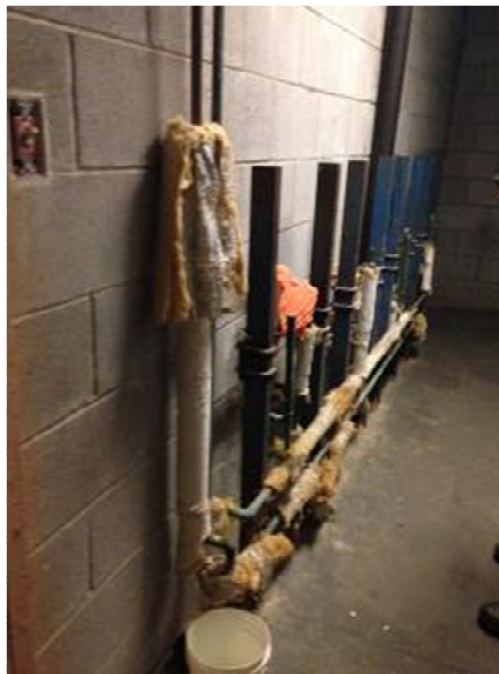
Wiring device coverplate needed on light switch in plumbing chase.

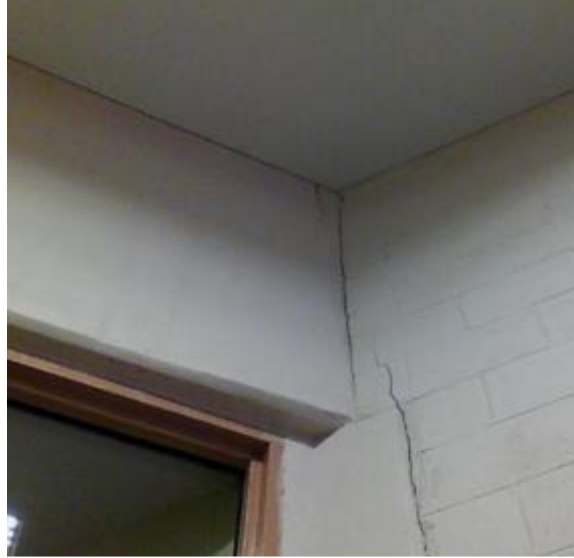
This is a representative crack located in the building.

While not part of the scope of the project, RMF noted many instances of visible cracks throughout the building. RMF recommends further investigation of these visible issues by a qualified structural engineer.

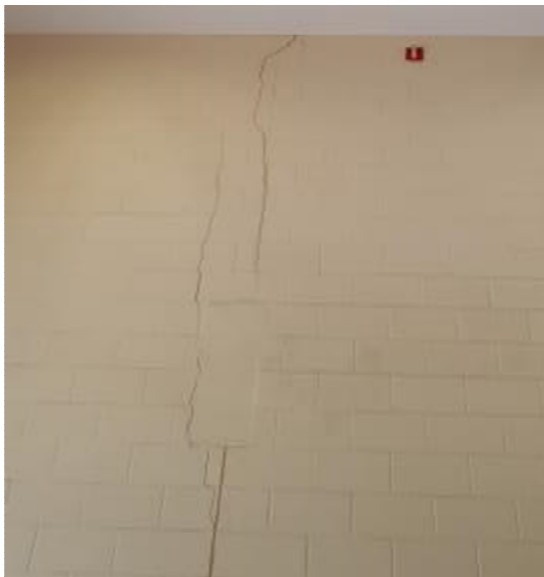
There is a crack in Multipurpose Room A100.

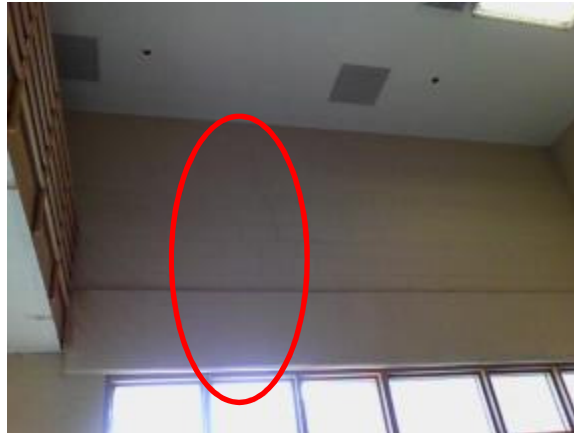
There is a crack in Multipurpose Room A100.

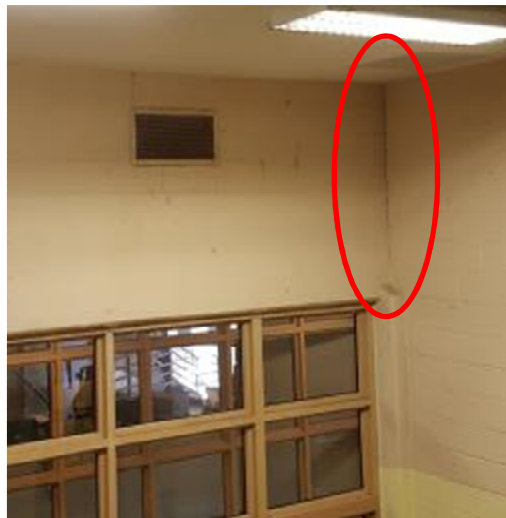
There is a crack in D-Block in the Special Management Dayroom E100.

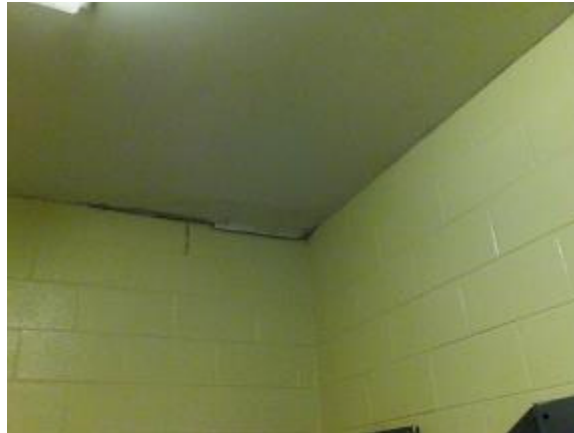
There is a gap between the wall and ceiling in Shower F103.

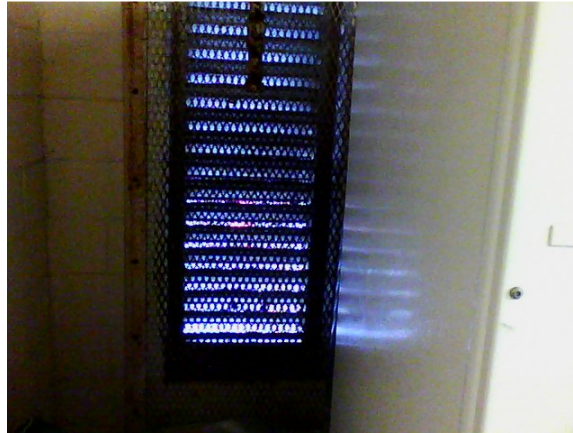
The building suffers from uncontrolled infiltration which has led to high indoor moisture levels. The uncontrolled infiltration is a result of the building exhaust system pulling in unconditioned air through large louvers throughout the building as the building operates at a negative pressure. The outdoor air being pulled in through the louvers is unfiltered and is not conditioned. The exhaust fans are used to remove odors from within the building and are required. As can be seen from the photo below, the louver, which should seal tightly to prevent infiltration, has a large amount of opening that lets in outdoor air without control. This louver should be sealed tightly with no visible light, or air, able to pass.

Typical louver allowing outside air to be pulled directly into the building when the exhaust system is running.

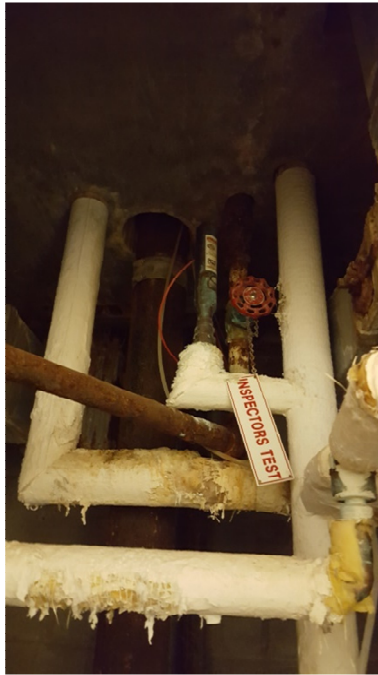
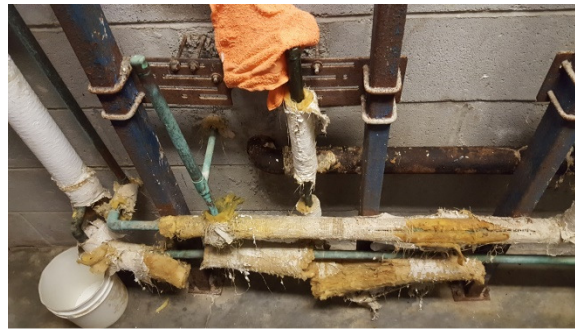
The examples above are of piping insulation in bad condition within chases of C block and E block.

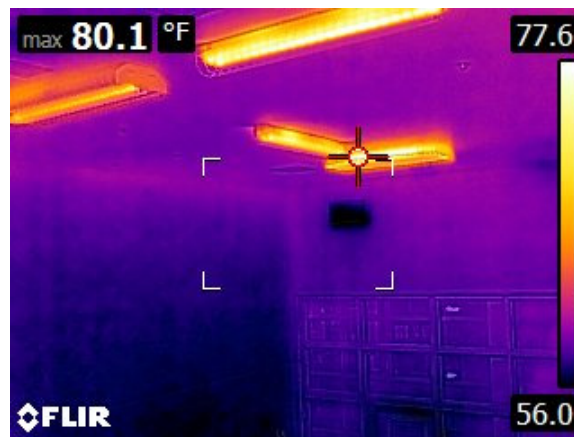
Space temperatures around 60°F were recorded within the housing units during field investigation. The housing units were designed to be cooled to a space temperature of 78°F in the summer. The overcooling of the spaces is resulting in increased potential for the spaces to reach the dew point. When the surface reaches the dew point, condensation will occur.

Temperatures within the housing unit above are extremely low.

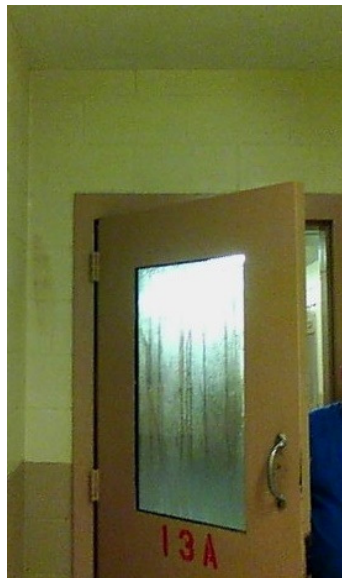
Since the kitchen is not conditioned, the interior rooms adjacent to the kitchen have an increased heating load through the partition walls. It is also important to note that there should not be conditioned spaces connected to unconditioned spaces without a vapor barrier. The walls surrounding the unconditioned space should be built like an exterior wall with proper insulation and a vapor barrier. At this time, the lack of an appropriate partition construction is leading to condensation on interior walls that separate the kitchen from the rest of the conditioned spaces in the building.

Moisture visible on the door separating the kitchen from the conditioned areas suggests there may be moisture above the ceiling as well.

RMF has calculated that the cooling and heating requirement for the kitchen and the cooling load is 20 tons for cooling and 128 MBH for heating. Adding cooling to the kitchen would decrease the temperature difference between the spaces and reduce moisture and condensation concerns where the kitchen abuts the conditioned spaces.

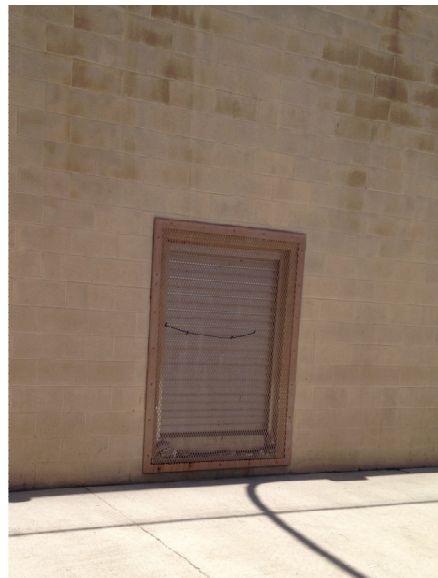
Security bars have been provided in transfer openings within the building. However, security bars have not been installed on the outside of large louvers. This is a security concern for possible inmate escape.

Security bars have not been provided in the louvers.

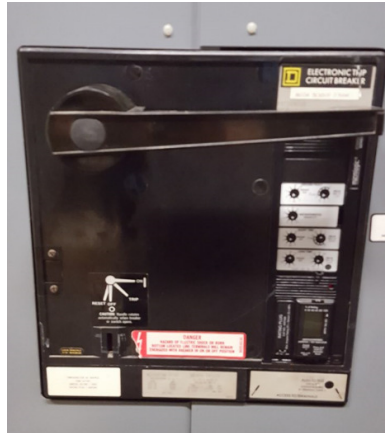
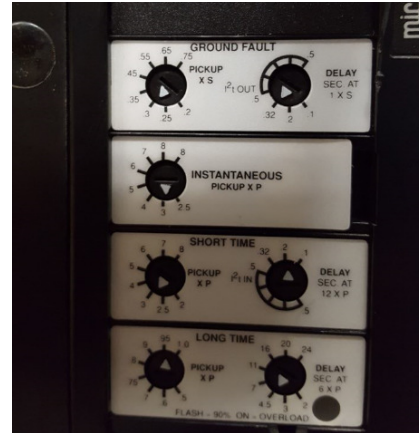
Per Georgetown County the 1600 amp, 3 pole, main circuit breaker has experienced some unexplained nuisance tripping. Without knowing any of the other circumstances during or prior to the breaker tripping, it is not possible to definitively say what corrective action could be recommended without completing a more comprehensive study of the distribution system.

A Circuit Breaker Coordination Study is recommended, since the main circuit breaker and several downstream breakers include an adjustable trip unit. The coordination study maximizes power system selectivity by isolating faults to the nearest protective device, as well as helping to avoid nuisance operations that are due to transformer inrush or motor starting operations. The study will result in updated values for the electronic trip units for the four adjustable circuit breakers based on the current loads.

The estimated cost for the circuit breaker coordination study recommendation is \$5,000.

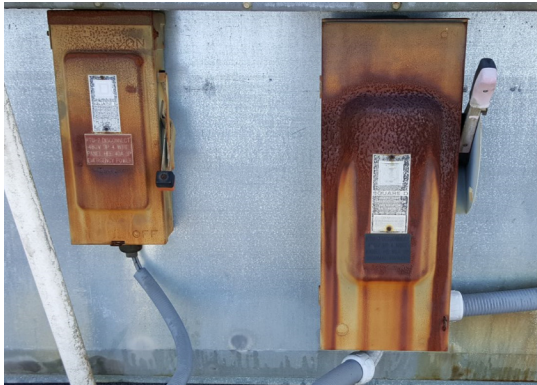
Square D Safety Switches (RTU-2) – Poor Condition

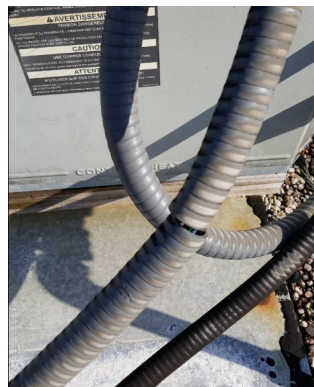
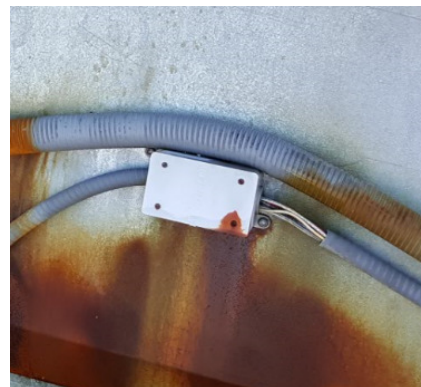
Split conduit (RTU-7)

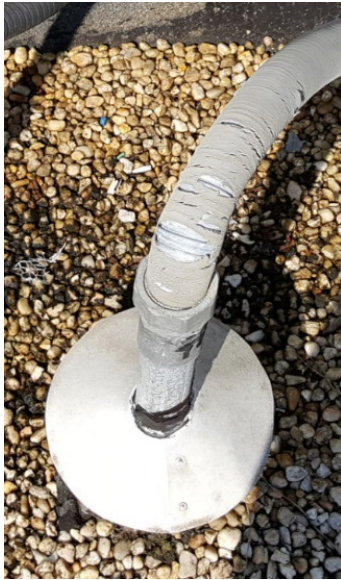
Exposed conductors (RTU-4)

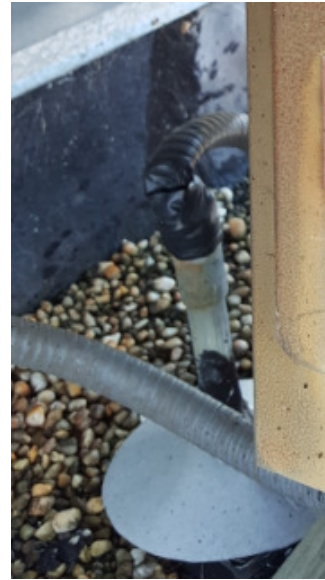
Deteriorated sunlight-resistant jacket (RTU-1)

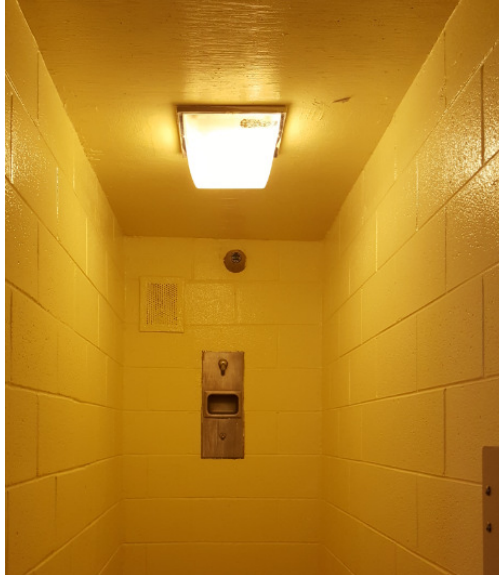
The light fixtures installed in all of the inmate showers have a significant amount of moisture damage.

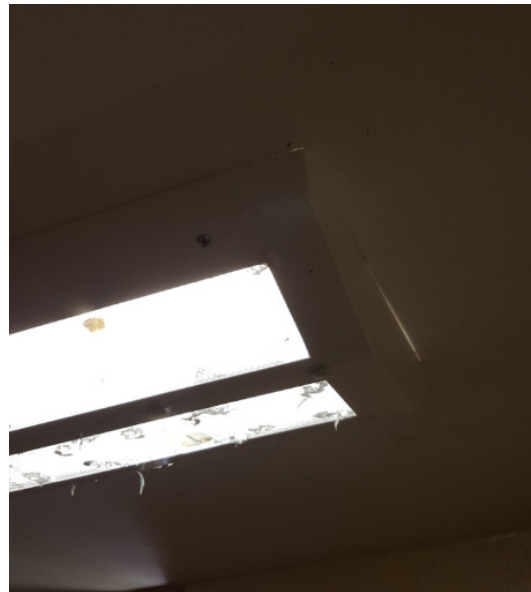
Throughout inmate cell and holding spaces the installed surface mounted light fixtures are not sealed tight to ceiling and are a potential ligature point.

Light Fixtures in Cell Block D & H not flush with ceiling. Note gap where light is leaking out from behind the fixture.

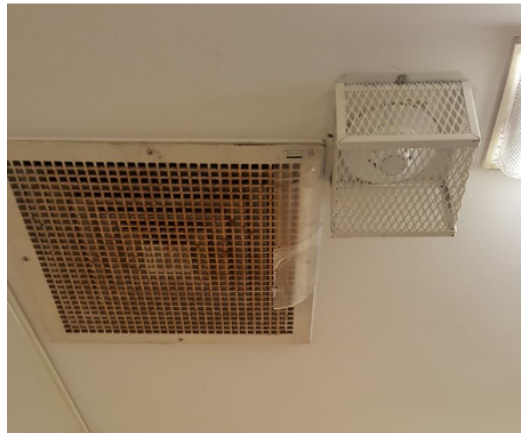
Booking Area

There are a several locations where a fire alarm smoke detector has been installed adjacent to the mechanical air supply device. Air deflectors are installed to direct the air away from the smoke detector. The air deflector is not intended for this application and is obstructing the proper air flow from the device to the space.

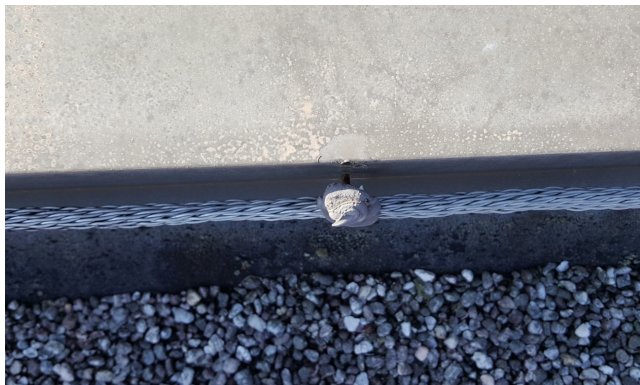
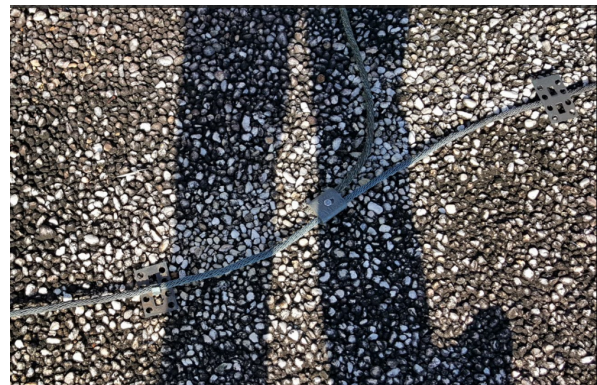
The installed 'franklin type' lightning protection system does not appear to be in working order. There are several loose connection points, cable is not adhered to the building, or any protection at all. System continuity and effectiveness has been compromised during the HVAC alterations and antennae additions. The typical life expectancy of a lightning protection system is dependent on periodic inspections being done when modifications occur to the roof or any roof mounted equipment.

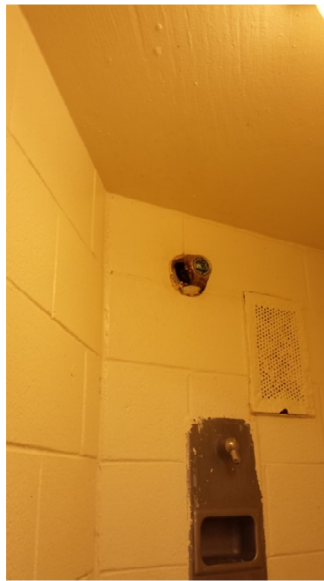
The excessive corrosion and rust in housing unit chases that implies there is moisture in the chase. There is even evidence of corrosion occurring on the exterior gates that lead to the booking area as well as rust on the exterior of the building in the recreation yards. There are rusted sprinkler heads within the building. All rusted sprinkler heads should be replaced not only for functionality, but also so contraband cannot be hidden behind the sprinkler heads.

Corroded sprinkler heads need to be replaced.

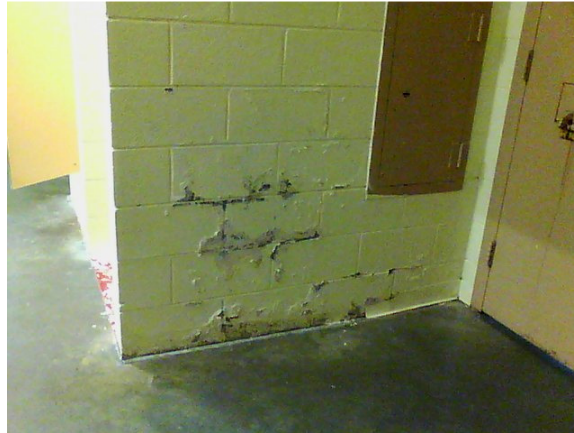
There are several locations where the paint is reacting to moisture issues. The paint on CMU block walls is delaminating due to apparent migration moisture. The paint is flaking off the drywall at the boiler room entrance. The group restrooms are frequently repainted due to paint chipping off.

Paint is delaminating.

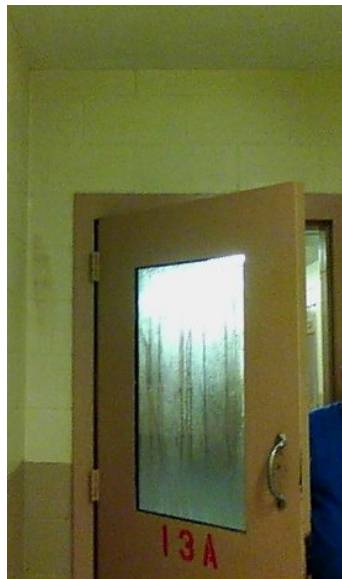
There is a massive thermal difference at the door in the corridor connecting the non-cooled kitchen area to the rest of the building. The window on the door is sweating which means moisture must also be occurring above the ceiling. Above the ceiling the moisture does not have the opportunity to dry out so it is probable that microbial growth is occurring.

Moisture visible on the door suggests there may be moisture above the ceiling as well.
