VISUAL ROOF SURVEY

OAKVIEW APARTMENTS

650 Howard Street
Spartanburg, South Carolina

Reference: Report of Roof Survey
Oakview Apartments
650 Howard Street
Spartanburg, South Carolina
REI Project No. GSP1033.001

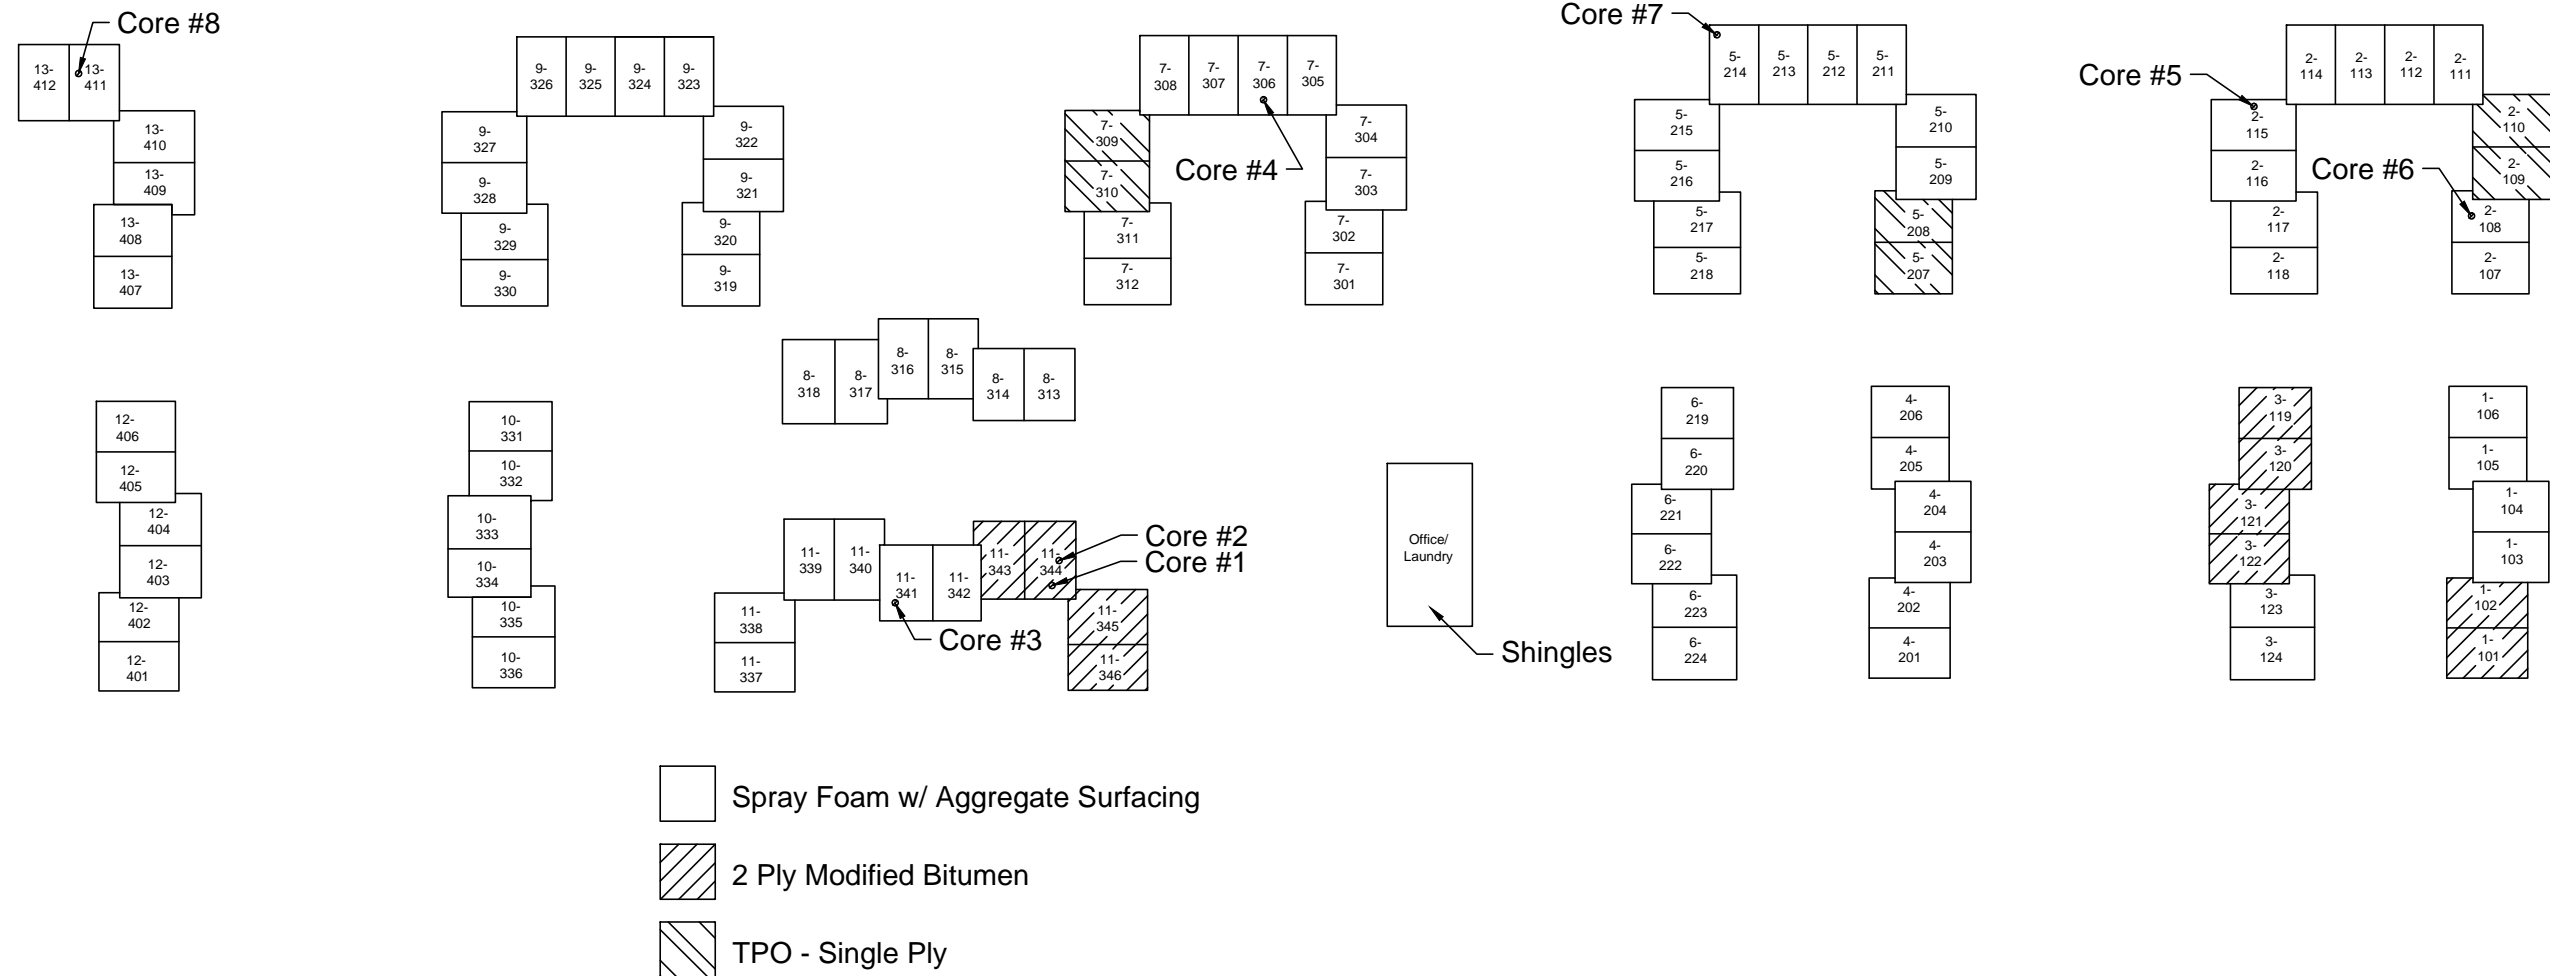
foam insulation with deterioration and gaps in the protective coating. The outer edge, or gravel stop, had a wire mesh attached to the side to hold the excess gravel on the roof. In addition to the visual observations, 8 separate roof locations were selected for additional core sampling and analysis. The approximate test locations are shown on the attached Roof Plan at the end of this report. The following testing was performed:

- Roof coring – the roof membrane was sampled by twisting a sharpened steel core barrel through the substrate. The sample was extracted for visual observations and additional testing. The insulation was moist or wet in 6 of the 8 cores performed. The roofing materials collected were placed in an individually sealed container and labeled. The core was repaired using a two ply seal surfacing material with an all-weather roofing cement.
- The 8 samples were forward to an environmental laboratory, using a chain of custody, where asbestos analysis was performed. Polarized Light Microscopy (PLM) analysis revealed Chrysotile fibers ranging from 5 to 25 percent in 5 of the 8 samples. The individual test results are presented in this report.
