**HAZARDOUS MATERIALS INSPECTION REPORT
OF THE
VIRGINIA HOSPITAL CENTER FACILITY
LOCATED AT
601 S. CARLIN SPRINGS ROAD
ARLINGTON, VIRGINIA**

AMA Job#: 19415
Contract #: 678-12
PO #: 273316

November 4, 2019

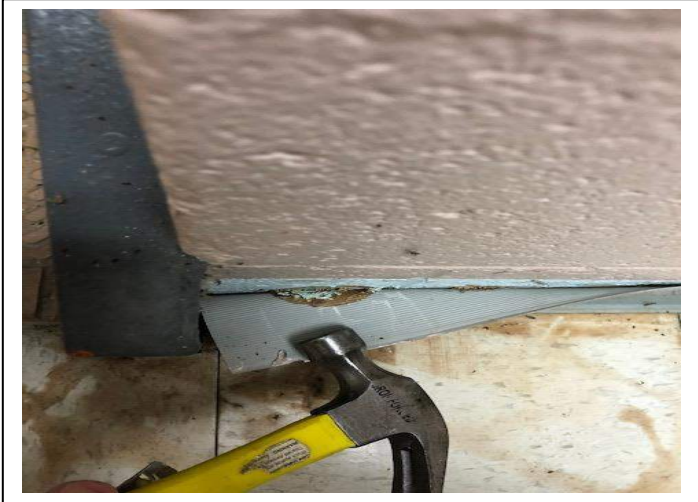
**Photo #9
Material: Tan Baseboard Mastic
Sample Result: No Asbestos Detected**

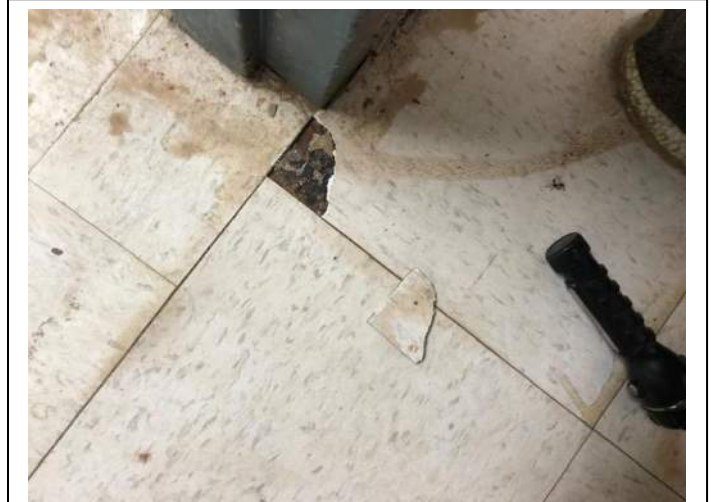
**Photo #10
Material: 12"X12" White With Black Streaks
Sample Result: No Asbestos Detected**

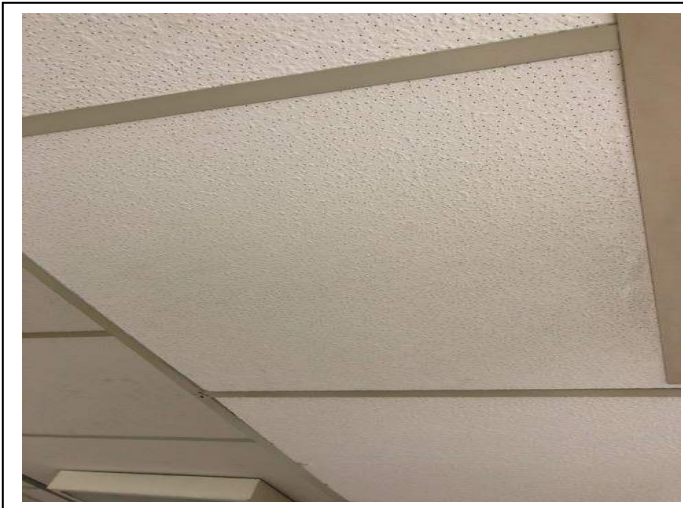
**Photo #15
Material: 2'x4' small pinhole ceiling tile
Sample Result: No Asbestos Detected**

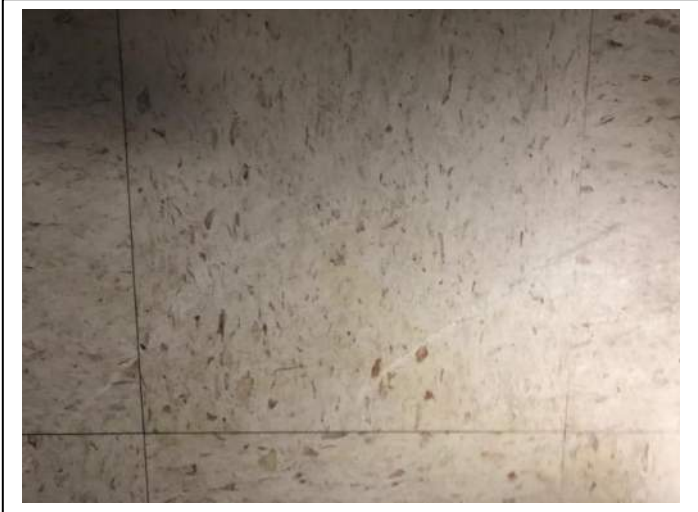
**Photo #17
Material: 12"x12" White With Red Specks
Floor Tile
Sample Result: No Asbestos Detected**

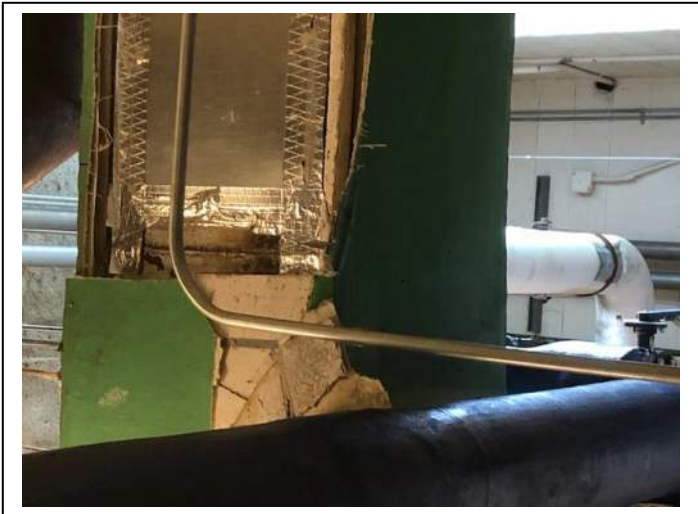
**Photo #23
Material: Green Canvas Mudded Duct
Sample Result: No Asbestos Detected**

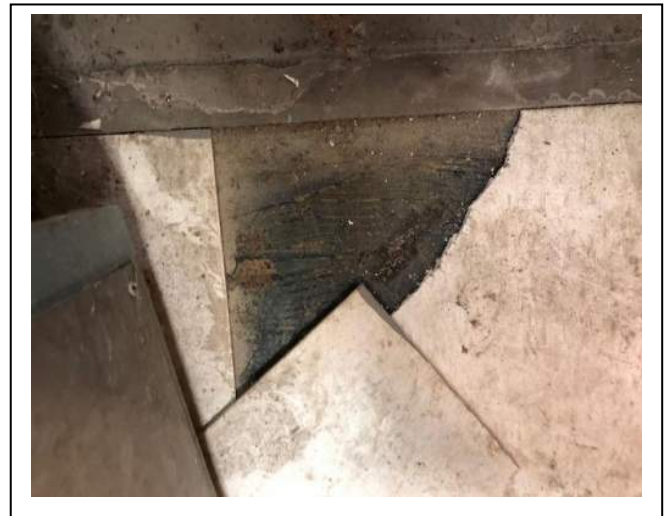
**Photo #36
Material: Black Floor Tile Mastic
Sample Result: 3-5% Chrysotile**

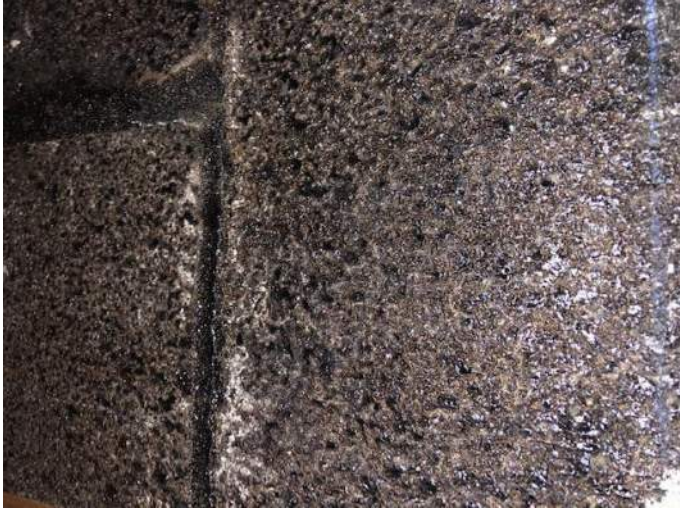
**Photo #69
Material: Black Vapor Barrier
Sample Result: No Asbestos Detected**

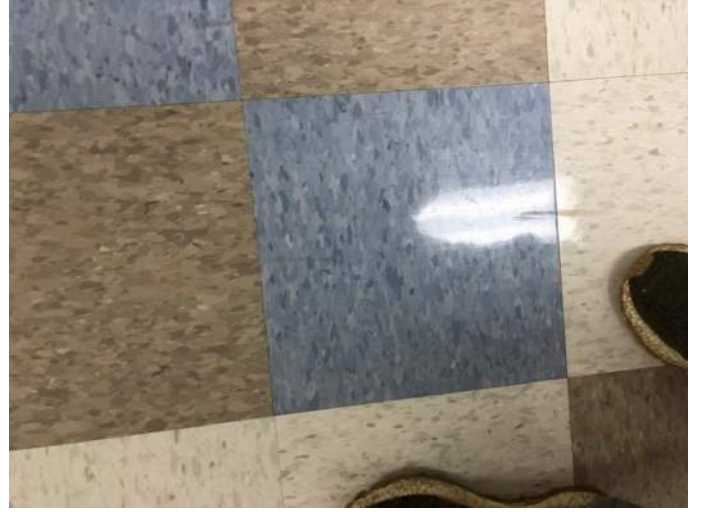
**Photo #70
Material: 12"x12" Blue Mottled Floor Tile
Sample Result: No Asbestos Detected**
