EXHIBIT "C"

COMPREHENSIVE ASBESTOS SURVEYS

COMPREHENSIVE ASBESTOS SURVEY

**COMMERCIAL BUILDING
1240 YEAMANS HALL ROAD
HANAHAN, SC 29410**

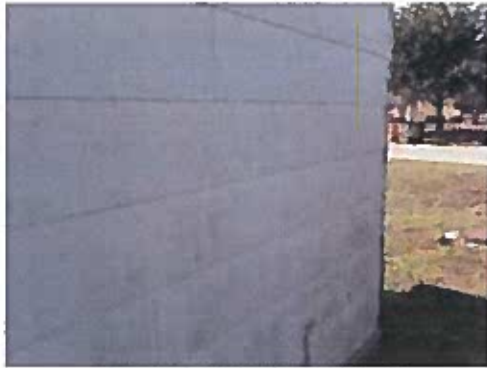
**HOMOGENEOUS AREA 01
TRANSITE SIDING**

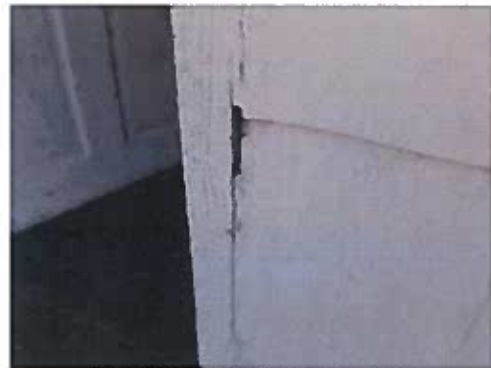
**HOMOGENEOUS AREA 04
EXTERIOR CAULK**

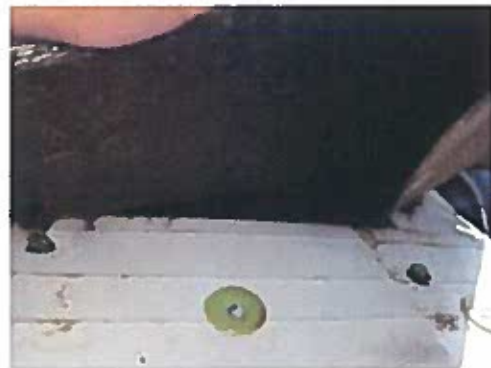
**HOMOGENEOUS AREA 06
ROOF FELT**

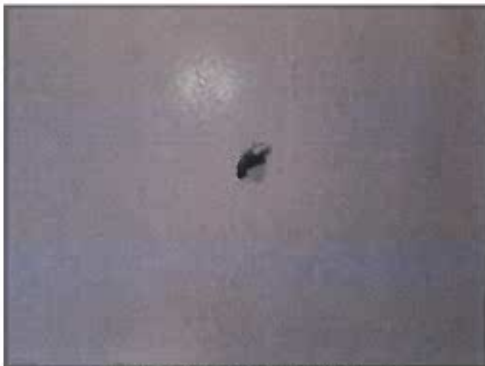
**HOMOGENEOUS AREA 09
DRYWALL**

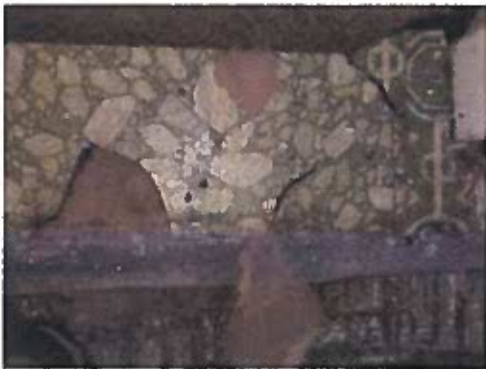
**HOMOGENEOUS AREA 23
VINYL SHEET FLOORING (GREEN ROCKS)**
