ASBESTOS INSPECTION REPORT

70 Foxfire Court

Asbestos Inspections, LLC Project # 2023-01-344

Inspection Completed On – September 14, 2023
Report Prepared On – October 4, 2023

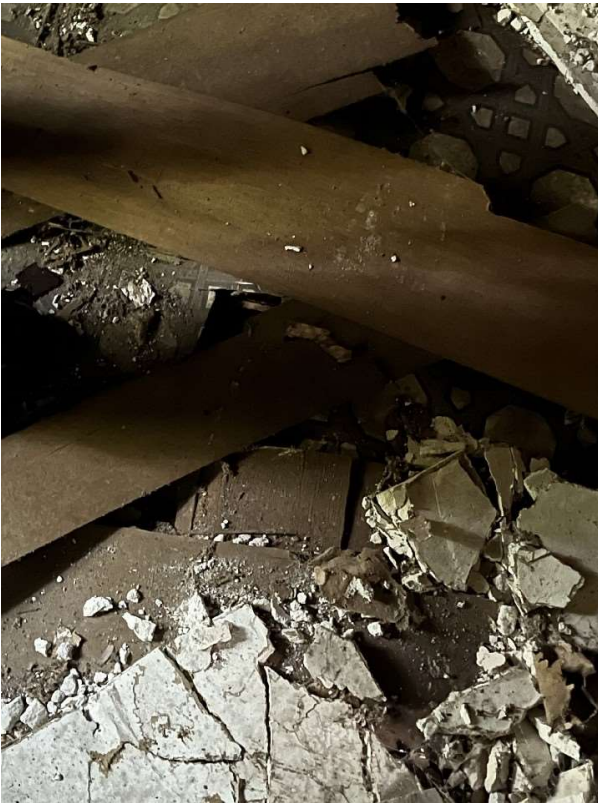
Interior Drywall on Floor

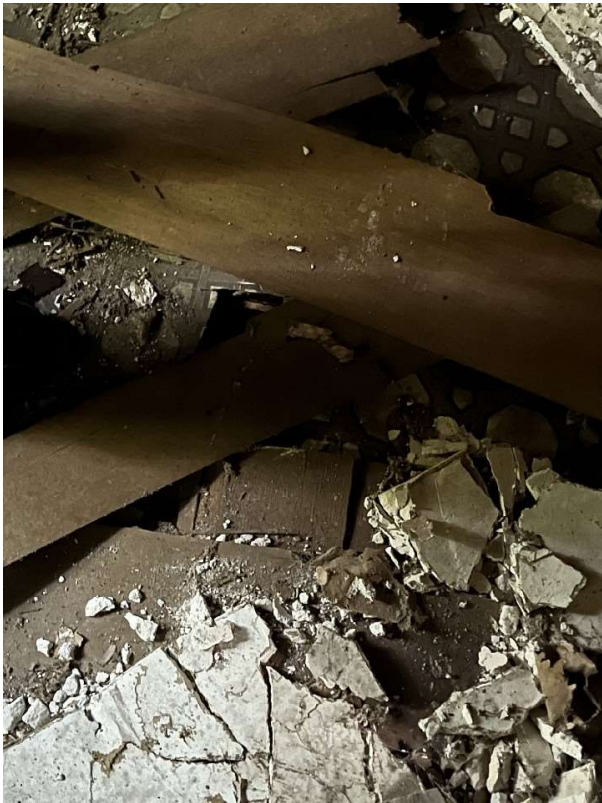
Interior Showing Drywall Debris

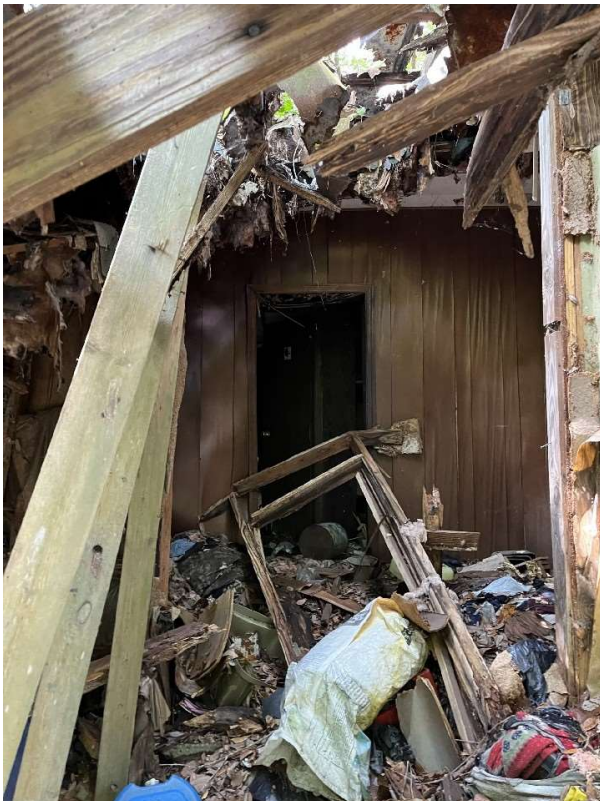
Interior Rear Addition Bathroom Showing
Asbestos Containing Vinyl Sheet Floor

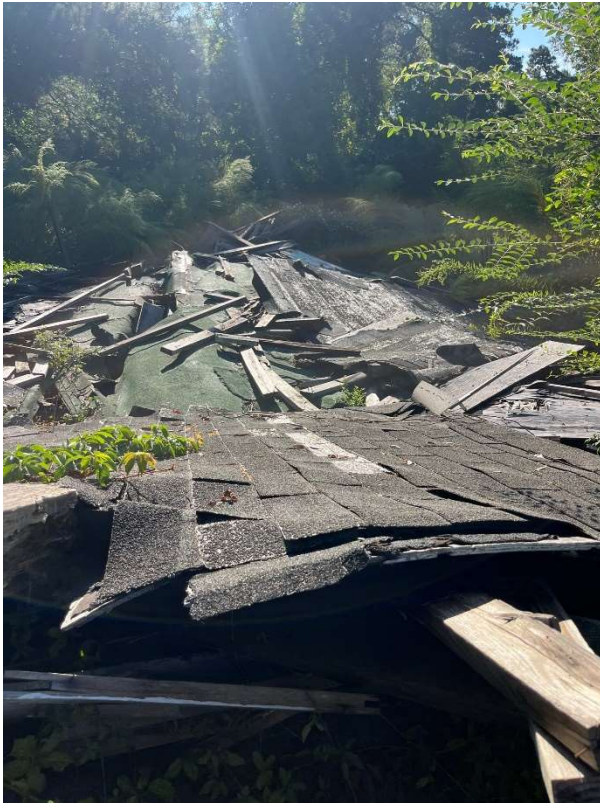
Debris Pile Showing Asphalt Shingles

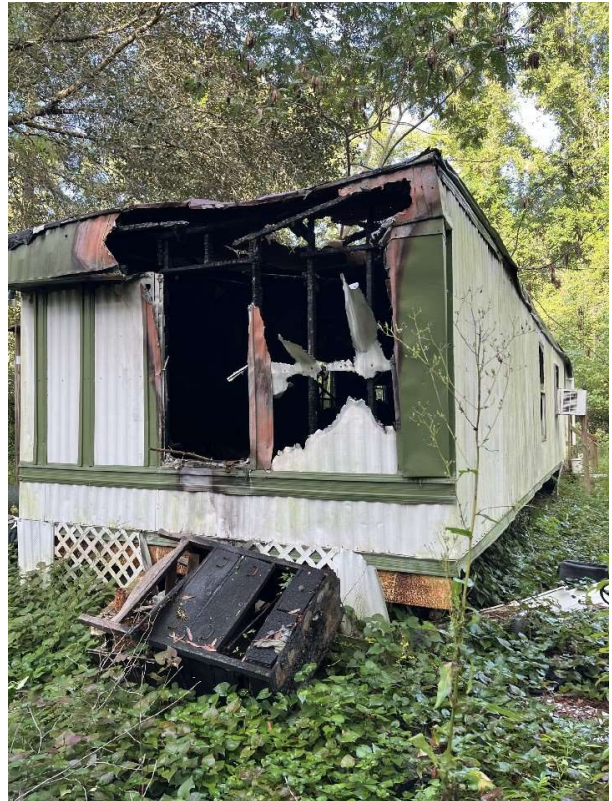
Exterior Right Side Showing Fire Damage

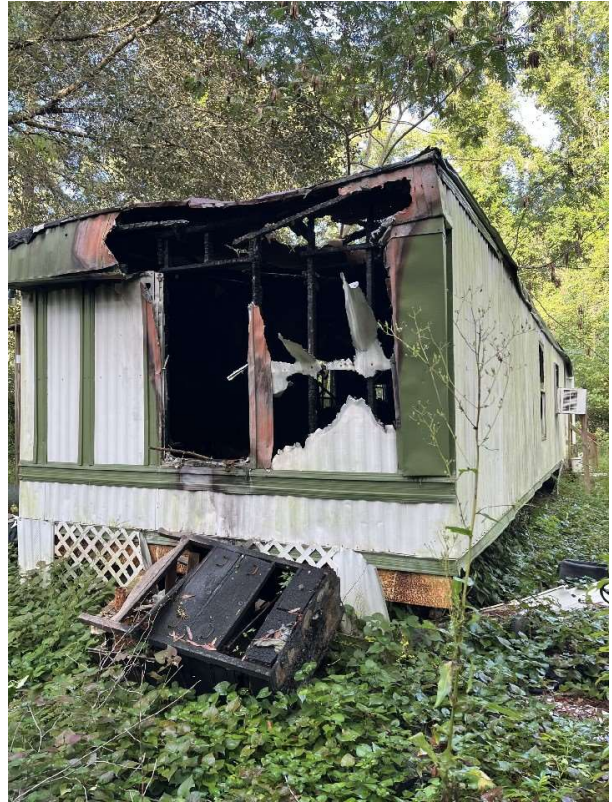
Exterior Right Side Showing Fire Damage
