**GRANT COUNTY/SILVER CITY AIRPORT COMMERCIAL SERVICE TERMINAL
ASSESSMENT**

AIP PROJECT NO. 3-35-0039-019-2018

AUGUST 2018

BOHANNAN HUSTON, INC.

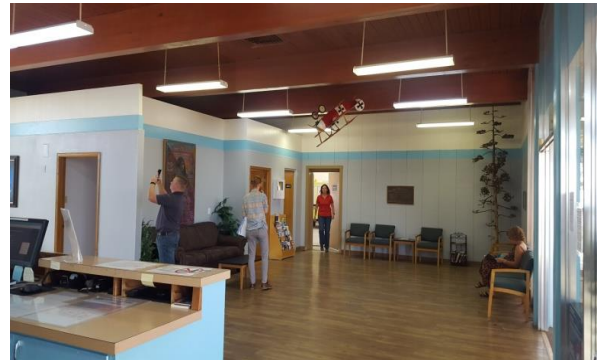
Figure 17: P7 PASSENGER WAITING LOBBY

1. The carpet throughout the waiting area is in disrepair and will need to be replaced. The cause is primarily because many of the windows and walls in this space allow water in, which pools in the corners, which are on a slightly lower grade than the rest of the building.
2. The Vinyl Composition Tile (VCT) plank flooring in the Vestibule (space 11) and Lobby (space 6) is warped due to installation over the top of the existing carpet and will need to be replaced.
3. The ceilings leak, leading to water damage throughout the floor surfaces of the building.
4. The asbestos tile in the Janitorial Closet (space 7) will need to be abated and replaced with new VCT.
5. More fixtures are required for the bathrooms as the pre-flight rush is too large to be accommodated by the single fixture bathrooms. This will require a renovation of the restroom and possibly adjacent areas.

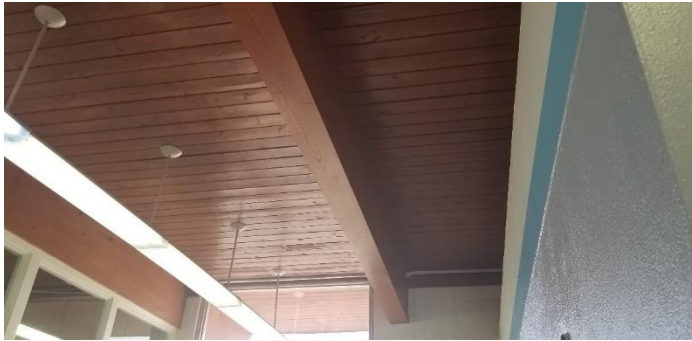
Figure 23: INTERIOR WOOD AND GLULAM BEAM
FRAMING – PASSENGER WAITING AREA

The building is a concrete masonry unit (CMU) building with a stack bond configuration and wood roof framing. At the time of the investigation, no structural cracking or settling was seen in the CMU. The wood framing appeared to be adequate, structurally; however we did note wood rot at the exterior of the members, seen in Figure 20 and Figure 21. Figure 23 shows the interior condition of the roof wood framing, which does not have visual signs of weathering or rot. At the northwest corner of the building, we found a CMU column that was weathered and had chipping paint. Figure 22 shows the extent of the weathering of the CMU. It is our opinion that this condition is not a structural issue. We recommend that the area be maintained on a regular basis to avoid further damage. At the north vestibule/ waiting area of the terminal, we were informed that the building was experiencing water seepage through the CMU stem wall into the building. Figure 24 and Figure 25 show the areas of the building where the seepage was being reported. At the time of our investigation no cracks were visible in the CMU stem walls. It is our opinion the lack of maintenance and lack of a vapor barrier below grade could be the cause of this moisture intrusion onto the building. It is difficult to determine the location of the moisture intrusion at the time of our investigation due to dry conditions. If the moisture is penetrating through the CMU, the reinforcement becomes vulnerable to rusting which can cause a decrease in strength. This rusting of the reinforcement causes the reinforcement to swell and cause further damage to CMU.
