COA AVIATION CAMPUS

Project Priorities

Existing Conditions, Program, Equipment

2019 07 10

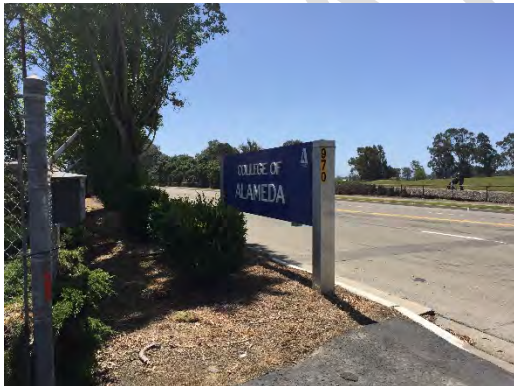
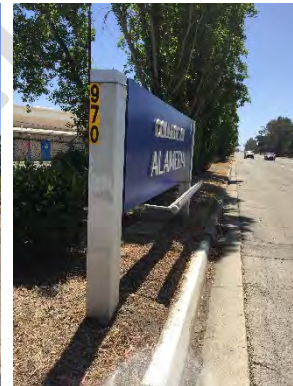
Existing District-standard campus entry sign has a light fixture but there is no site electrical available to connect.

College of Alameda sign at campus entry, no electrical connection for sign light

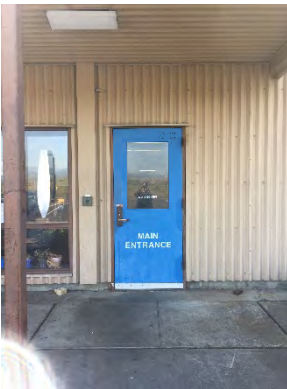
The “front door” for the program is on the east side of Hangar B, past Hangar A, and is not visible from the street or from the entry gate.

Front door to program, Hangar B

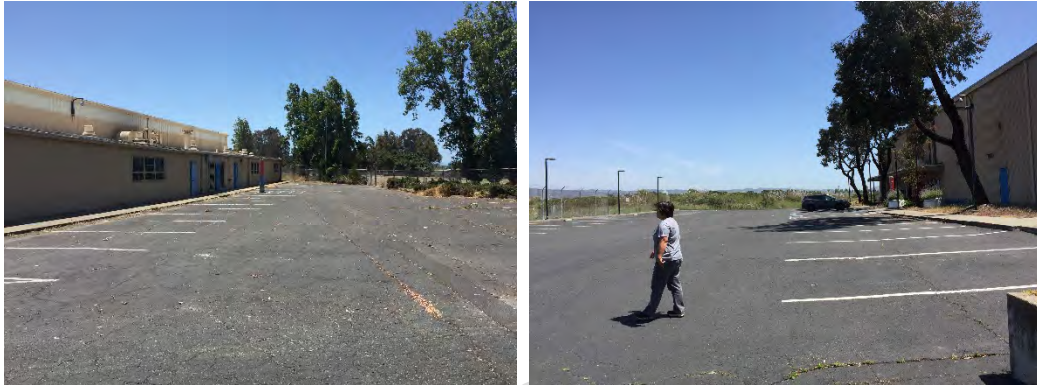
A minimum of 85 stalls are needed for current enrollment, not including ADA, a net increase of 20 stalls. Ideally, an additional 30+ stalls would better support expansion for aviation industry programs beyond AMT. There may be an opportunity to lease some adjacent, unimproved property for parking personal vehicles and to improve the total stall count by improving the shape of the area available for parking.

Personal vehicle parking at Hangar A and Hangar B

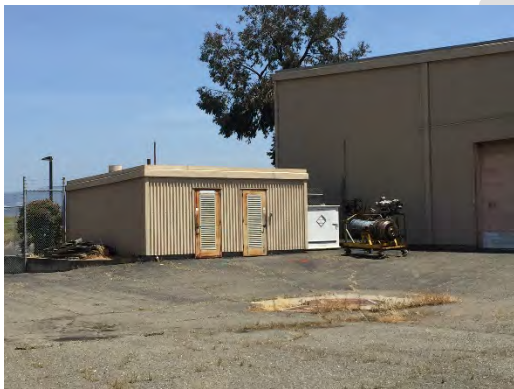
Airplanes, chemicals, engines, discarded items, supplies, jet fuel, and hazmat are stored outside. Jet fuel is currently stored in a white shed adjacent the chemical storage shed. The chemical storage shed is divided into separate spaces for open containers and sealed containers.

Chemical storage, jet fuel storage between Hangar A and Hangar B

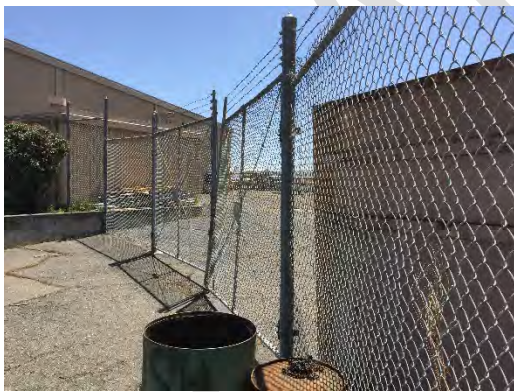
Theft is a significant problem. Per EC, the program files an average of two police reports per year. In addition to small tool theft, there was an incident in which thieves cut through the chain link facing Harbor Bay Parkway and stole an entire engine. A calibrated wrench costs about \$1000 – the program used to have 20, now has 6. “If we purchased a power washer, it would be gone within a week.” Fake cameras currently being used as a deterrent. Staff would like to be able to monitor all doors.

Fence between Ramp Area and Parking

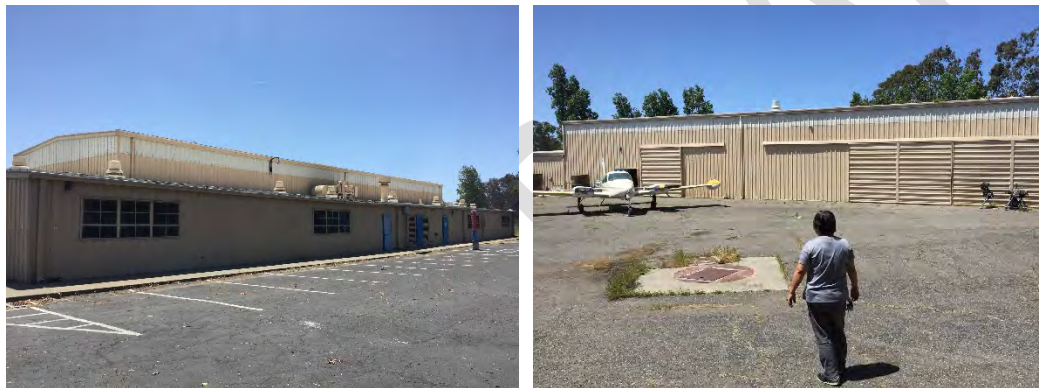
Front of Hangar A

Hangar doors at Hangar A

Two sets of hangar doors in Hangar A – one has not been functional in a very long time (“never” per one of the engineers). Carburetor and electrical work stations are relatively stationary. Engines get moved in and out but the hangar door adjacent to the Engine area does not get used much because the closing mechanism is unreliable. Most movable items (engines, sometimes also airplanes) go through the door on the propeller side because the door is in better condition. Hangar A might only need one hangar door but reliable functionality is essential.

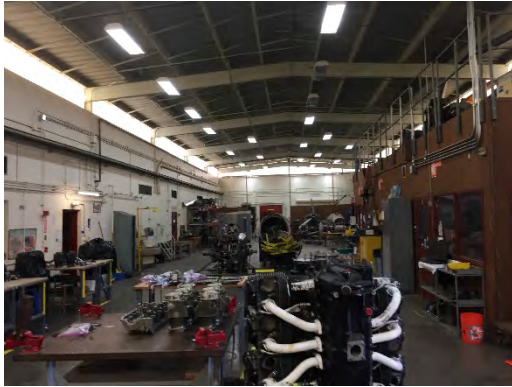
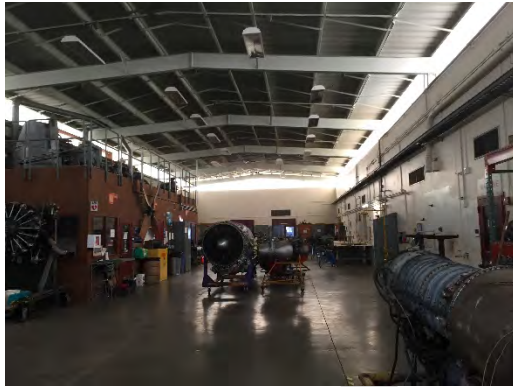
- Hangar A is the older building, higher priority for replacement.
- Electrical problems – outlet capacity/layout may be inadequate for instructional use, especially in the Electrical Shop.
- Glare and temperature issues in the shops and classrooms.
- The dimensions of one space currently being used as a general classroom in Hangar A required the acquisition of unusually narrow depth tables in order to accommodate 25 full size students.
- High bay space needs an overhead lift. Program is currently using a portable hoist.

Interior of Hangar A, high bay space

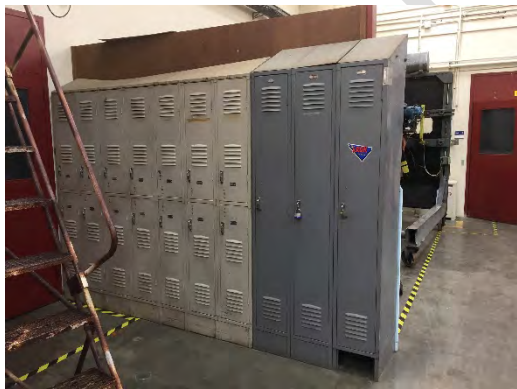
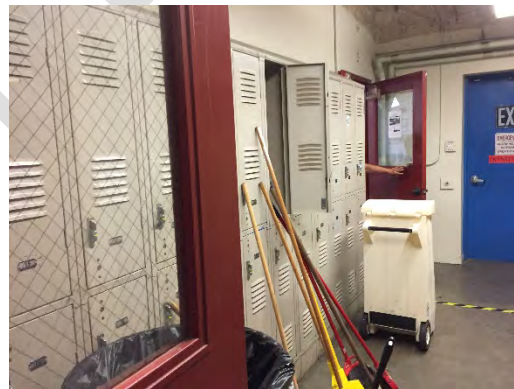
Student lockers at Hangar A high bay space and hallway to third general classroom

There are student lockers located at the Hangar B entry, in the Hangar A high bay space, and the hallway to the third classroom in Hangar A. Existing locker quantity is adequate to support 3 cohorts but staff report that locker condition is poor.

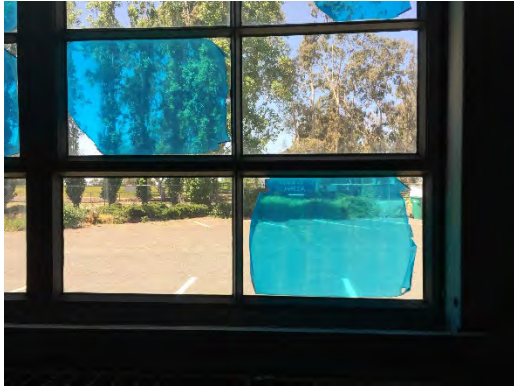
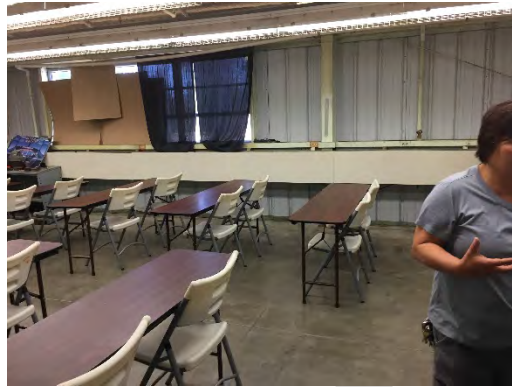
Glare and temperature issues at general classroom near Electrical Shop, Hangar A

- **Electrical Shop:** The existing space for the electrical shop is directly adjacent to a general classroom but both rooms have glare and temperature issues. Power supply to this room is inadequate for instructional purposes although power supply to the campus overall may be adequate.

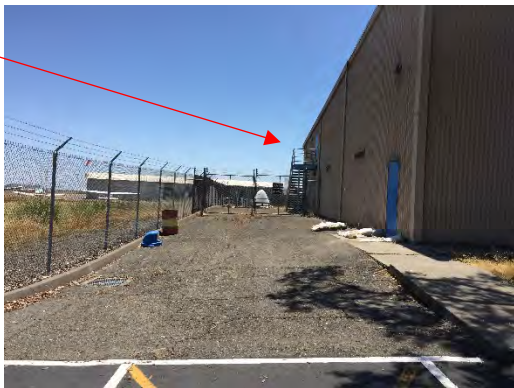
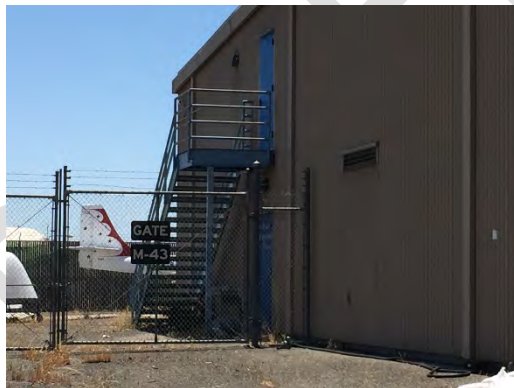
Exterior exit stair from Hangar B mezzanine. Maintenance staff access the roof using a ladder from this location.

- Exit door at Hangar B mezzanine and exterior doors elsewhere do not function properly – frames are bent and doors are warped, perhaps due to differential expansion of materials. It takes tremendous force to open some of the doors. Doors that are in constant use have fewer problems but all need to function properly for emergency exiting and accessibility.
- Both entry doors to Hangar B, Room 110 are bad (“mangled”).
- Locks – Review keying, including boiler room(s), IT room, electrical (Hangar B exterior), storage sheds, and fence gates. Replace hardware and lock systems. Include salt environment ratings for exterior doors, frames, and hardware.

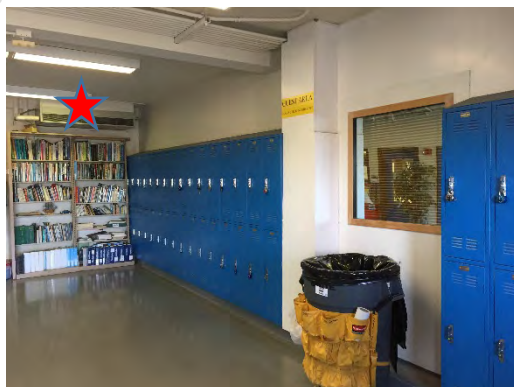
Student lockers at entry lobby, Hangar B

★ This HVAC unit does not work. See HVAC, below.

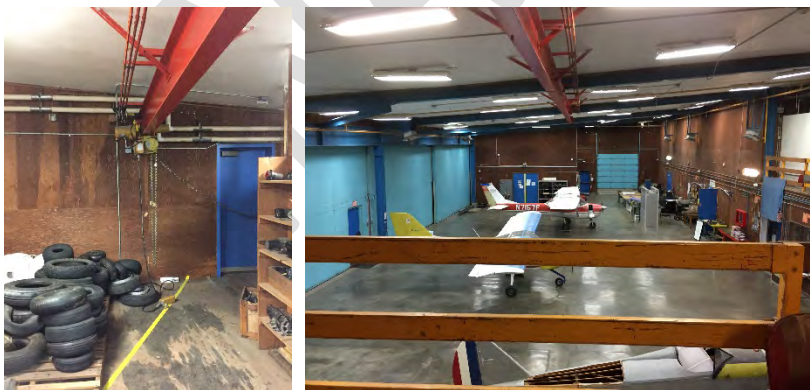
Unauthorized entry unrelated to theft is also a problem. The pull chain for the overhead hoist at Hangar B mezzanine is hooked to the mezzanine level exit door to prevent entry after unauthorized people were found sleeping in the facility last winter.

Overhead hoist at mezzanine and overview of hoist at airframe area

Existing method is to use a combination of portable hoist and forklift. This system should be replaced with an overhead hoist capable of lifting the largest loads.

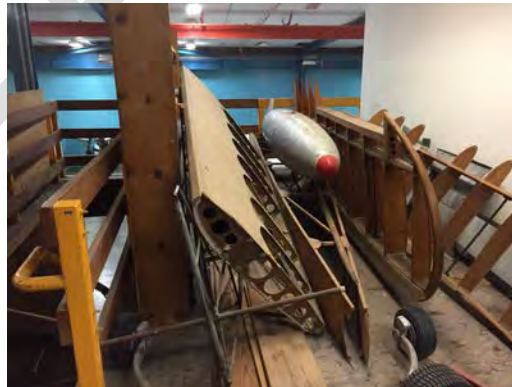
Wooden airframe storage at Mezzanine

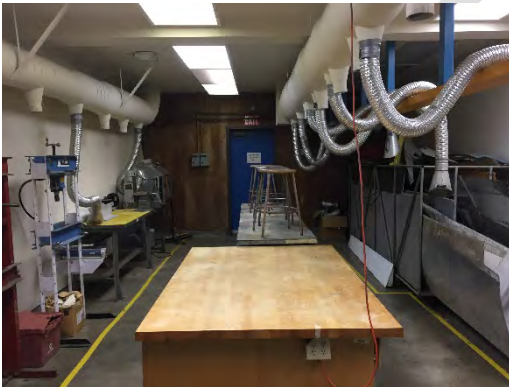
- **Composites Shop:** the AMT curriculum involves a lot of fiberglass work. The existing suction system was fabricated in-house. This space needs at least 15 snorkels, total. Ideally, the filtration system would be a built-in air filtration system, such as the one used by the AMT program at Solano CCD. Filtration system for this area is on the AEDA project equipment list but might need to be reclassified as building HVAC. The Composites Shop is in Hangar B.

Suction Heads (Snorkels) in Composites Lab

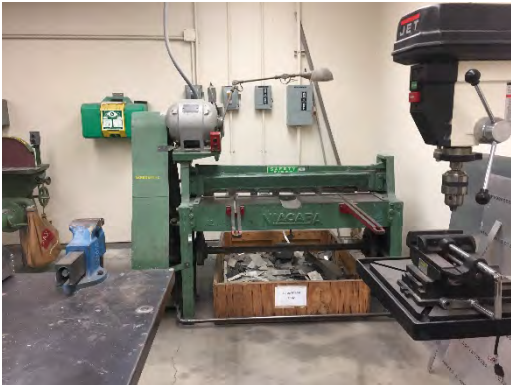
Sheet metal cutter, older, functional

Note: maintenance staff would like to have the older sheet metal cutter if it is discarded by the instructional program.

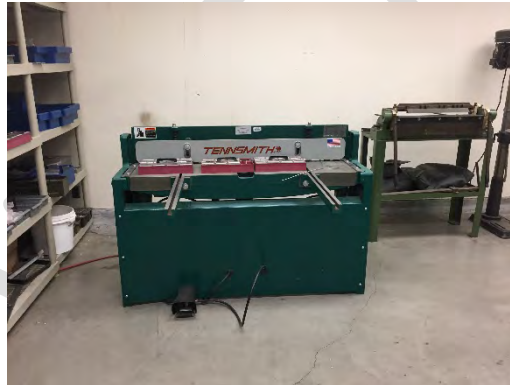
Sheet metal cutter, newer, non-functional

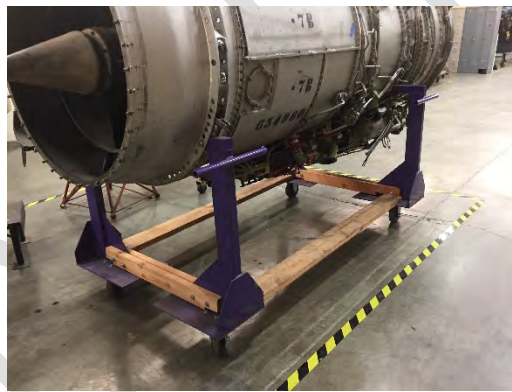
Engine on display stand (stand made in-house)

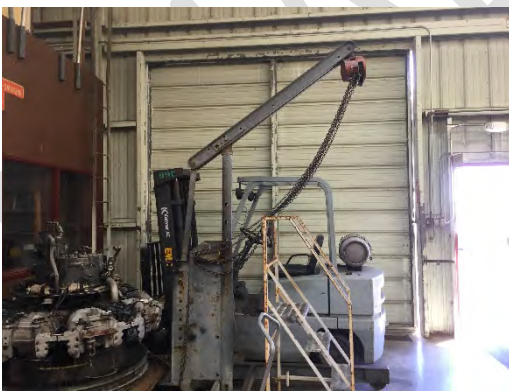
Portable Hoist

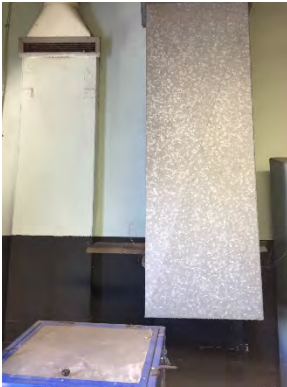
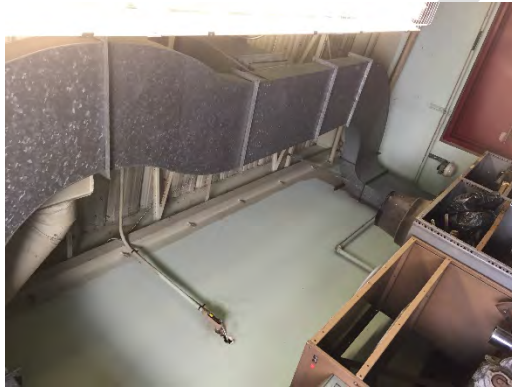
- **Corrosion Room:** per the FAA, must be a separate room. This area currently includes solvent tank and sand blasting equipment. Needs air quality improvement (filtration?). The corrosion room was created in Hangar A in 2018.

Ventilation and ductwork at corrosion room

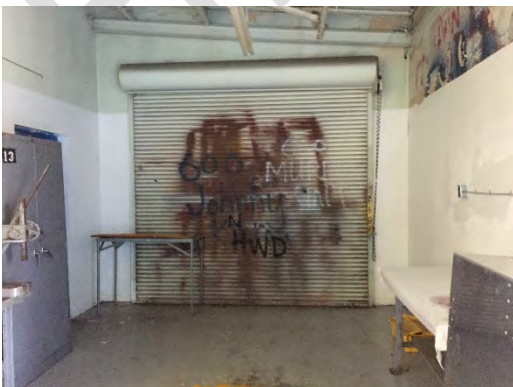
- **Paint Shop:** The paint shop was converted to the valve grinding room. Current program paints outside in the ramp area. Per EC, an indoor paint shop is not required.
- **Valve Grinding Room:** per the FAA, valve grinding must be a separate room. The new magaflex machine will be located here, with its enclosure. The valve grinding room was created in Hangar A in 2018 by in-house staff.

Valve Grinding Room (former paint shop)

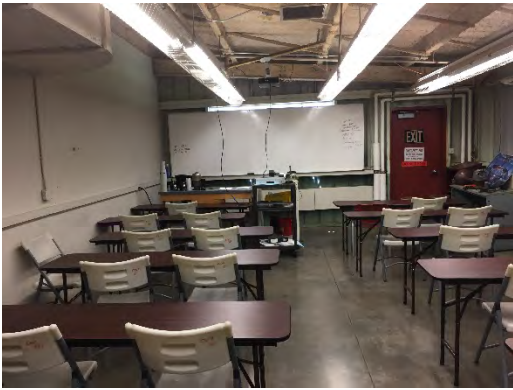
General Classroom, Hangar A*

*This room was previously a shop, and is not well designed for general classroom use.

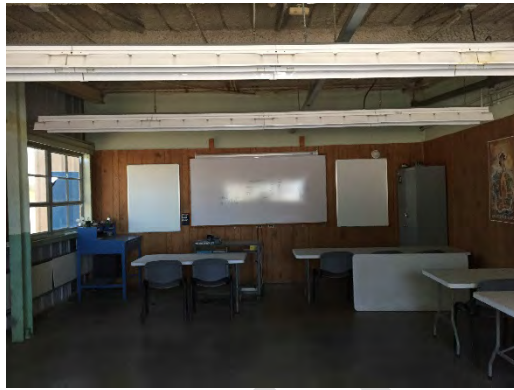
General Classroom near Electrical Shop, Hangar A

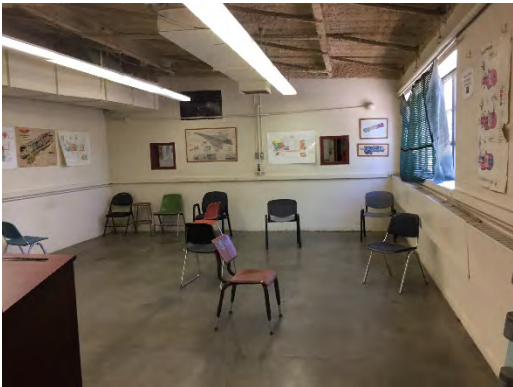
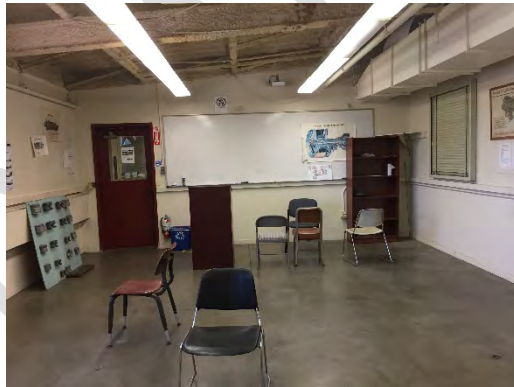
Air quality, temperature, and circulation is important for 3-hour classes. All rooms currently used as general classrooms need better air. There are two existing spaces used as general classrooms in Hangar B and three in Hangar A (one in A is infrequently used because the lighting is inadequate). The program needs a total of 6 spaces that can be used as general classrooms (perhaps 7, with avionics, see Future Programs, above). Three existing spaces currently used as general classrooms at the ground level can be reverted to shop/lab space.

Third general classroom, Hangar A

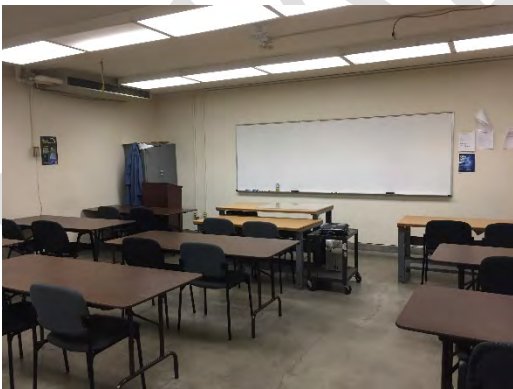
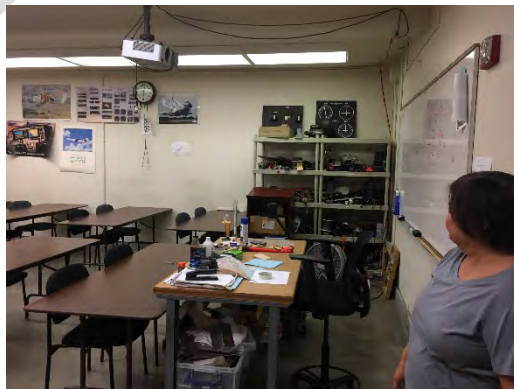
General Classrooms, Hangar B

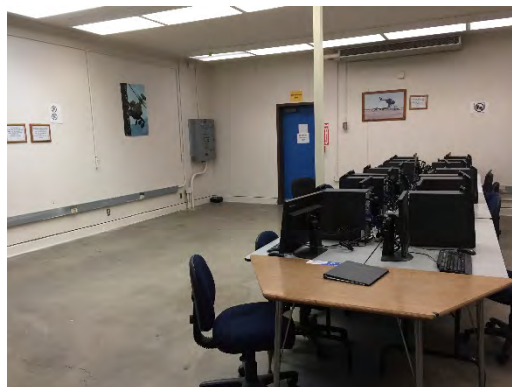
More space than needed for this function

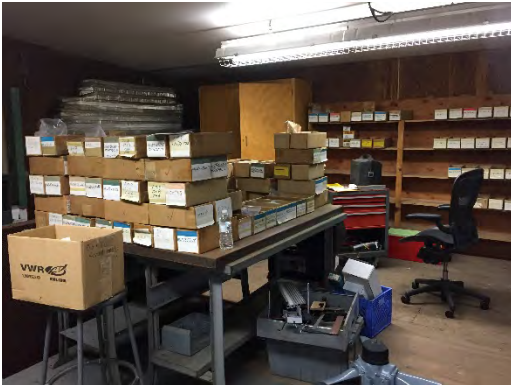
The partitioned/screened area at the Hangar B mezzanine is a quarantine area for donated parts and supplies that need to be inventoried.

Donated parts at mezzanine, awaiting inventory

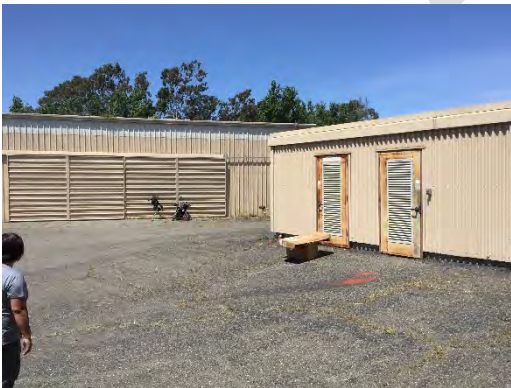
- **HazMat:** There is hazmat storage in a shed outside (one compartment for unopened containers, one for opened) plus jet fuel storage in adjacent shed. There are also flammable storage cabinets in the Hangars. The hazmat storage strategy should be reviewed.

Hazmat storage shed in yard

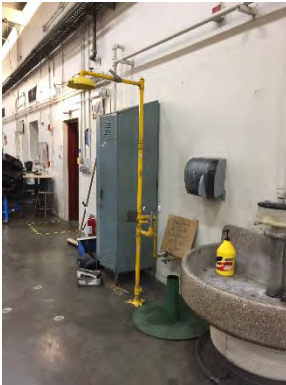
There is a sink and eyewash station in the Hangar B entry and in the Hangar A high bay space. There is an eyewash at the corrosion room in Hangar A. Sink and eyewash station location and type should be reviewed.

Sink + eyewash, Hangar A

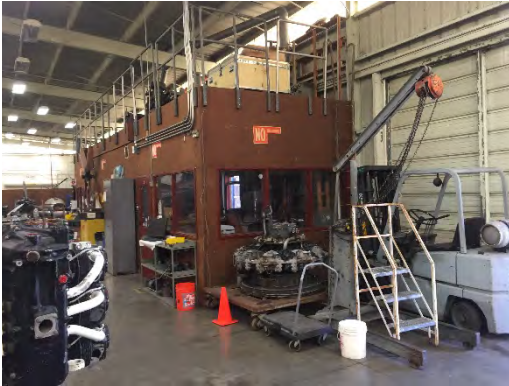
There are two faculty offices in Hangar A, both located in an area partitioned off from the high bay space, between the engine and propeller areas. The partitioned area has an office on either side of a utility/storage room. Water intrudes into both of these offices.

Faculty Offices, Hangar A

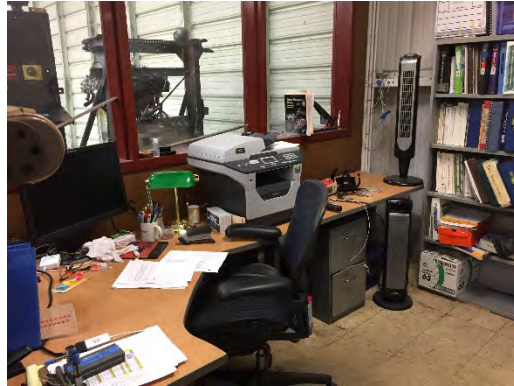
Faculty Office, Hangar A

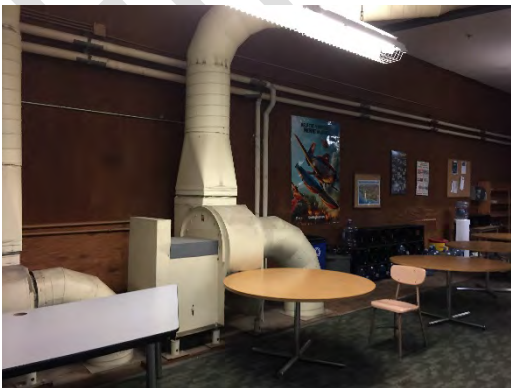
Existing fan (and filter?) on Hangar B mezzanine, over Composites Lab.

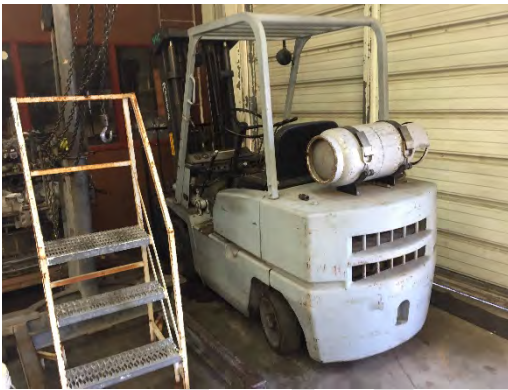
Existing forklift was obtained by trading scrap metal. Repaired / re-built in-house. Inadequate for tasks.

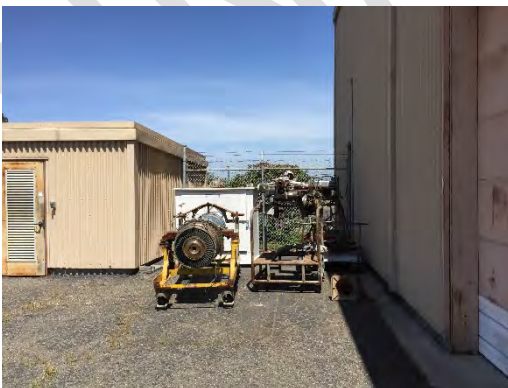
Many existing ones were fabricated in-house, but it would better to have ones that are commercially manufactured. Need 25 total, in a variety of sizes. Per EC, currently have 12 small ones, 3 large, 1 extra large. A large one would cost \$40-50k to purchase. Of the existing ones, 14 are in good condition. Engine test stands are generally located in the Engine Area, Hangar A. Engine test stands are not the same as engine tie-downs, which are also used for testing engines (see Site).

Engine test stands, large

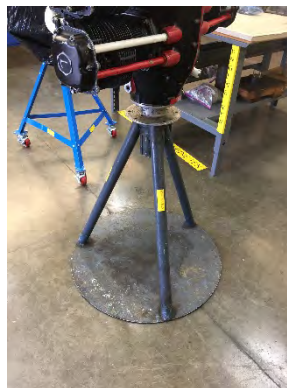
Engine test stands, small

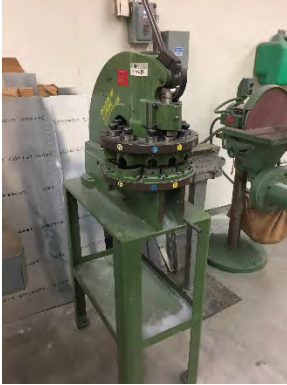
Making an access hole cover is part of the curriculum. There is an existing machine but the hole diameter is not adjustable so the program is currently cutting circles by hand. The circle cutter machine is located in the Metal Shop.

Existing circle cutter

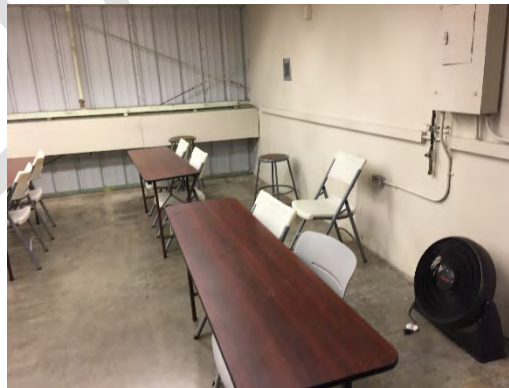
Floor Fan, general classroom, Hangar A

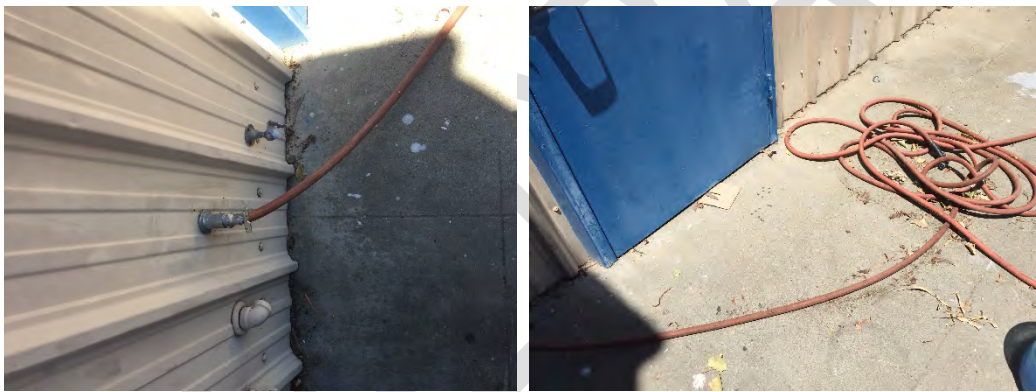
The air compressor is very old and uses too much power. Its valves and pipes are leaking. Compressor room is at the Hangar B mezzanine but is accessed from exterior.

Compressed air spigot at exterior, near Valve Grinding Room

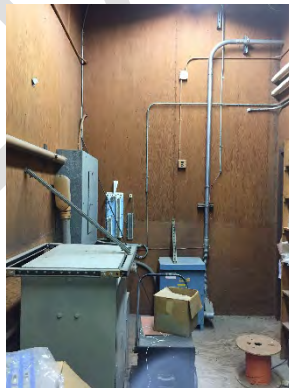
The assistant chief engineer notes that the electrical panel and transformer at the Hangar B mezzanine need to be re-indexed and perhaps refreshed and that the panels near Hangar B Room 104 are disorganized and that the panel doors are broken.

Electrical room at mezzanine, Hangar B

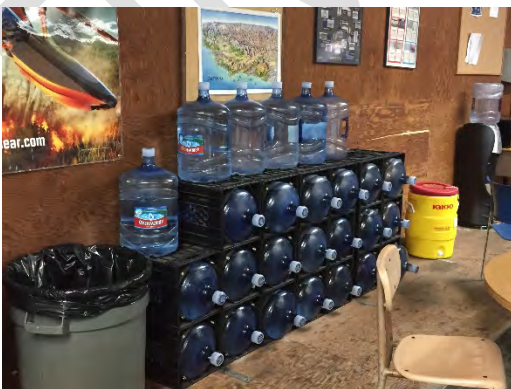
The sewer in Hangar B frequently backs up, at least twice per year. Maintenance staff confirm that plumbing back-ups impacting restrooms are among the top five most common/pressing work order requests for this facility. The tap water is occasionally unsafe to drink (2-3x/year) when the building water is shut down due to toilet malfunction (the broken pipe below is not fixable because it is ceramic). Drinking water is stored in large jugs outside the front door to Hangar B and/or on the Hangar B Mezzanine.

Drinking water storage at Mezzanine
