Structural Assessment Memo

Main Street Pier Existing Concrete Slab and Foundations

Daytona Beach, Florida

August 2019

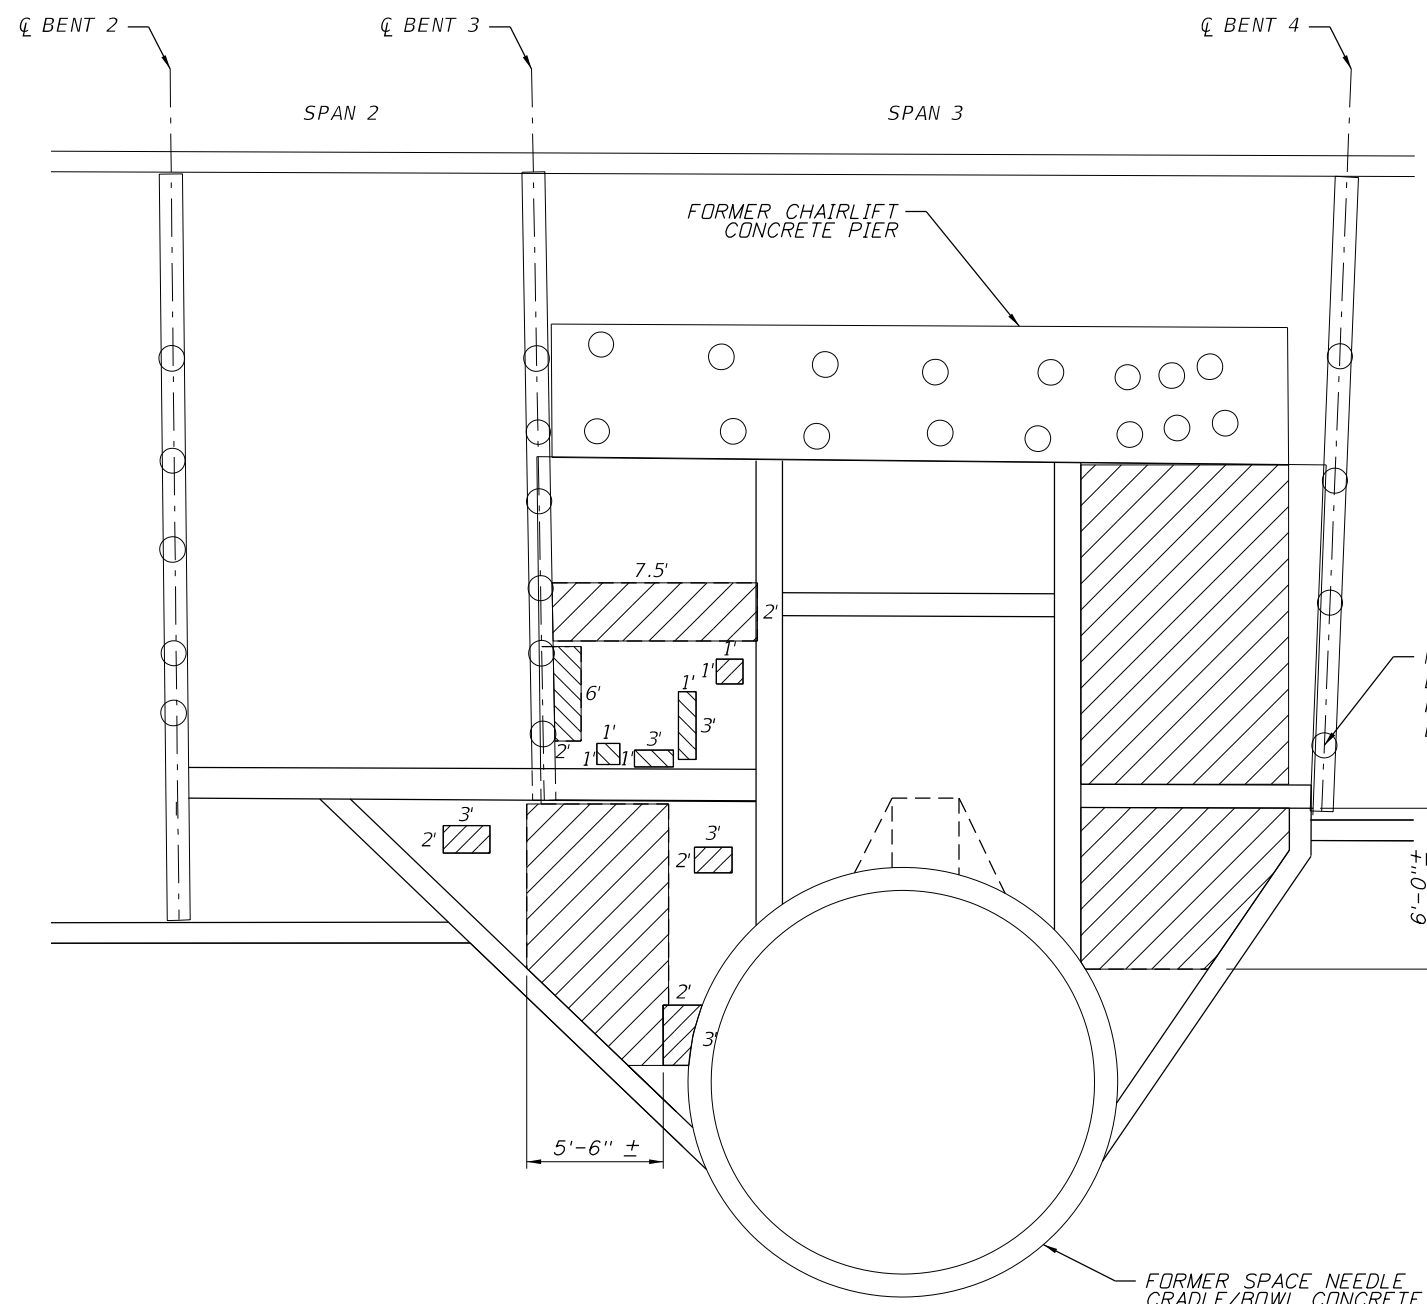
CONCRETE SLAB BOTTOM DETERIORATION PLAN

- Concrete beams and slab between Bents 2 through 4 – Several cracks, delaminations, and spalling occur at both the slab and beams (see Photo 5).
- Steel channel beams with transverse steel channels/plates at end for connection of timber bent cap to concrete beam between Bents 2 through 4 – Steel members exhibit major corrosion and section loss. The connection of one of the channels to a concrete beam was also compromised (see Photo 6).

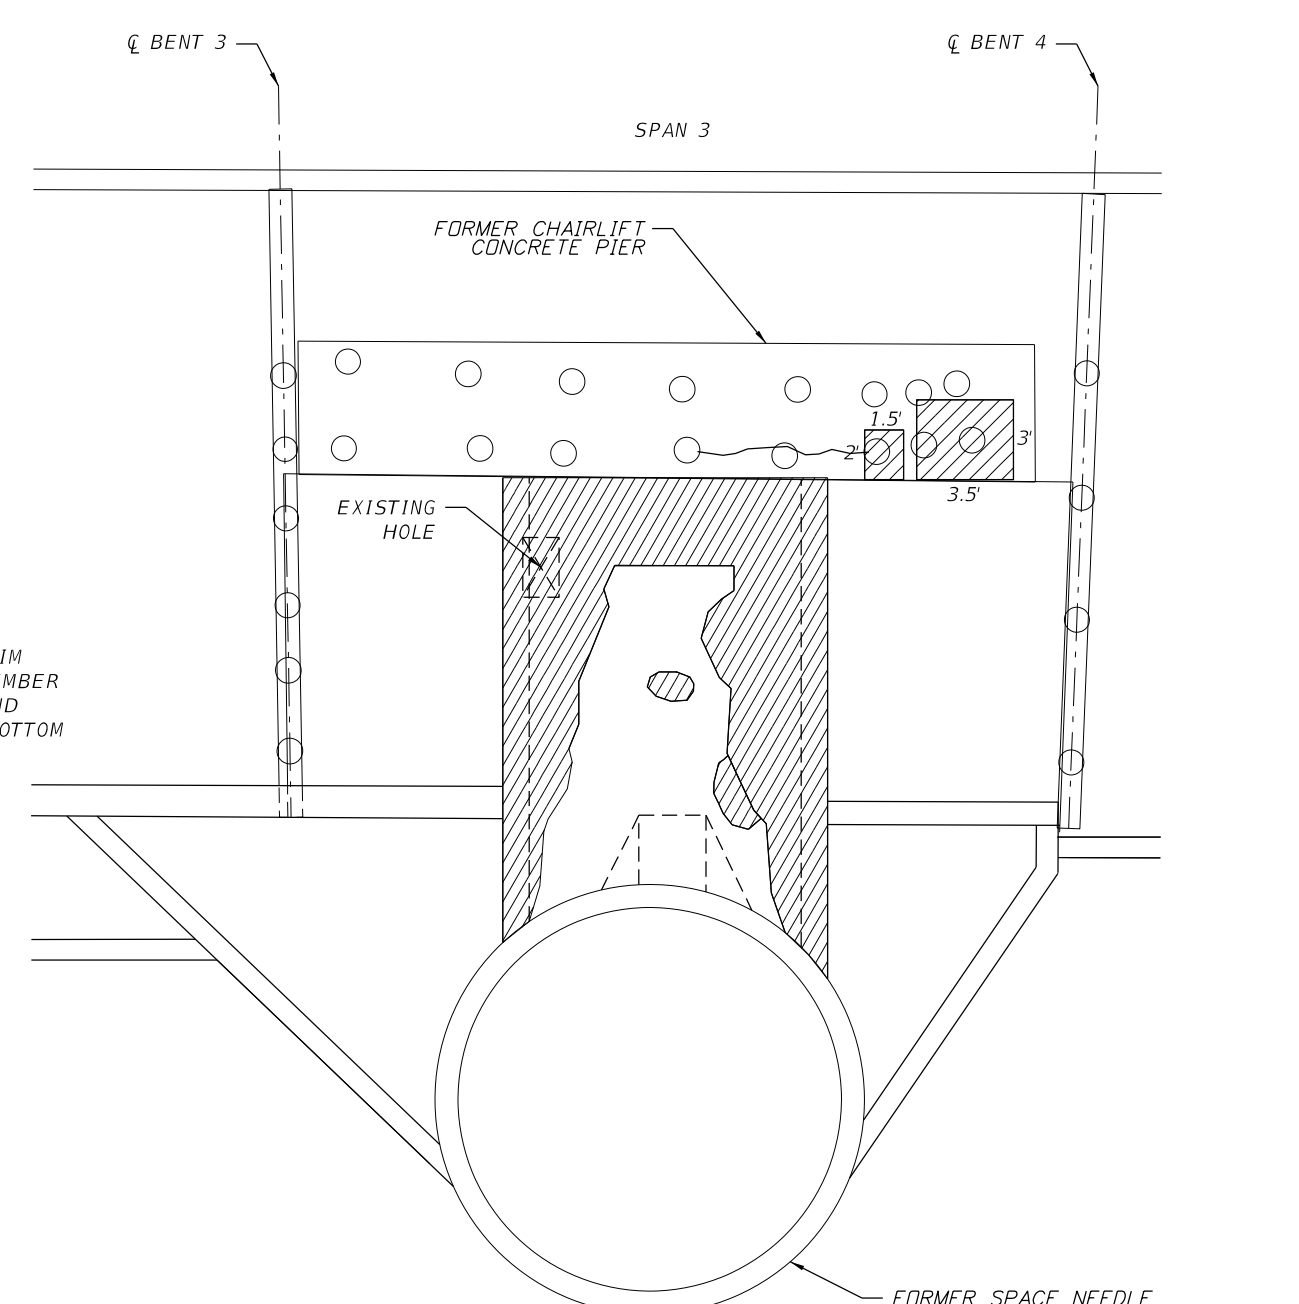
FORMER CHAIRLIFT CONCRETE PIER AND CONCRETE U-BEAM (VAULT) BOTTOM DETERIORATION PLAN

- Former chairlift concrete pier support between Bents 3 and 4 – Some minor cracks are present on the south face as well as delaminations on the bottom (see Photo 3).

- Concrete U-beam (vault) and slab between Bents 3 and 4 – Several cracks, delaminations, and spalling occur at both the north and south faces as well as the bottom (see Photo 4).

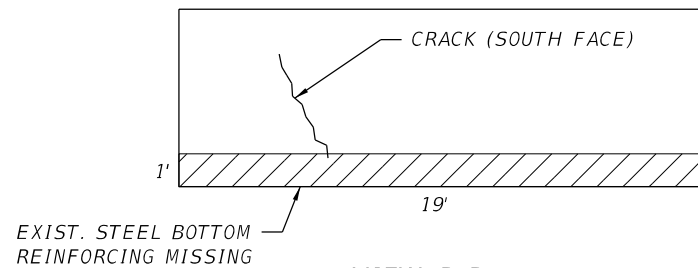
VIEW D-D
(EXIST. 8"X48" CONCRETE BEAM (WING), LOOKING SOUTHWEST)

- Former space needle cradle/bowl concrete support and adjacent concrete beams (wings) – No deficiencies of the bowl and cylindrical concrete wall were noted (see Photo 1). The adjacent concrete beams (wings) have major corrosion and the loss reinforcing at the bottom of beams (full length) along with concrete spalling (see Photo 2).

- Remove existing concrete beams (wings) adjacent to the former space needle cradle/bowl concrete support. Replace with timber framing.
- Repair former chairlift concrete pier support between Bents 3 and 4 with epoxy crack injection and concrete patch repair.

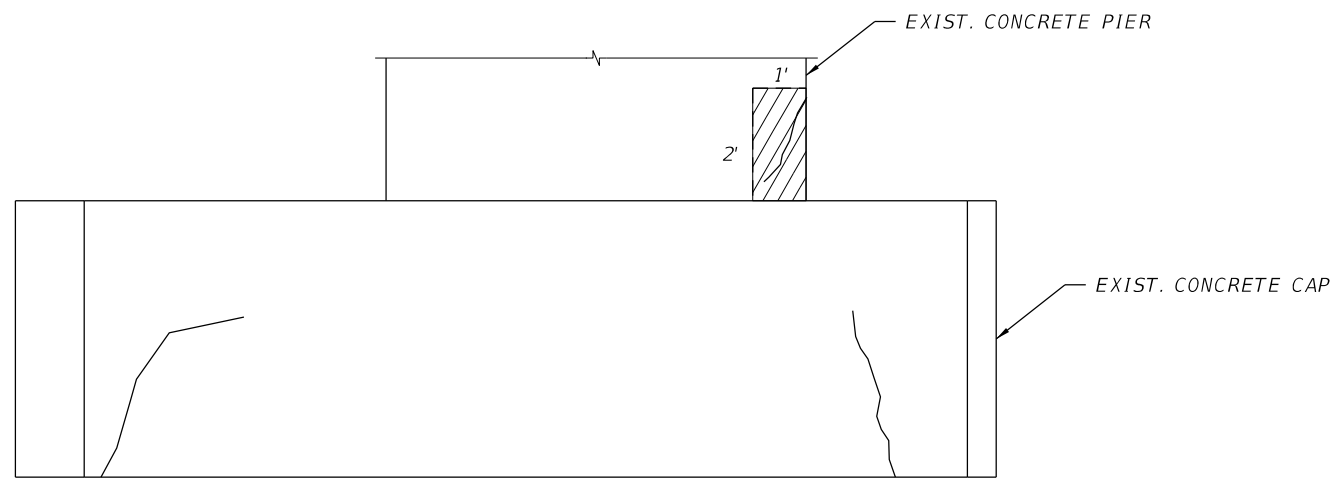
VIEW J-J
(NORTH FACE)

- Former chairlift concrete pier support between Bents 14 and 15 – Several cracks and delaminations were found on the three faces of the pier cap and pier above. Severe deterioration of the bottom of the cap was noted with the exposed bottom layer of reinforcing exposed and a large delamination on the north side of the bottom (see Photos 8 and 9).

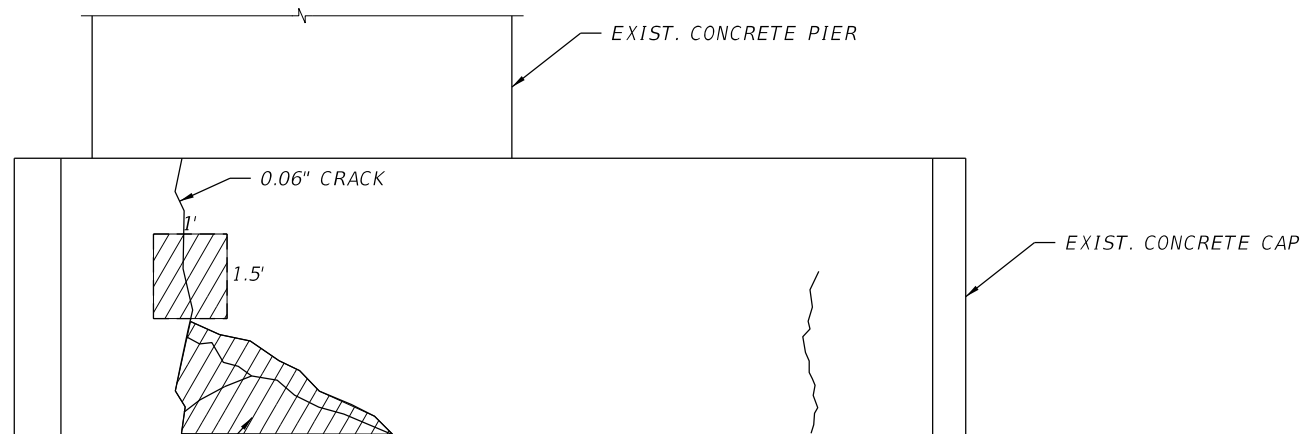
VIEW K-K
(SOUTH FACE)

EXIST. STEEL
REINFORCING
EXPOSED
