**Engineering Evaluation of Concrete Condition
and Steel Sheet Pile Wing Wall Thickness
St. Johns River Water Control Structure S-96C
Indian River County, Florida**

Ardaman & Associates, Inc.

St. Johns River Water Management District
P.O. Box 1429
Palatka, Florida 32178

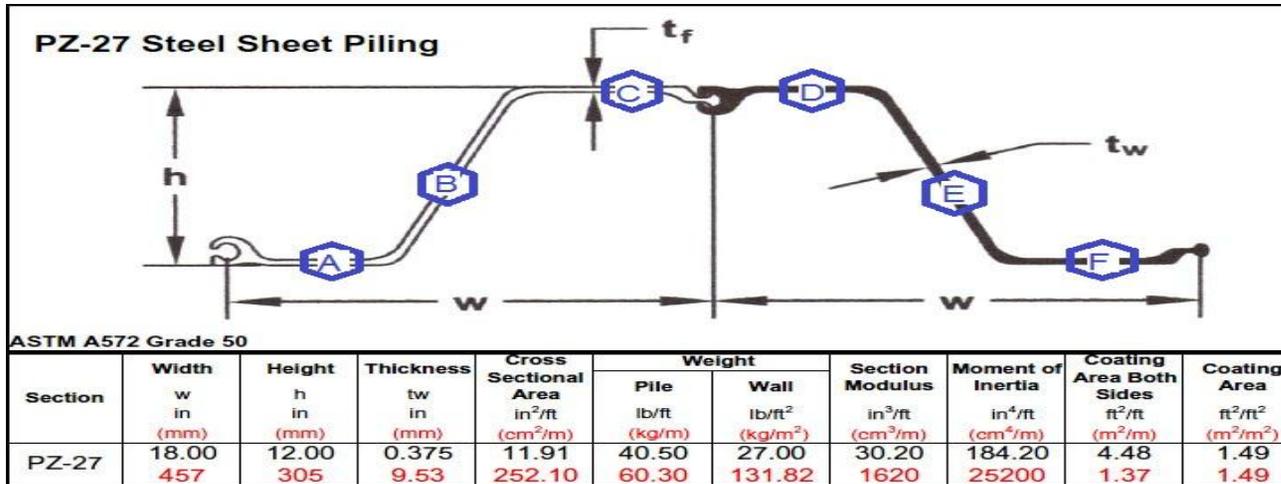
Approximate Reading Designation Location

TABLE 3A
Ultrasonic Thickness Readings
Steel Sheet Pile Wing Walls
Water Control Structure S-96C
SJRWMD, Indian River County, Florida

Reading Designation	Wing Wall Average Thickness Reading (inches)					
	North Wall (Upstream)			South Wall (Upstream)		
	1	2	3	1	2	3
A	0.398	0.399	0.416	0.403	0.429	0.430
B	0.386	0.398	0.404	0.404	0.427	0.405
C	0.394	0.406	0.411	0.392	0.373	0.409
D	0.985	0.404	0.412	0.403	0.427	0.427
E	0.393	0.411	0.420	0.411	0.422	0.416
F	0.406	0.427	0.454	0.404	0.428	0.407
Maximum Value	0.985	0.427	0.454	0.411	0.429	0.430
Minimum Value	0.386	0.398	0.404	0.392	0.373	0.405
Average Value	0.494	0.408	0.420	0.403	0.418	0.416
Median Value	0.396	0.405	0.414	0.404	0.427	0.413

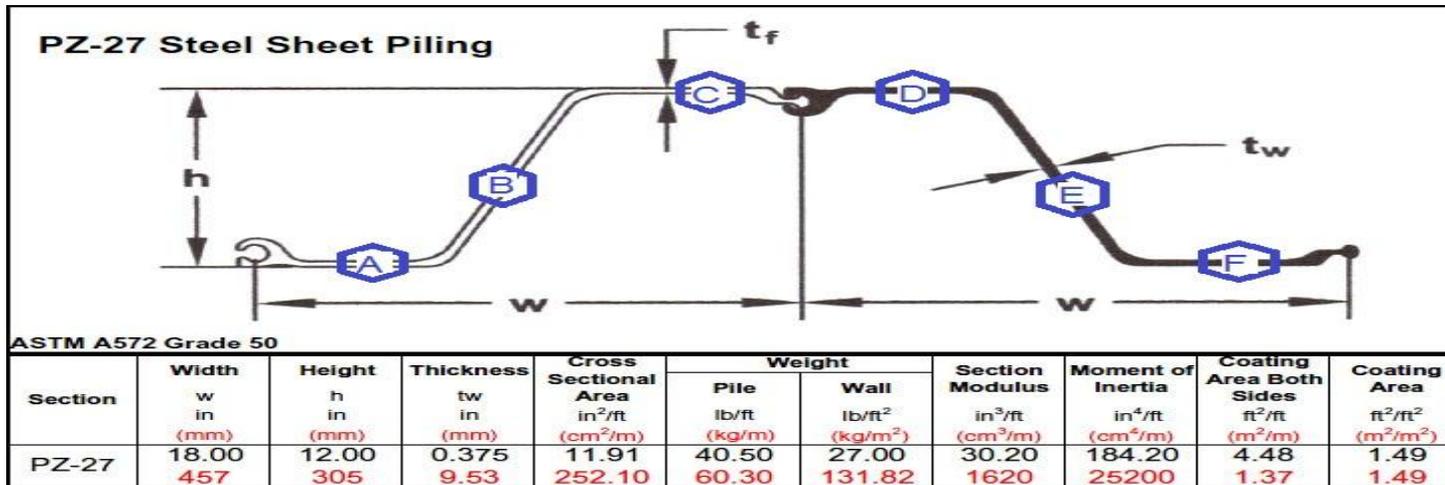
Approximate Reading Designation Location

TABLE 3B
Ultrasonic Thickness Readings
Steel Sheet Pile Wing Walls
Water Control Structure S-96C
SJRWMD, Indian River County, Florida

Reading Designation	Wing Wall Average Thickness Reading (inches)									
	North Wall (Downstream)					South Wall (Downstream)				
	1	2	3	4	5	1	2	3	4	5
A	0.396	0.387	0.390	0.390	0.399	0.419	0.409	0.393	0.403	0.397
B	0.388	0.388	0.390	0.387	0.397	0.428	0.394	0.384	0.383	0.397
C	0.409	0.399	0.425	0.415	0.400	0.396	0.385	0.389	0.429	0.401
D	0.426	0.401	0.427	0.419	0.403	0.419	0.407	0.384	0.407	0.401
E	0.398	0.392	0.406	0.405	0.411	0.399	0.398	0.403	0.374	0.397
F	0.388	0.390	0.416	0.416	0.408	0.384	0.386	0.390	0.375	0.407
Maximum Value	0.426	0.401	0.427	0.419	0.411	0.428	0.409	0.403	0.429	0.407
Minimum Value	0.388	0.387	0.390	0.387	0.397	0.384	0.385	0.384	0.374	0.397
Average Value	0.401	0.393	0.409	0.405	0.403	0.408	0.397	0.391	0.395	0.400
Median Value	0.397	0.391	0.411	0.410	0.402	0.409	0.396	0.390	0.393	0.399
