May 21, 2021

Subject: Asbestos Roofing Survey
San Antonio Elementary School – Rooms 3-10 (4 Classroom Buildings)
650 Carne Road, Ojai, CA 93023
FCG Project Code: Ojai USD-62

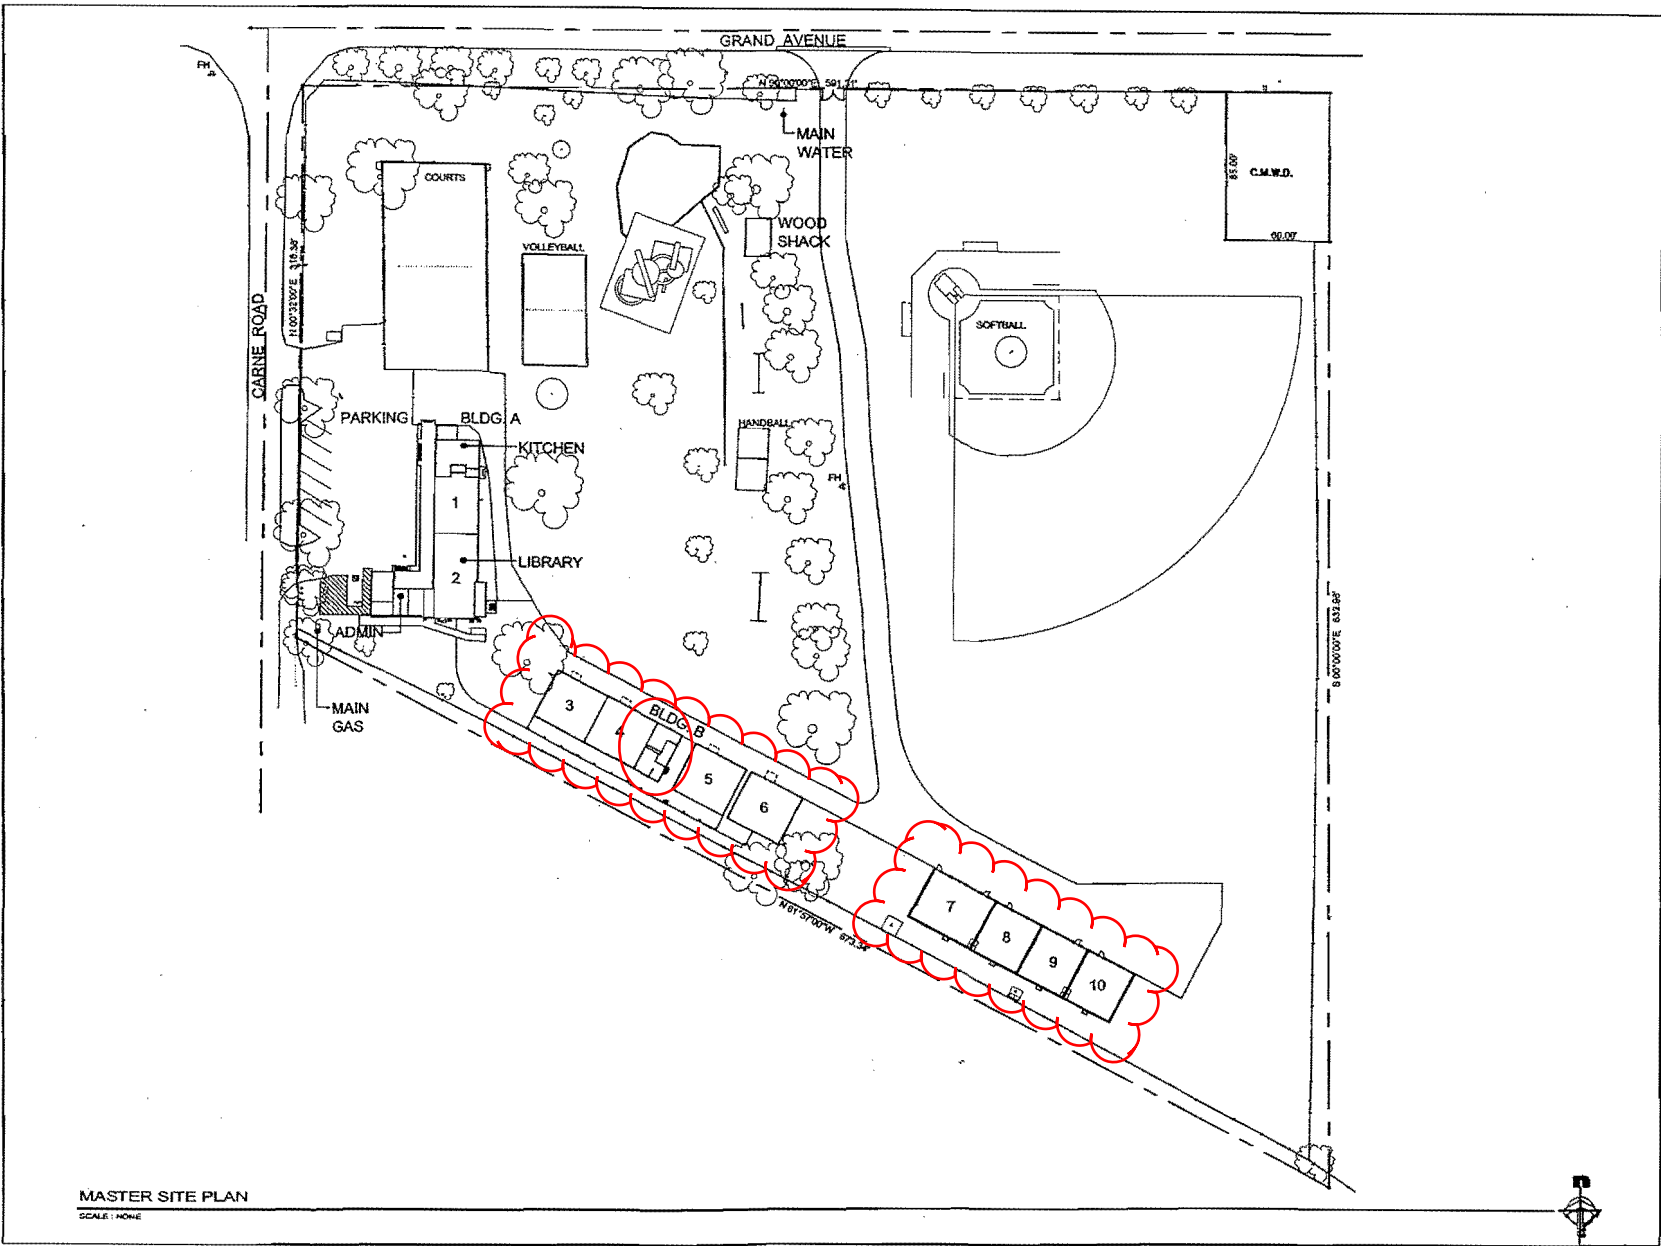
MASTER SITE PLAN
SCALE: NONE

**Asbestos Roofing Survey
San Antonio School
650 Carne Road, Ojai
Sample Locations Noted in Red**
