**Engineering Evaluation of Concrete Degradation  
and Steel Sheet Pile Wing Wall Thickness  
C-54 Canal Water Control Structure S-157  
SJRWMD, Brevard County, Florida**

May 28, 2013  
File No. 13-60-6303

Subject: Engineering Evaluation of Concrete Degradation and  
Steel Sheet Pile Wing Wall Thickness  
C-54 Water Control Structure S-157  
SJRWMD, Brevard County, Florida

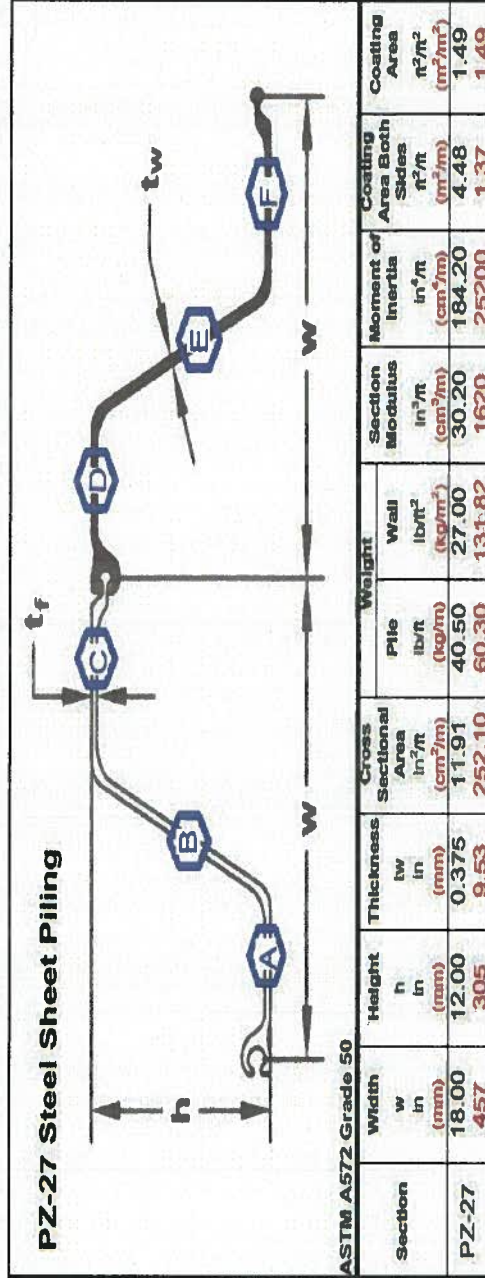
Approximate Reading Designation Location

In general, the thickness readings for all walls exceeded the as-built sectional thickness of 0.375 inch. We note that readings may have been influenced by the corrosion.

Ultrasonic Thickness Readings  
Steel Sheet Pile Wing Walls  
C-54 Canal Water Control Structure S-157  
SJRWMD, Brevard County, Florida

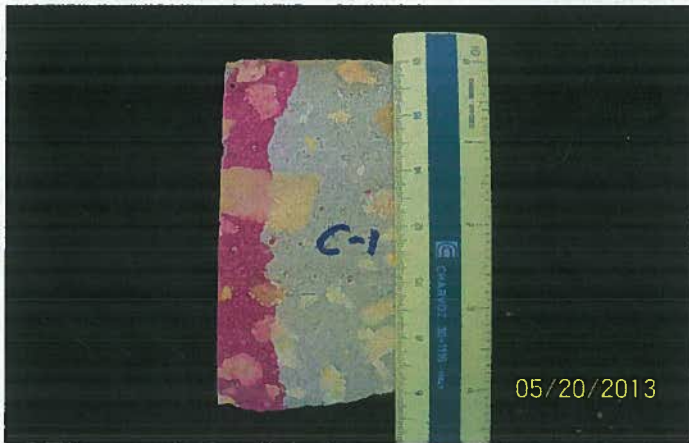
**Core 1**

In general, evidence of erosion (pitting) was not present or measurable. This was consistent with our visual observations. Within the cores we observed no evidence of rust bleeding (as would be expected from corroding reinforcing steel) or leaching of paste due to acid attack. These results also are consistent with our field observations.
