COA AVIATION CAMPUS

Project Priorities

Existing Conditions, Program, Equipment

2019 07 10

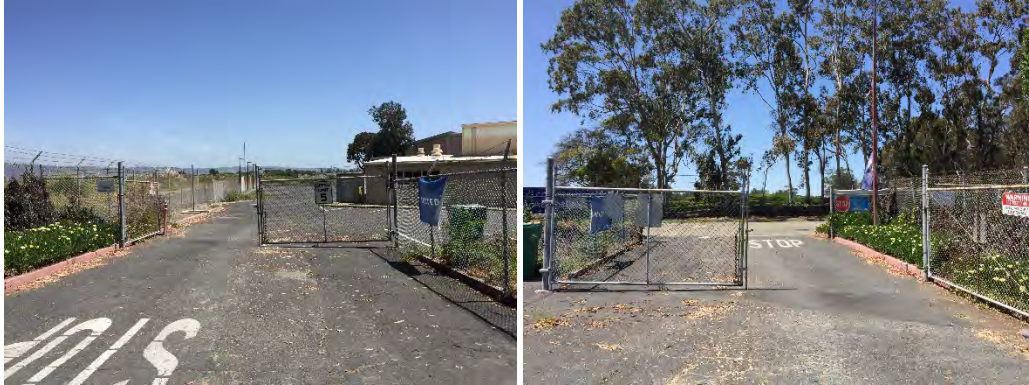
There is a lot of speeding and drag racing on Harbor Bay Parkway at night. Safety for vehicles entering and exiting the campus is an issue. The noise also impacts instruction.

Campus entry, towards campus

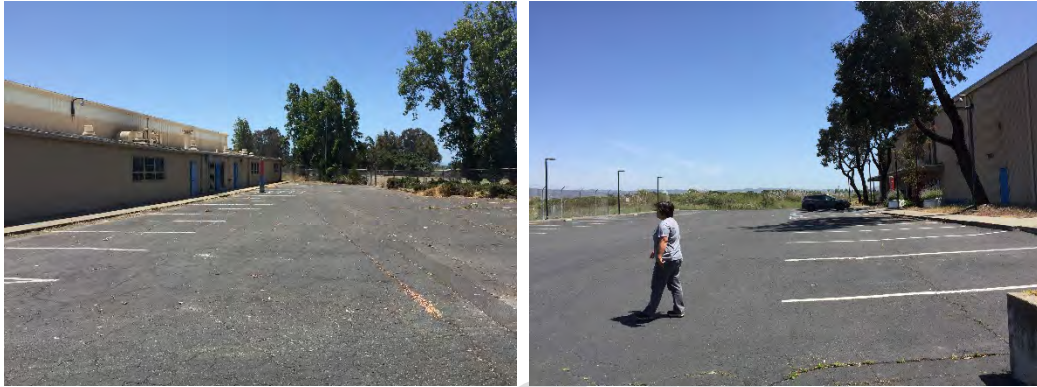
A minimum of 85 stalls are needed for current enrollment, not including ADA, a net increase of 20 stalls. Ideally, an additional 30+ stalls would better support expansion for aviation industry programs beyond AMT. There may be an opportunity to lease some adjacent, unimproved property for parking personal vehicles and to improve the total stall count by improving the shape of the area available for parking.

Personal vehicle parking at Hangar A and Hangar B

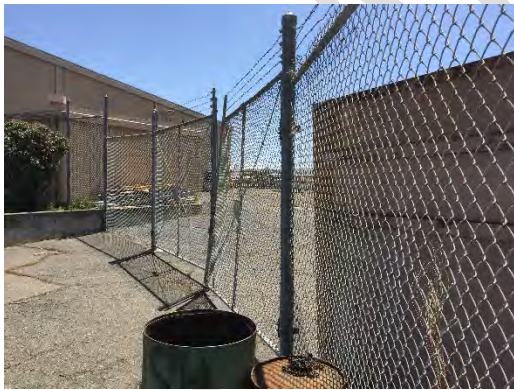
Theft is a significant problem. Per EC, the program files an average of two police reports per year. In addition to small tool theft, there was an incident in which thieves cut through the chain link facing Harbor Bay Parkway and stole an entire engine. A calibrated wrench costs about \$1000 – the program used to have 20, now has 6. “If we purchased a power washer, it would be gone within a week.” Fake cameras currently being used as a deterrent. Staff would like to be able to monitor all doors.

Fence between Ramp Area and Parking

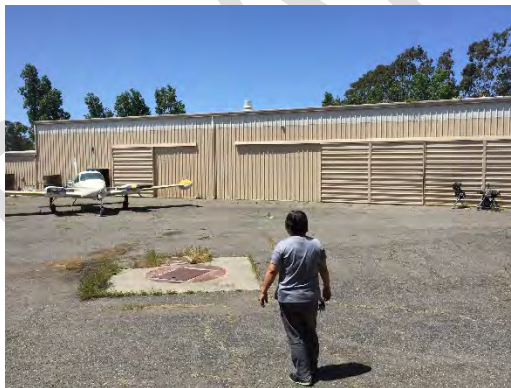
Hangar doors at Hangar A

Two sets of hangar doors in Hangar A – one has not been functional in a very long time (“never” per one of the engineers). Carburetor and electrical work stations are relatively stationary. Engines get moved in and out but the hangar door adjacent to the Engine area does not get used much because the closing mechanism is unreliable. Most movable items (engines, sometimes also airplanes) go through the door on the propeller side because the door is in better condition. Hangar A might only need one hangar door but reliable functionality is essential.

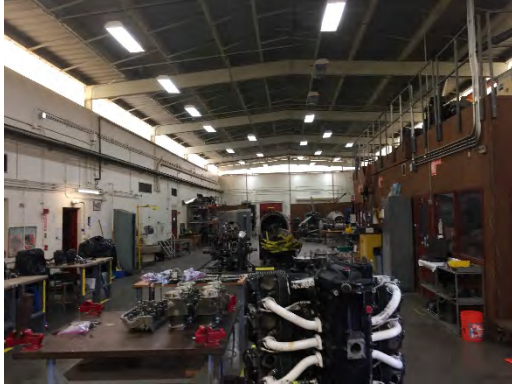
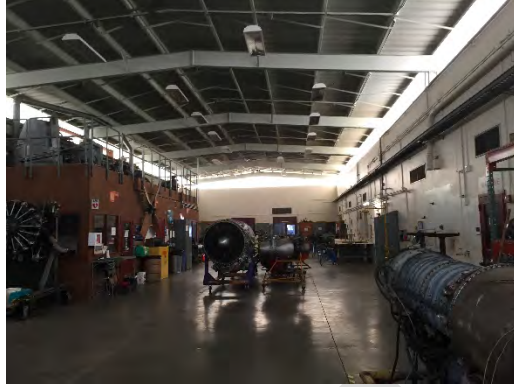
- Hangar A is the older building, higher priority for replacement.
- Electrical problems – outlet capacity/layout may be inadequate for instructional use, especially in the Electrical Shop.
- Glare and temperature issues in the shops and classrooms.
- The dimensions of one space currently being used as a general classroom in Hangar A required the acquisition of unusually narrow depth tables in order to accommodate 25 full size students.
- High bay space needs an overhead lift. Program is currently using a portable hoist.

Interior of Hangar A, high bay space

Existing method is to use a combination of portable hoist and forklift. This system should be replaced with an overhead hoist capable of lifting the largest loads.

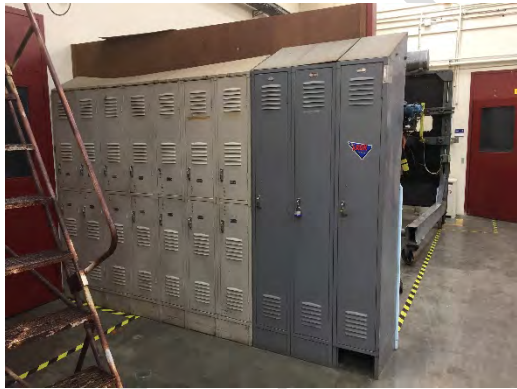
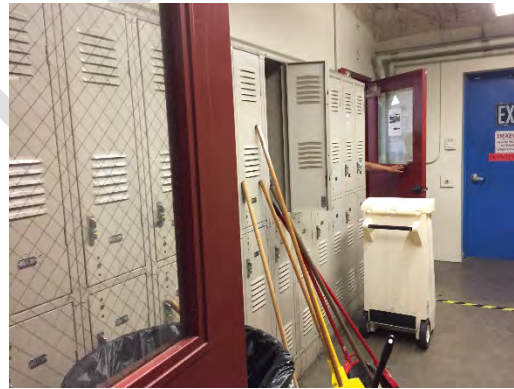
Student lockers at Hangar A high bay space and hallway to third general classroom

There are student lockers located at the Hangar B entry, in the Hangar A high bay space, and the hallway to the third classroom in Hangar A. Existing locker quantity is adequate to support 3 cohorts but staff report that locker condition is poor.

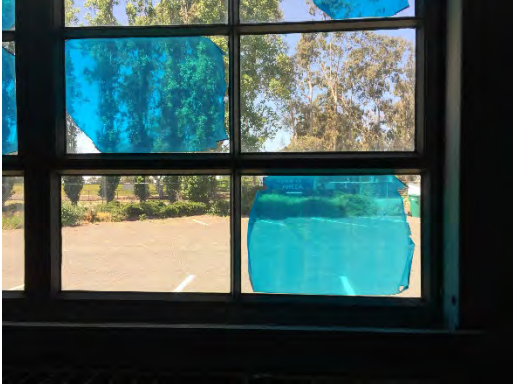
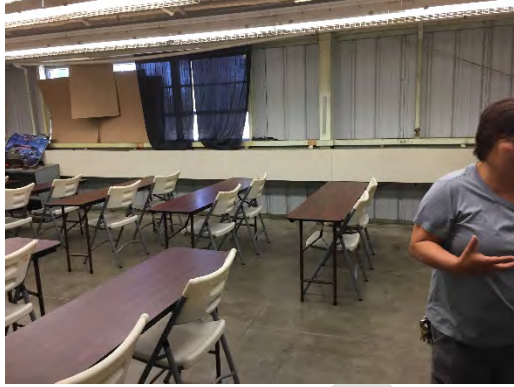
Glare and temperature issues at general classroom near Electrical Shop, Hangar A

- Electrical Shop:** The existing space for the electrical shop is directly adjacent to a general classroom but both rooms have glare and temperature issues. Power supply to this room is inadequate for instructional purposes although power supply to the campus overall may be adequate.

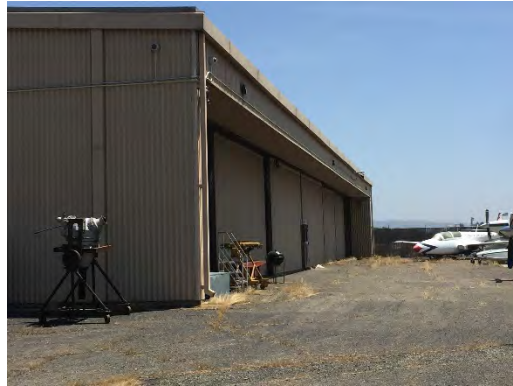
Two double hangar doors at Hangar B

Two sets of hangar doors in Hangar B – the one on the mezzanine side has been out of operation for two years because it is broken but otherwise would be used. To restore functionality requires, at a minimum: replace entire track and motor plus new seals and controls. It might be a better investment to replace the hangar doors in their entirety.

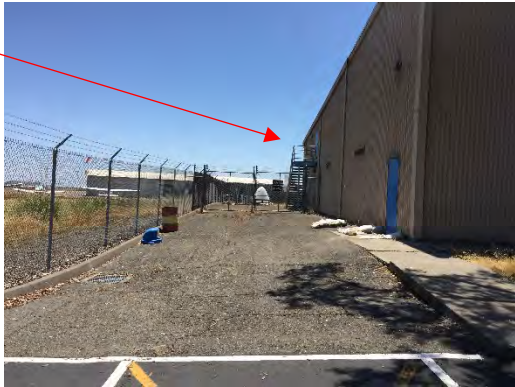
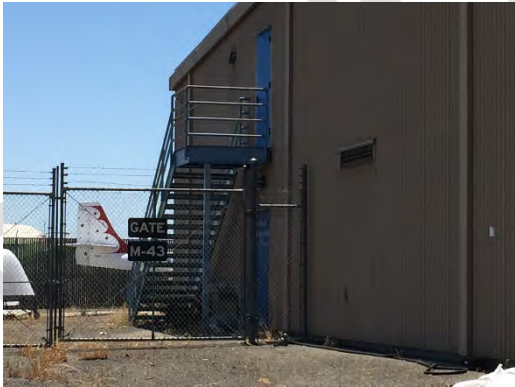
Components, below). The paved yard suffers occasionally from ponding. The current drain system collects the water in a hole and then pumps it out to the street (see also Utilities, below). Weeds grow in the many cracks.

Hangar B roll-up door, paved area between Hangar B and Hangar A

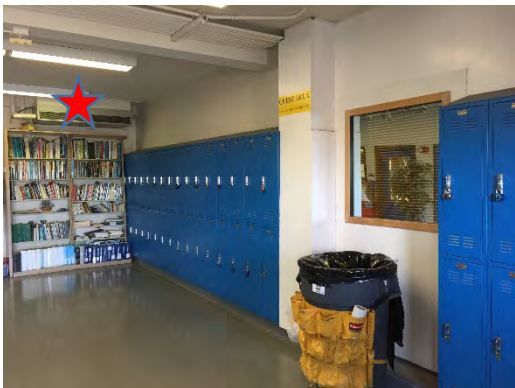
Student lockers at entry lobby, Hangar B

★ This HVAC unit does not work. See HVAC, below.

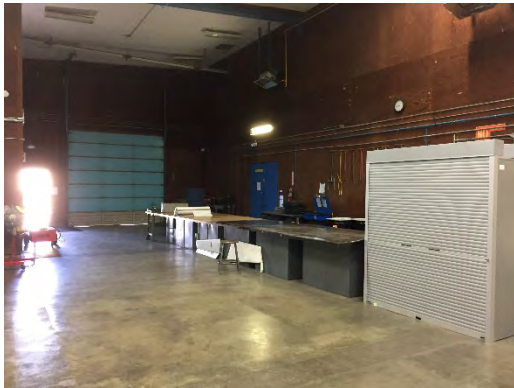
Roll-up door at Hangar B, from interior

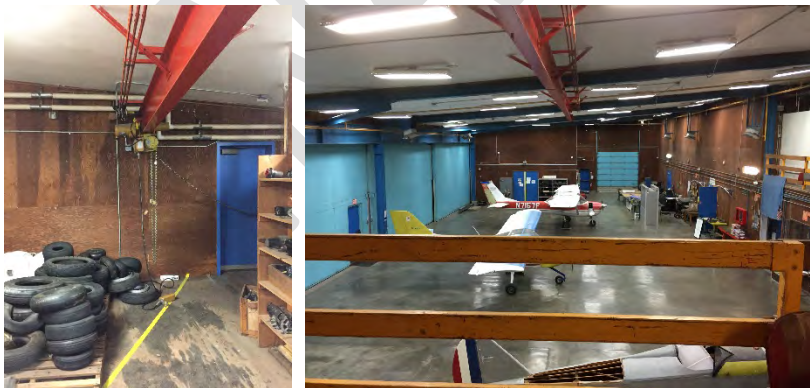
Unauthorized entry unrelated to theft is also a problem. The pull chain for the overhead hoist at Hangar B mezzanine is hooked to the mezzanine level exit door to prevent entry after unauthorized people were found sleeping in the facility last winter.

Overhead hoist at mezzanine and overview of hoist at airframe area

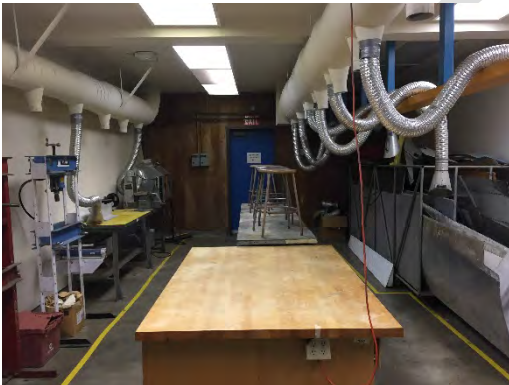
- **Composites Shop:** the AMT curriculum involves a lot of fiberglass work. The existing suction system was fabricated in-house. This space needs at least 15 snorkels, total. Ideally, the filtration system would be a built-in air filtration system, such as the one used by the AMT program at Solano CCD. Filtration system for this area is on the AEDA project equipment list but might need to be reclassified as building HVAC. The Composites Shop is in Hangar B.

Suction Heads (Snorkels) in Composites Lab

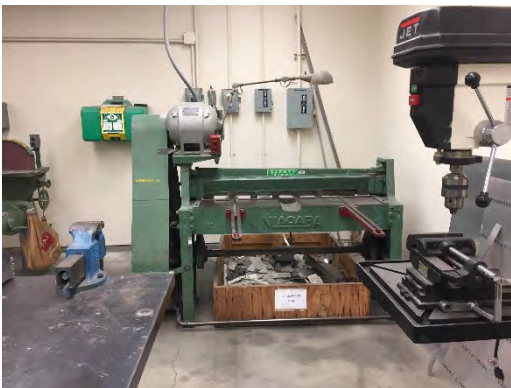
Sheet metal cutter, older, functional

Note: maintenance staff would like to have the older sheet metal cutter if it is discarded by the instructional program.

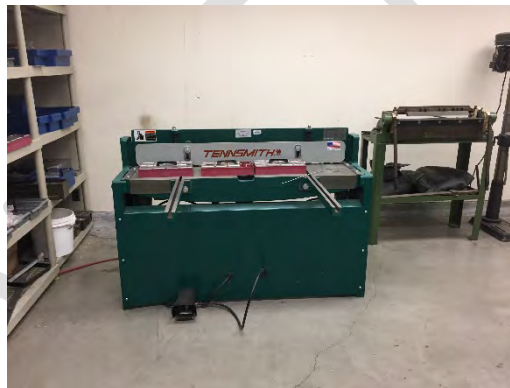
Sheet metal cutter, newer, non-functional

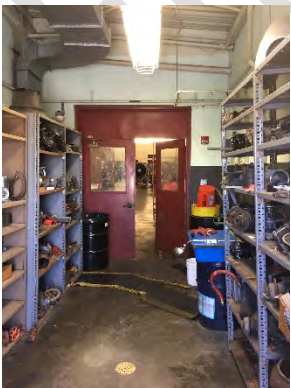
Corrosion room

- **Corrosion Room:** per the FAA, must be a separate room. This area currently includes solvent tank and sand blasting equipment. Needs air quality improvement (filtration?). The corrosion room was created in Hangar A in 2018.

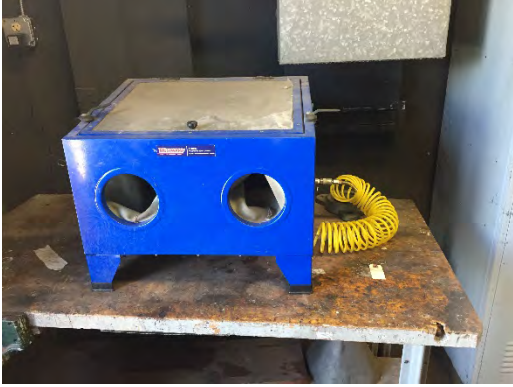
Sandblasting equipment at corrosion room

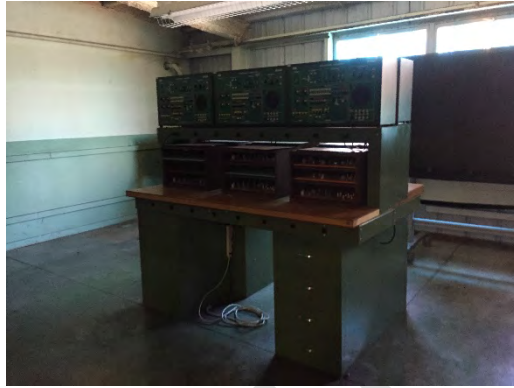
Structural reinforcement at informal partition between general classroom and Electrical Shop

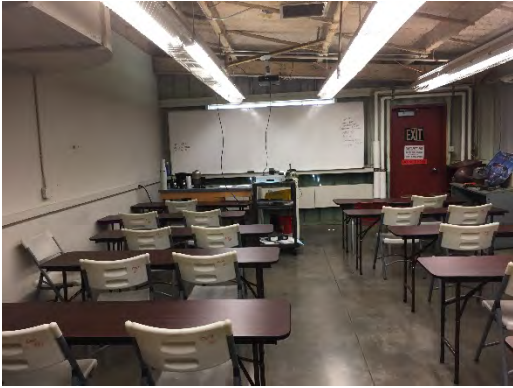
General Classroom, Hangar A*

*This room was previously a shop, and is not well designed for general classroom use.

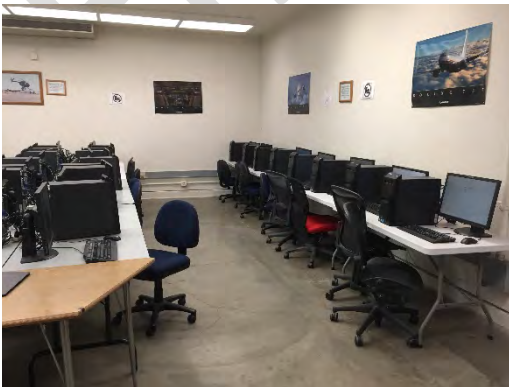
Computer Lab

The sump pump control panel is located in this Computer Lab. It is old and noisy, disruptive for instruction and testing, even when the pump failure alarm is not triggered. The pump failure alarm is a “loud foghorn.”

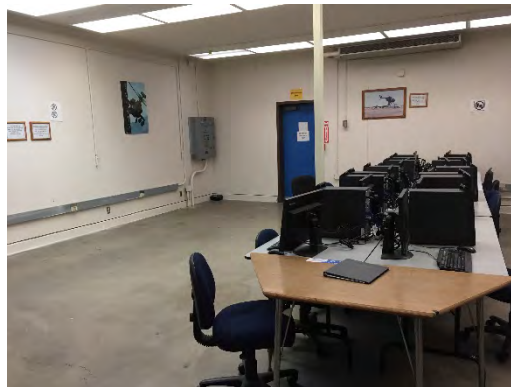
More space than needed for this function

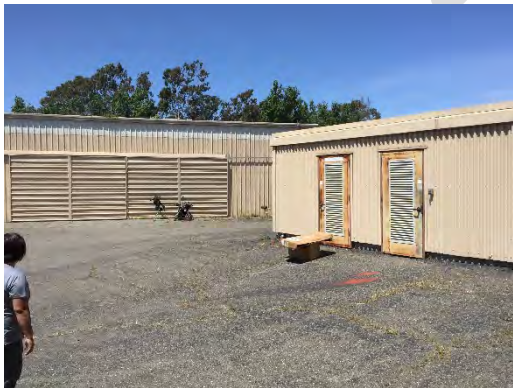
- **HazMat:** There is hazmat storage in a shed outside (one compartment for unopened containers, one for opened) plus jet fuel storage in adjacent shed. There are also flammable storage cabinets in the Hangars. The hazmat storage strategy should be reviewed.

Hazmat storage shed in yard

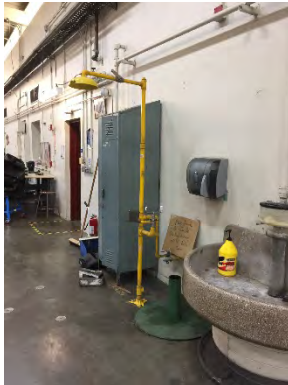
There is a sink and eyewash station in the Hangar B entry and in the Hangar A high bay space. There is an eyewash at the corrosion room in Hangar A. Sink and eyewash station location and type should be reviewed.

Sink + eyewash, Hangar A

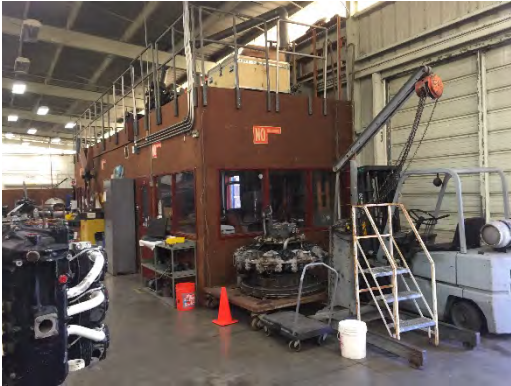
There are two faculty offices in Hangar A, both located in an area partitioned off from the high bay space, between the engine and propeller areas. The partitioned area has an office on either side of a utility/storage room. Water intrudes into both of these offices.

Faculty Offices, Hangar A

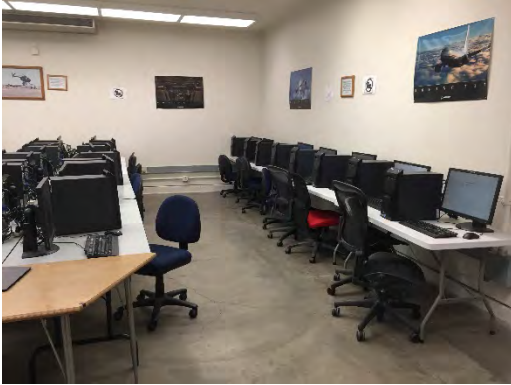
21 student stations existing but need a minimum of 25, ideally 30, plus instructor/supervisor station.

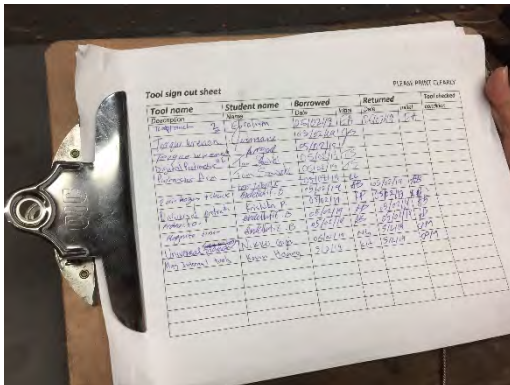
Tool checkout sheet

FAA requires accurate tracking of student time in/out and inventory control. The program is currently using a punch card system and paper notes.

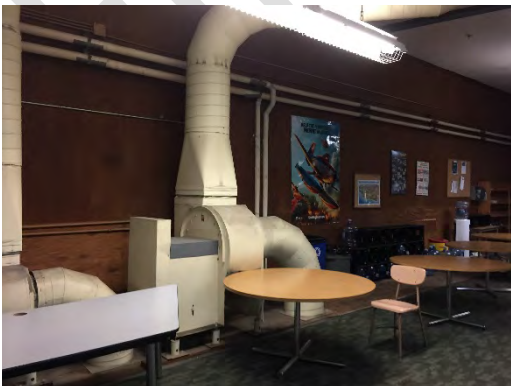
Existing fan (and filter?) on Hangar B mezzanine, over Composites Lab.

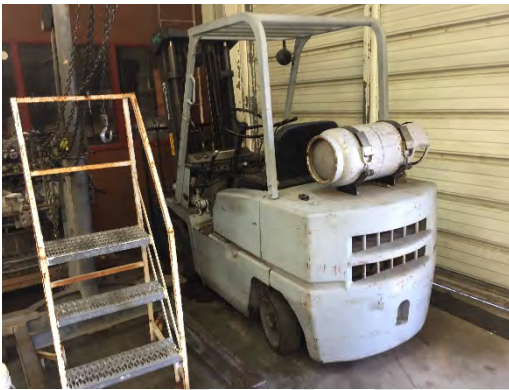
Existing forklift was obtained by trading scrap metal. Repaired / re-built in-house. Inadequate for tasks.

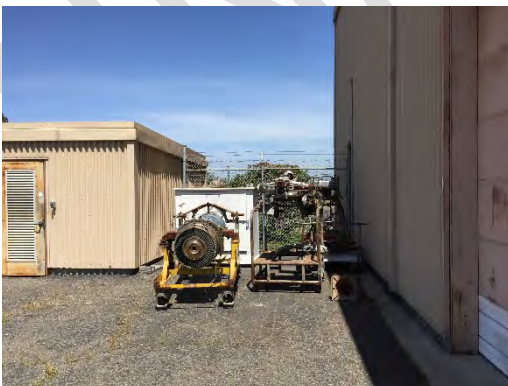
Engine test stands, large

Many existing ones were fabricated in-house, but it would better to have ones that are commercially manufactured. Need 25 total, in a variety of sizes. Per EC, currently have 12 small ones, 3 large, 1 extra large. A large one would cost \$40-50k to purchase. Of the existing ones, 14 are in good condition. Engine test stands are generally located in the Engine Area, Hangar A. Engine test stands are not the same as engine tie-downs, which are also used for testing engines (see Site).

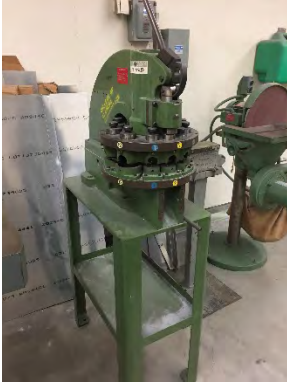
Existing circle cutter

Making an access hole cover is part of the curriculum. There is an existing machine but the hole diameter is not adjustable so the program is currently cutting circles by hand. The circle cutter machine is located in the Metal Shop.

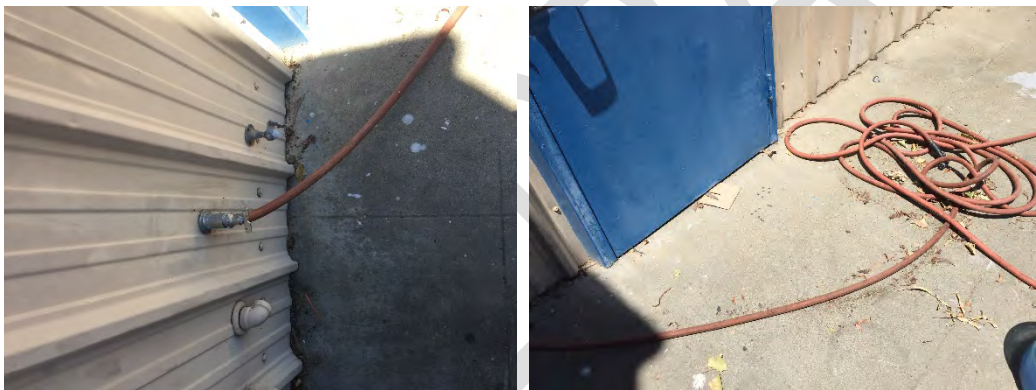
The air compressor is very old and uses too much power. Its valves and pipes are leaking. Compressor room is at the Hangar B mezzanine but is accessed from exterior.

Compressed air spigot at exterior, near Valve Grinding Room

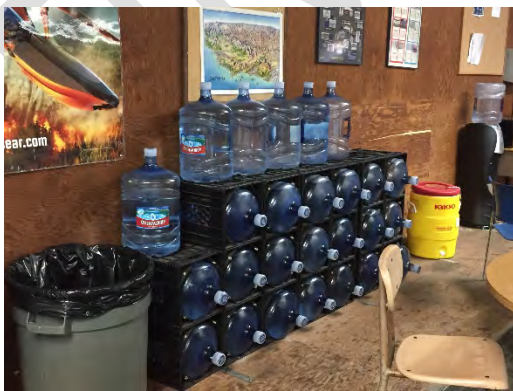
The sewer in Hangar B frequently backs up, at least twice per year. Maintenance staff confirm that plumbing back-ups impacting restrooms are among the top five most common/pressing work order requests for this facility. The tap water is occasionally unsafe to drink (2-3x/year) when the building water is shut down due to toilet malfunction (the broken pipe below is not fixable because it is ceramic). Drinking water is stored in large jugs outside the front door to Hangar B and/or on the Hangar B Mezzanine.

Drinking water storage at Mezzanine

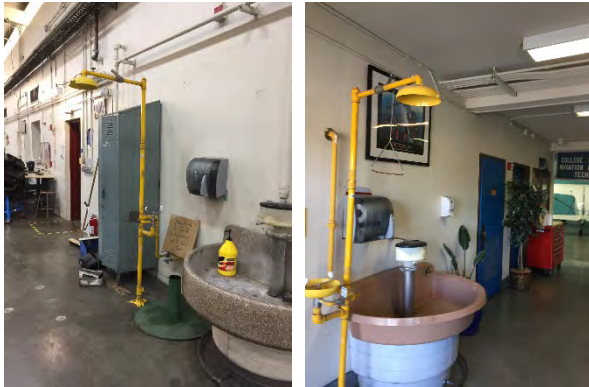
There is an emergency shower/eyewash and hand sink at the Hangar B entry lobby, the Hangar A high bay space, and the Corrosion Room. Emergency showers and eyewashes are required by the FAA and by OSH. Existing emergency showers and eyewashes are not connected to drainage. Emergency (?) shower needed for women's restroom.

Sinks, emergency shower and eyewash stations at Hangar A high bay space and Hangar B entry lobby.
