**BOTKINS LANE BRIDGE  
ABUTMENT REPAIR \***

SCOUR REMEDIATION  
EXHIBITS  
MASONRY ABUTMENT

# SMALL STRUCTURE INSPECTION REPORT

STRUCTURE NAME: Botkins Lane Bridge  
INSPECTED BY: J. Agler 12/11/2022

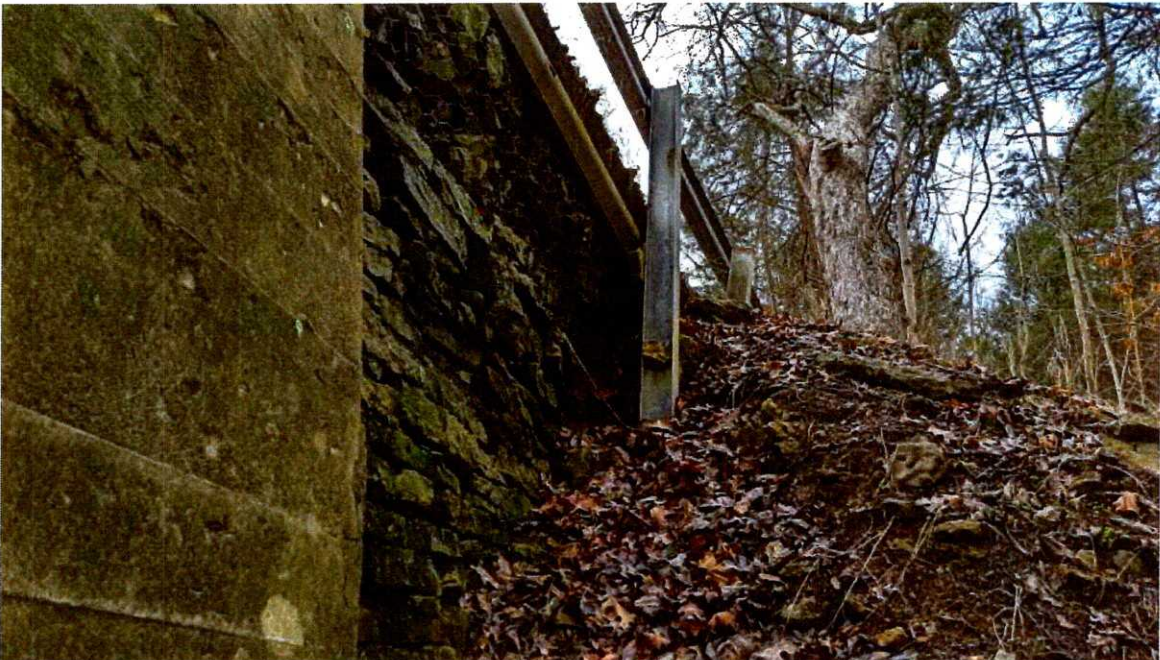
Photo 14. Masonry Wall and Embankment at Northwest Quadrant

The turned back masonry wings on the north quadrants and the SW quadrant are dry laid stone. The previously noted (2016 inspection) large hole in the NW abutment outer face has been patched with formwork left in place and appears to be bulging out from the concrete patch (no change from 11/2021 inspection). Concrete portion of abutments generally have spalling and cracks with efflorescence and honeycombing, more significantly in the west abutment. The west end of the middle bracing W-section of the abutment is corroded with section loss and has a vertical crack leading to it. The masonry portion of the abutments have vertical cracks through stones (see Photos 20-22 for cracked stones at west abutment). The noted full height cracks from the 2016 inspection have been repaired, but the vertical cracking through stones remain.
