# Yates Hall Steam Tunnel

## Pittsburg State University

# Structural Assessment Report

**Date:**  
October 20, 2022

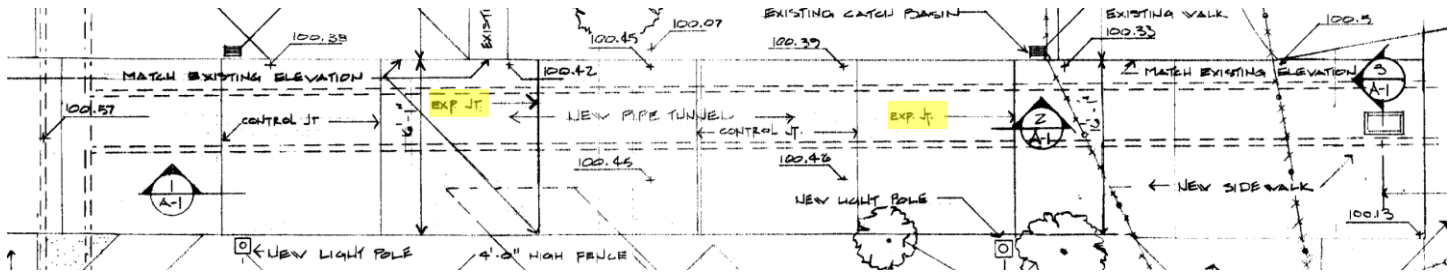
The original construction documents, dated August 11, 1980, were reviewed as part of this assessment. The drawings indicate two expansion joint locations in the tunnel lid. The drawings also note that control joints are to be at 16'-0" o.c. maximum.

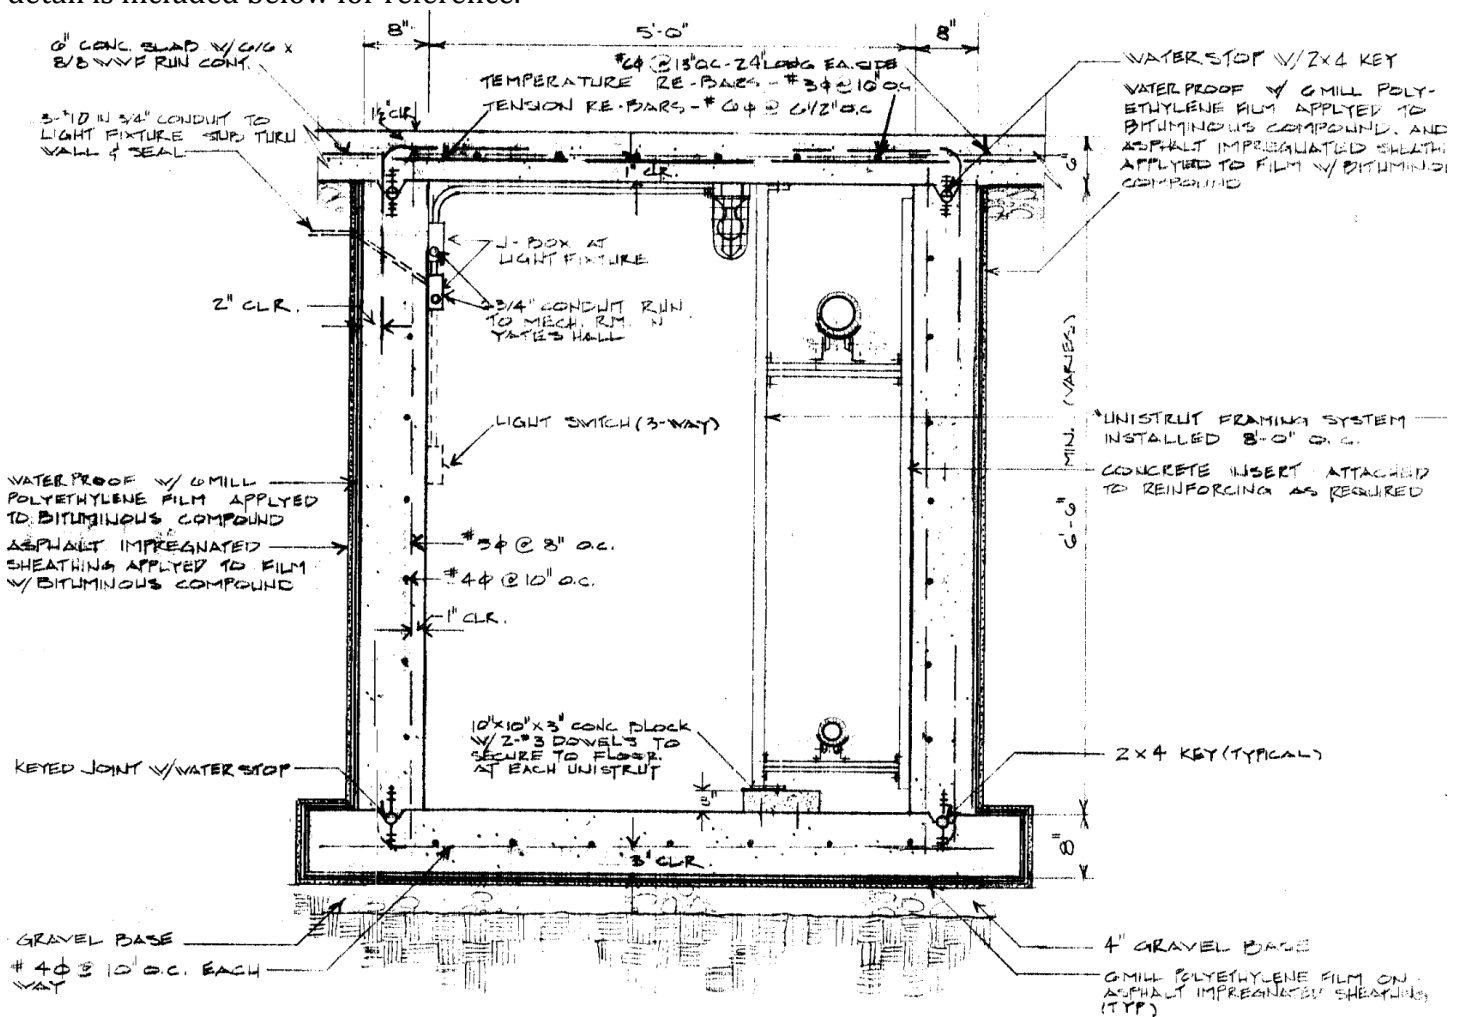
The section through the tunnel indicates there are to be waterstops and keys between the top of the tunnel walls and the concrete lid. The concrete slab is to be reinforced with welded wire fabric, #6 tension bars at 6½" on center, and #3 temperature reinforcement at 10" on center. The strength of the concrete was not called out. A concrete strength of 3,000 psi was assumed for calculation purposes. The detail is included below for reference.

The spalled concrete on top of the slab reveals that the welded wire fabric reinforcing does not have the concrete cover of 1½" to the surface of the slab as indicated in the detail. To protect the reinforcing from water infiltration and subsequent damage, the reinforcing should have been placed to maintain the indicated clear distance between it and the top of the slab. The American Concrete Institute (ACI) requires a cover of 1" minimum between top of concrete and reinforcing for exposed slabs. From the images provided in the exterior spalling section, it is shown that the depth between the top of concrete and the welded wire reinforcing is less than required.
