**EXHIBIT "A"**  
**SCOPE OF WORK**

REMOVAL OF ASBESTOS  
MATERIALS (ACBM)

# **COMPREHENSIVE ASBESTOS SURVEY**

**COMMERCIAL BUILDING  
1240 YEAMANS HALL ROAD  
HANAHAN, SC 29410**

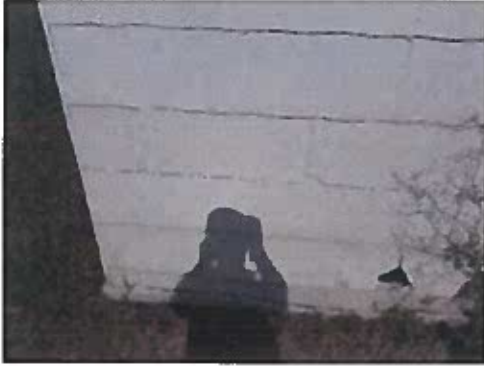
**HOMOGENEOUS AREA 01  
TRANSITE PANEL**

Asbestos fibers were identified in the Transite Siding. Approximately 1,440 square feet is present and in good condition. This material is considered Category II – Non Friable Asbestos and is located on the exterior walls.

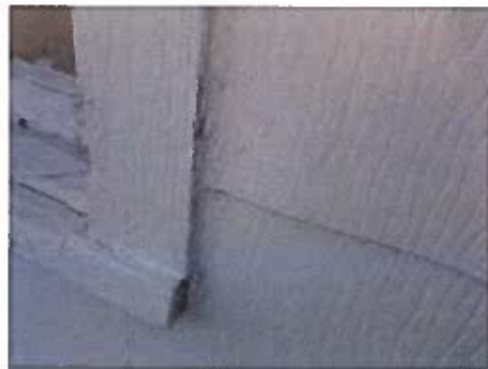
**HOMOGENEOUS AREA 04  
EXTERIOR CAULK**

Asbestos fibers were identified in the Exterior Caulk. Approximately 80 square feet is present and in good condition. This material is considered Category I – Non Friable Asbestos and is located around exterior windows and doors.

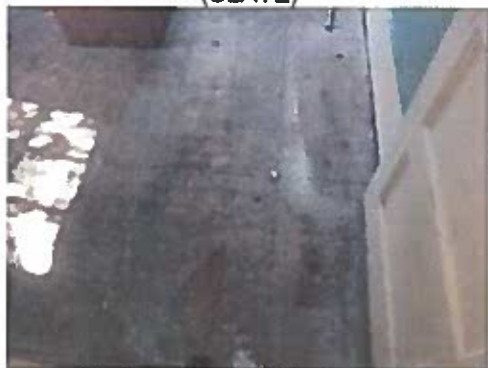
**HOMOGENEOUS AREAS 13, 14  
9" FLOOR TILE (BEIGE)  
MASTIC (BLACK)**

Asbestos fibers were identified in the 9” Floor Tile (beige) and the associated Floor Tile Mastic (black). Approximately 236 square feet of each is present and is significantly damaged condition. These materials are considered RACM – Friable Asbestos and are located in Bedroom B (layer 2) and Bedroom A (layer 1). **Note: Floor Tiles may be located under cabinets, appliance and non-load bearing walls.**

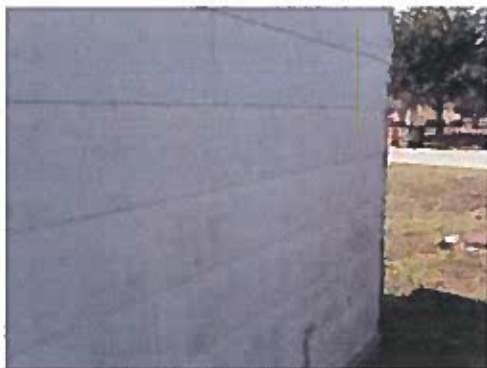
**HOMOGENEOUS AREA 01  
TRANSITE SIDING**

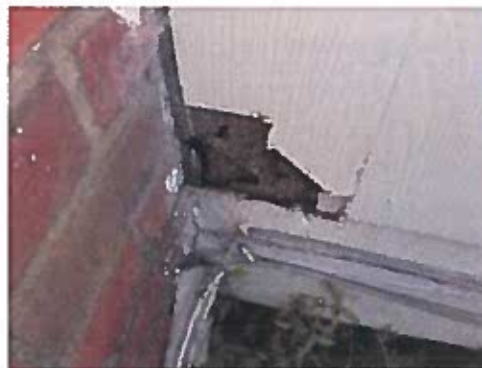
**HOMOGENEOUS AREA 02  
SIDING FELT**

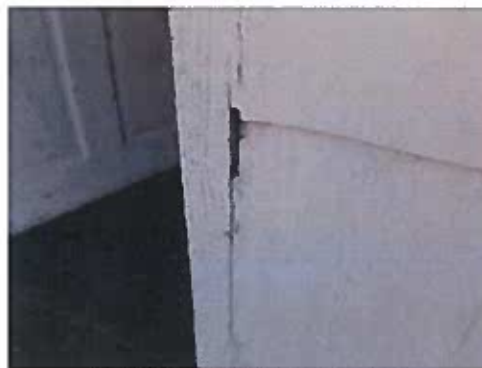
**HOMOGENEOUS AREA 04  
EXTERIOR CAULK**

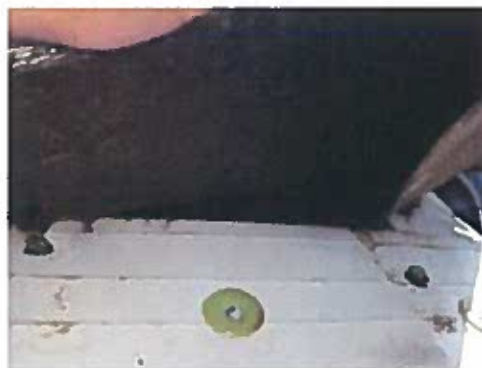
**HOMOGENEOUS AREA 06  
ROOF FELT**

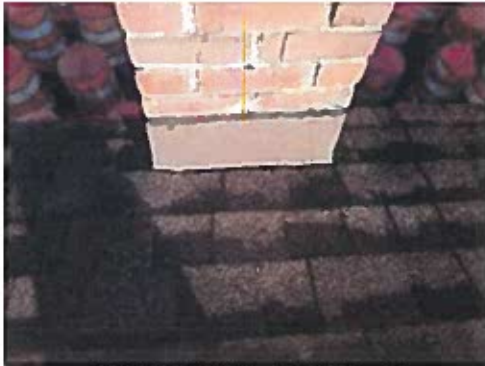
**HOMOGENEOUS AREA 07  
BRICK MASTIC (BLACK)**

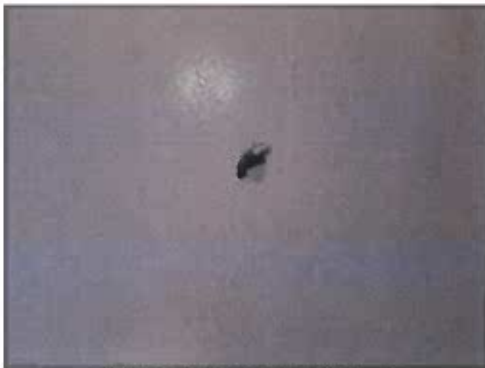
**HOMOGENEOUS AREA 09  
DRYWALL**

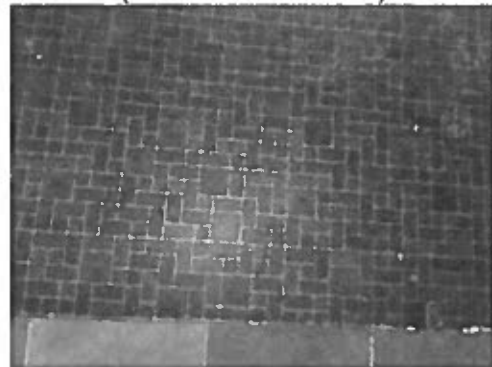
**HOMOGENEOUS AREAS 17, 18  
VINYL SHEET FLOORING (BLUE BRICK)  
MASTIC (TAN)**

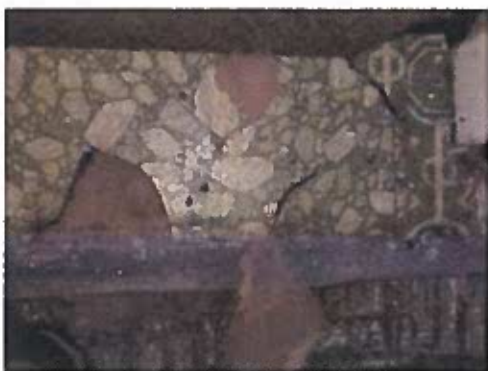
**HOMOGENEOUS AREA 23  
VINYL SHEET FLOORING (GREEN ROCKS)**
