Node Inspection - 8/9/2023 - 1828

Date 8/9/2023	Time 12:03	Manhole Number 1828	Access Type Manhole	City Georgetown	Street Front Street and
Surveyed By Matthew Headrick	Certificate Number U-0419-07030528	PO Number	Work Order	Pre-Cleaning No Pre-Cleaning	Sheet Number

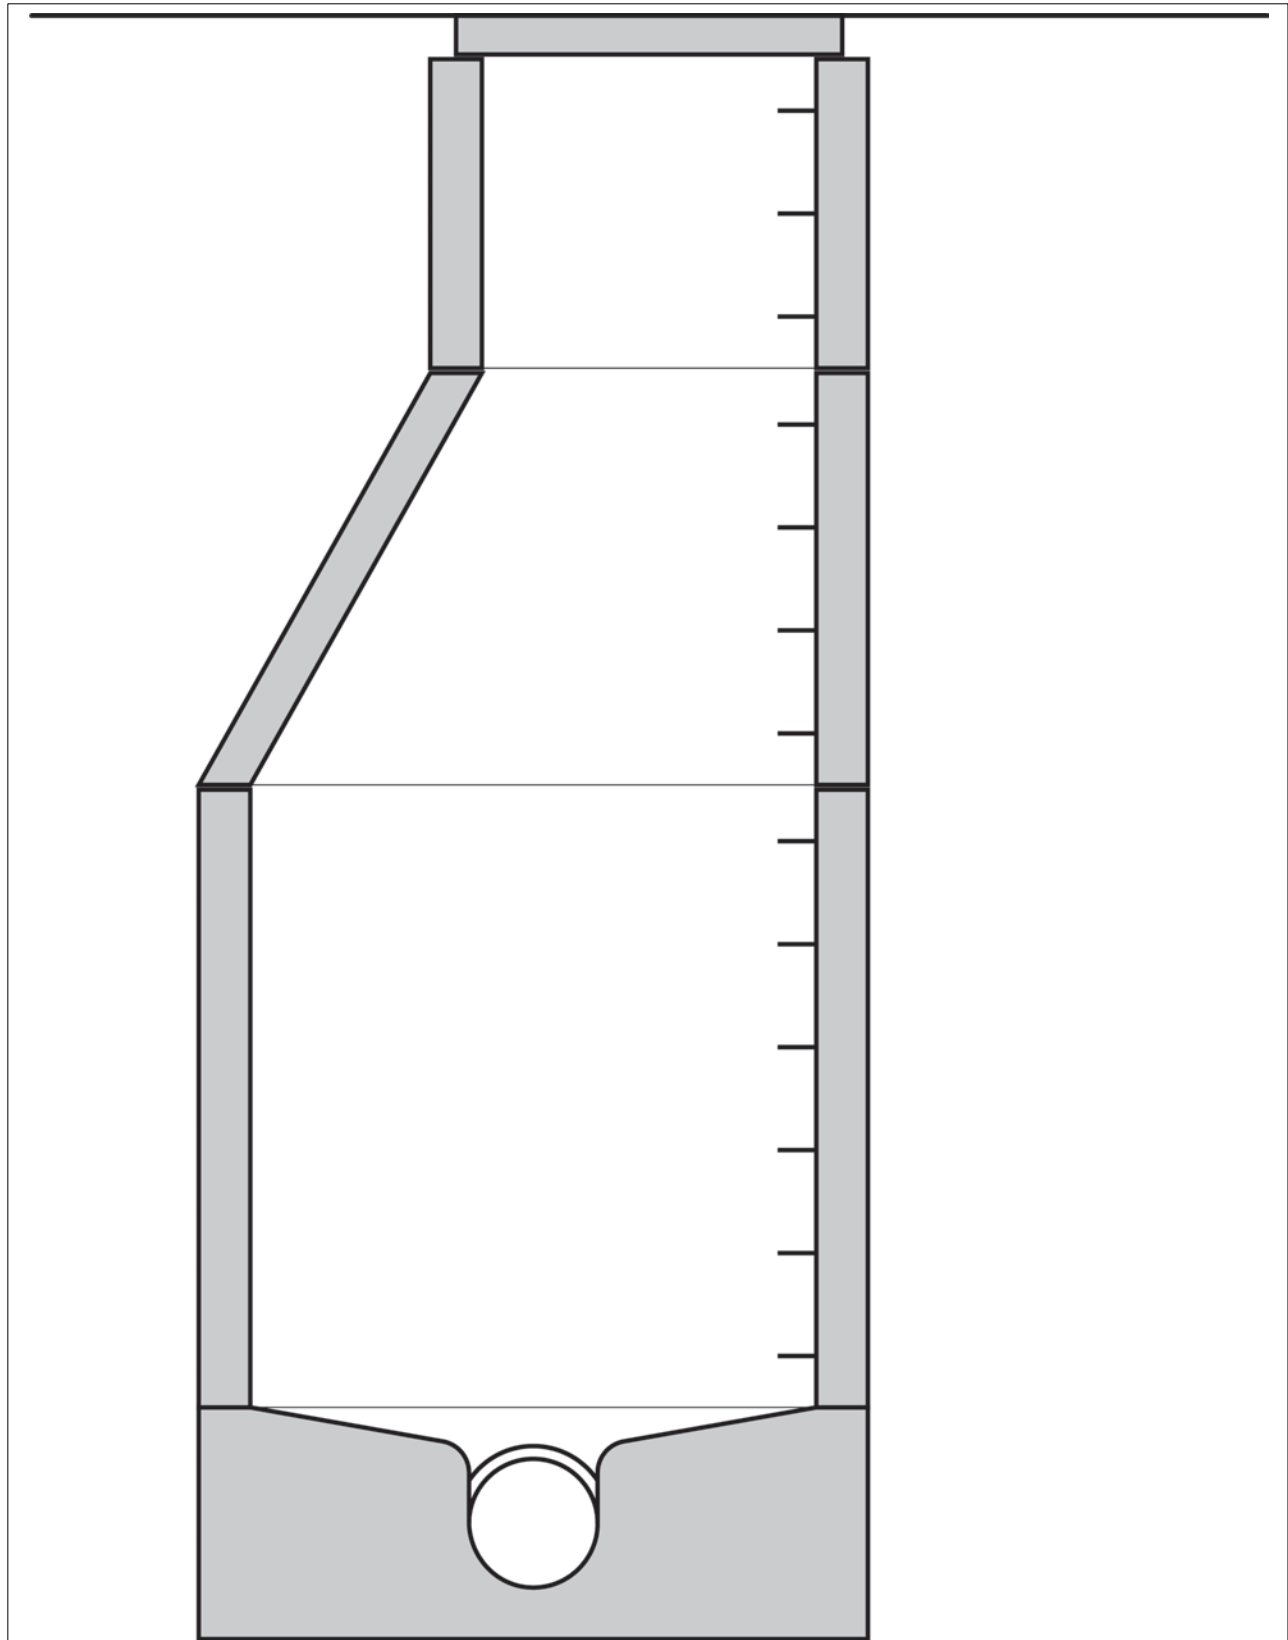
Node 2D Sketch - 8/9/2023 - 1828

Nr.	Distance	MACP Code	Observation	Remark
3	6.9'	BSV	Broken Soil Visible, 18inch defective, 18inch intrusion at 1 o'clock, within 8 inch, Start	soil visible
4	8.2'	DB	Displaced Brick from 8 o'clock to 11 o'clock	displaced bricks
5	9.5'	MML	Missing Mortar Large from 12 o'clock to 12 o'clock	Fully exposed bricks with gaps

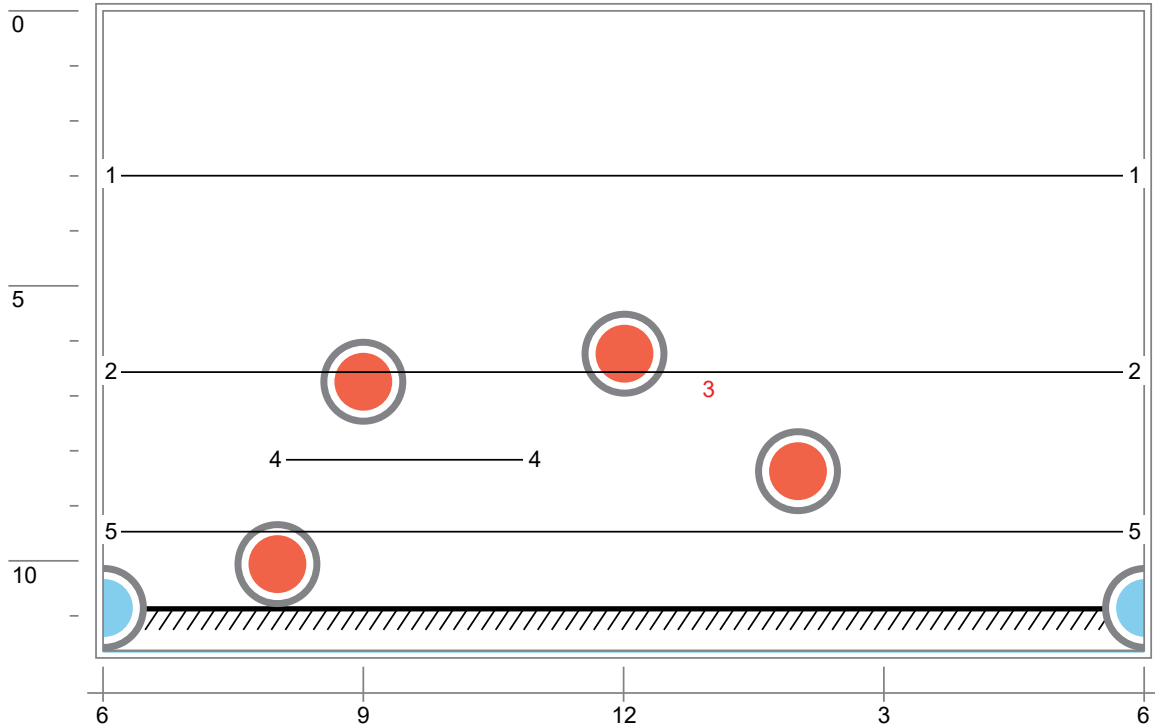
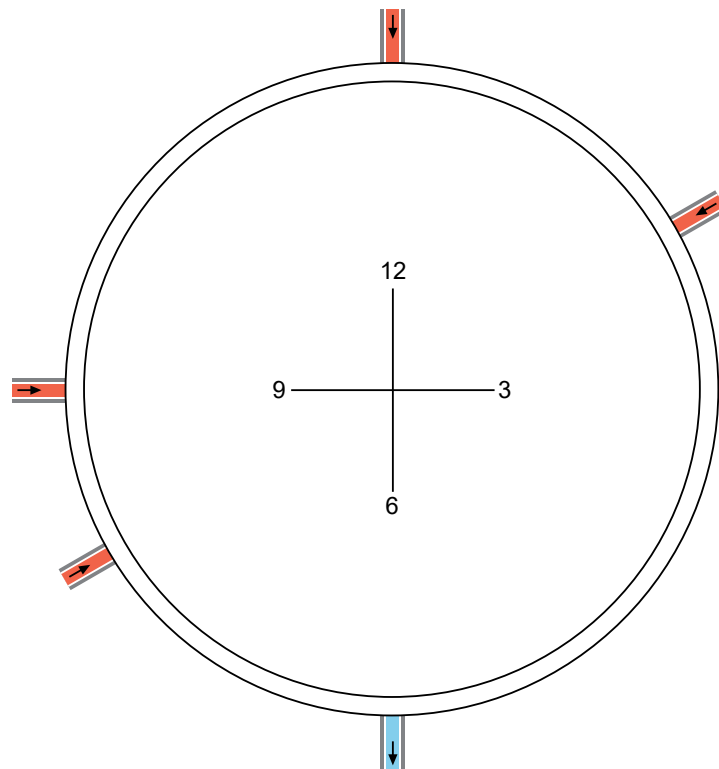
Node Drawings - 8/9/2023 - 1828

Nr.	Distance	MACP Code	Observation	Remark				
1	3.0'	MML	Missing Mortar Large from 12 o'clock to 12 o'clock	Fully exposed bricks with gaps				
2	6.6'	MML	Missing Mortar Large from 12 o'clock to 12 o'clock	Fully exposed bricks with gaps				
QSR	QMR	QOR	SPR	MPR	OPR	SPRI	MPRI	OPRI
4332	3114	4333	21.0	7.0	28.0	2.6	1.4	2.2
