MEMORANDUM

SUBJECT: City of Aztec Reservoir No. 1 Rehabilitation Project

I. Part I: Project Overview

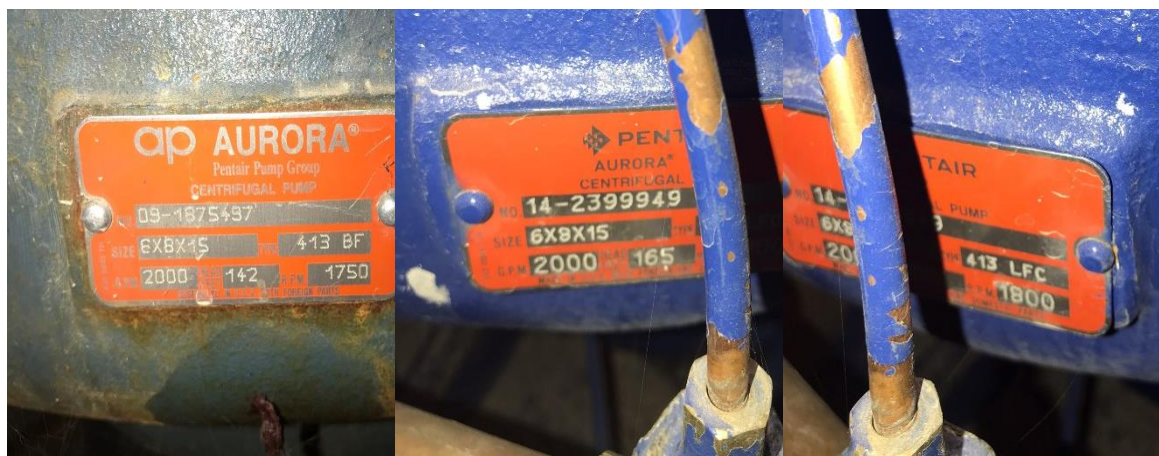
Figure 25 – Pump Nameplates

Under current operations, water is pumped to Reservoir 2 from the Animas Ditch or the Animas River and is then pumped from Reservoir 2 to Reservoir 3 via the Navajo Pump Station. The pump station has two pumps rated at 2,000 GPM in a 1+1 configuration. A picture of the nameplates is shown below.

Pressure and flow readings taken during the site visit on February 2, 2019 downstream of the pump were 1,800 GPM at a pressure of 88 psi with one pump operational. This operating point is slightly lower than the 2,000 gpm that the pump is rated for, see Figure 28 for the existing pump curve. Additional readings were taken on a subsequent site visit on July 30, 2019, with similar results. The test points are shown on System Curve Figure 30. Figure 26 contains a simplified schematic of the current operations and the proposed operations with the rehabilitation of Reservoir 1. From Reservoir 3, the water gravity feeds to the WTP prior to distribution. The hydraulic profile of the current system is displayed in Figure 27.

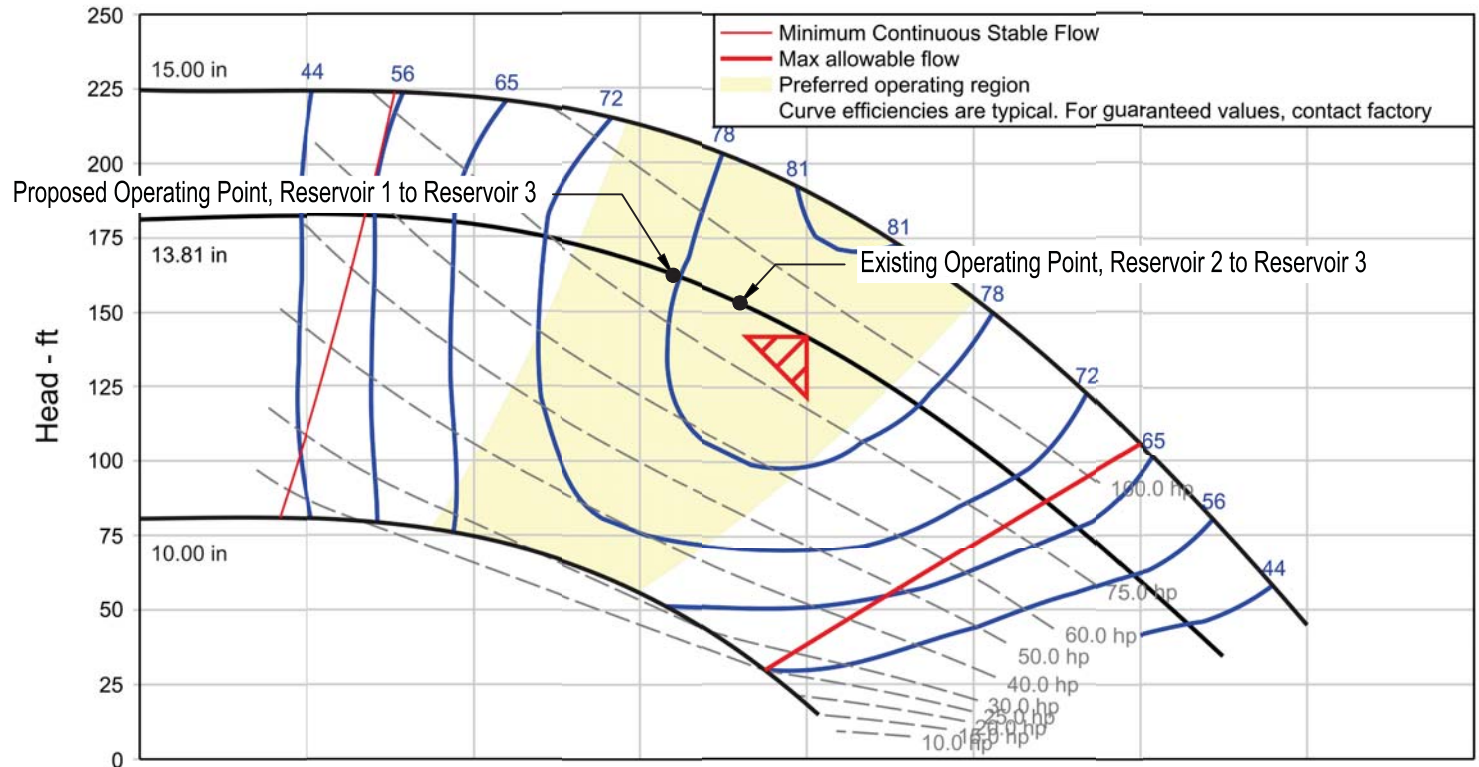
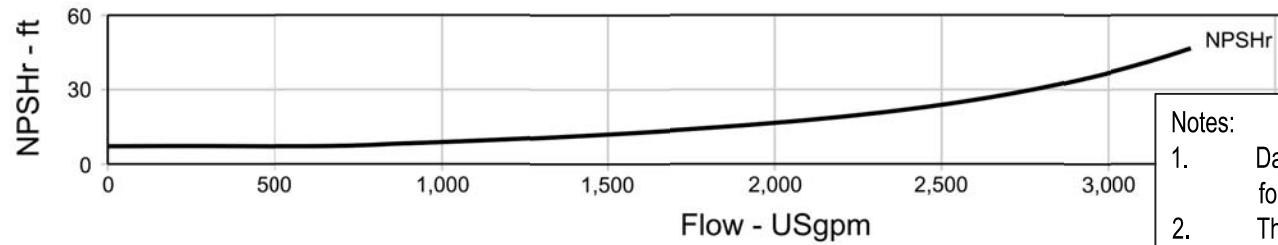
Figure 28
 Pump Curve
 Existing Pumps

The existing pump in use is a Pentair centrifugal vertical split case pump rated for 2,000 gpm, 142 feet of head, and 1,750 rpm. Using estimated WSEs of 5,825 ft and 5,760 ft, respectively for Reservoir 3 and Reservoir 2, the Static Head was determined to be 75 ft, making the Total Dynamic Head (TDH) approximately 154 ft. The observed performance point of 1,800 gpm at 88 psi from the February 2019 site visit was used to calibrate the system curve by refining the friction coefficient for the pipe. The friction value (C factor) was determined to be 105 and was taken to be the representative friction value for the system and is used in all the system curves in this report. The reservoir water surface elevations for the suction side reservoirs are estimated at half full in order to account for more conservative low water operating conditions.

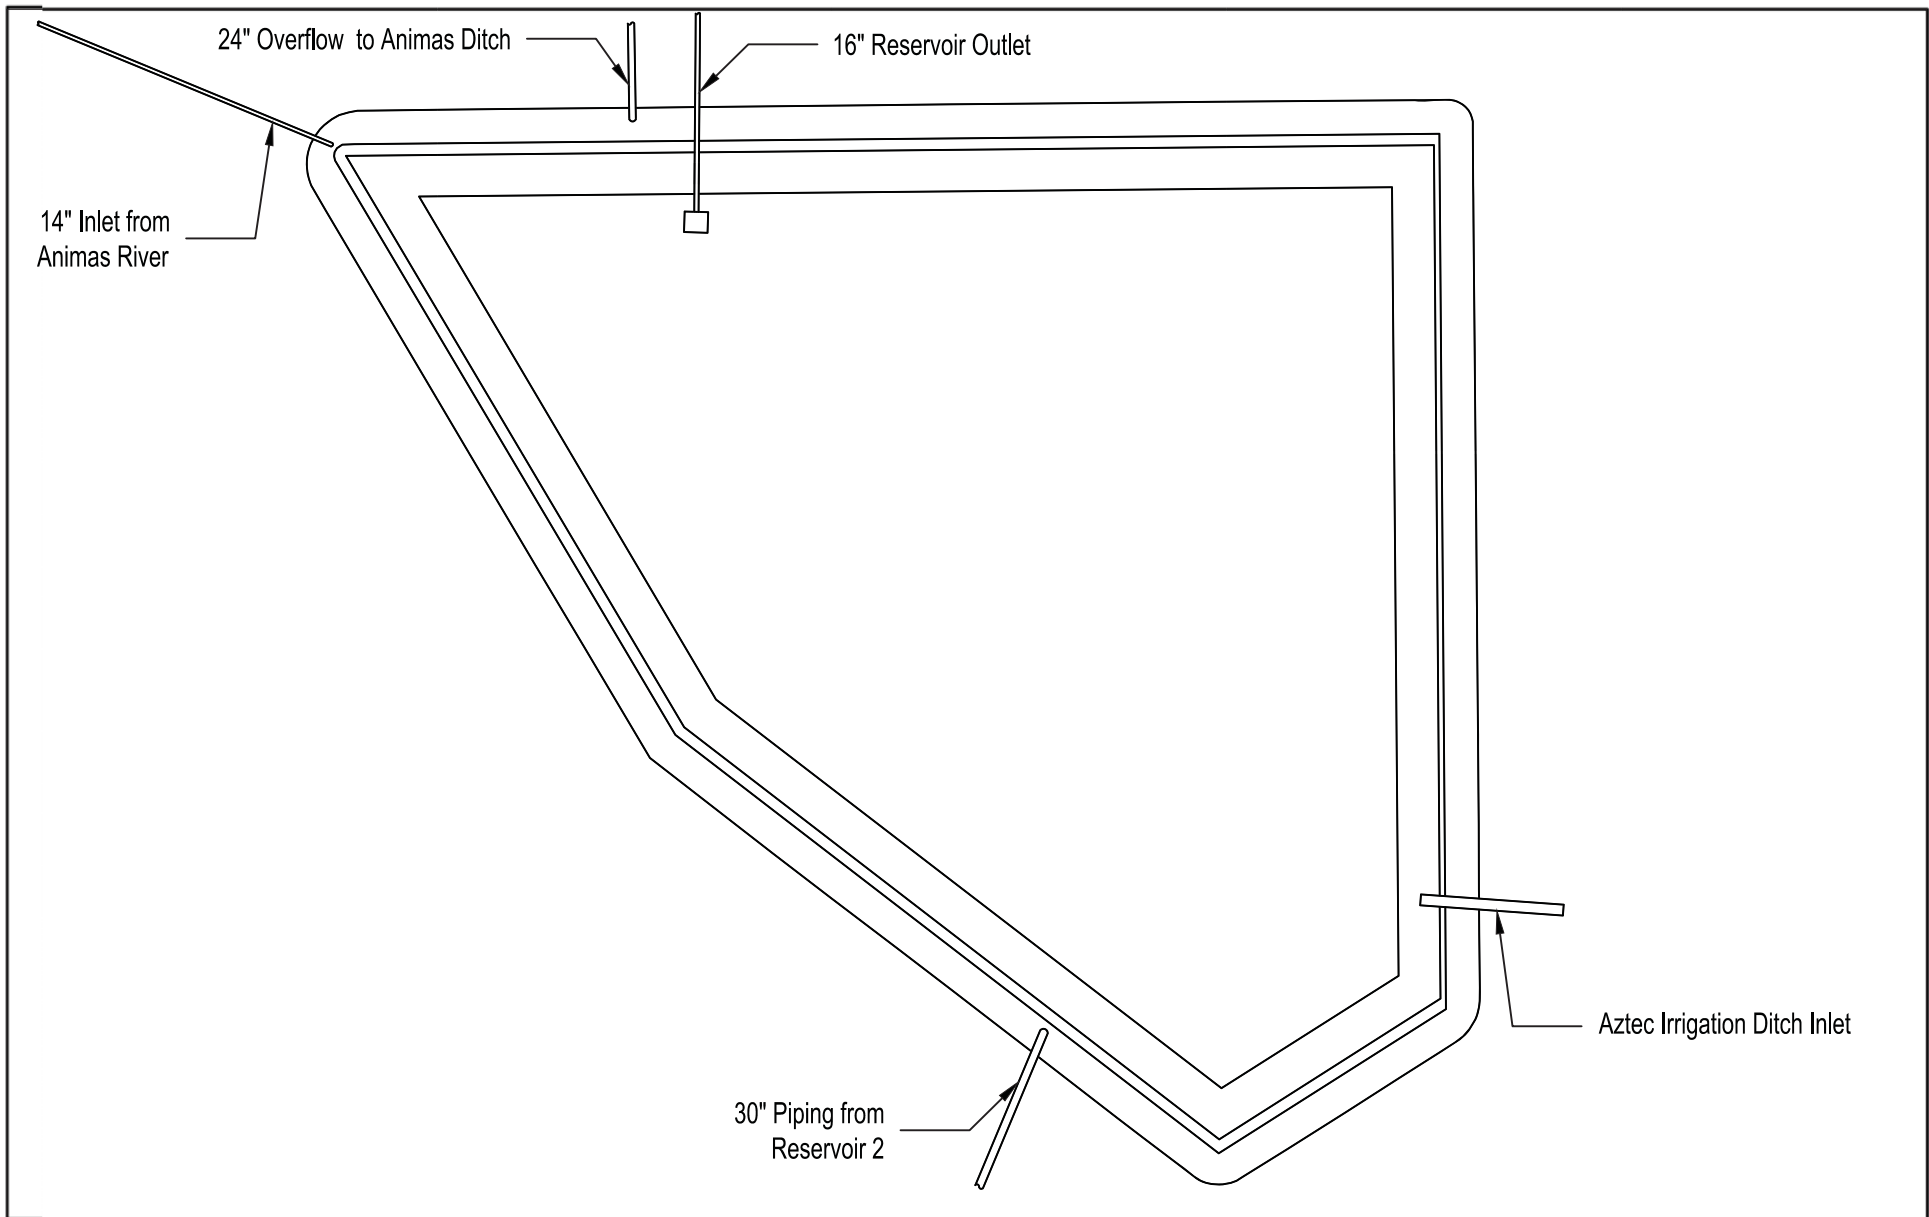
Figure 33
Reservoir 1
Inlet and Outlet Locations

30-inch Piping from Reservoir 2 - The piping from Reservoir 2 to Reservoir 1 is in Zone 4 of the reservoir which contains a significant amount of damage to the structural integrity of the concrete due to this outfall. The approximately 350 LF of piping should be replaced as part of the project.

24-inch Overflow to Animas Ditch - The overflow line to the Aztec ditch is silted in and needs replacement; this includes approximately 450 LF of 24-inch pipe.

16-inch Drainage Line and Valve - The tower is in poor condition and needs replacement, the piping and valve to the pump station should also be replaced as part of this effort as the piping appears corroded and the valve is leaking.

Outlet Structure Tower- During the site evaluation, it was noted that there are underlying problems beneath the most recent layer of concrete. There is concern that the exposure to water and freeze-thaw over time has compromised the structural integrity of the tower. Regardless of which option is chosen, we recommend that a new outlet structure be built at the location of the existing structure. Although the steel bridge used to access the structure was found to be in decent condition and could be reused after rehab and recoating of the steel members, it is also recommended that the catwalk be replaced with the tower.

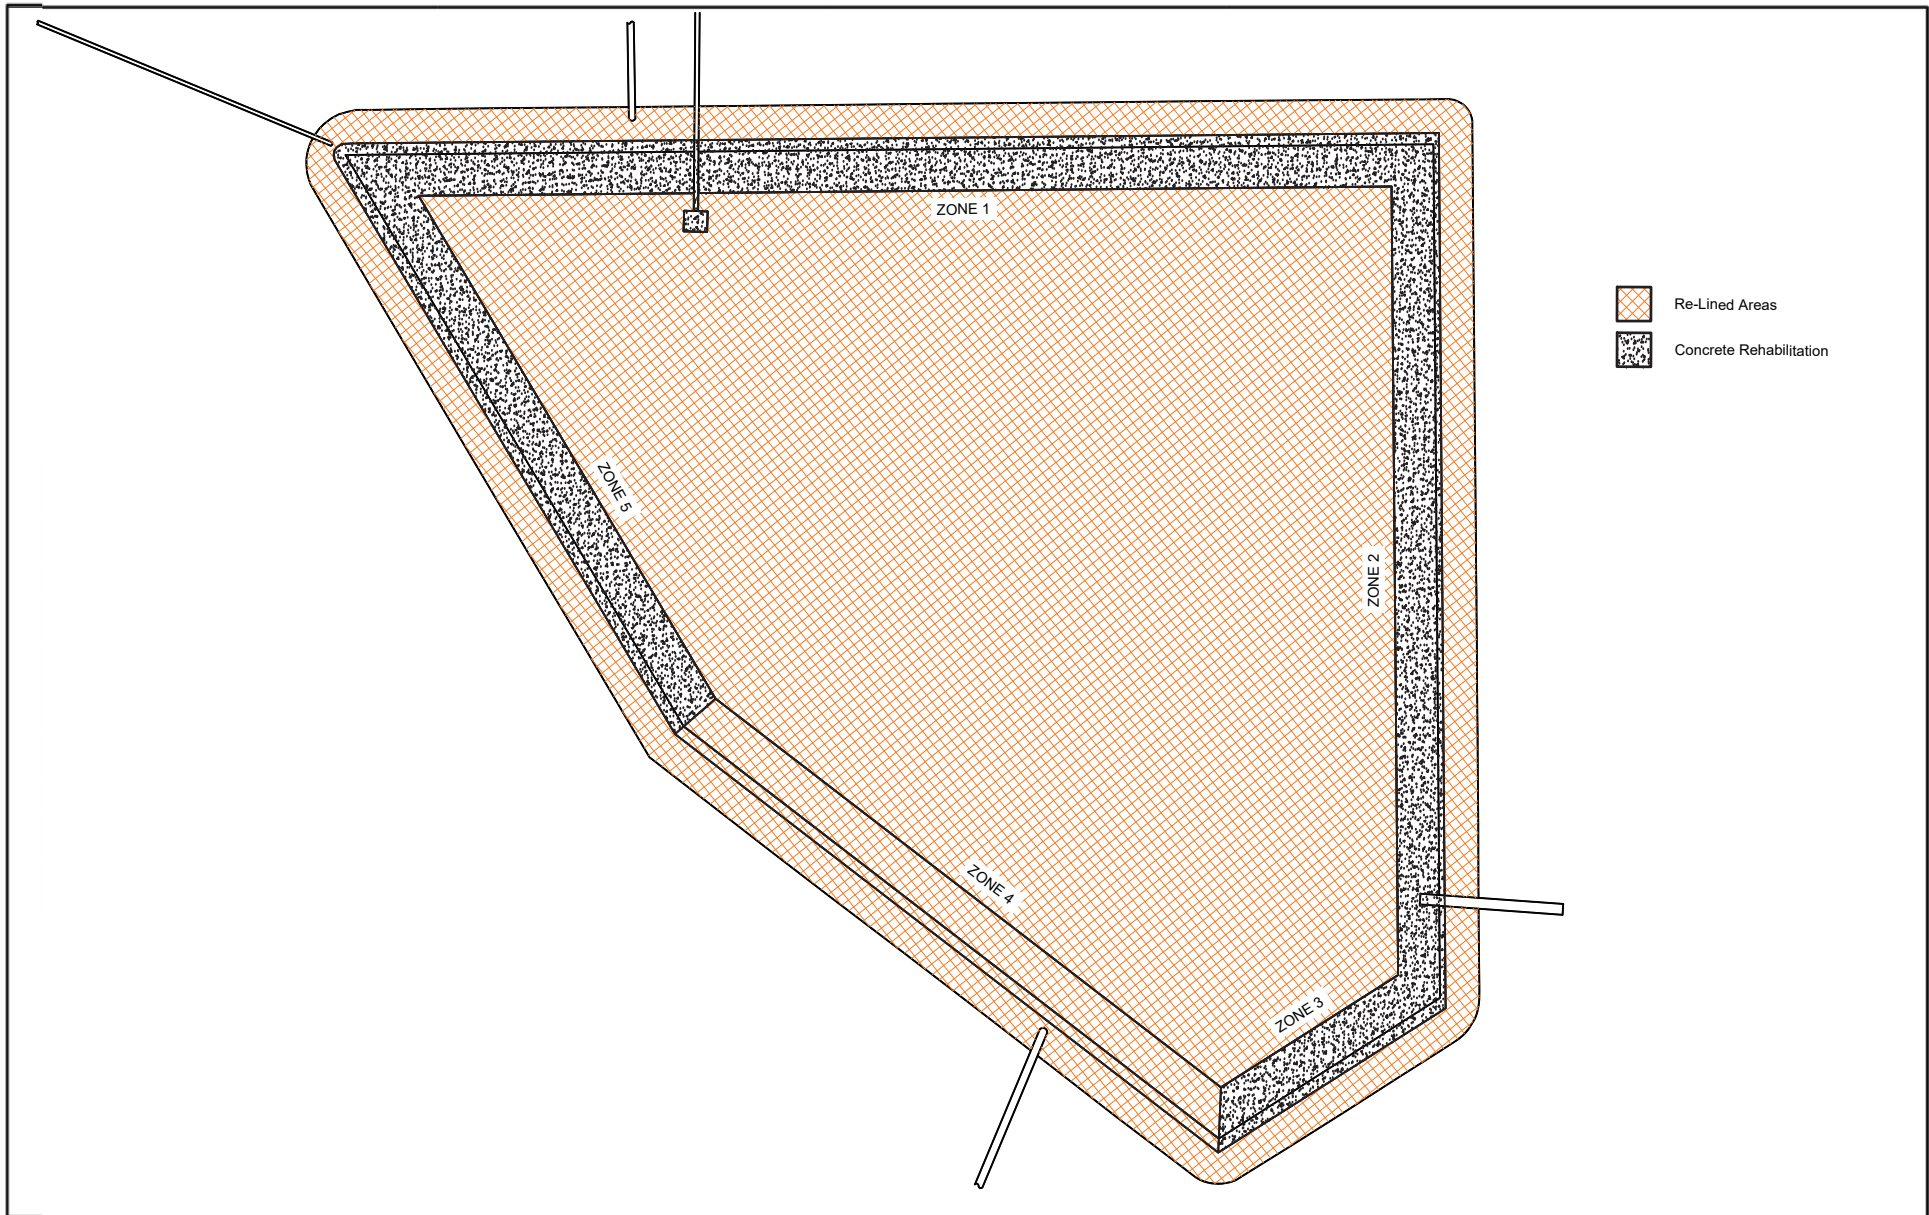
Figure 34
 Reservoir 1
 Option 2 Re-Lined Areas

Another method evaluated to restore the integrity of the reservoir, is adding an impermeable synthetic liner in addition to repairing some of the existing panels. Figure 34 displays the areas where the liner would be installed and the areas that would consist solely of concrete rehabilitation. From our site visit evaluation, it was determined that in order to maintain the integrity of the reservoir, all concrete panels in the upper half of the reservoir would need to be cleared of faulty material and replaced by a layer of impermeable liner. To achieve a successful installation of the liner in the upper half, the shotcrete panels would need to be ground down to a flattened surface in order to avoid ripping the liner. The step between the upper and lower sections of the shotcrete panels would need to be completely removed and replaced so that the liner can be properly attached to the upper portion of the reservoir. The liner would also be attached into a newly dug trench of concrete surrounding the top boundary of the reservoir. Based on calculations performed by the team, roughly 116,000 sq. ft of impermeable synthetic liner would be required and 20,382 sq. ft. of concrete would need to be removed.

In regard to the lower portion of the reservoir, panels found to have extensive cracking and/or spalling would require specific maintenance procedures including but not limited to the removal and replacement of all joints and delaminated and spalled concrete. In our evaluation, we determined that Zone 4 (including both top and bottom panels) would need to be completely removed and replaced by the impermeable liner. The team noticed extensive damage to the slopes surrounding the inlet pipe from Reservoir 2 and the placement of the liner would prevent further damage to the earthen slopes. For this option, an estimated 3,541 ft of joint material would be required for the lower portion.

This alternative will use a 60 mil HDPE liner backed by a 200 mil geonet to provide additional support and cushioning for the liner against the remaining concrete. The area around the inlet/outlet pipes and the ramp would be double lined so that the topmost liner acts as the sacrificial liner in the event of damage, maintaining the watertight integrity of the liner. Although this method of partial concrete rehab/partial liner installation will improve the reservoir integrity, it will not be completely watertight.

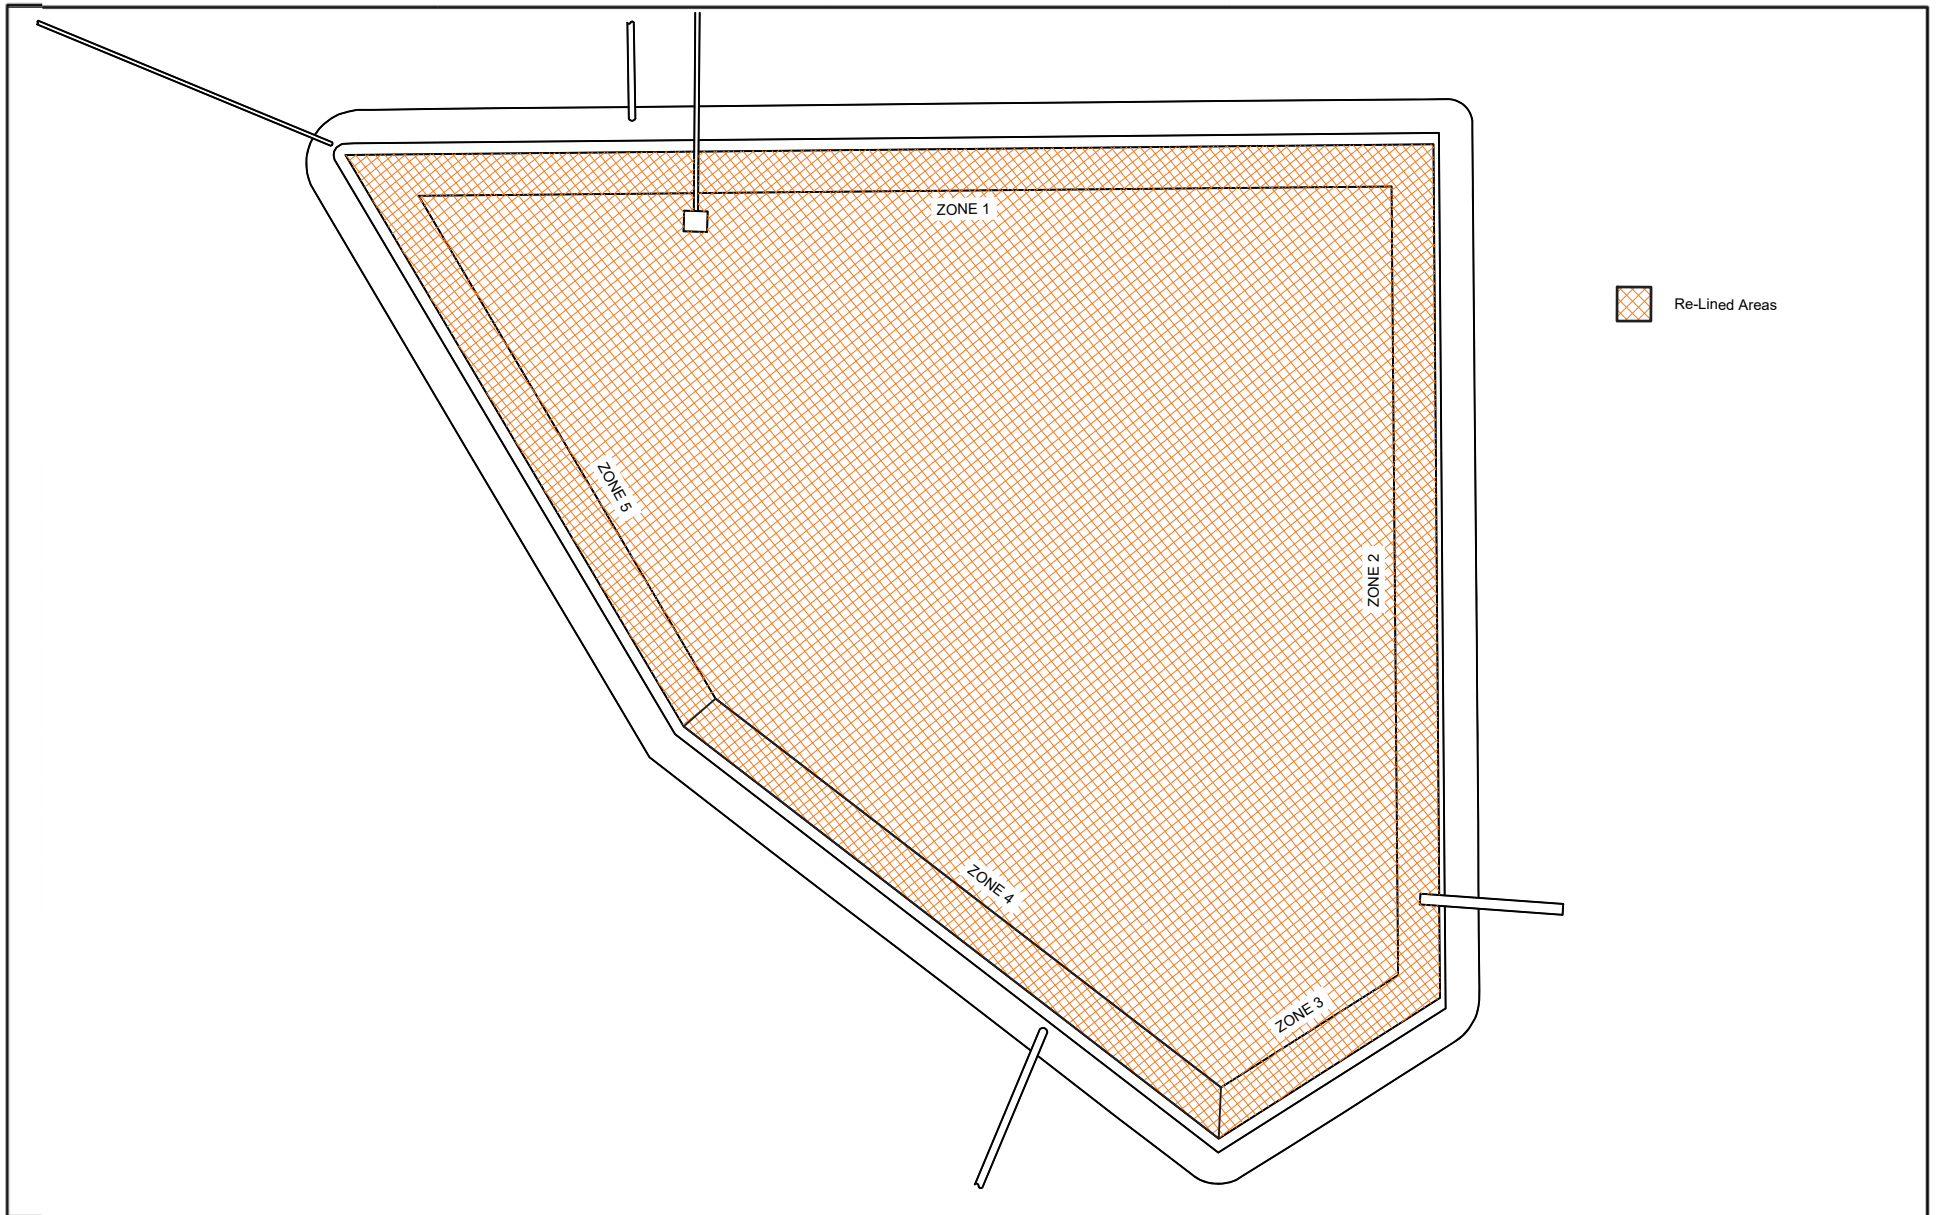
Figure 44
Reservoir 1
Option 5 Re-Lined Areas

This option involves the partial rehabilitation of Reservoir 1 as well as the construction of the new Reservoir 4. The purpose of the rehabilitation would solely be to take advantage of the gravity flow from the Aztec Irrigation Ditch. Rehabilitation of Reservoir 1 includes only the bottom half of the reservoir and results in a reduced capacity of roughly 5 MG with a new overflow elevation of 5,725 ft. This option would also require the basic rehabilitation items included in Options 1 through 3 with a few minor adjustments: the replacement of the 24-in overflow line to the Animas Irrigation Ditch would include the relocation of the overflow to a lower elevation for the reduced capacity, the 14-in Inlet from the Animas River may be abandoned, it is recommended that the outflow from Reservoir 2 be renovated in case there is a need to drain that reservoir in the future. The area for rehabilitation is displayed in Figure 44.
