**STRUCTURAL ASSESSMENT
OF
MARSHWALK AND VETERANS PIER
MURRELLS INLET, SC
EW #: 161166.003**

February 24, 2021

**GEORGETOWN COUNTY
PARKS AND RECREATION DEPARTMENT**

**The EARTHWORKS Group
11655 HIGHWAY 707
MURRELLS INLET, SC 29576
843-651-7900**

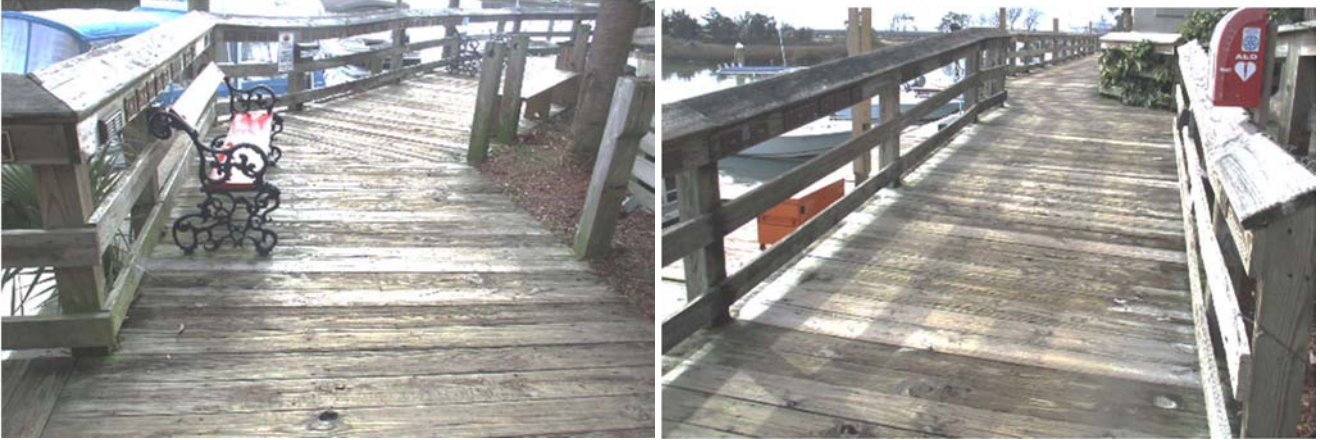
The guardrail consists of 6x6 posts, 2x6 lower guardrail, a 2x6 middle guardrail, and a combination 2x6 and 2x12 cap rail screwed together for structural integrity. The guardrail in Phase 1A will require repairs due to damaged boards, corrosion of connectors, and other age related deterioration.

Photo 2 & 3 - Phase 1A view from entry between Bovines and Wahoos and looking South at corner

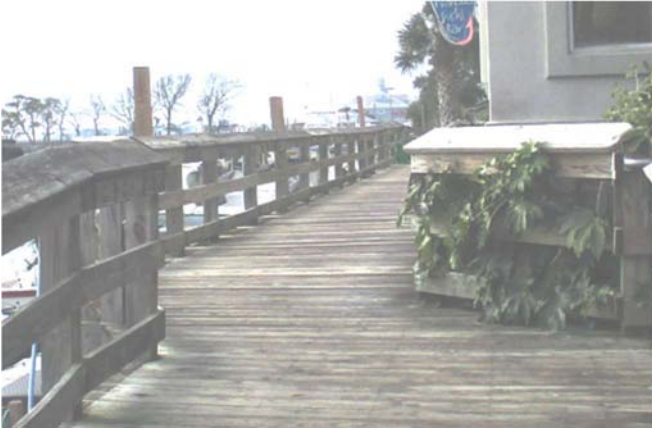
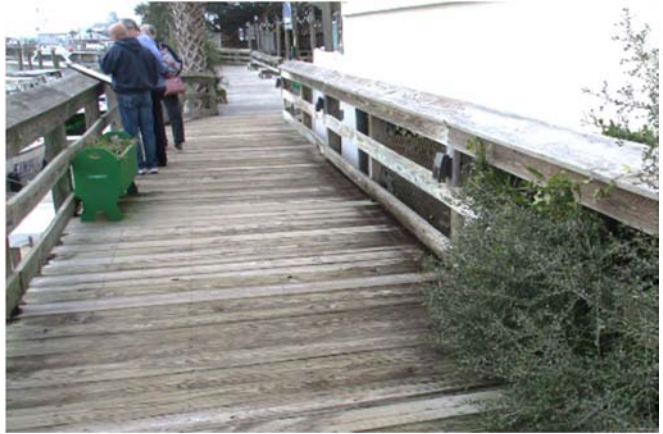
The guardrail consists of 6x6 posts, and 2x6 lower guardrail, a 2x6 middle guardrail, and a combination 2x6 and 2x12 cap rail screwed together for structural integrity. The outside guardrail post on the cantilever portion has a 6x6 knee brace back into the pile caps to transfer lateral loads. The guardrail in Phase 1B will require repairs due to damaged boards, corrosion of connectors, and other age related deterioration.

Photo 6 & 7 - Phase 1B looking South behind Wahoo's at start and end of boardwalk

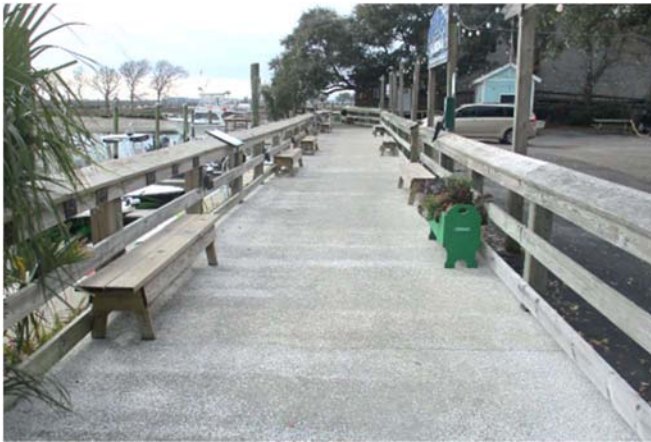
Photo 12 – Phase 1C looking north

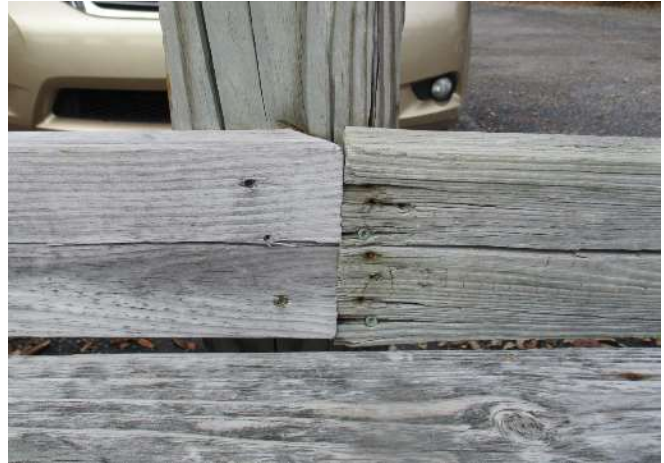
Photo 15 – Typical rail joint at post

Corrosion of Metal Fasteners – Metal fasteners in this Phase were mainly screws connecting the rails to the posts. Older connectors have been replaced in some areas with new screws due to corrosion failure. All new construction should be completed with stainless steel screws.

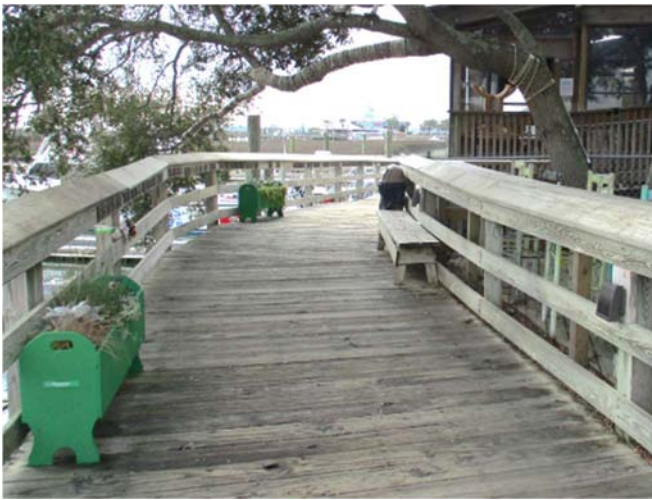
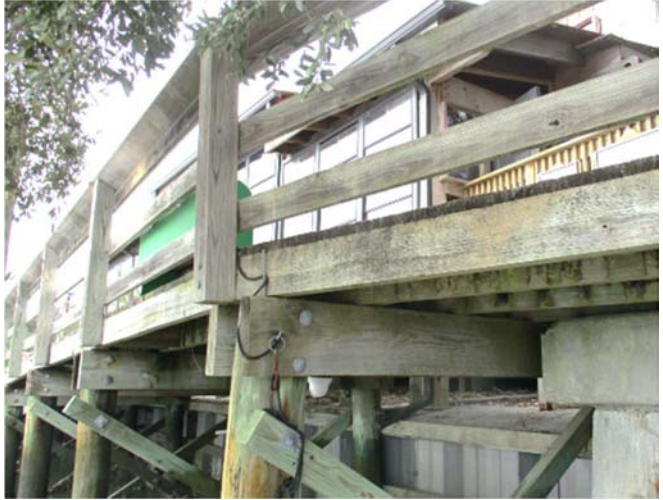
Photos 18 & 19 – Phase 1D is a transition from concrete to wood in front of Drunken Jacks

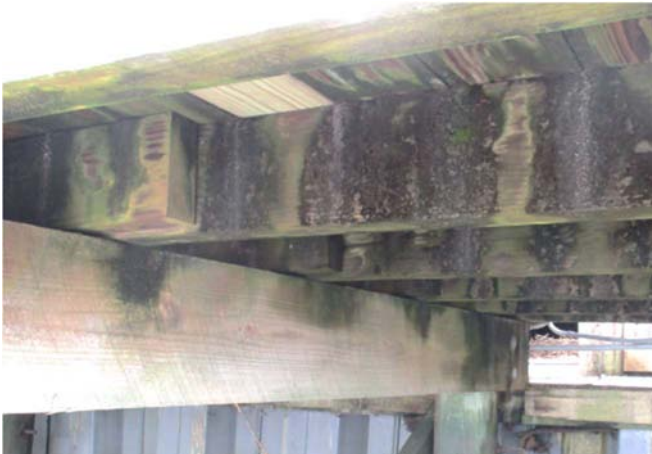
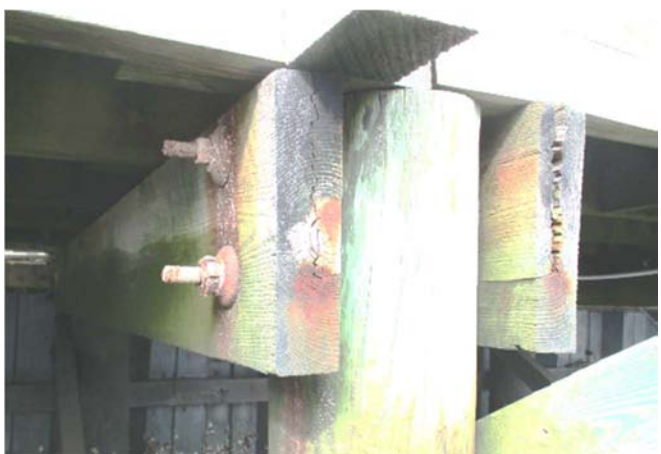
Corrosion of Metal Fasteners – Metal fasteners in this Phase were in various states of corrosion, with some fasteners completely corroded and other having light rust. The majority of the pile cap to joist connectors in this phase were in good condition and do not require replacement. Some of the galvanized bolts connecting pile caps, braces, and guardrail posts were corroded and should be marked for replacement.

Photos 20 & 21 – Typical framing of WBOW in Phase 1D showing pile caps, joists and bolts

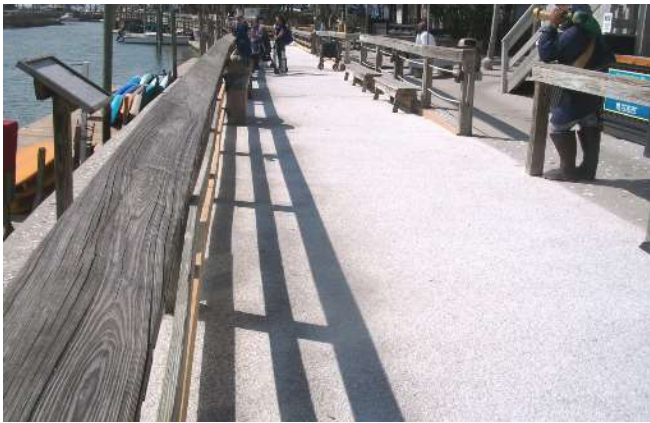
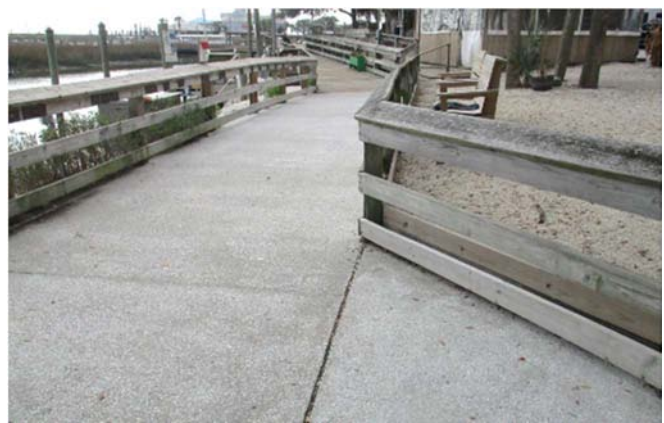
Photos 24 & 25 – Phase 1E looking south from Drunken Jacks (start) and to Mullet Hut (end)

The guardrail consists of 6x6 posts, 2x6 lower guardrail, a 2x6 middle guardrail, and a combination 2x6 and 2x12 cap rail screwed together for structural integrity. The outside guardrail in Phase 1E was replaced in 2018, but the interior guardrail was not included with this work. Some portions of the inside guardrail show wood deterioration consistent with the age, including splitting and checking, as well as metal connector failure. Selected locations on the top cap of the outside guardrail show deterioration of the wood due to splitting and checking. Portions of the inner rails have been replaced, new connectors have been installed into the existing rails to replace corroded connectors.

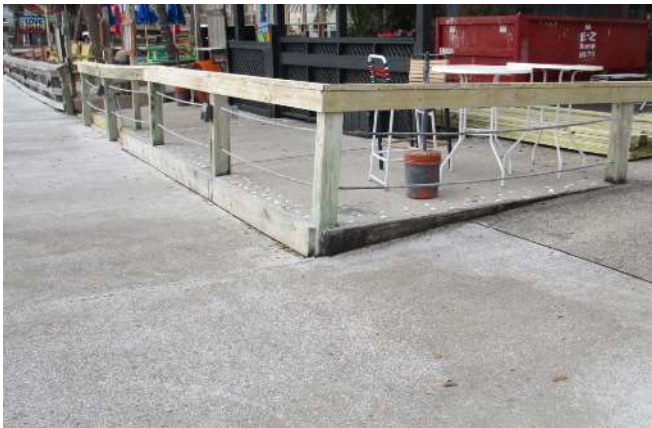
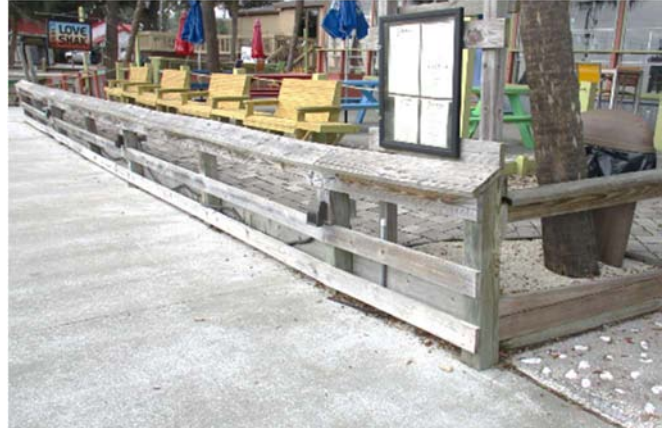
Photos 28 & 29 – Inside guardrails separating the Marshwalk from private property

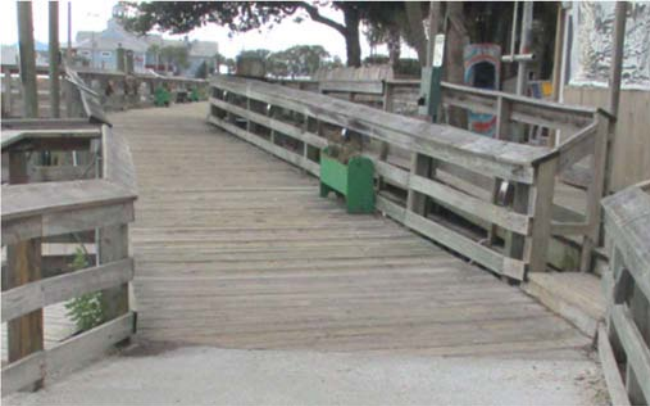
The guardrail consists of 6x6 posts, and 2x6 lower guardrail, a 2x6 middle guardrail, and a combination 2x6 and 2x12 cap rail screwed together for structural integrity. The outside guardrail post is bolted directly into the outside 3x8 joist to transfer lateral loads. The guardrail in Phase 2 will require repairs due to damaged boards, corrosion of connectors, and other age related deterioration.

Photo 34— Phase 2 looking south from Mullet Hut

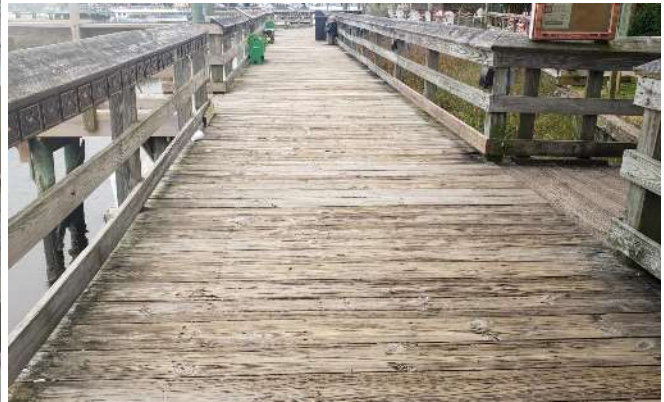
Photo 35 – Phase 2 from Creek Ratz looking south

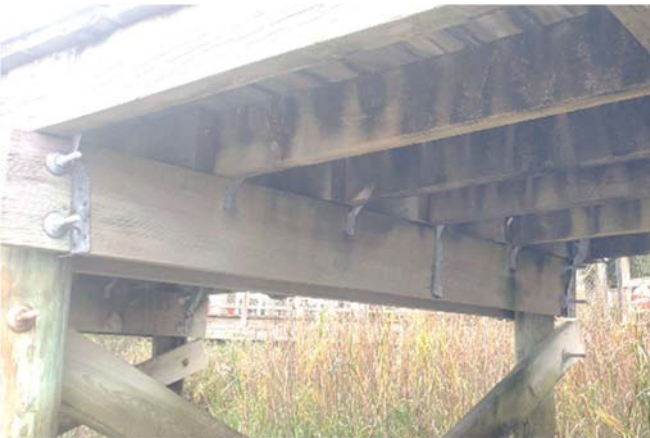
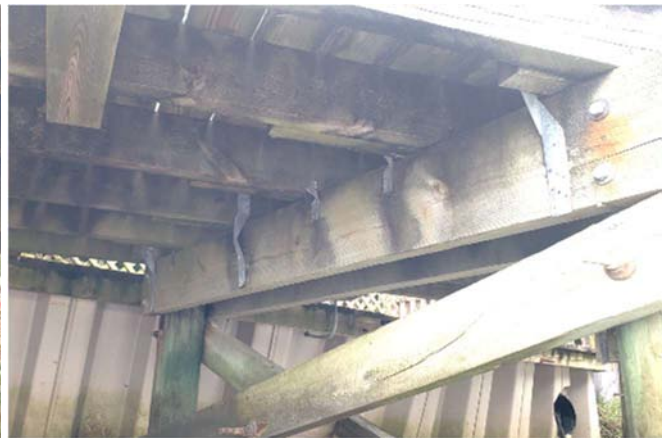
Photos 36 & 37 – Phase 2 framing of piles, pile caps, joists and metal connectors

Corrosion of Metal Fasteners – Metal fasteners in this Phase were in various states of corrosion, with some fasteners completely corroded and other having light rust. Numerous deck screws have failed, resulting in loose walk boards. The majority of the pile cap to joist connectors in this phase were in good condition and do not require replacement. Some of the galvanized bolts connecting pile caps, braces, and guardrail posts were corroded and should be marked for replacement.

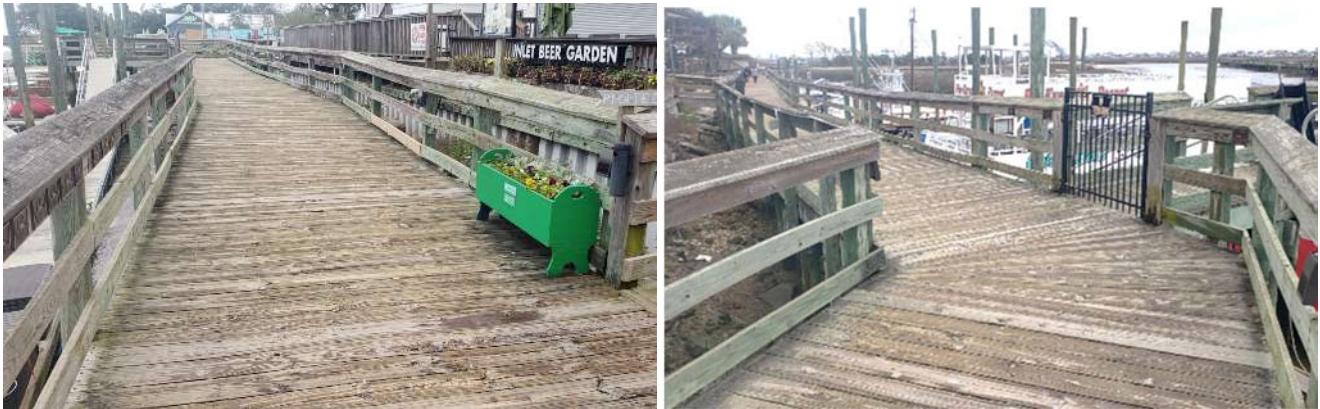
Photo 40 & 41 - Phase 3A viewed from the North and the South ends, respectively

The guardrail consists of 6x6 posts, 2x6 lower guardrail, a 2x6 middle guardrail, and a combination 2x6 and 2x12 cap rail screwed together for structural integrity. The guardrail in Phase 3A will require repairs due to damaged boards, corrosion of connectors, and other age related deterioration.

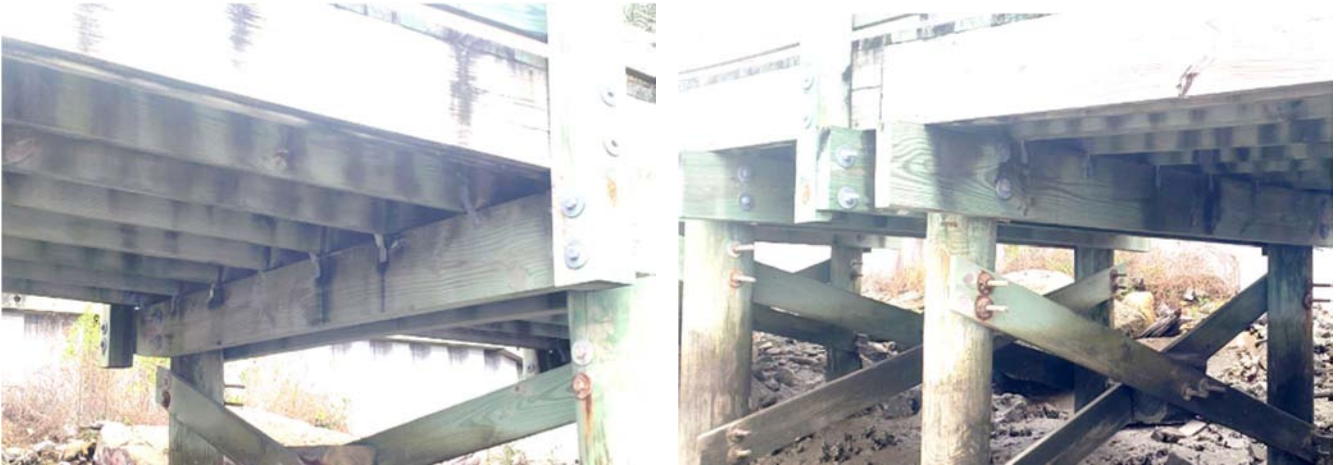
Photo 42 & 43 - Typical pile, pile cap, and joist framing below Ph 3A and connection at Ph 2 boardwalk

Corrosion of Metal Fasteners – Metal fasteners in this Phase were in various states of corrosion, with some fasteners completely corroded and other having light rust. The majority of the pile cap to joist connectors in this phase were in good condition and do not require replacement. Some of the galvanized bolts connecting pile caps, braces, and guardrail posts were corroded and should be marked for replacement.

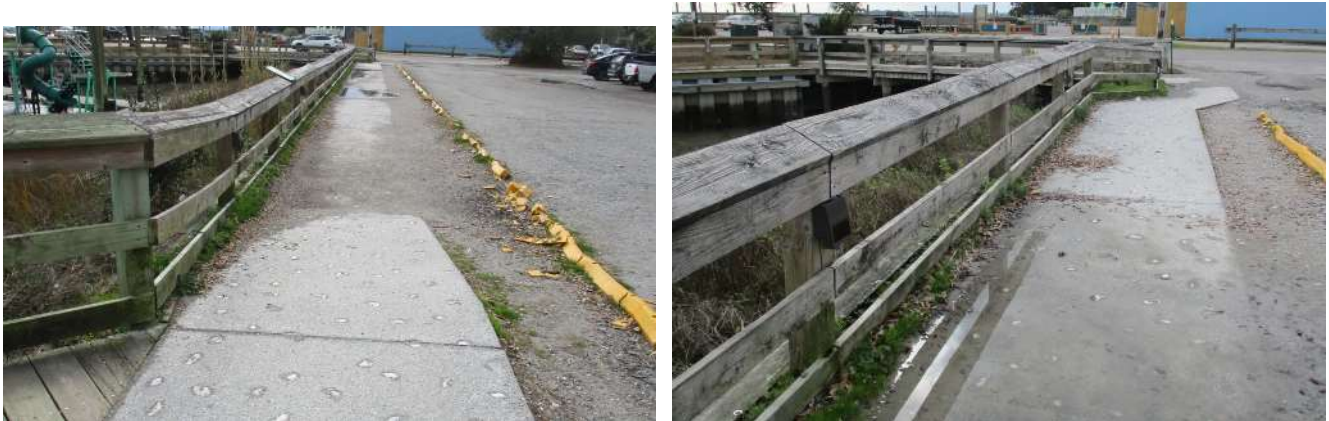
Photo 44 & 45 – Phase 3B looking South from Claw House and from middle toward Phase 3C

The boardwalk surface consists of tabby textured concrete with embedded shells and the majority of the damage observed beyond normal wear was cracks and settlement of edges near joints. This section of concrete sidewalk is at or below the slag and gravel surface of the parking lot, and surface runoff brings sediment onto the surface of the sidewalk. There are vehicle stops placed on the surface, which also contributes to sediment tracking onto the concrete sidewalk.

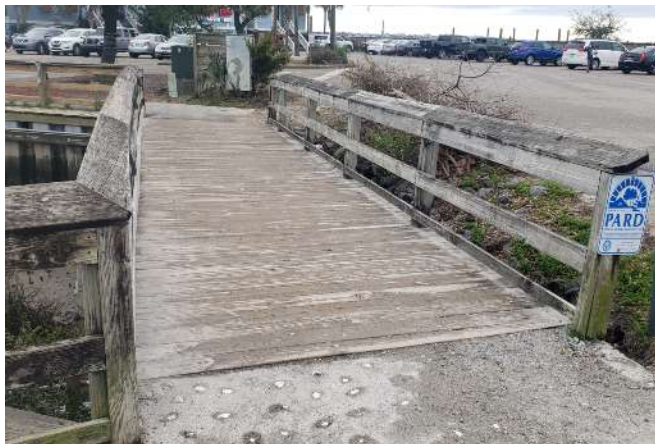
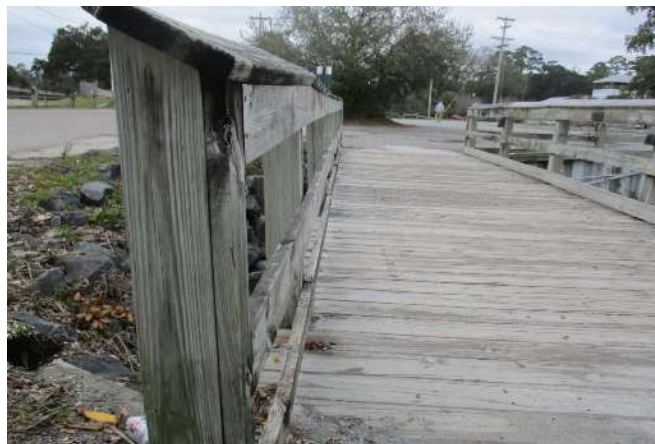
The boardwalk decking consists of treated 2x8s attached to the joists using stainless steel screws. Structural damage, including wood rot from moisture and splitting/checking of wood was observed in several locations consistent with exterior use (pedestrian traffic and environmental exposure to sun and rain). Galvanized metal connectors were not observed to be installed from the pile caps to the joists.

Photo 50 & 51 – Phase 3C viewed from the west and the east ends, respectively

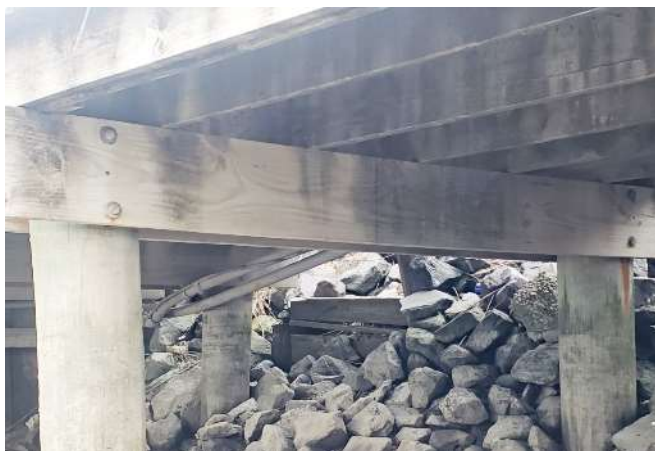
The foundation is constructed as 12" timber piles with 4x12 pile caps bolted to the pilings. Treated 2x12 joists at 16" spacing was installed for walkway decking support. This area was observable from the adjacent ground.

Photo 52 - Piles, pile caps and joists at Phase 3C

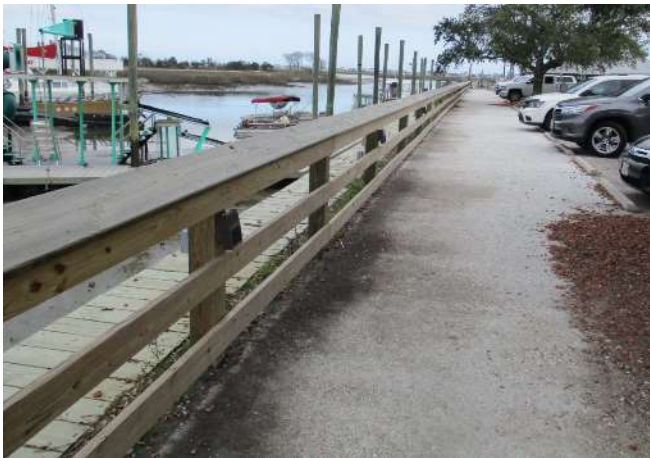
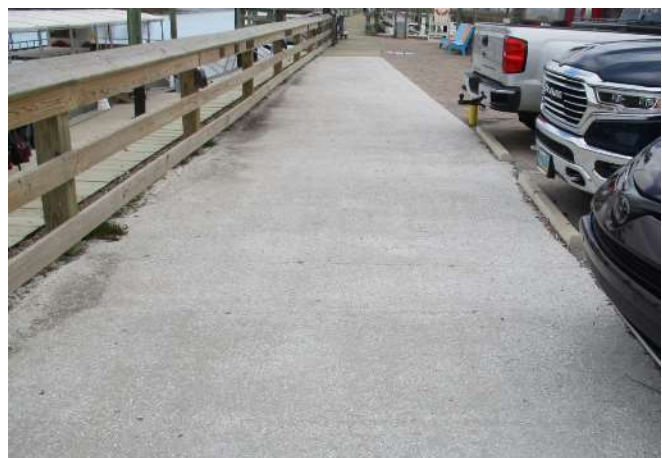
Structural - Phase 3D consists of 303 LF of Concrete Walkway at Grade from the terminus of Phase 3C to the start of Phase 4A (the Veterans Pier). The concrete walkway and guardrail were replaced in March 2020 and are in good shape. The retaining wall at Wicked Tuna was also replaced, so no repairs in this phase are required.

Photos 54 & 55 – Phase 3D walkway looking from South toward Phase 4A at start and end

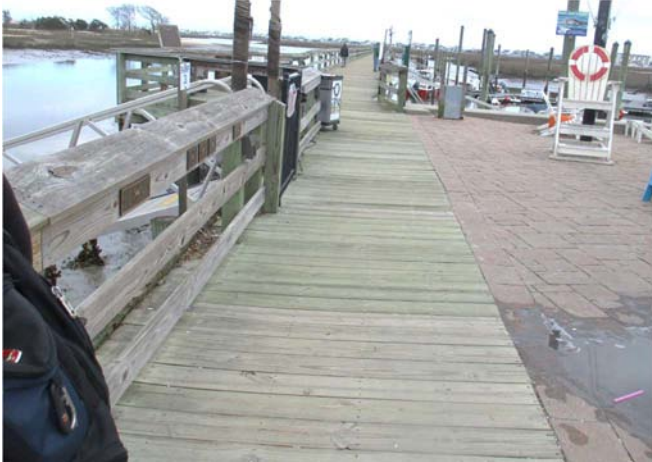
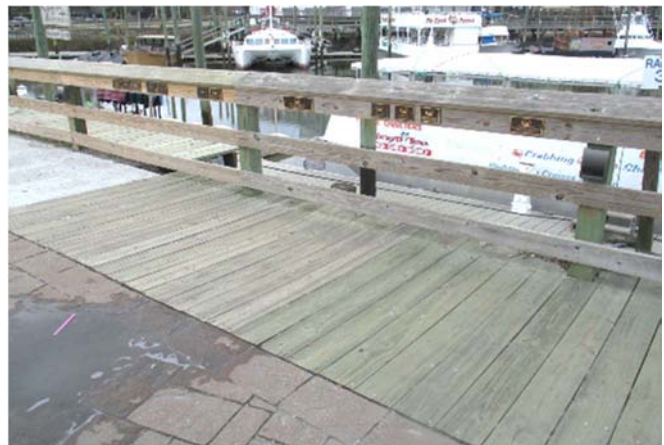
Photos 56 & 57 – Phase 4A walkway landward of retaining wall that was replaced in 2017

The foundation of the WBAG was similar to Phase 1A and is not discussed since it was replaced in 2017. The foundation for the WBOW is constructed as 12" timber piles with 4x12 pile caps bolted to the pilings. Pile cap spacing is 10 feet on center, with a total of 77 groups of pile caps (A – BY). Treated 2x12 joists at 16" spacing were installed for walkway decking support. This area was observable from the ground below the pier and from the adjacent floating docks. The galvanized metal connectors on Phase 4A are the most severely corroded on all phases observed, and the majority of these connectors are missing. These connectors are designed to reduce damage to the walkway framing from flotation during the storm surge, and replacement of these uplift connectors is critical to minimize damage from future storm events.

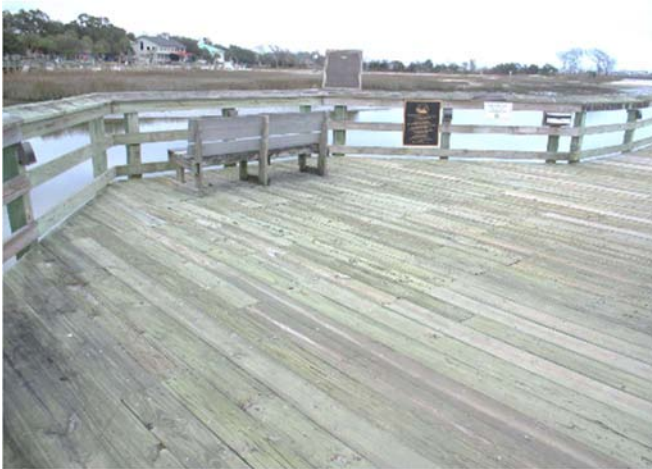
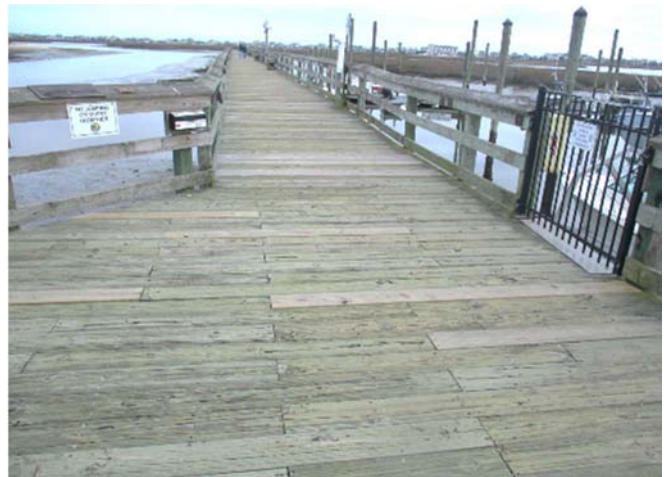
The boardwalk decking consists of treated 2x8s attached to the joists using stainless steel screws. Structural damage, including splitting and checking of wood was observed in numerous locations consistent with exterior use (pedestrian traffic and environmental exposure to sun and rain). Portions of the decking over land were replaced in 2017, with the portions over water originally constructed in 2005.

Photos 58 & 59 – Phase 4A walkway seaward of retaining wall that was constructed in 2005

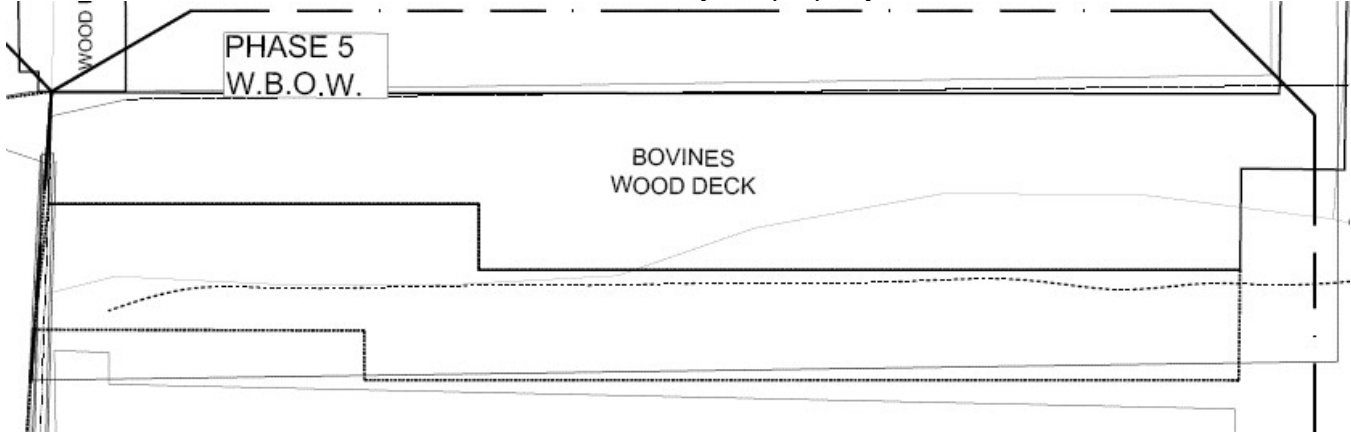
Figure 21 – Phase 5 Location

Structural - Phase 5 consists of 105 LF of Wood Boardwalk over Water that is constructed in front of Bovine's restaurant and is a 10 ft wide portion of the overall structure that also includes the wood deck in front of Bovine's. This structure was built in 2015 by the property owner.

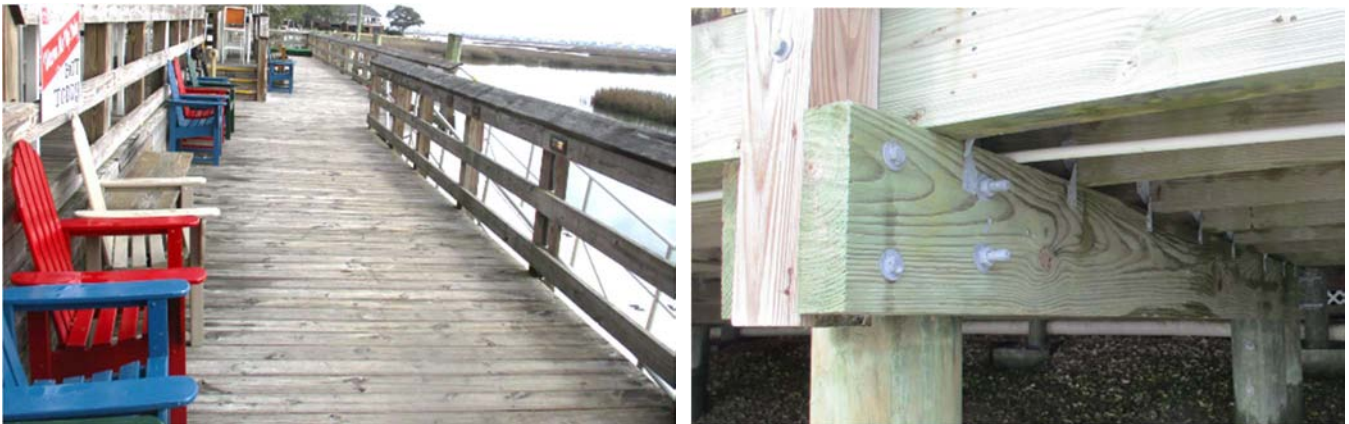
The foundation is constructed as 12" timber piles with 4x12 pile caps bolted to the pilings. Pile cap spacing is 10 feet on center. Treated 2x12 joists at 16" spacing were installed for walkway decking support. This area was observable from the adjacent floating docks. The boardwalk decking consists of treated 2x8s attached to the joists using stainless steel screws. No significant damage was observed beyond normal wear consistent with exterior use (pedestrian traffic and environmental exposure to sun and rain).

The guardrail consists of 6x6 posts, 2x6 lower guardrail, a 2x6 middle guardrail, and a combination 2x6 and 2x12 cap rail screwed together for structural integrity. The guardrail in Phase 5 did not show any significant damage and did not appear to require repairs.

Photo 66 & 67 – Phase 5 in front of Bovines did not appear to have damage requiring repairs

Corrosion of Metal Fasteners –The majority of the pile cap to joist connectors and bolts observed in this phase are in good condition and do not require replacement.
