# City Of Waycross

## CONDITION ASSESSMENT REPORT

**Tank Name:**  
Industrial Blvd North Tank

**Project Number:**  
102429

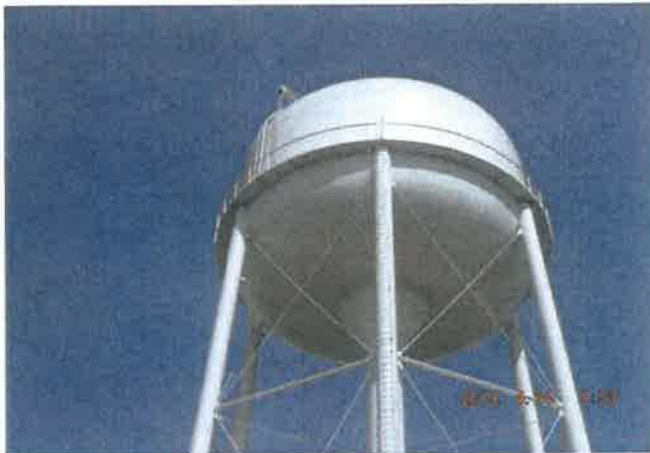
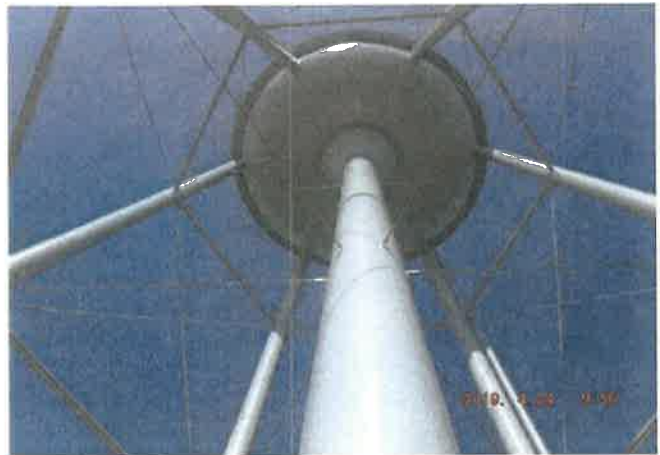
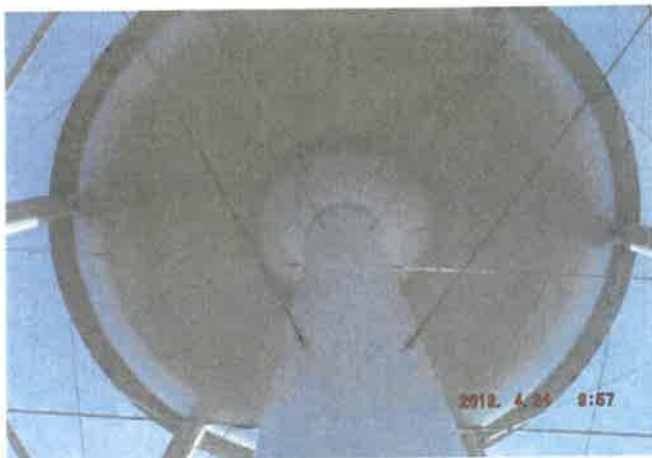
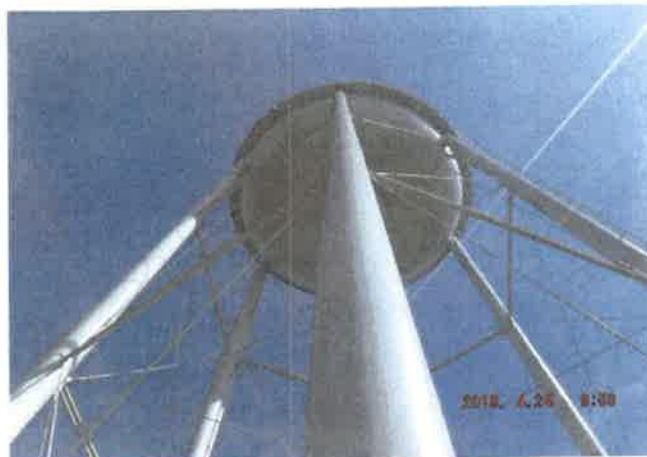
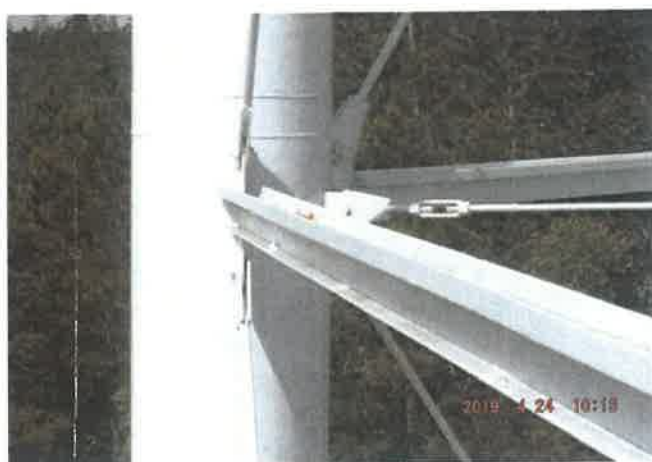
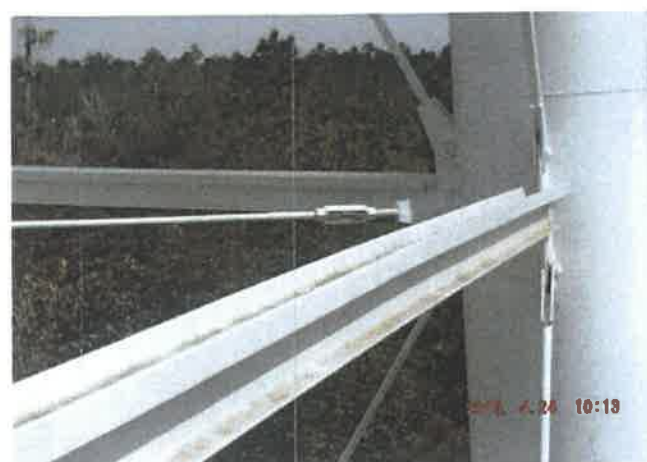
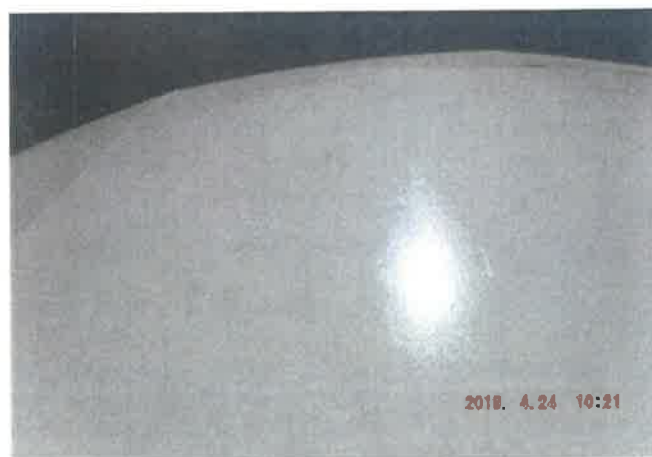
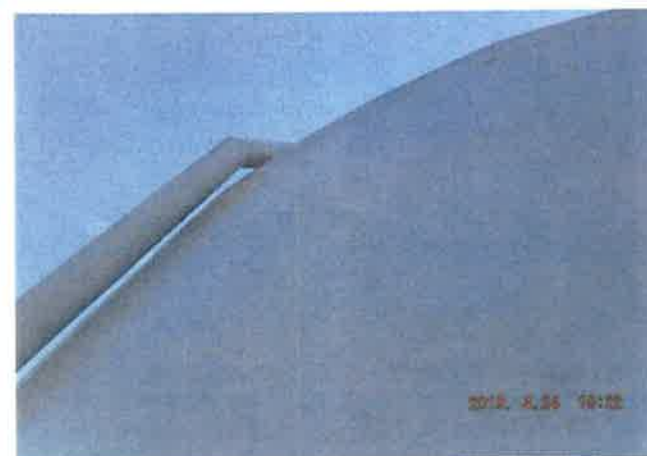
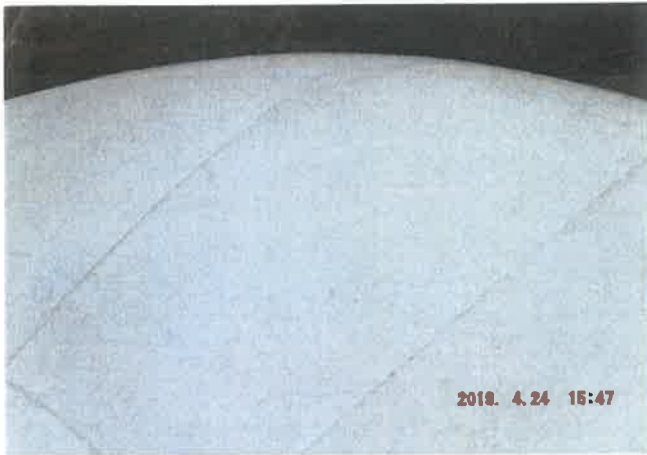
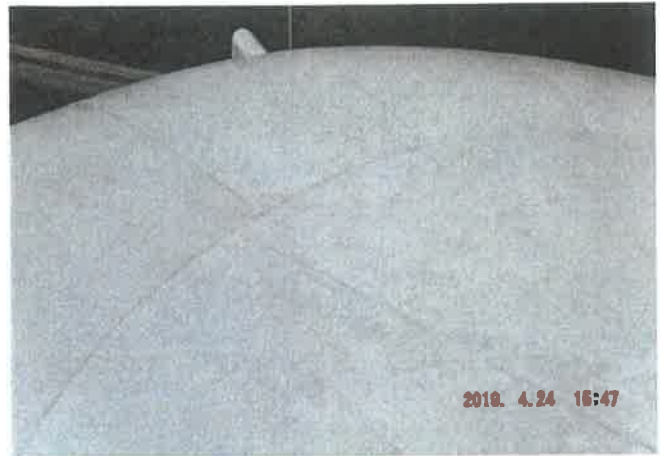
- **Interior Coating Condition:** Visible areas of the Interior lining are in good condition and continues to protect the substrate.
- **Exterior Coating Condition:** No deficiencies noted in the exterior coating.

Exterior coating

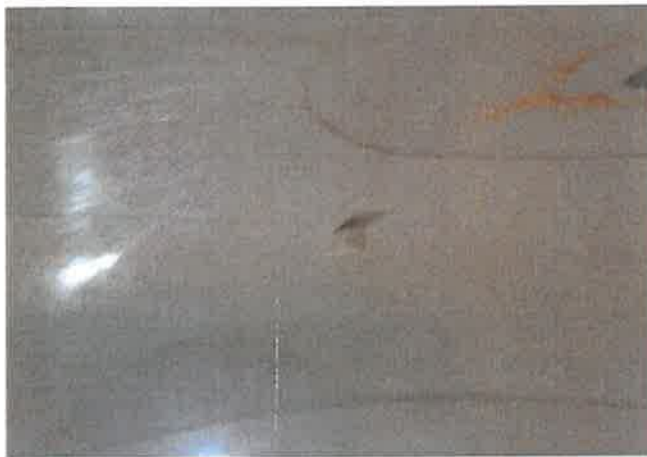
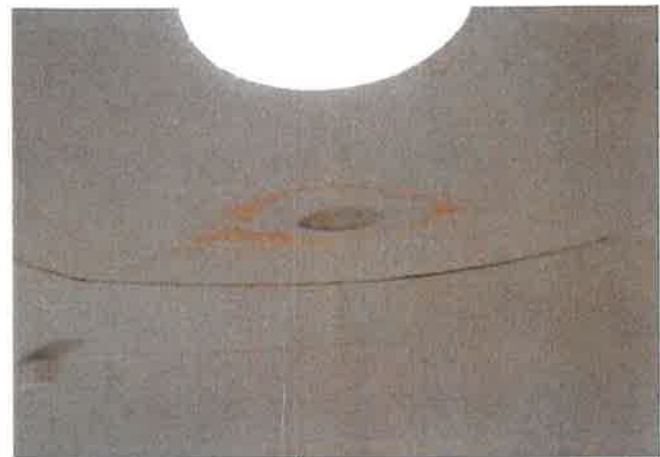
Interior

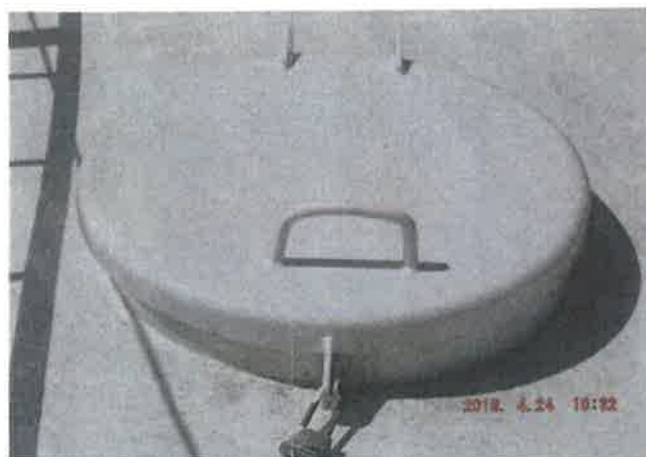
- **Safety Climbing Devices:** Ladders are equipped with secured safety climb devices.
- **Access Hatch1:** No deficiencies noted.

Access hatch

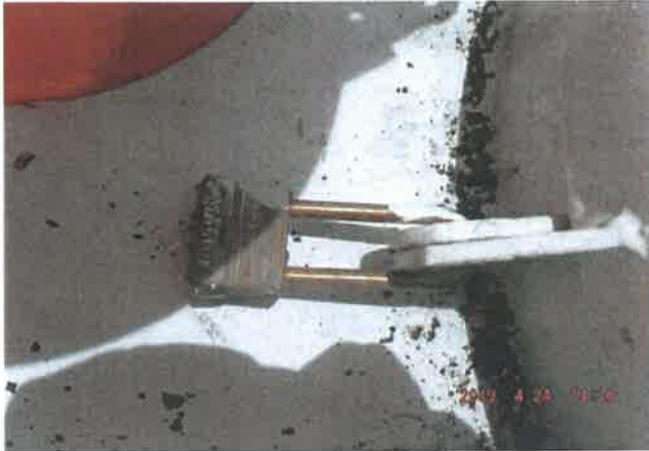
- **Fence Around Site:** Tank is located inside a fenced-in area that is secure.
- **Ladder Gate/Access Door:** Exterior ladder has a ladder gate installed and is locked.
- **Access Hatch Locked:** Access hatch is locked and secured.
- **Evidence Of Vandalism:** No evidence of vandalism was found.

Roof access hatch locked

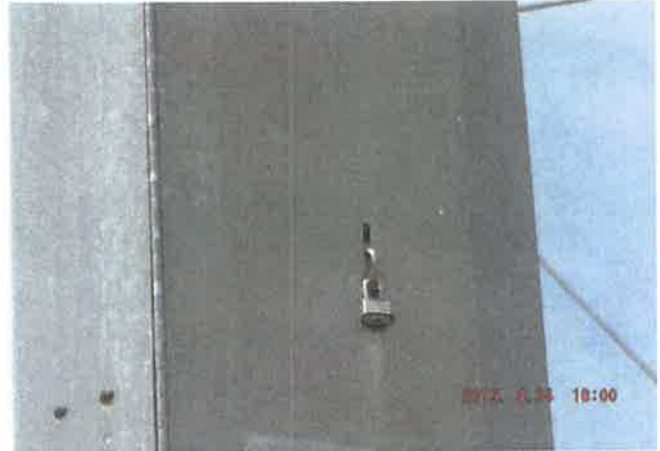
Ladder gate locked

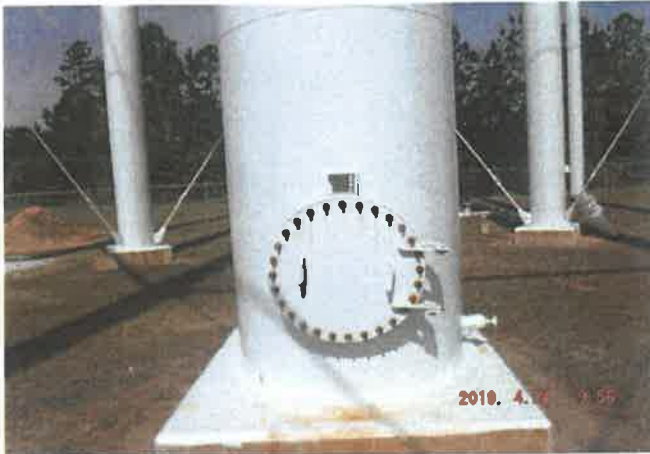
Riser manway

- **Anchor Bolts:** Anchor bolts are protected and show no rust or corrosion.
- **Riser Pipe:** No deficiencies noted with riser. Paint coating continues to protect the substrate.

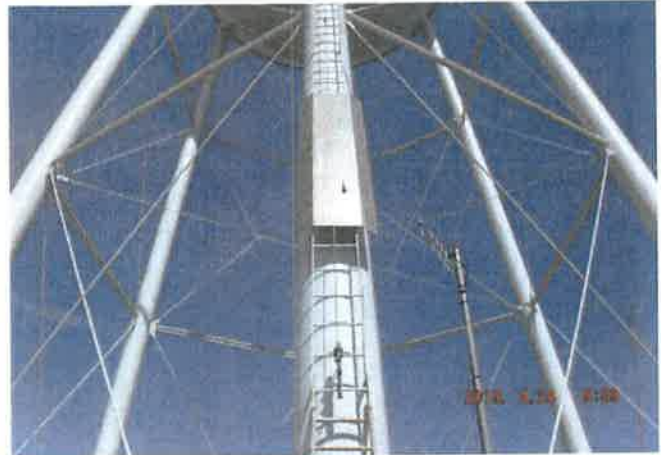
- **Access Ladders:** No deficiencies noted for dry-side access ladder stiles, rungs and connections.
- **Column Flanges:** Column flanges are painted and no corrosion is present.

Access ladder

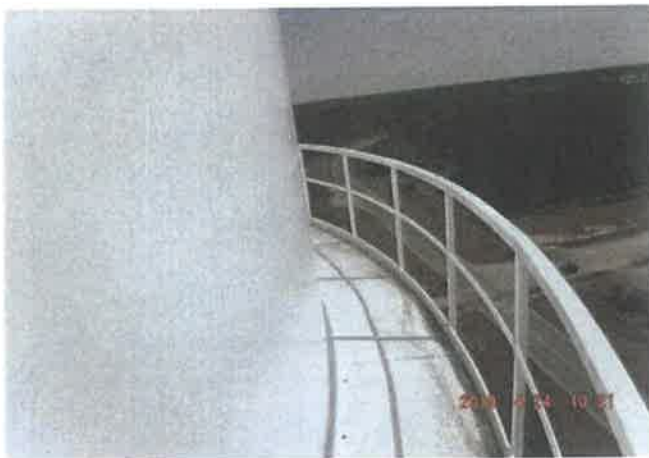
- **Balcony:** No deficiencies or corrosion damage noted for balcony railings and landings.
- **Interior Ladders:** Interior ladder partially inspected from hatch. Ladder is beginning to show minor corrosion and will be scheduled for touch up.

Balcony and handrail

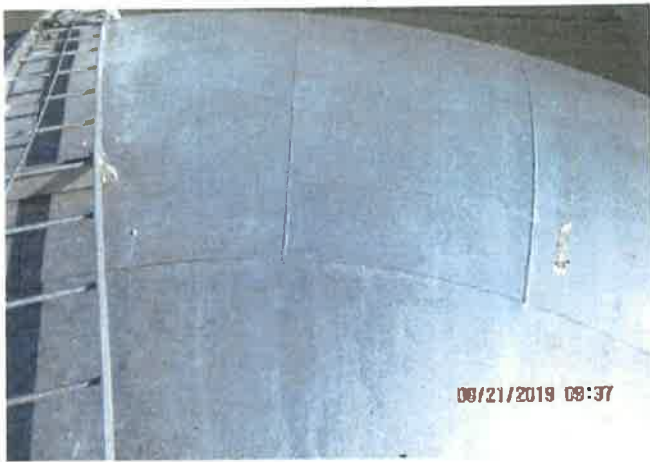
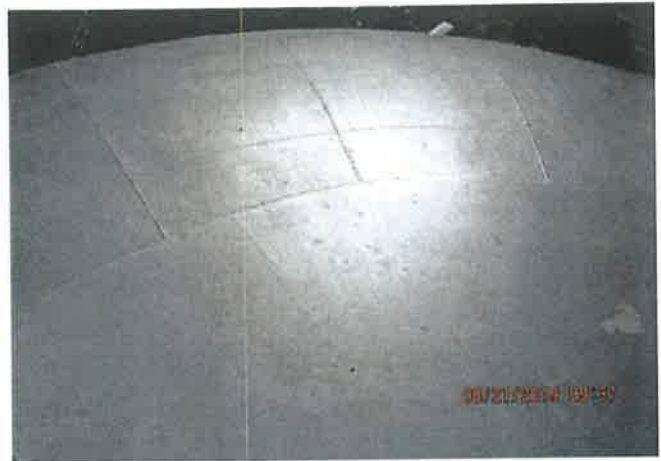
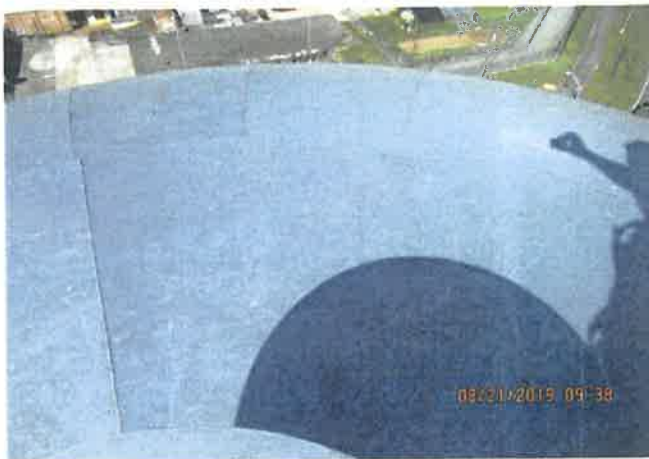
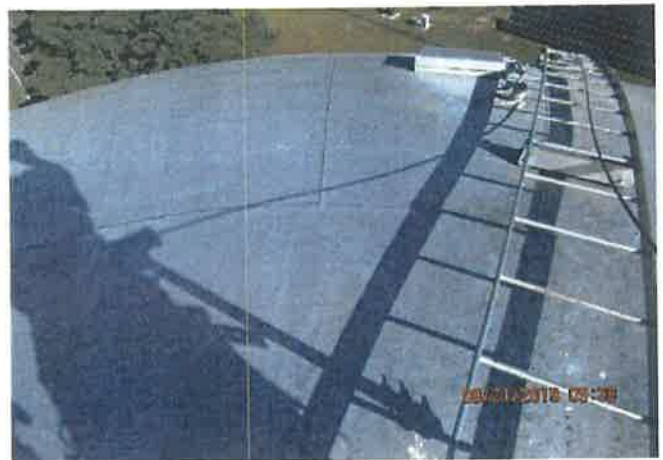
- **Interior Coating Condition:** Interior coating is in good condition and continues to protect the substrate.
- **Exterior Coating Condition:** No deficiencies noted in the exterior coating.
- **Logo Condition:** Logo is faded and will need to be retraced in the near future.

Exterior Roof Coating

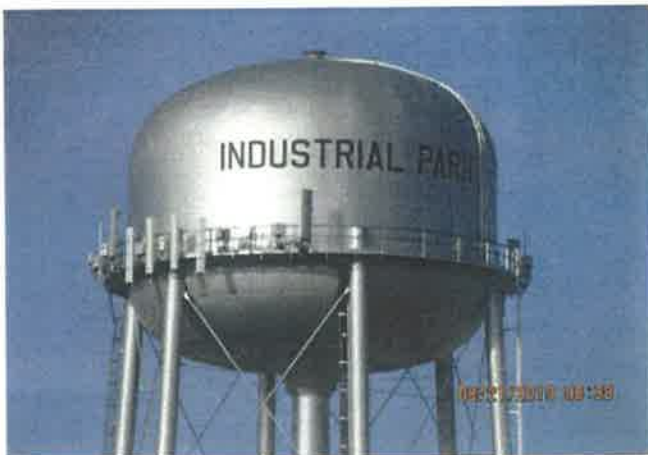
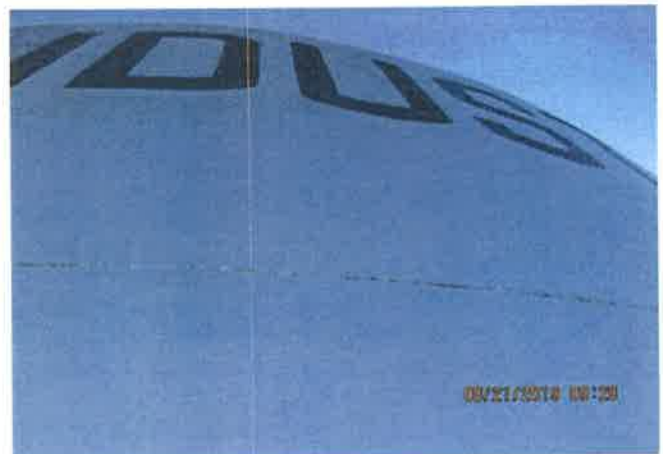
Exterior Logo Coating

Exterior Logo and Sidewall Coating

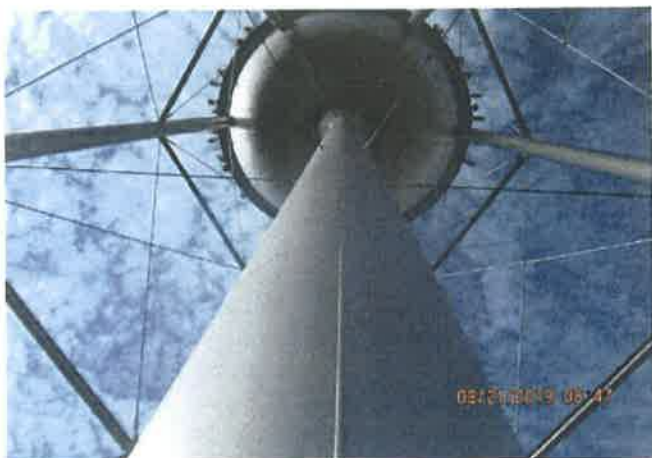
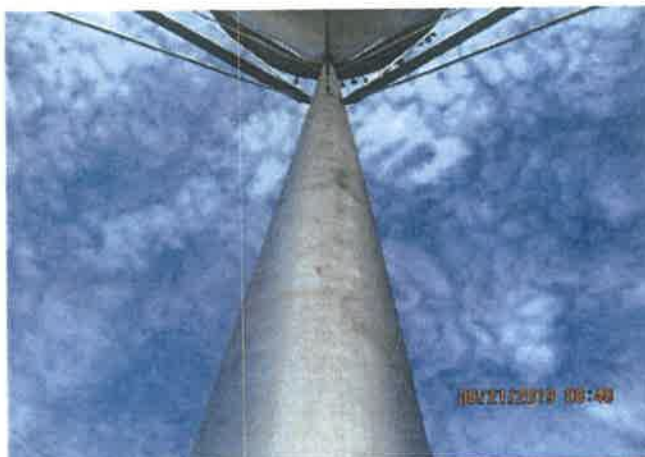
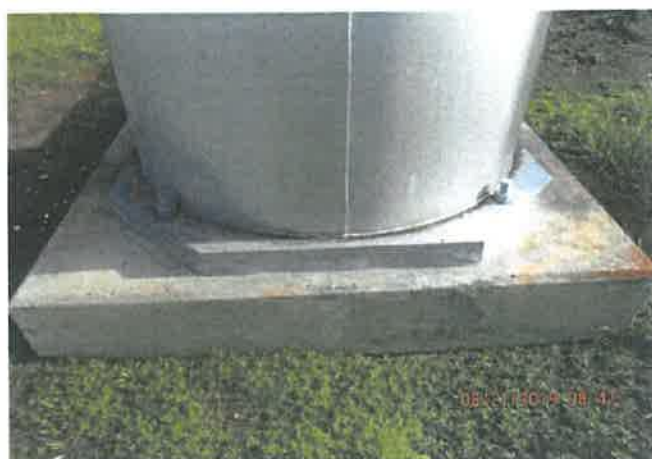
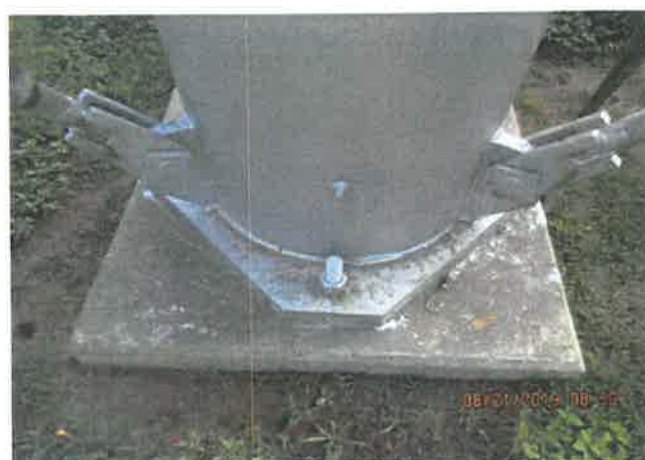
Exterior Under Belly and Riser Coating

Exterior Leg Coating

Exterior Riser Base Coating

Exterior Leg Base Coating

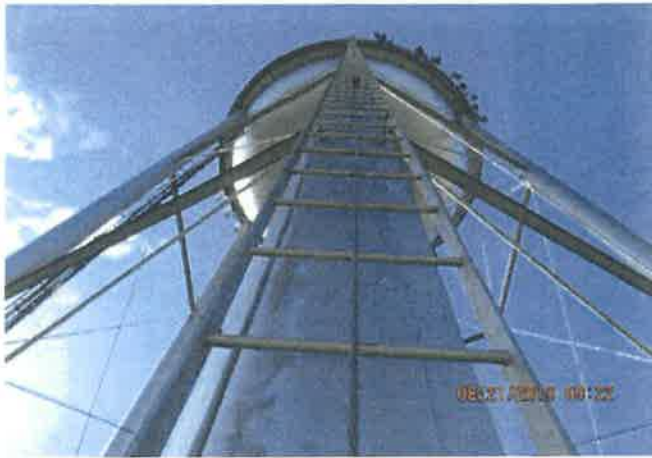
- **Safety Climbing Devices:** Ladders are equipped with secured safety climb devices.
- **Access Hatch1:** No deficiencies noted with the wet interior roof access hatch.

Cable Safety Climb On Access Ladder

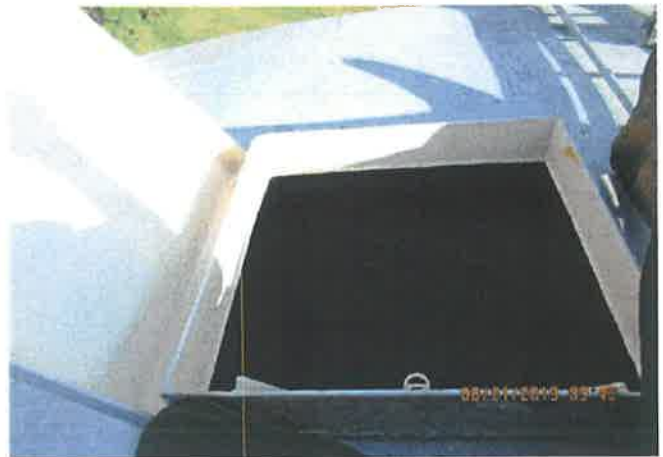
Wet Interior Roof Access Hatch Open

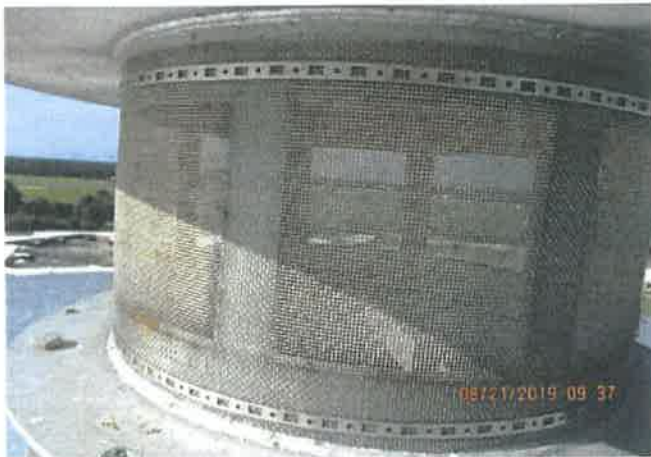
- **Vent Screen:** No deficiencies noted with vent screen.
- **Evidence Of Foreign Matter:** No evidence of foreign matter observed.
- **Sediments:** Light sediment in bottom of tank was cleaned out with pressure washing.

Vent Screen

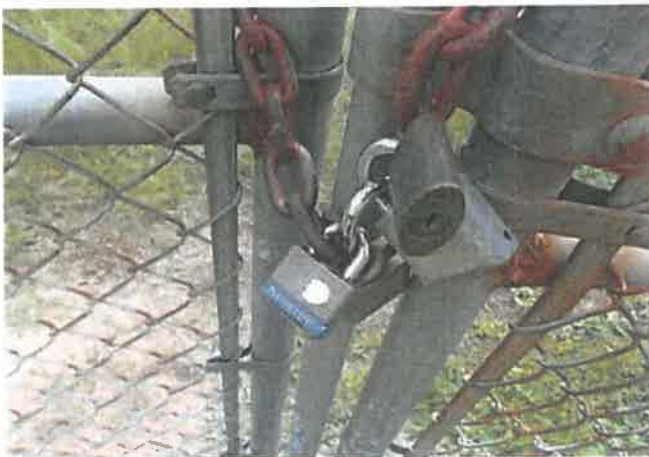
- **Fence Around Site:** Tank is located inside a fenced-in area that is secure.
- **Ladder Gate/Access Door:** Exterior ladder has a ladder gate installed and is locked.
- **Access Hatch Locked:** Access hatch is locked and secured.
- **Evidence Of Vandalism:** No evidence of vandalism was found.

Locked Site Fence

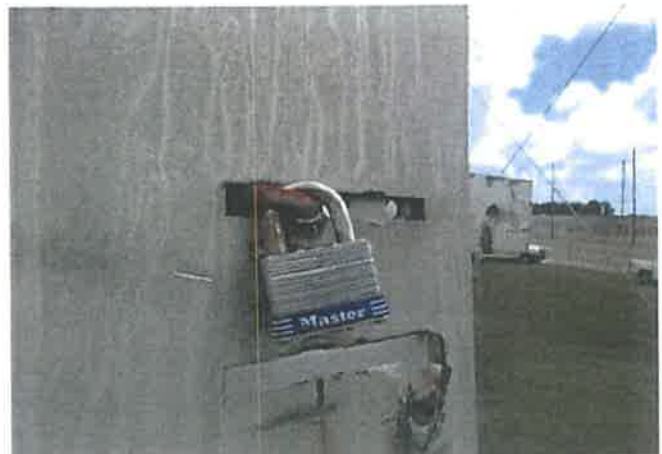
Locked Ladder Gate

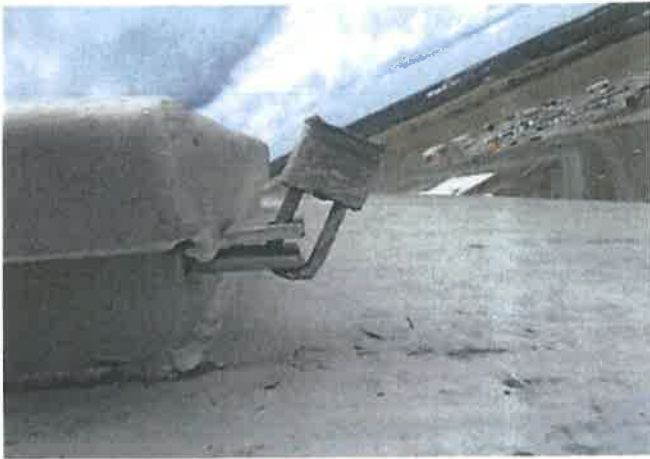
Locked Access Hatch

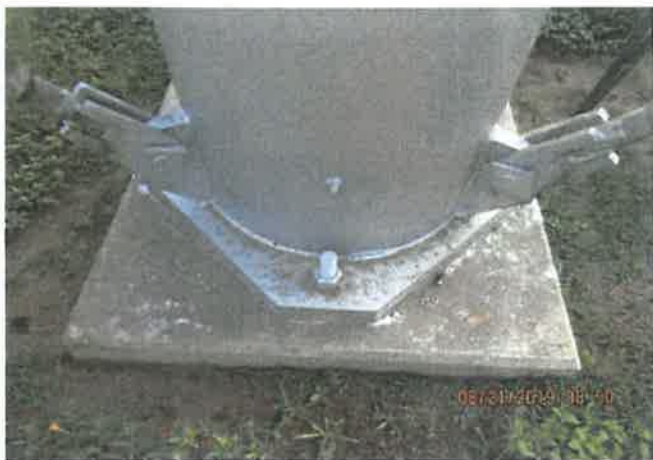
**Leg Structure and Foundation**

- **Foundation:** Foundation appears in good condition. No deficiencies noted.
- **Legs:** No deficiencies noted with tank legs. Paint coating continues to protect the substrate.

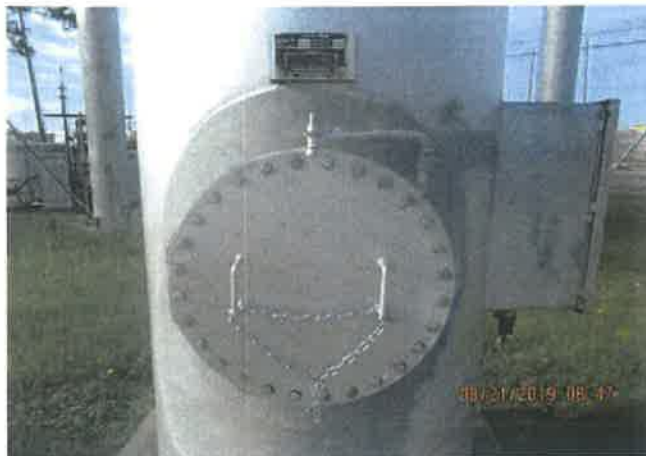
**Davit Arm Riser Manway**

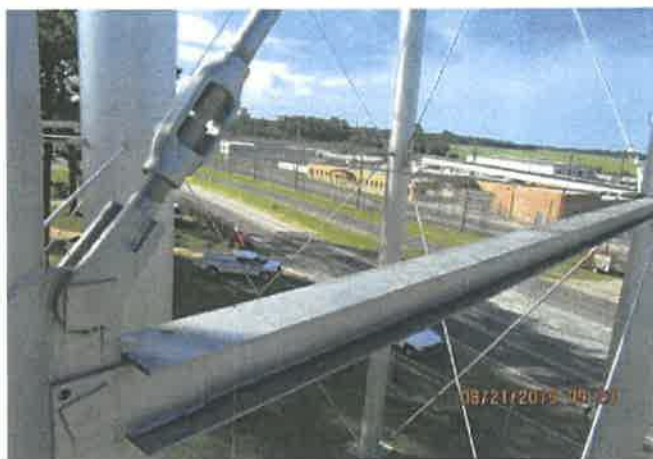
**Strut and Rod Connections**

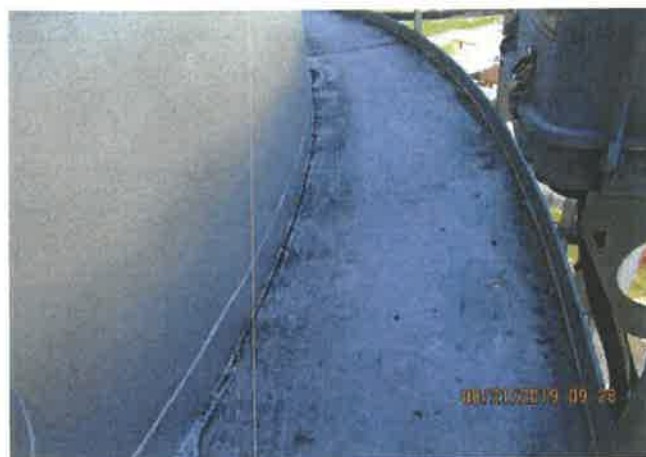
**Balcony**

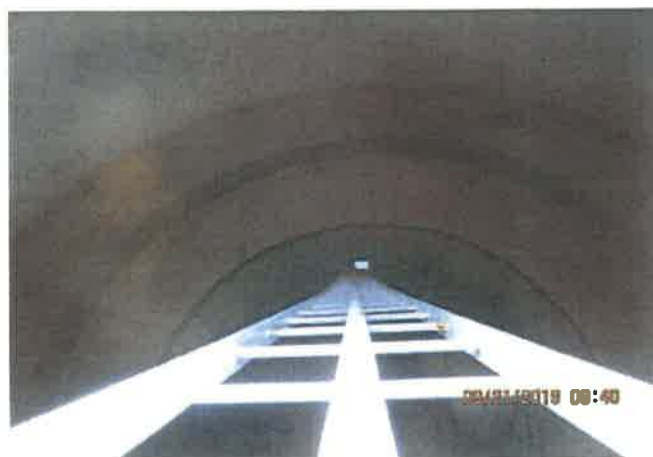
**Interior Access Ladder**

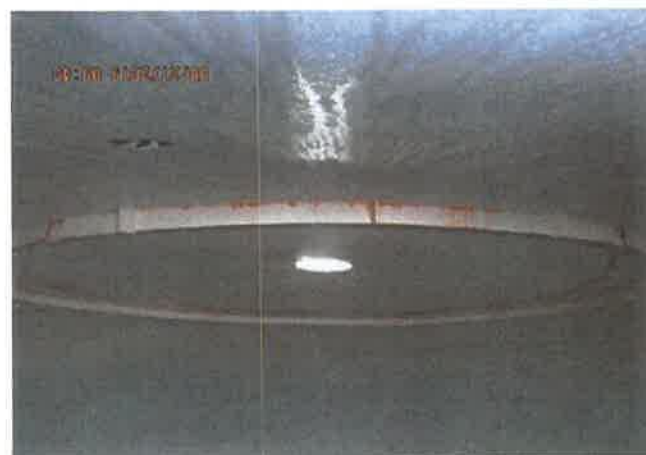
**Interior Roof Structure**

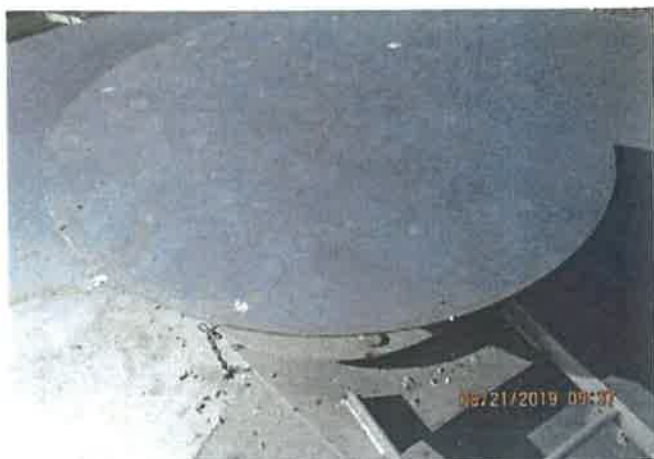
Vent Structure

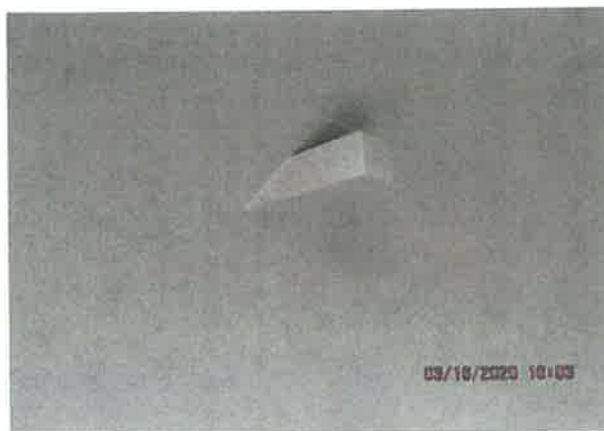
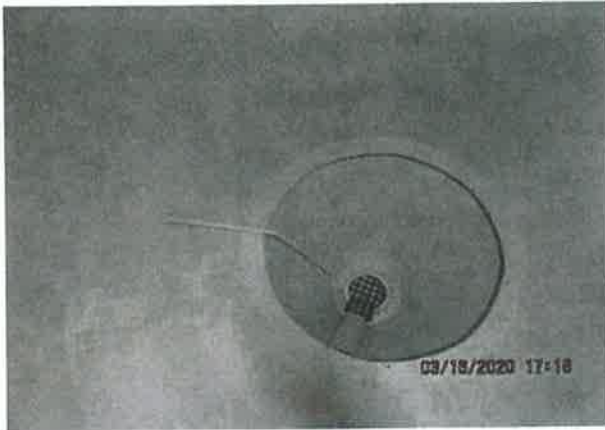
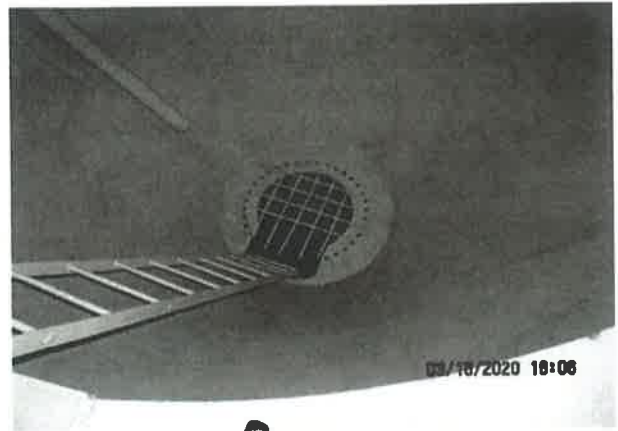
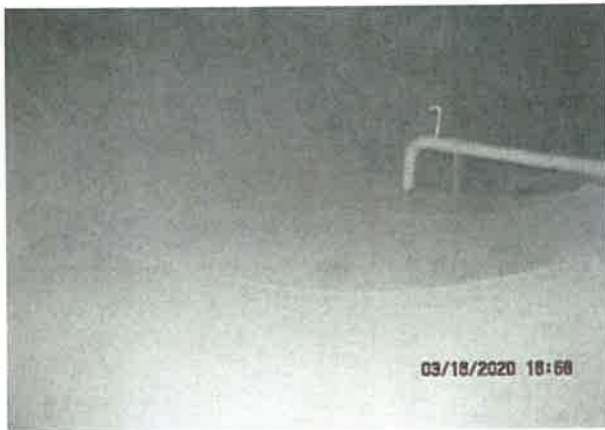
- **Interior Coating Condition:** Interior coating is in good condition.
- **Exterior Coating Condition:** No deficiencies noted in the exterior coating.
- **Logo Condition:** No deficiencies noted.

Interior coating

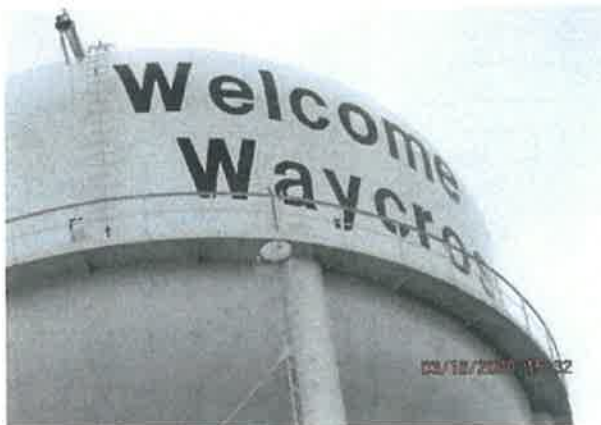
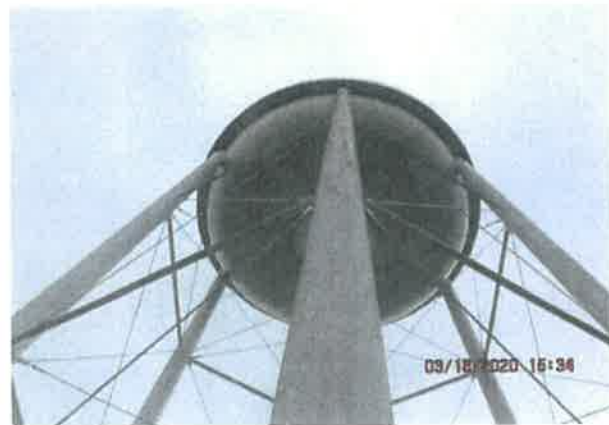
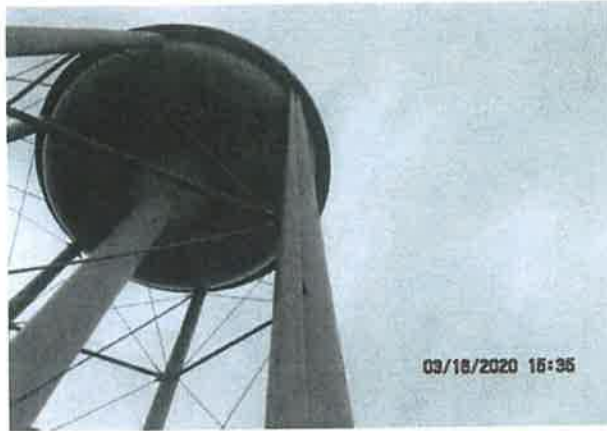
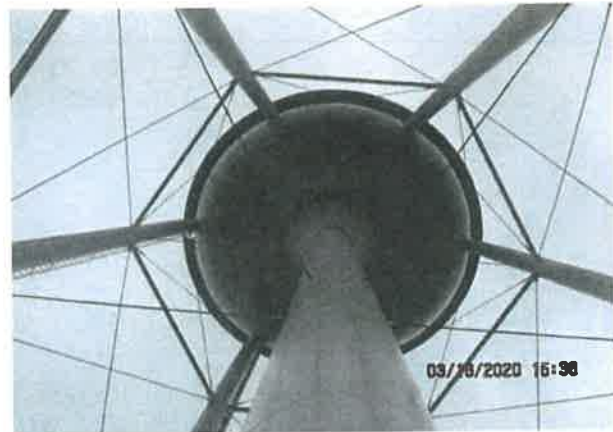
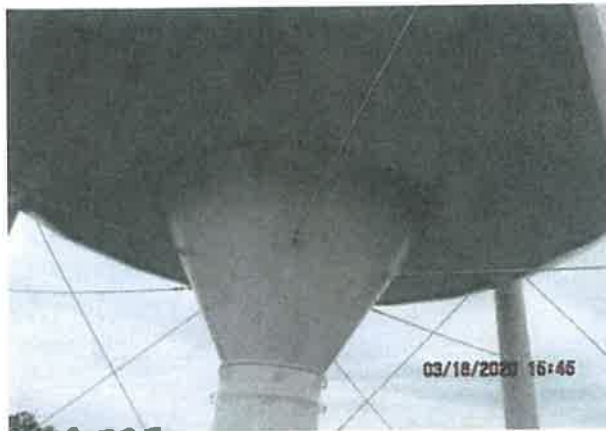
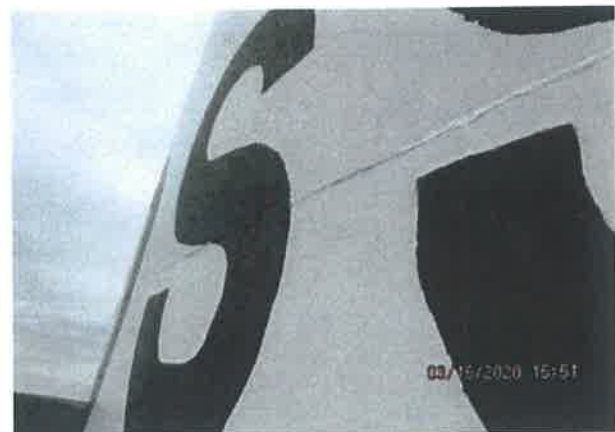
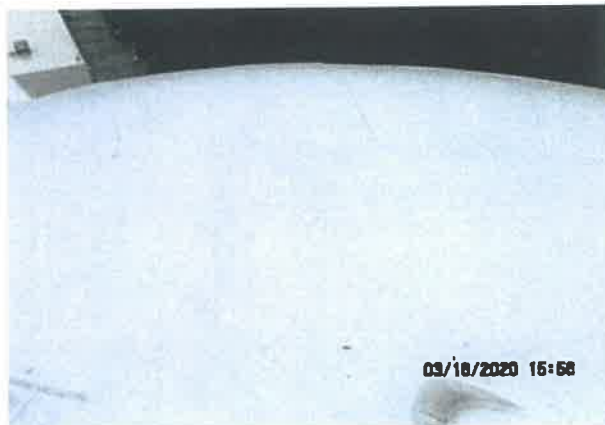
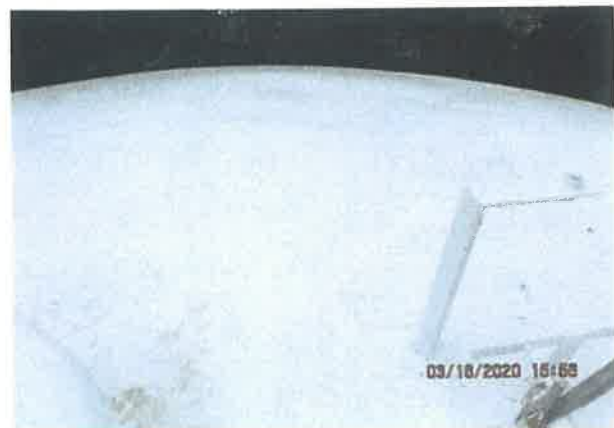
Exterior coating

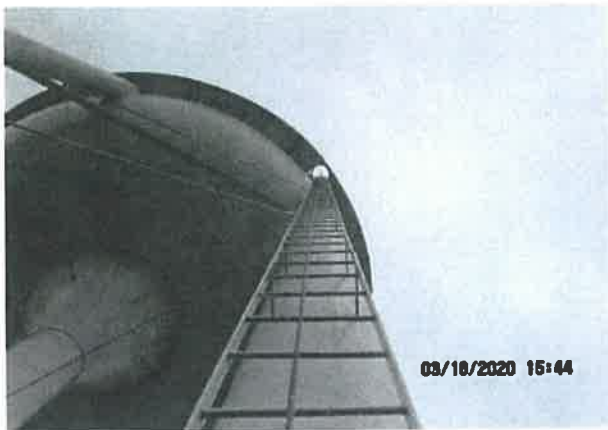
- **Safety Climbing Devices:** Ladders are equipped with secured safety climb devices.
- **Access Hatch1:** No deficiencies noted.

Safety climb cable

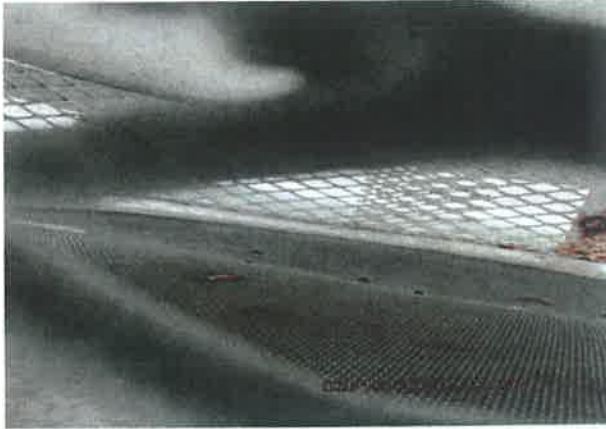
- **Vent Screen:** No deficiencies noted with vent screen.
- **Evidence Of Foreign Matter:** No evidence of foreign matter observed.
- **Sediments:** No sediment present in tank.

Roof vent screen

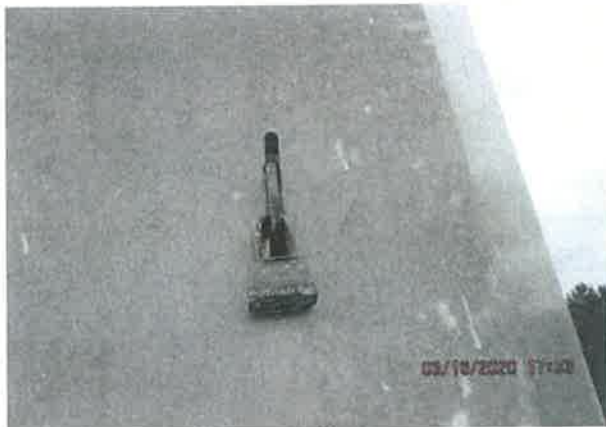
Ladder gate locked

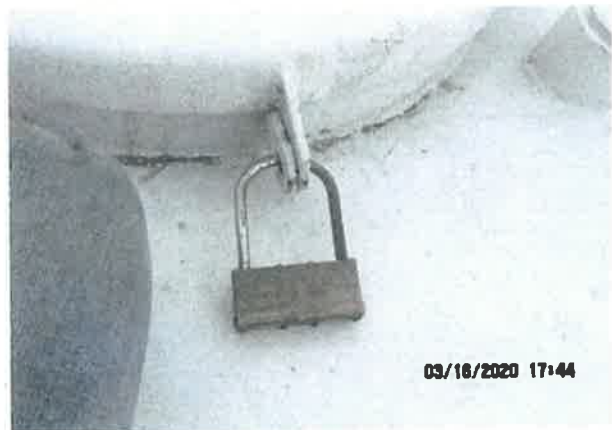
Roof access hatch locked

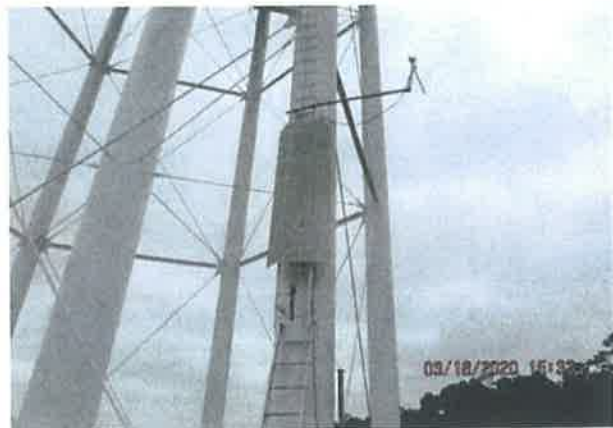
- **Access Ladders:** No deficiencies noted for dry-side access ladder stiles, rungs and connections.
- **Column Flanges:** Column flanges are painted and no corrosion is present.

Access ladder

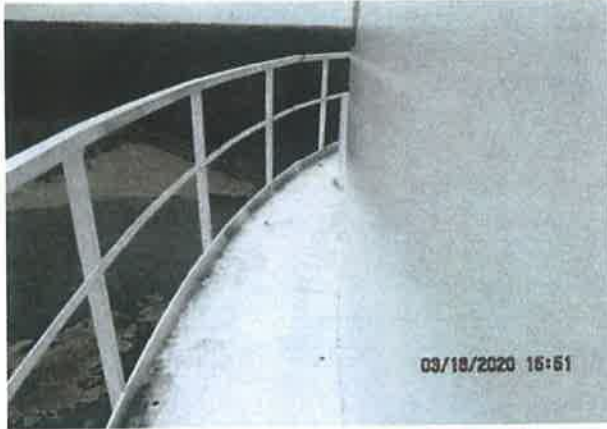
- **Balcony:** No deficiencies or corrosion damage noted for balcony railings and landings.
- **Interior Ladders:** No deficiencies noted for the interior ladder stiles, rungs and connections.

Balcony and handrail

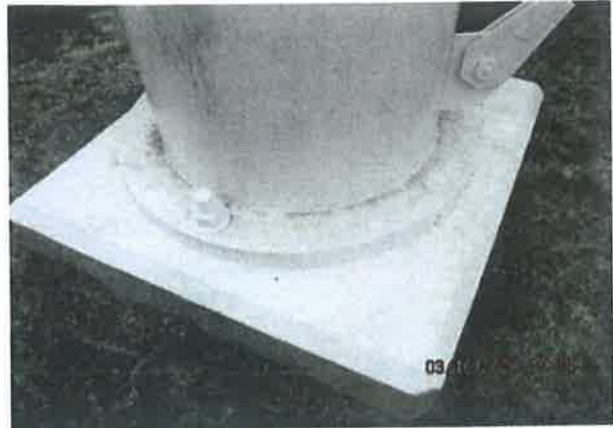
- **Foundation:** Foundation appears in good condition.
- **Legs:** No deficiencies noted with tank legs. Paint coating continues to protect the substrate.

- **Anchor Bolts:** Anchor bolts are protected and show no rust or corrosion.
- **Riser Pipe:** No deficiencies noted with riser. Paint coating continues to protect the substrate.

Foundation/Anchor bolt

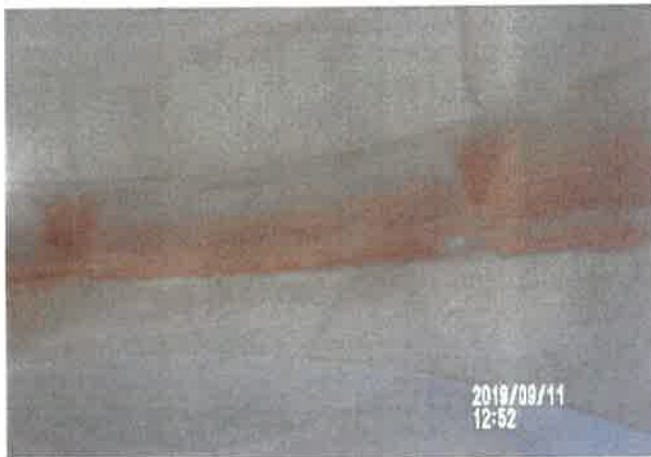
- **Interior Coating Condition:** Interior coating is in good condition and continues to protect the substrate.
- **Exterior Coating Condition:** No deficiencies noted in the exterior coating.
- **Logo Condition:** No deficiencies noted.

Interior Bowl to Sidewall Coating

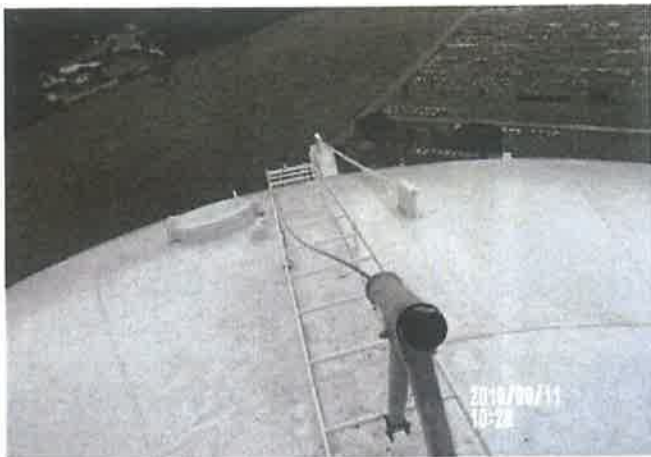
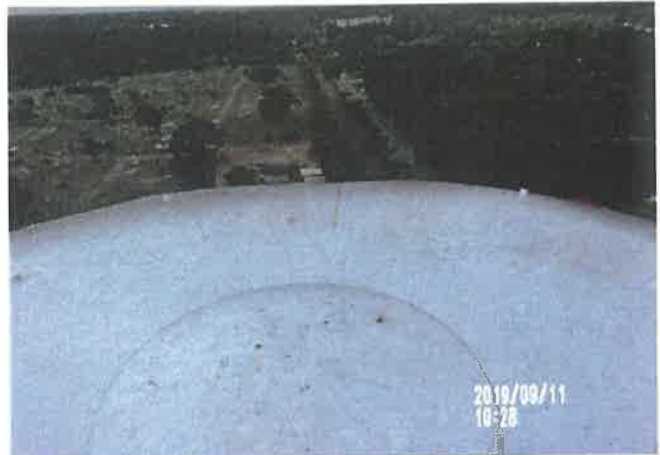
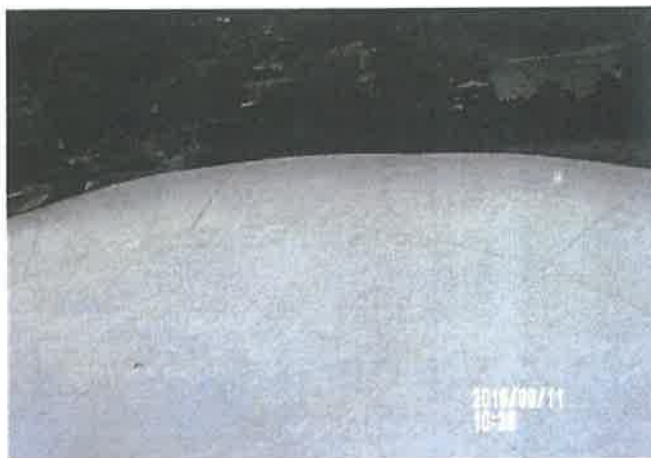
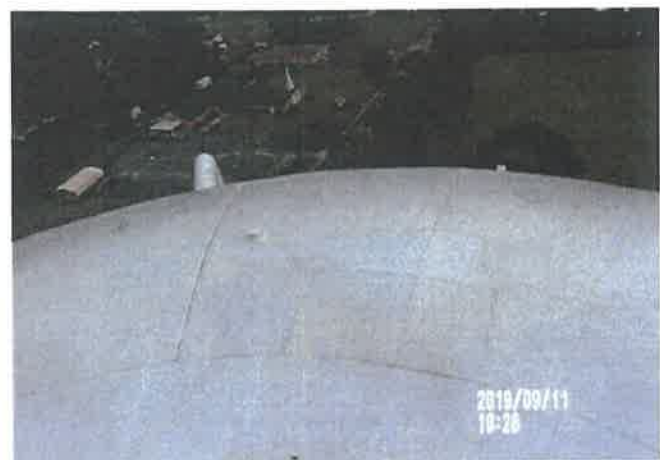
Exterior Roof Coating

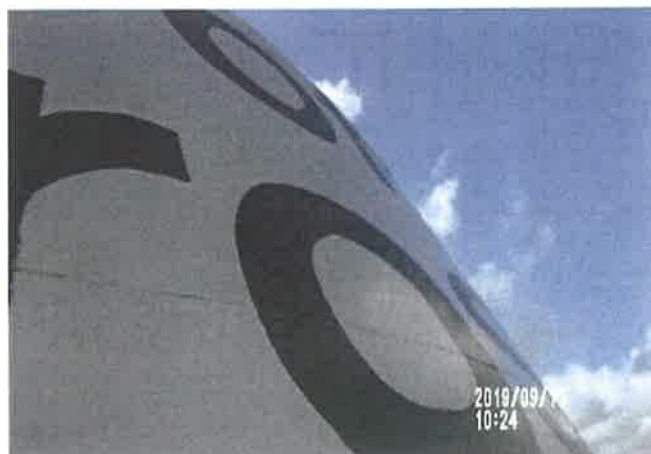
Exterior Logo and Sidewall Coating

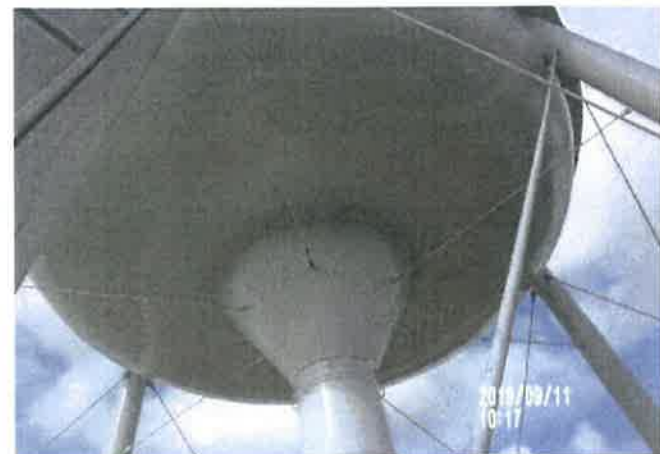
Exterior Under Belly Coating

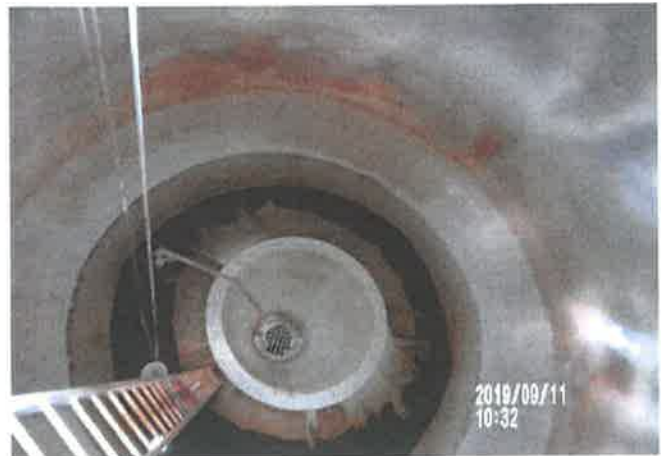
Interior During Washout

- **Vent Screen:** No deficiencies noted with vent screen.
- **Evidence Of Foreign Matter:** No evidence of foreign matter observed.
- **Sediments:** Light sediment in bottom of tank was cleaned out with pressure washing.

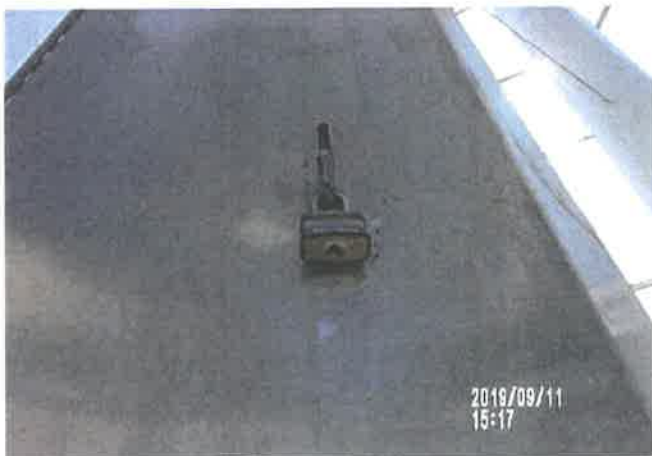
Locked Ladder Gate

- **Fence Around Site:** Tank is located inside a fenced-in area that is secure.
- **Ladder Gate/Access Door:** Exterior ladder did not have a ladder gate installed. Ladder gate installed during inspection.
- **Access Hatch Locked:** Access hatch is locked and secured.
- **Evidence Of Vandalism:** No evidence of vandalism was found.

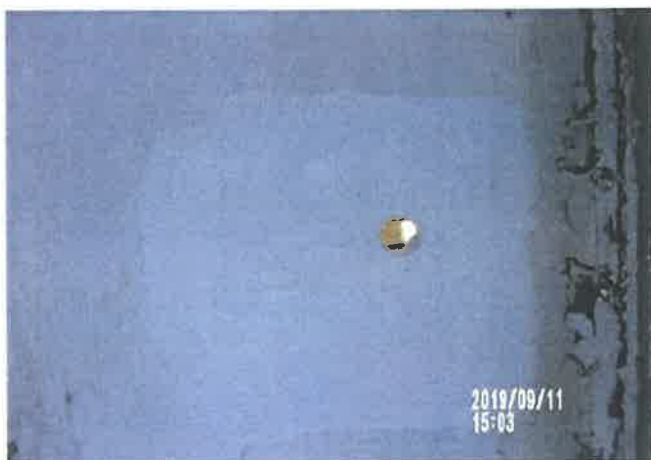
Balcony Weep Holes Drilled and Coated

- **Balcony:** Balcony landings have several areas where water will not drain. Weep holes were installed at inspection so water can drain. No other deficiencies noted with balcony railing or landings.

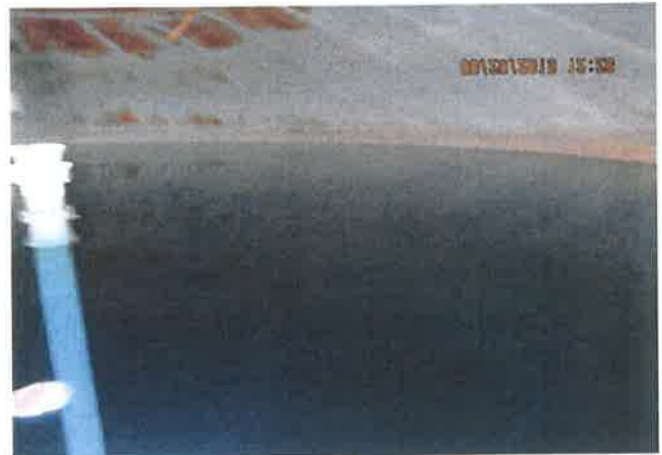
Interior Sidewall/Roof Coating

- **Interior Coating Condition:** Interior coating is beginning to show minor breakdown below the high water level. The interior coatings will be reviewed for scheduling renovation.
- **Exterior Coating Condition:** Exterior coating has chalked and faded, but still continues to provide protection. Areas will continue to be monitored.
- **Logo Condition:** No deficiencies noted.

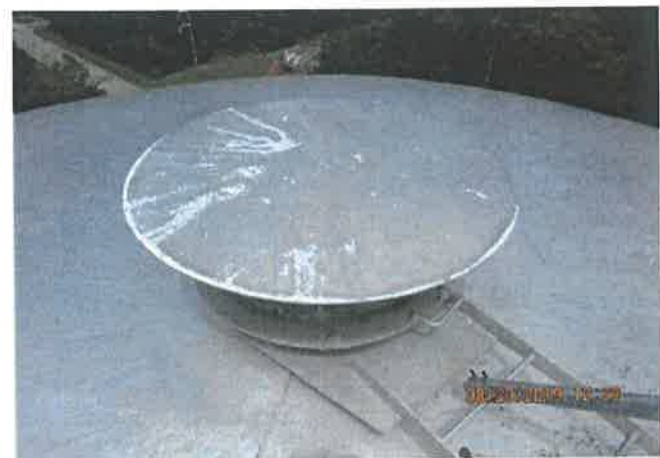
Vent Structure

- **Vents:** Roof vent is beginning to show minor corrosion and will be scheduled for repair or replacement.
- **Overflow Pipe:** Tank is equipped with an internal overflow.

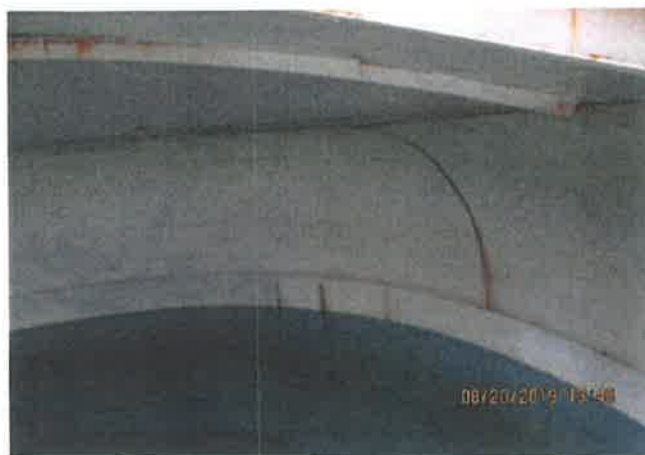
Interior Sidewall/Roof Coating

- **Interior Coating Condition:** Minor rust streaking/staining deficiencies were noted with the interior coating. Areas will continue to be monitored.
- **Exterior Coating Condition:** No deficiencies noted in the exterior coating.
- **Logo Condition:** No deficiencies noted.
