# City Of Waycross

## CONDITION ASSESSMENT REPORT

**Tank Name:**  
Industrial Blvd North Tank

**Project Number:**  
102429

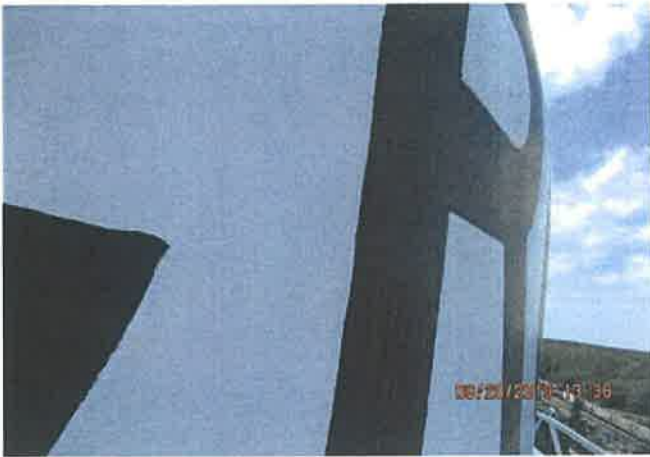
Exterior Roof Coating

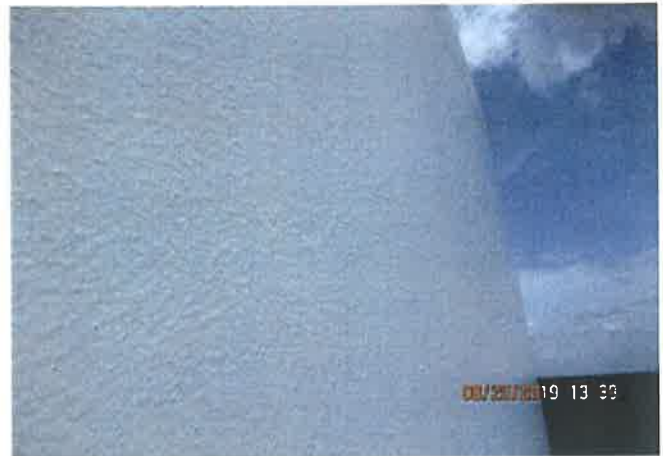
Exterior Sidewall Coating

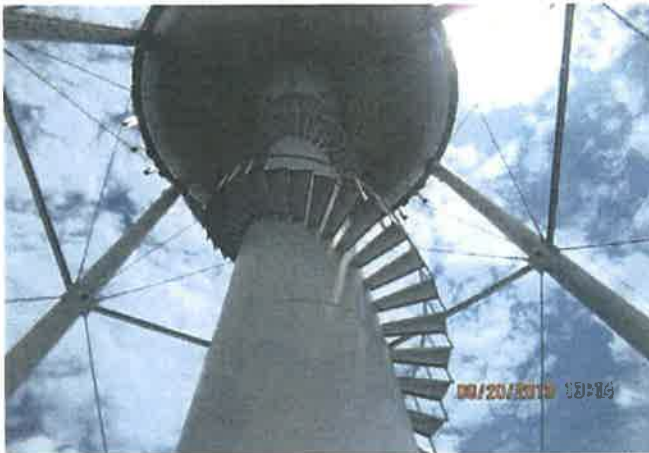
Exterior Sidewall Coating

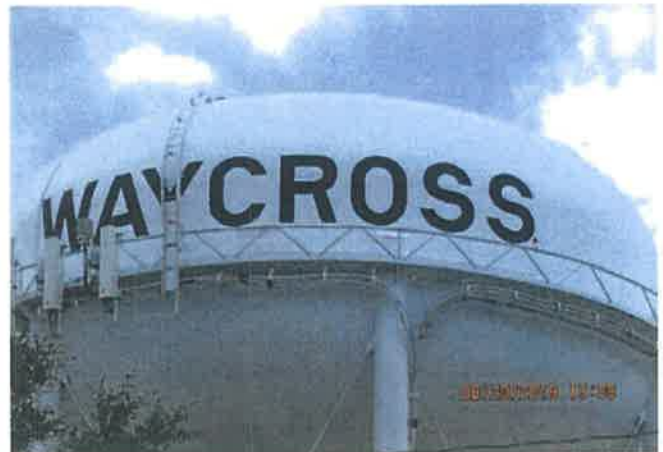
Exterior Under Belly Coating

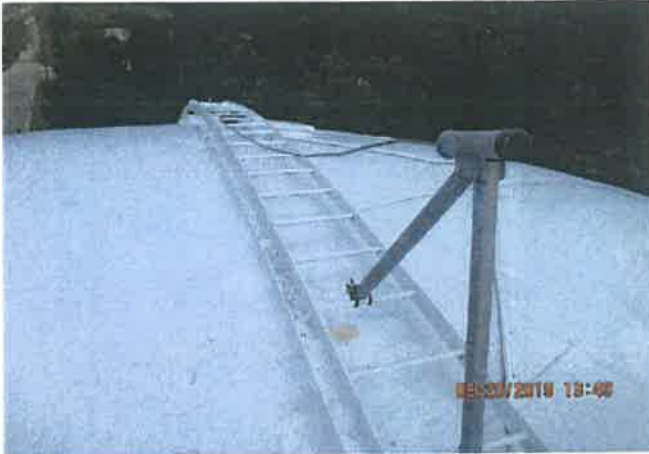
- **Access Hatch1:** No deficiencies noted.

Wet Interior Access Hatch

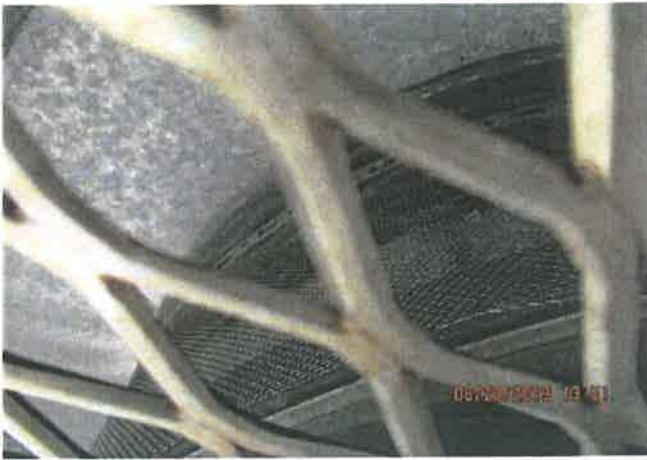
- **Vent Screen:** No deficiencies noted with vent screen.
- **Overflow Pipe Screen Flapper:** Overflow pipe is equipped with screen. No deficiencies noted with screen.
- **Evidence Of Foreign Matter:** No evidence of foreign matter observed.
- **Sediments:** Sediment was present in the bottom of the tank and will be cleaned out at the next scheduled washout.

Vent Screen

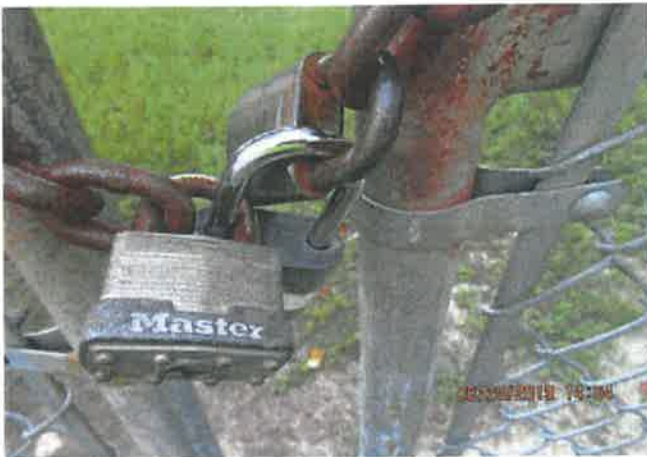
- **Fence Around Site:** Tank is located inside a fenced-in area that is secure.
- **Access Hatch Locked:** Access hatch is locked and secured.
- **Evidence Of Vandalism:** No evidence of vandalism was found.

Fence Around Site Locked

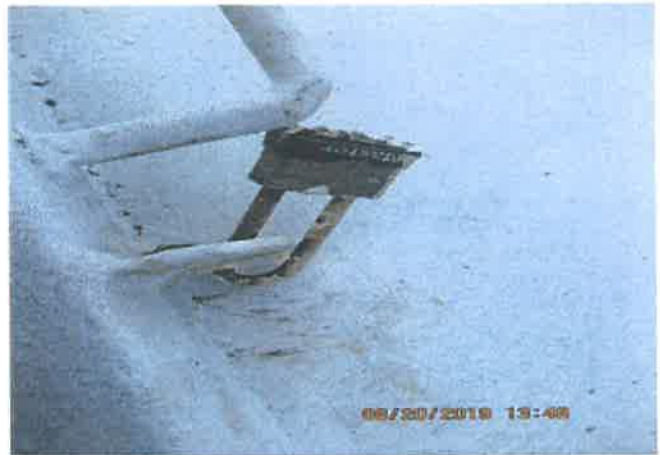
Wet Interior Access Hatch Locked

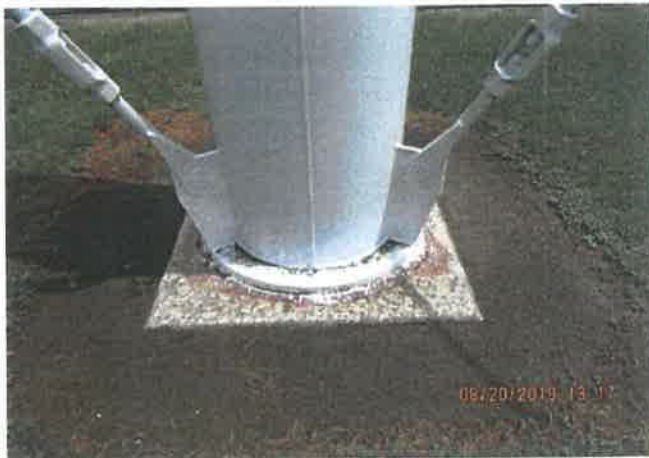
- **Foundation:** Foundation appears in good condition, no deficiencies noted.
- **Legs:** No deficiencies noted with tank legs. Paint coating continues to protect the substrate. Light mildew exists on structure.

Leg Structure

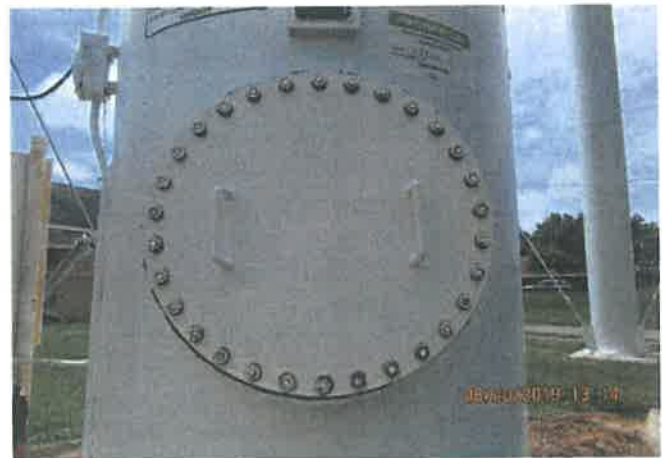
- **Anchor Bolts:** Anchor bolts are protected and show no rust or corrosion.
- **Riser Pipe:** No deficiencies noted with riser. Paint coating continues to protect the substrate.

Riser Manway

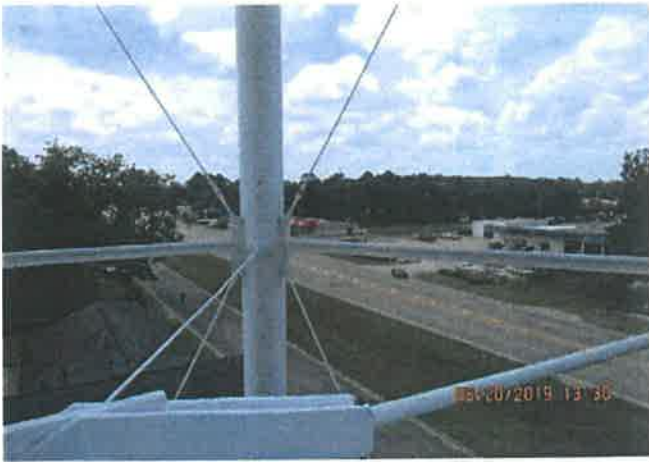
Strut Connections

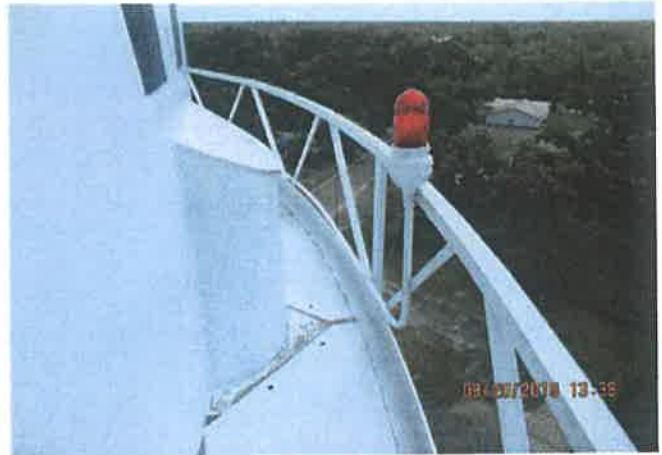
- **Balcony:** No deficiencies or corrosion damage noted for balcony railings and landings.
- **Interior Ladders:** Interior ladder partially inspected from hatch. No deficiencies noted with visible portion of ladder.

Balcony and Handrail

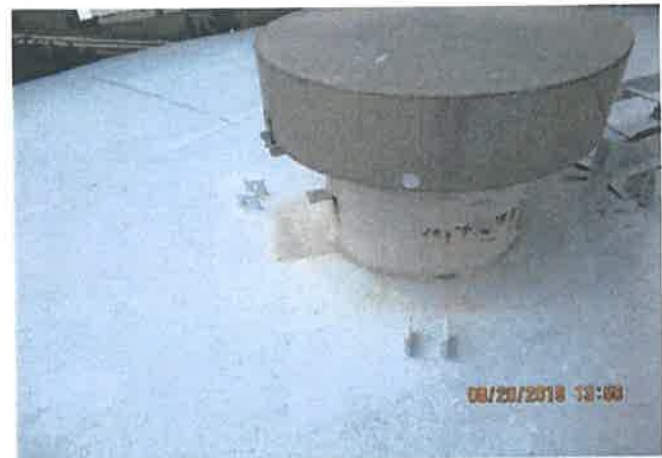
- **Vents:** No deficiencies noted with vent.
- **Overflow Pipe:** Tank is equipped with an internal overflow.
- **Welds:** No deficiencies noted with weld seams.

Vent Structure

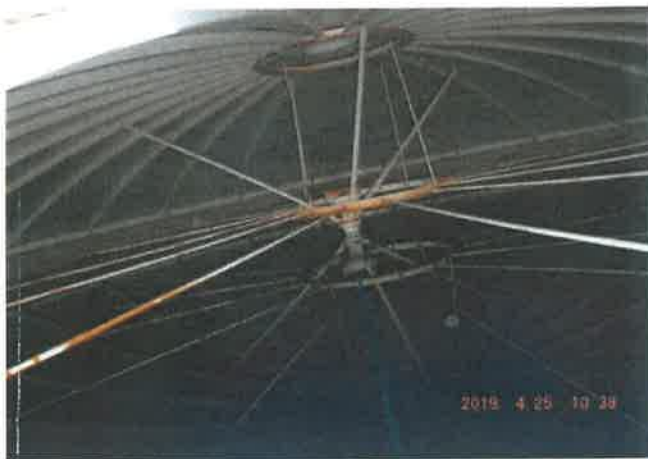
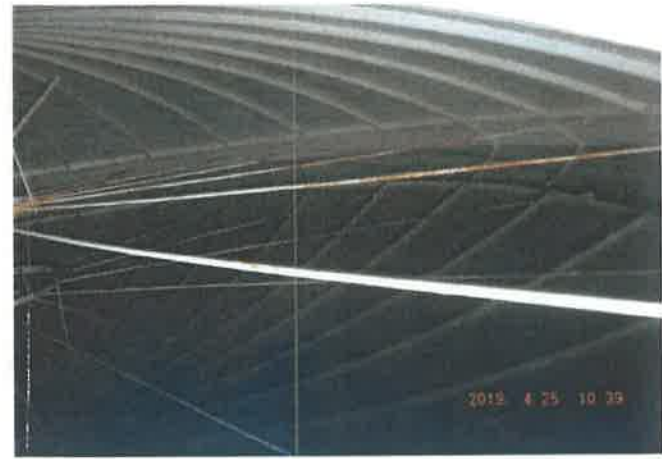
- **Interior Coating Condition:** Visible areas of the Interior lining are in good condition and continues to protect the substrate.
- **Exterior Coating Condition:** No deficiencies noted in the exterior coating.
- **Logo Condition:** No deficiencies noted.

Interior

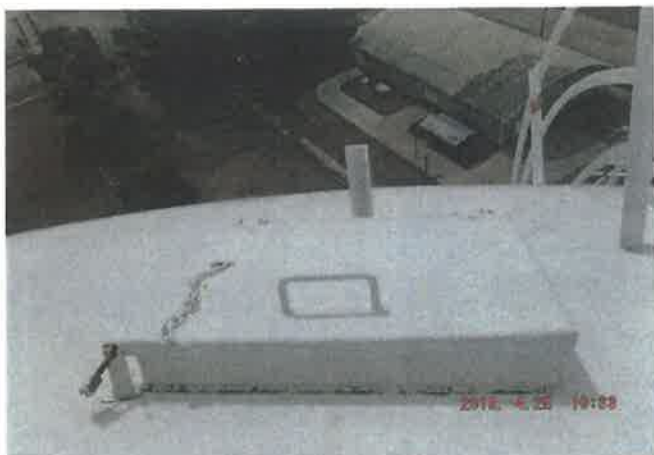
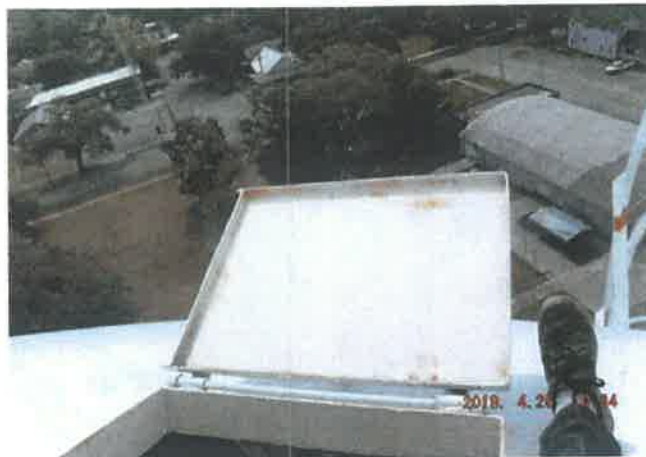
- **Access Hatch1:** No deficiencies noted.

Roof access hatch

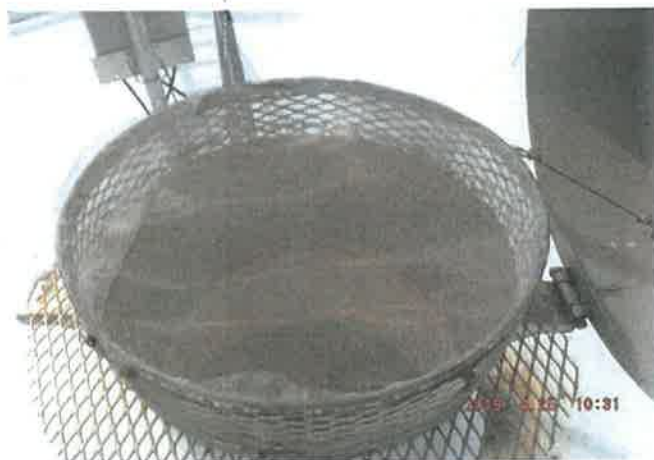
- **Vent Screen:** No deficiencies noted with vent screen.
- **Evidence Of Foreign Matter:** No evidence of foreign matter observed.

Roof vent screen

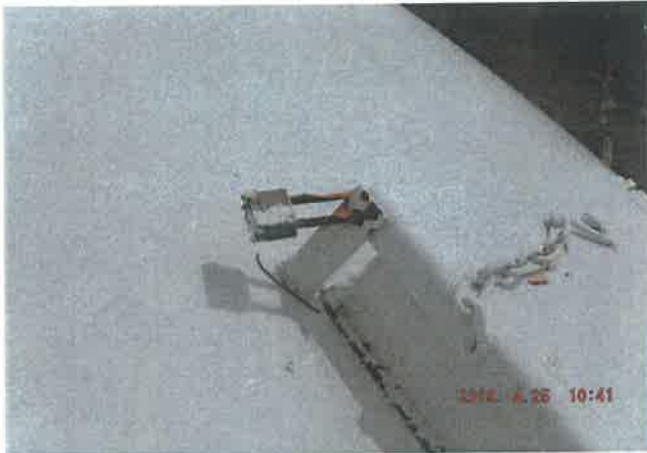
Roof access hatch locked

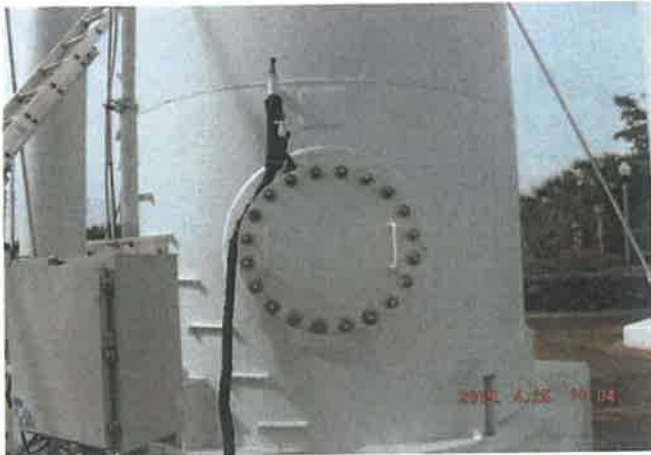
- **Riser Pipe:** No deficiencies noted with riser. Paint coating continues to protect the substrate.
- **Riser Rods:** No deficiencies noted with riser rods.

Riser manway

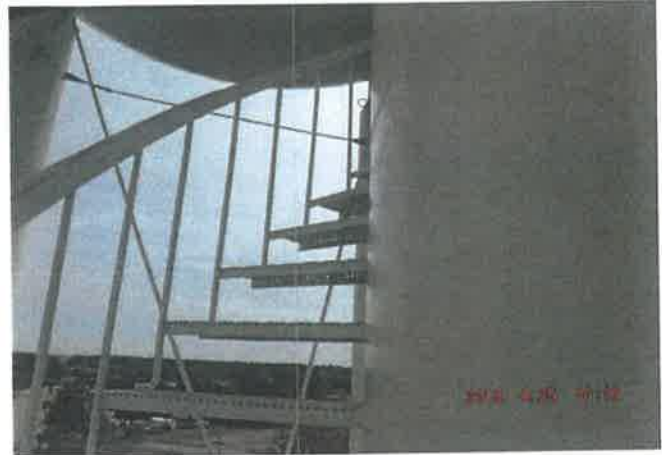
- **Access Ladders:** No deficiencies noted with spiral staircase.
- **Column Flanges:** Column flanges are painted and no corrosion is present.
- **Anchor Bolts:** Anchor bolts are protected and show no rust or corrosion.

Access staircase

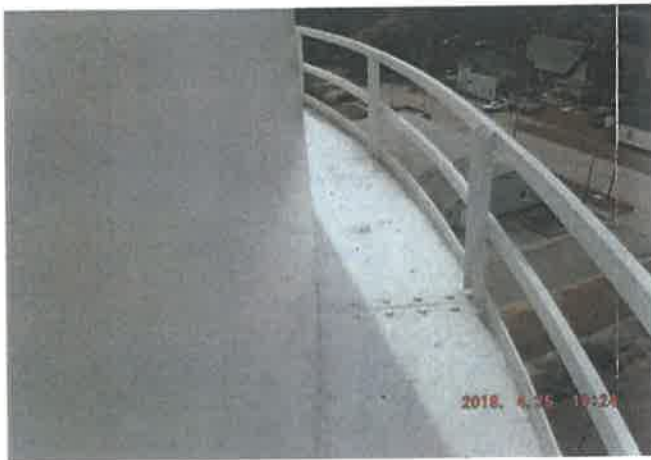
- **Wind Rods:** No deficiencies noted with wind rods.
- **Watertight Conditions:** There are no visible leaks at the time of the inspection.
- **Balcony:** Balcony landings have several areas where water will not drain. Repairs will be scheduled. No other deficiencies noted with balcony railing or landings.

Balcony and handrail
