**ASBESTOS INSPECTION REPORT**  
**GEORGETOWN CITY HALL**  
Georgetown, South Carolina  
Asbestos Inspections, LLC Project # 2018-152  
*Performed in general accordance with SCDHEC regulation 61-86.1  
along with OSHA regulation 29 CFR 1926*

**Inspection Completed On – June 18, 2018**  
**Report Prepared On – June 27, 2018**

Subject: Asbestos Inspection Report  
Georgetown City Hall  
120 North Fraser Street  
Georgetown, South Carolina  
Asbestos Inspections, LLC Project # 2018-152

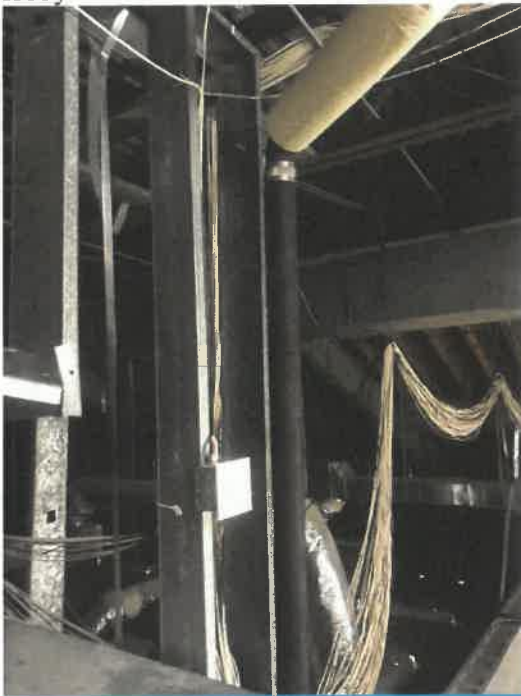
HVAC system above ceiling tiles in public lobby
