City of Springfield

Bid #1061 Summary

Panasonic Corporation of North America

## Report of operation monitoring of ECO i systems at The Center

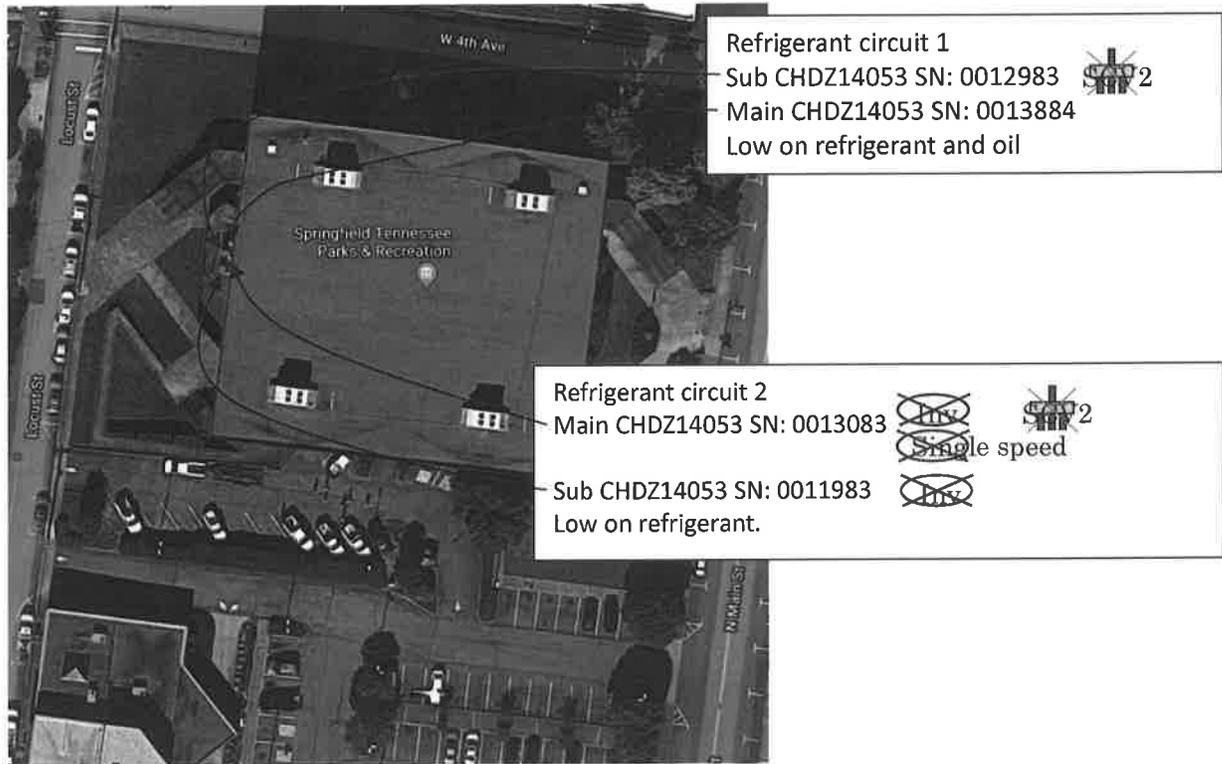
Fig. 1 Location of each systems around the building

Circuit	Indoor	Issues found		Evaluation of impact
1	22 units	12 ton Sub	SCV2 is stuck in cooling mode position, and needs replacing.	Capacity loss about 40%.
		Low on refrigerant and oil		
2	26 units	12 ton Main	Inverter compressor and 3rd. compressor are leaking electricity to ground and need replacing.	Capacity loss about 60%.
			SCV2 is stuck in cooling mode position, and needs replacing.	
		12 ton Sub	Inverter compressor is leaking electricity to ground and needs replacing.	
		A little low on refrigerant
