Asbestos & Lead Based Paint Assessment

City of Spartanburg
213 Windigo Road
Spartanburg, South Carolina 29306

Project Number: 0124-01

June 13, 2024

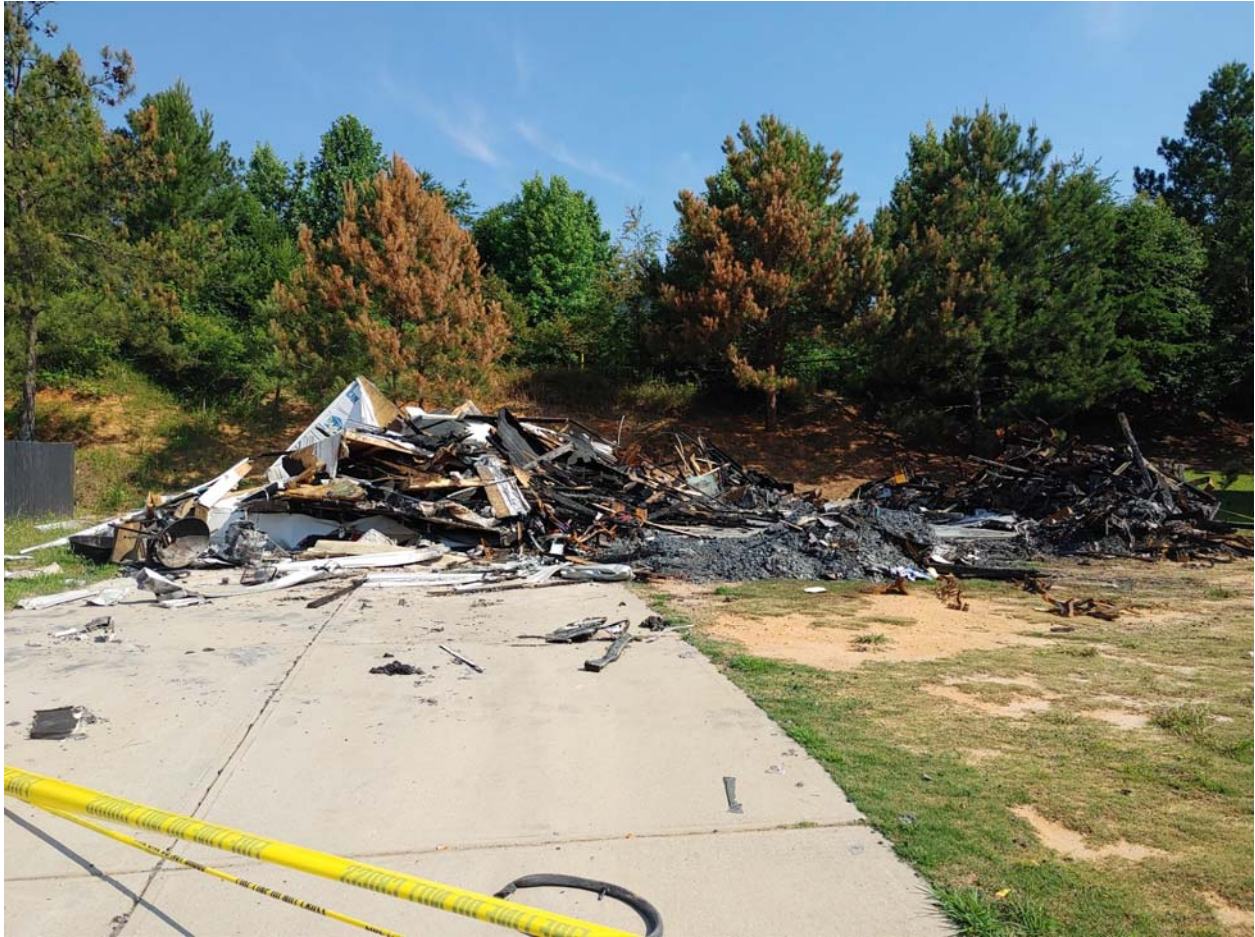
- The residence has burned down and collapsed into a debris pile.
- Roof shingles & felt, vinyl siding over wood, drywall with joint compound were observed in the debris pile.
- Large portion of materials were unidentifiable due to fire damage.

At the time of the assessment, the roof of the residence was found to be burned down and collapsed into a debris pile. Subsequently, the building materials and finishes not sampled during the survey should be presumed to be ACM. Apex recommends that the residence be demolished in place and materials be treated and disposed of as regulated asbestos containing materials (RACM).

1. Demolish the residence/debris pile with presumed ACM in place and dispose of the waste stream as friable Regulated Asbestos Containing Materials (RACM) and delivered to an asbestos approved hazardous waste landfill for disposal.
