**Engineering Evaluation of Concrete Condition
and Steel Sheet Pile Wing Wall Thickness
St. Johns River Water Control Structure S-96B
Indian River County, Florida**

Subject: Engineering Evaluation of Concrete Condition and
Steel Sheet Pile Wing Wall Thickness
St. Johns River Water Control Structure S-96B
Indian River County, Florida

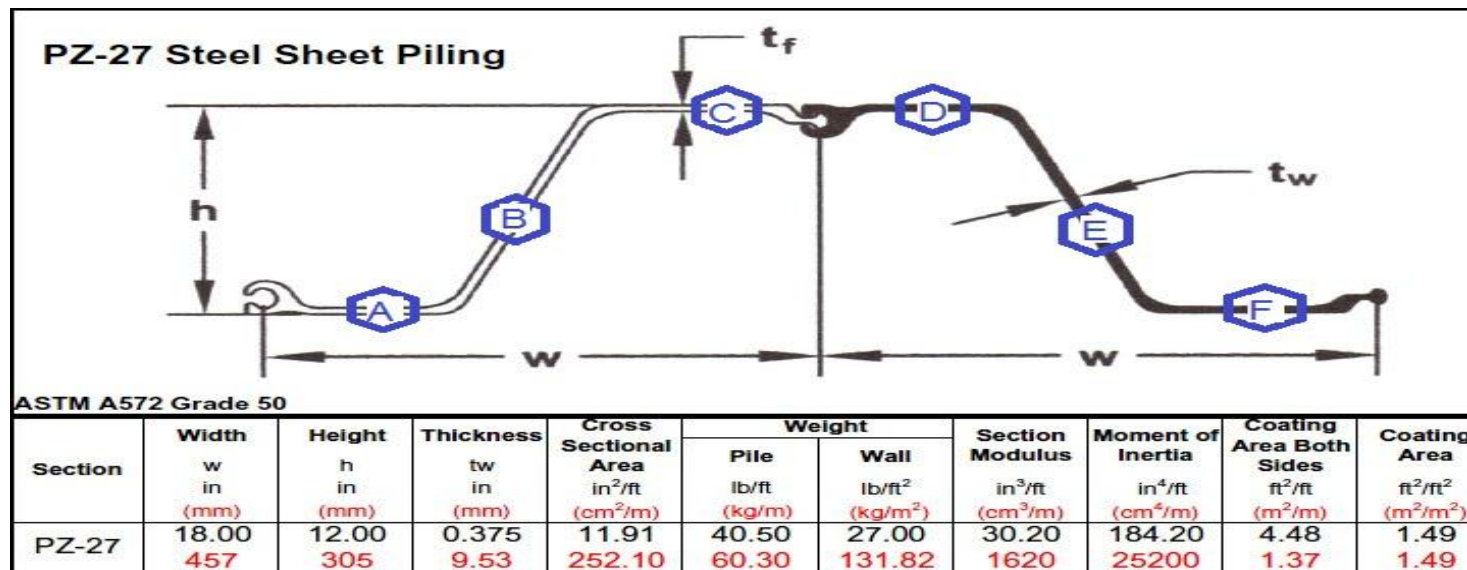
Approximate Reading Designation Location

Based on our observations and thickness readings, it is our opinion that the steel sheet pile wing walls have not experienced excessive erosion or corrosion due to physical or chemical conditions. It appears that the wing walls have been treated with corrosion inhibiting paint/coatings in the past. We note that the coating on the southwest wingwall is peeling. Routine periodic applications of additional paint/coatings are expected.

TABLE 3A
Ultrasonic Thickness Readings
Steel Sheet Pile Wing Walls
Water Control Structure S-96B
SJRWMD, Indian River County, Florida

Relative to the upstream steel sheet pile wing walls, we recommend that the corrosion occurring at the joints and at the water level be pressure washed and/or sand blasted to remove the corrosion and then repaint/coat the prepared surface as needed.

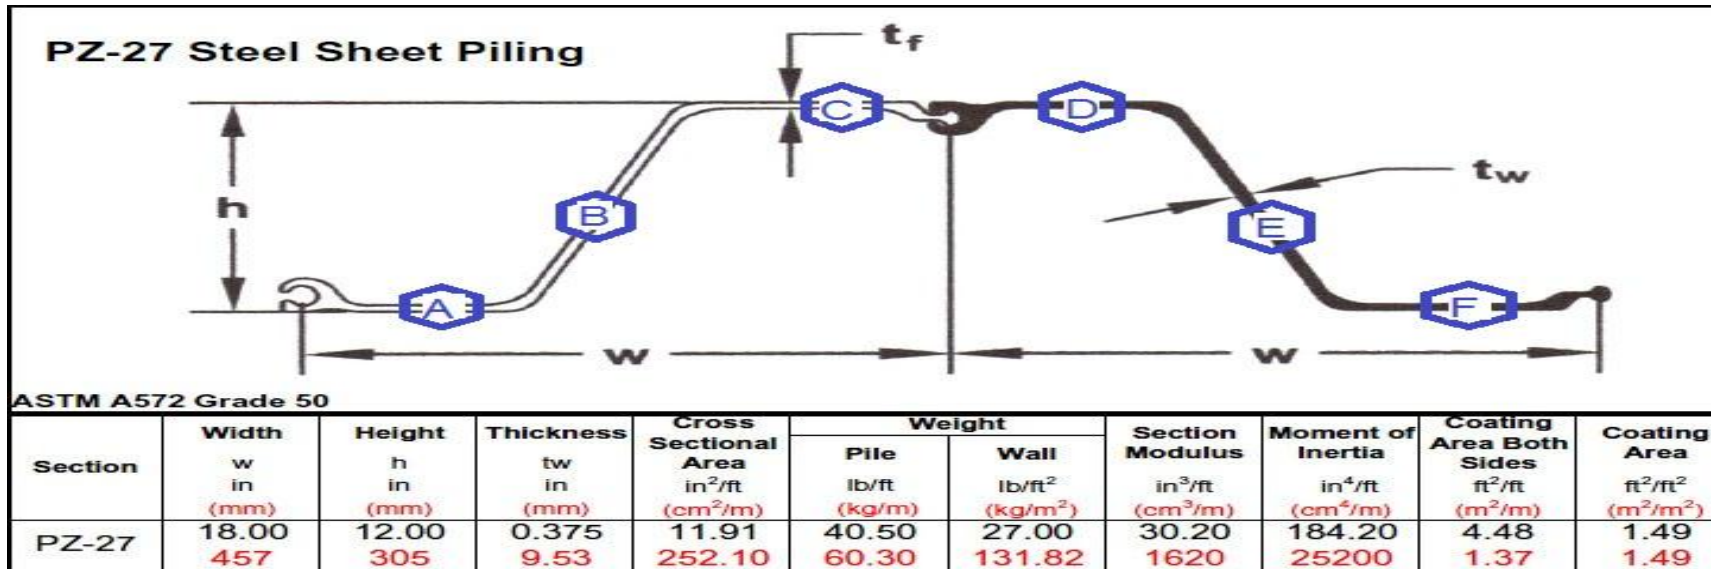
Approximate Reading Designation Location

TABLE 3B
Ultrasonic Thickness Readings
Steel Sheet Pile Wing Walls
Water Control Structure S-96B
SJRWMD, Indian River County, Florida

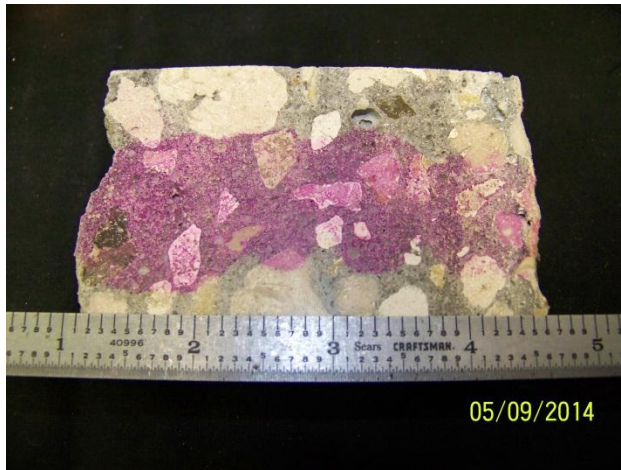
Core 1A

- White to tan to crushed fossiliferous limestone and siliceous limestone.
- Nominal maximum particle size is ¾ inch graded down to ⅛ inch.
- The particles are equidimensional with a sub-rounded to sub-angular texture.
- Volume of coarse aggregate appears reasonable.
- Coarse aggregate relatively well distributed.
- Aggregate paste bond is good.
- No indications of cement-aggregate reactions were noted within the coarse aggregate.
- One aggregate piece in Sample 3A was found to contain a crack partially through the piece. This does not appear to be the result of a reactive aggregate. (Photo 9)

- No cracking observed, except for the crack observed in the coarse aggregate piece. The piece of aggregate was well embedded in the concrete and is not considered to be an issue at this time.
