## City of Havelock Engineering Services Gray Fox Road Infrastructure Improvements

# Structure Safety Report

## 2 Year Complete Topside and Underwater Element Inspection

DIVISION: 2 COUNTY: CRAVEN STRUCTURE NUMBER: 240216 FREQUENCY: 24 MONTHS

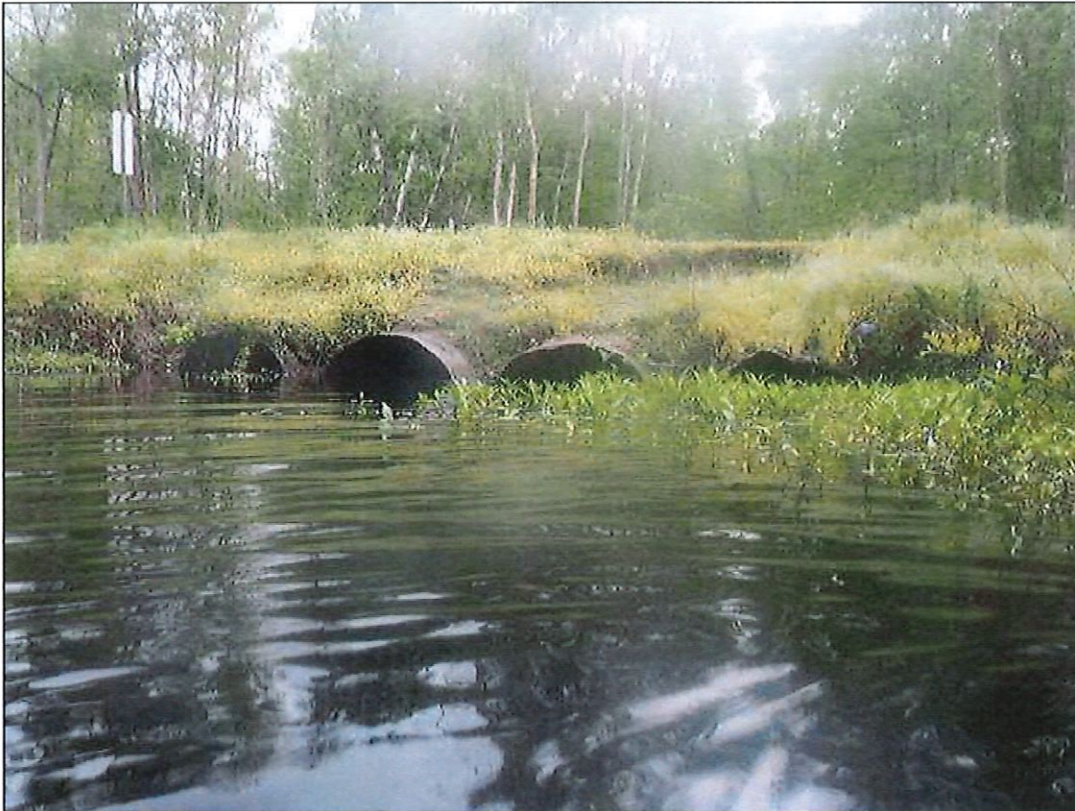
LOOKING UPSTREAM

Priority Level	Defect Type	Quantity	Defect Description
②		80	DRIFT AT THE UPSTREAM END FROM MUDLINE TO 1' ABOVE TOP OF PIPES EXTEND +/- 5' INTO PIPES.(PAR)
