ROSA PARKS ESCAMBIA
COUNTY AREA TRANSIT (ECAT)
BUS WASH

**FACILITIES
ASSESSMENT
REPORT**

CAA Project No. 21003
Revised 18 AUGUST 2021
PHASE 1 - REPAIR

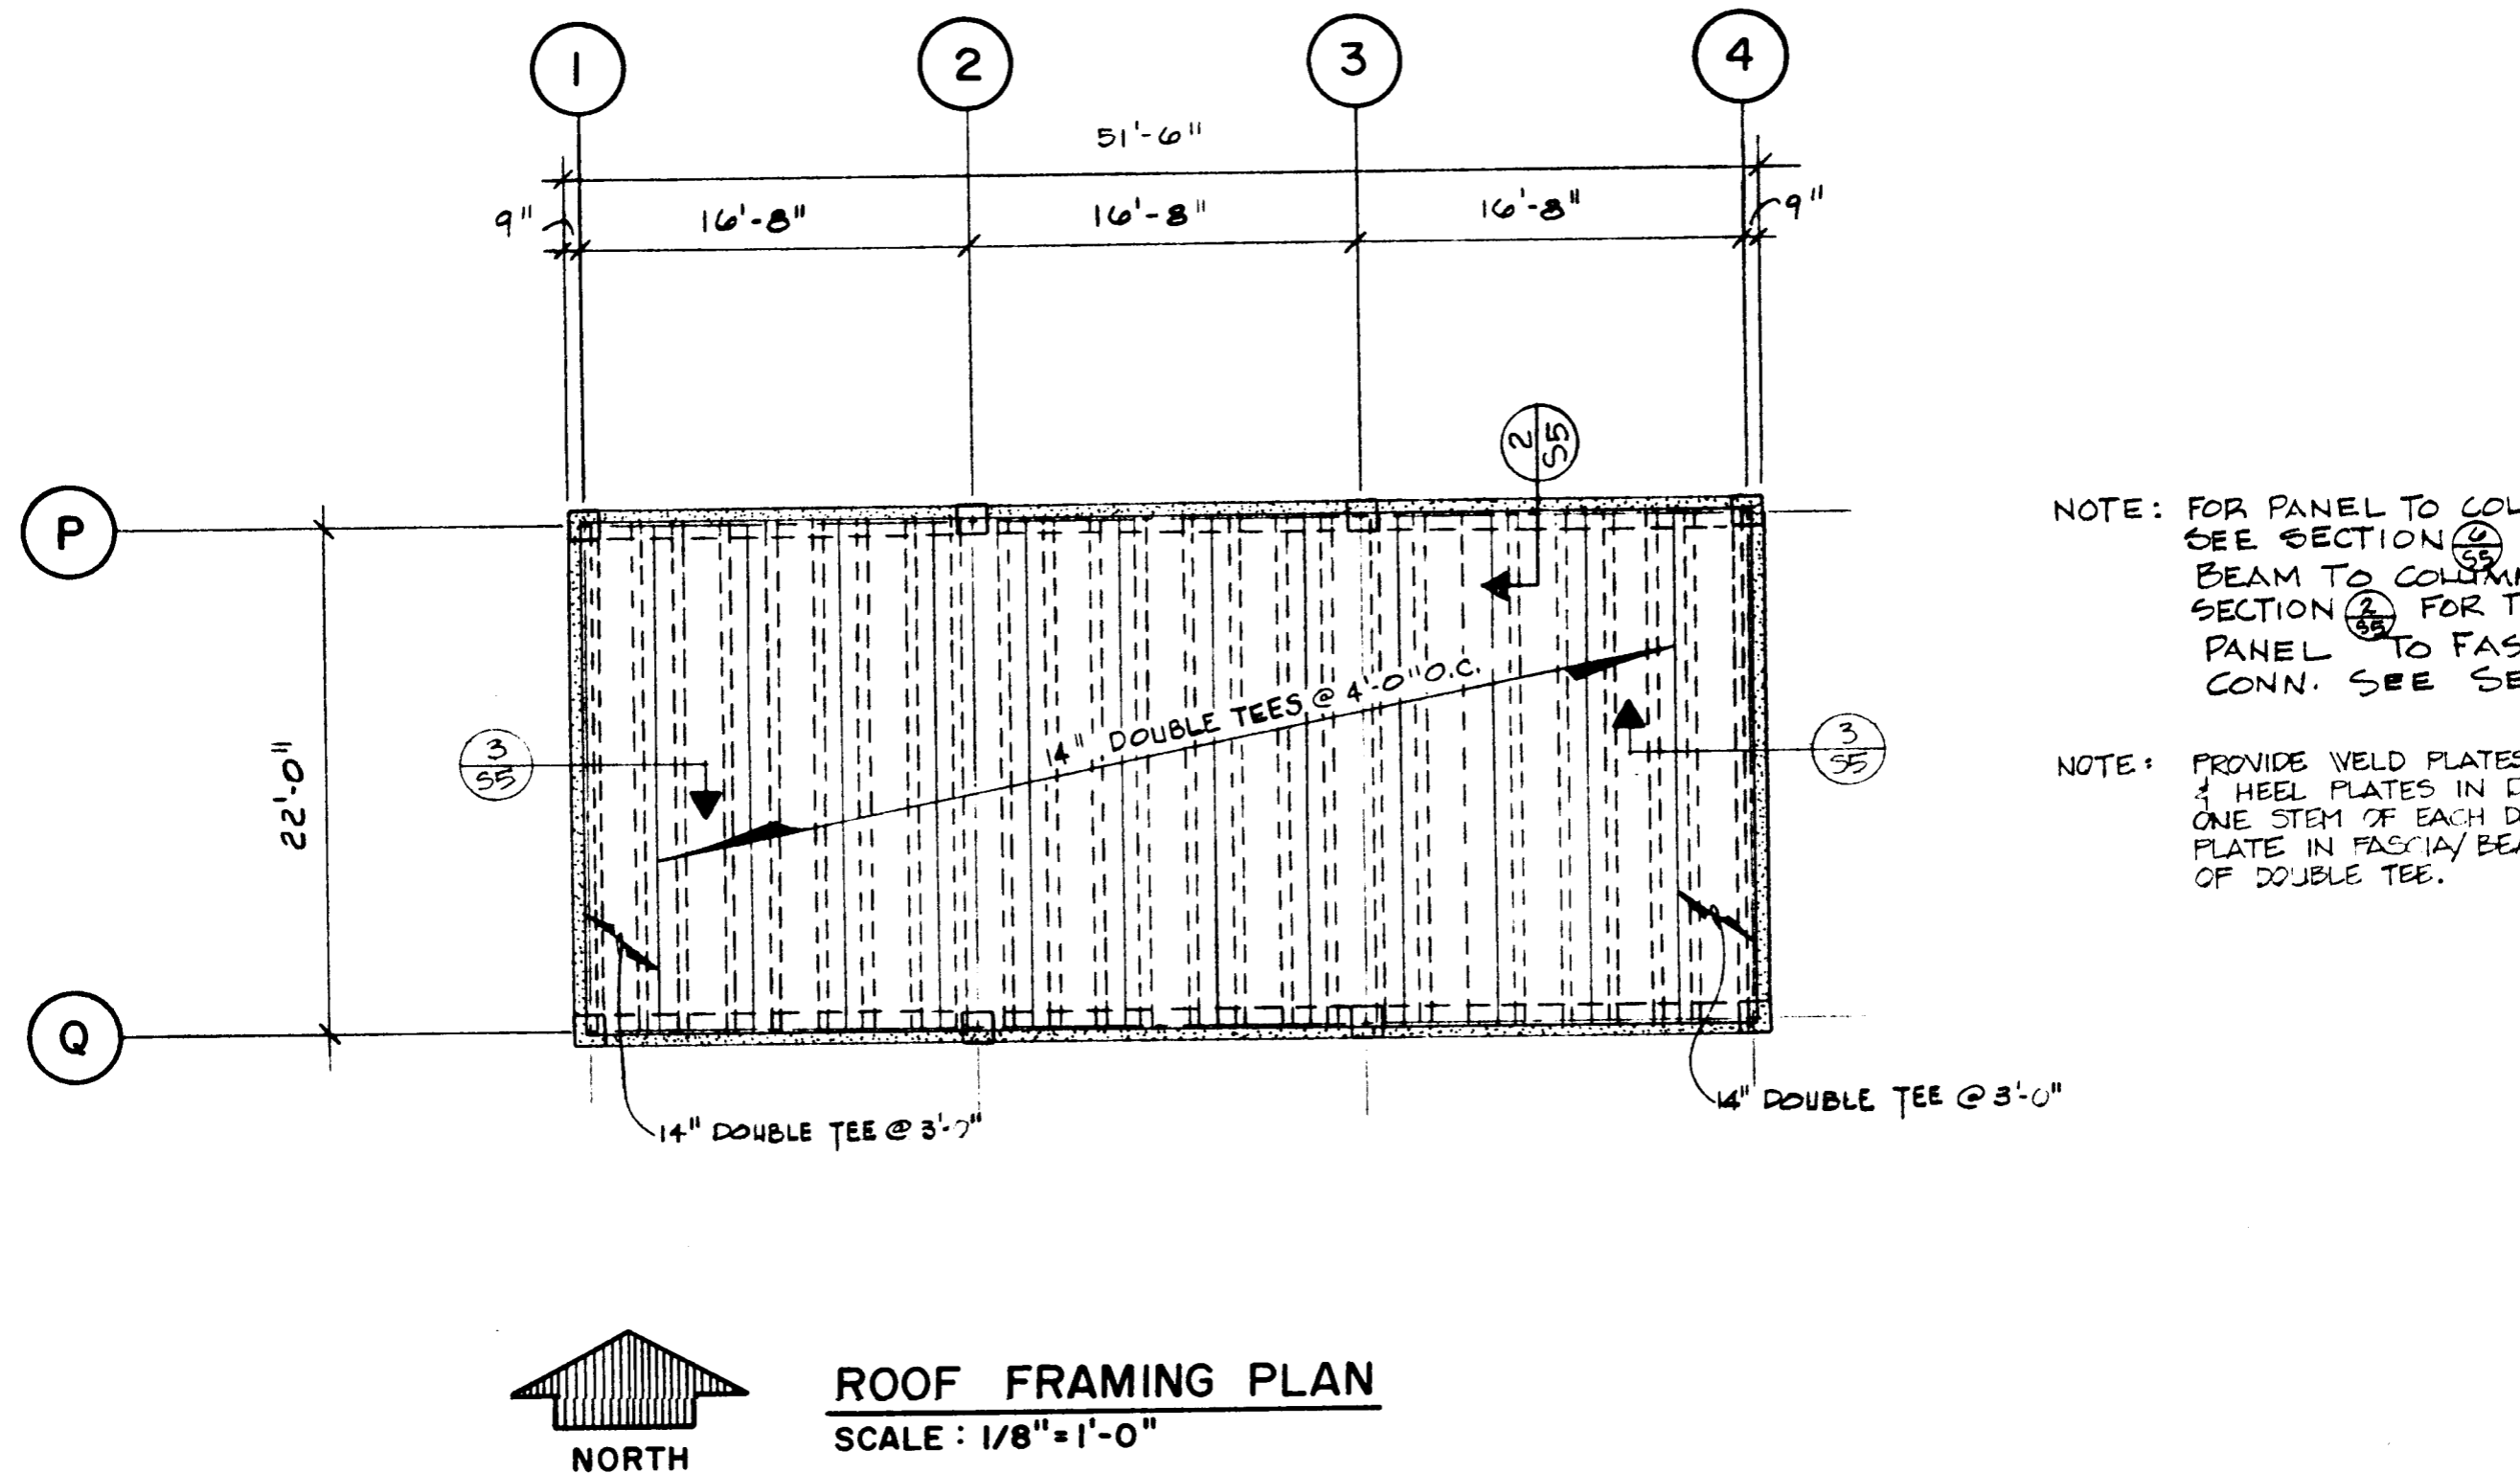
Exterior – Located to the South Side of the structure, a V-Crimp galvanized metal roof is attached and (2) panels were noted to be damaged.

**V-Crimp roof -
Wind blown debris damage**
