Nighthawk **Imaging Services**

1069 Thunderbolt Dr
Report

RE: Thunderbolt Career & Tech - 1069 Thunderbolt Dr. Walterboro, SC 29488

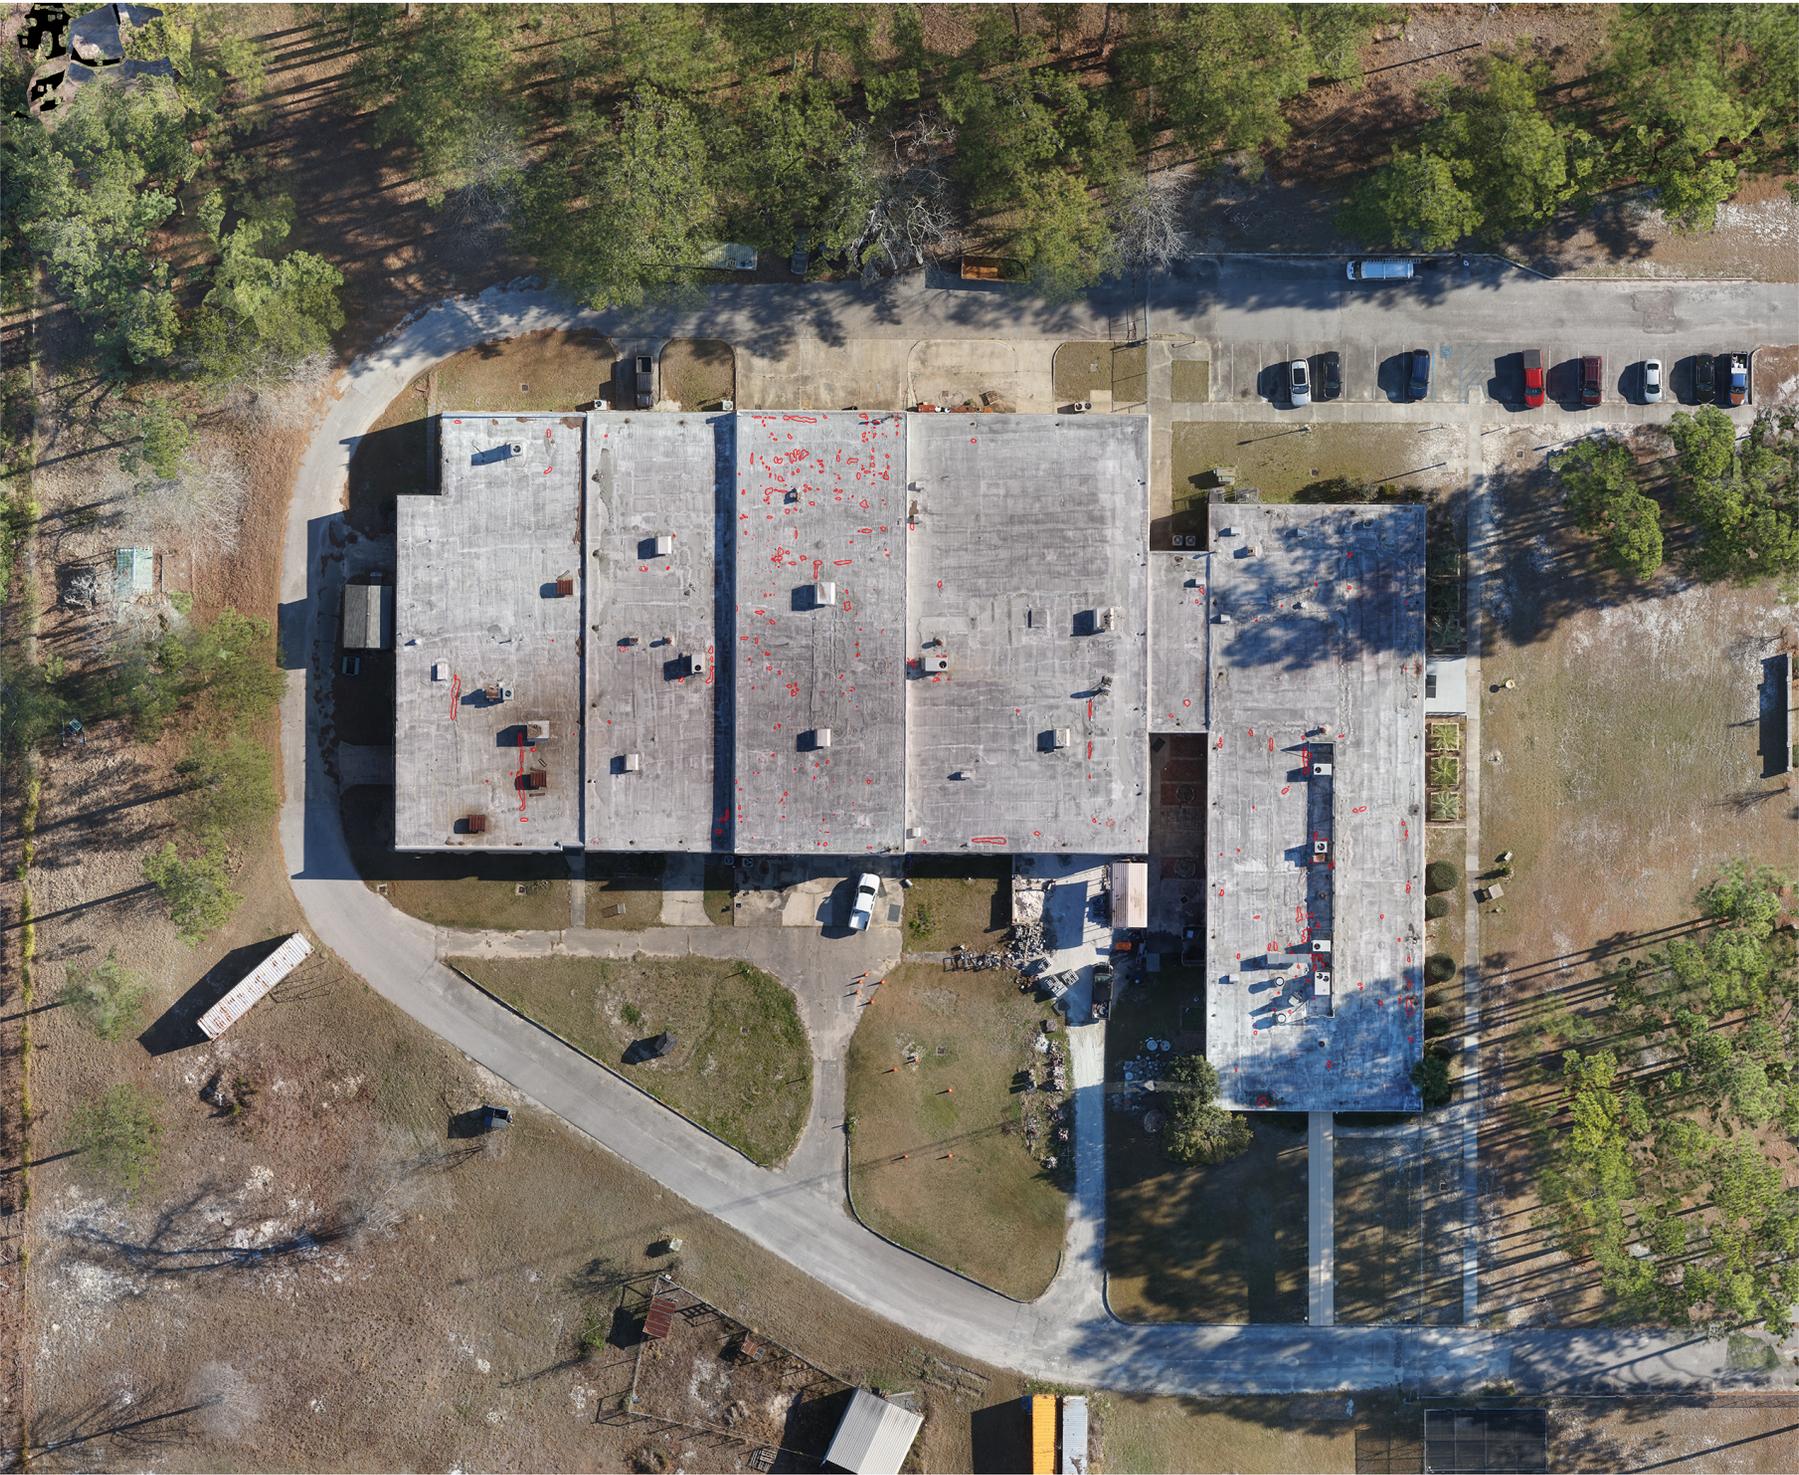
We documented our inspection of the facility by taking both infrared and visual aerial photos of the entire roof assembly and plotting the results on the scaled roof drawing. Analysis of the imagery and data indicates that we found numerous (over about 275) areas of wet and/or damp roof insulation. We have used the computer to calculate the total roof area of wet roof insulation. There are however other areas or defects such as cracks, blisters, and the like, that contractors will need to consider when preparing their roof bids responsibly. The total roof area was 51,291 sq ft, and the wet regions of insulation totaled approximately 660 sq ft.

- Roofing contractors and/or consultants need to verify the type, depth of insulation, and the total square footage of roof insulation needing to be replaced.
