GEOTECHNICAL ENGINEERING REPORT

**Arlington County Department of Human Services Group Home
Arlington, Virginia**

**16 July 2020
270060006**

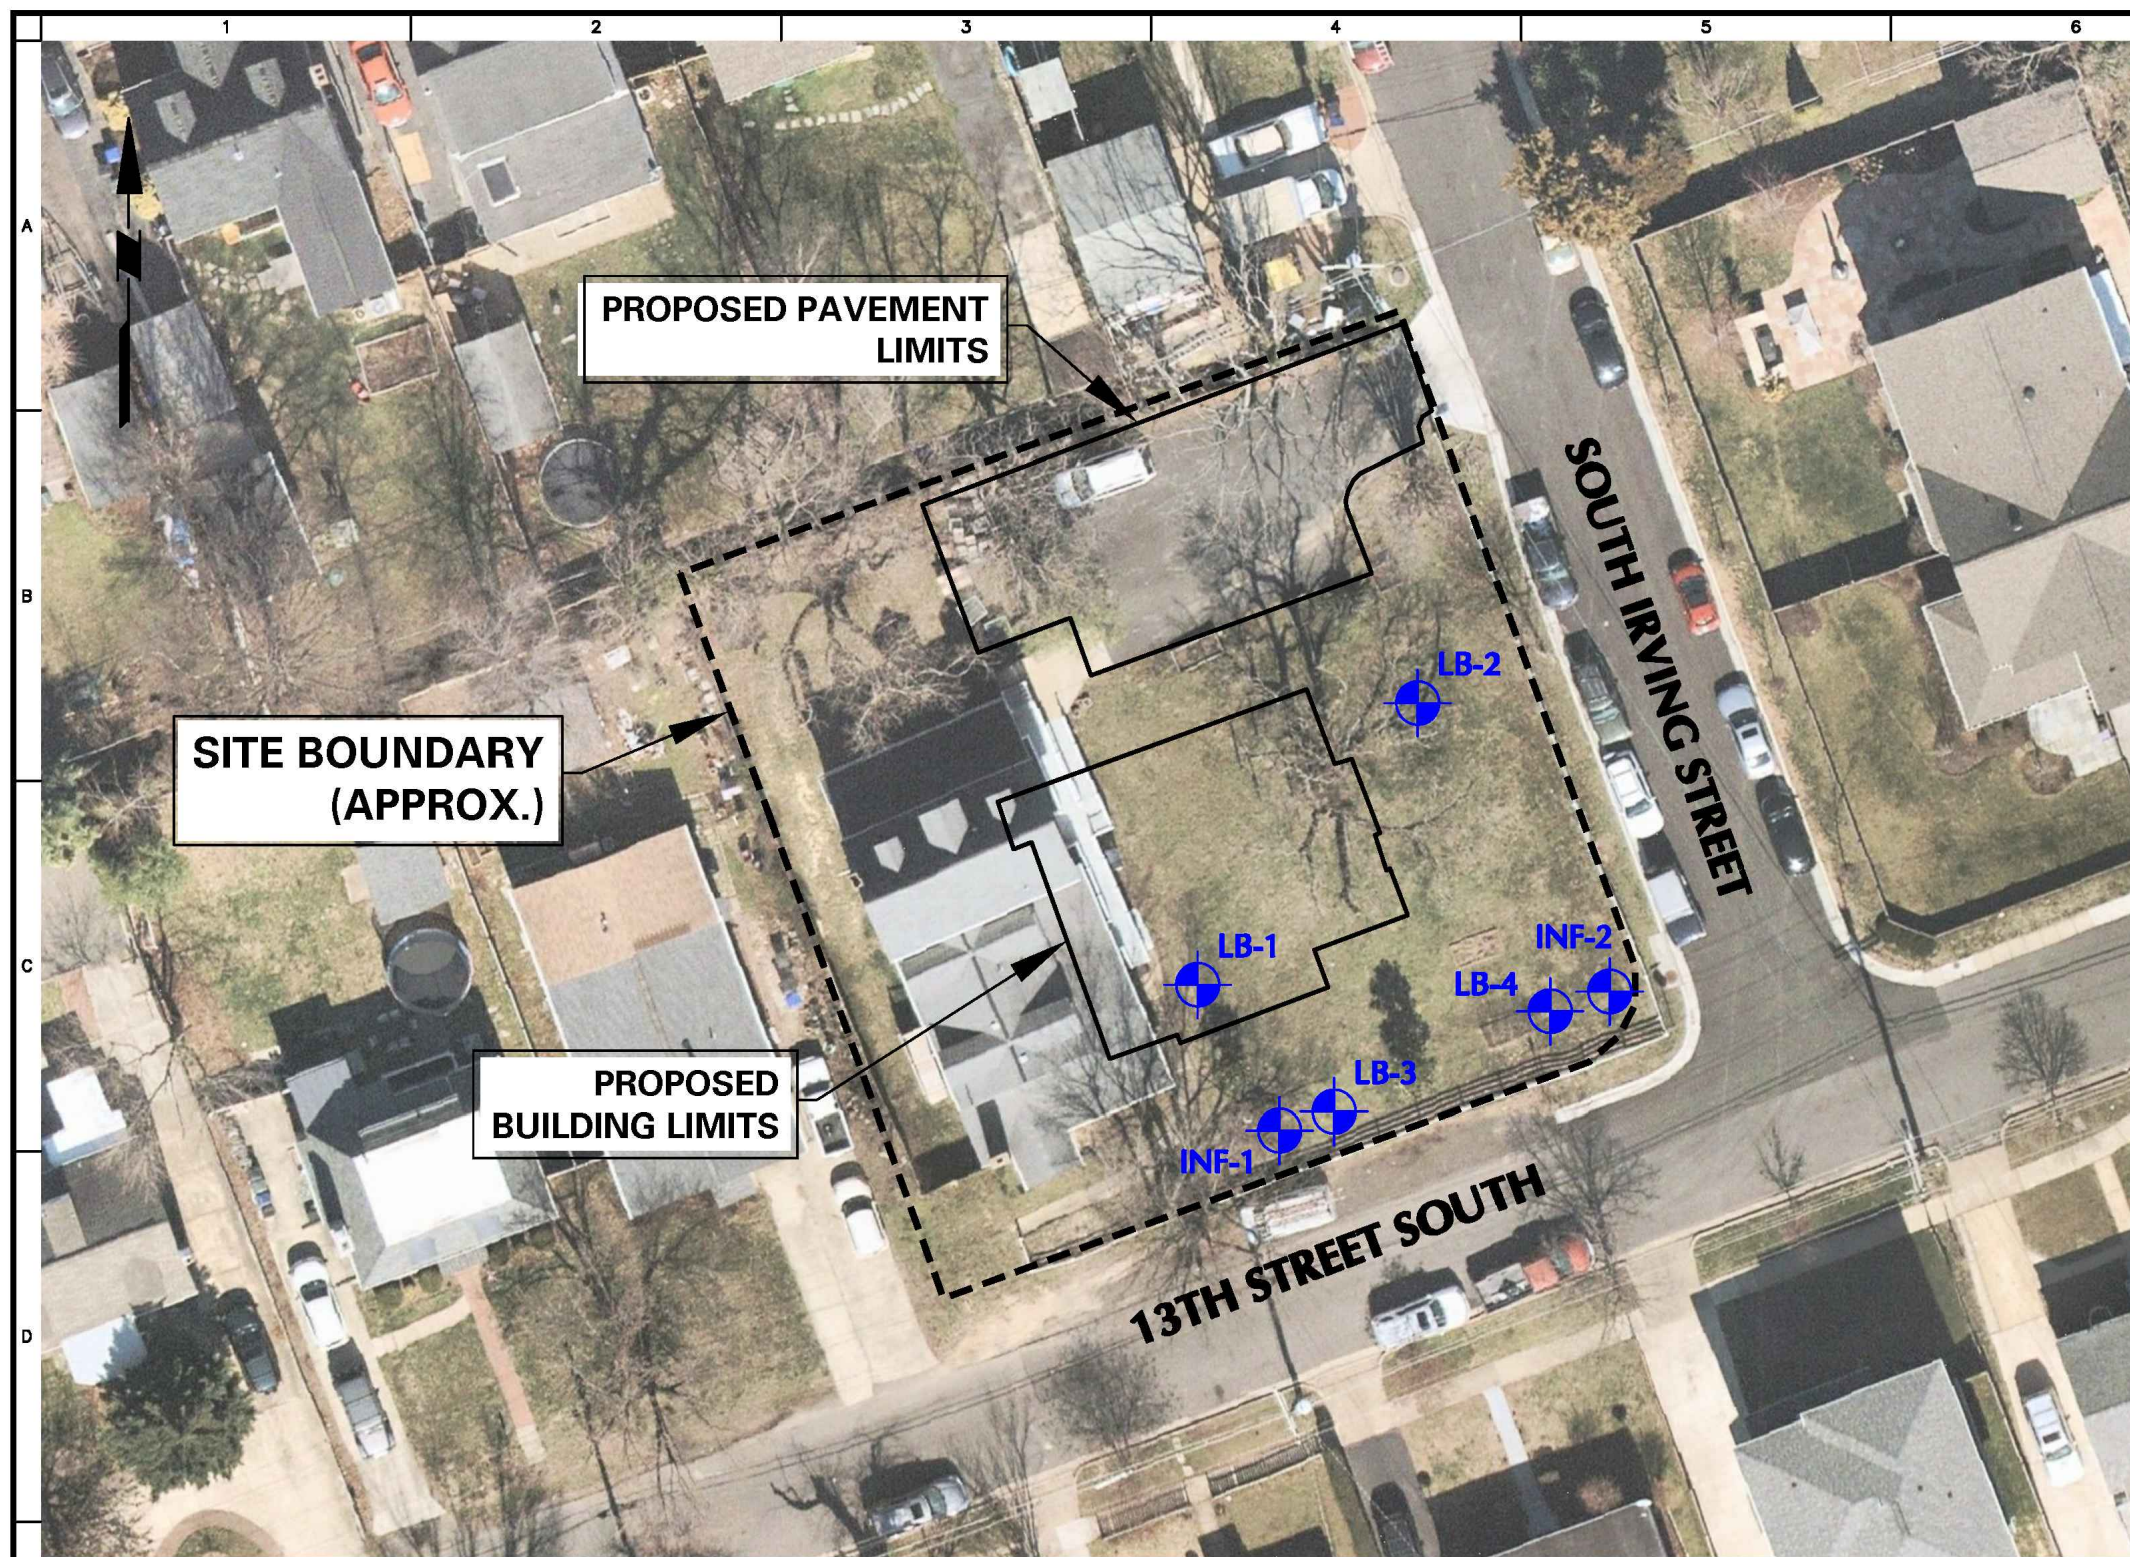
Project ARLINGTON COUNTY DHS GROUP HOME	Drawing Title INVESTIGATION PLAN	Project No. 270060006	Drawing No. 2
Date 7/16/20	Drawn By BSS	Checked By KJL	Sheet 2 of 5

- BACKGROUND AERIAL IS REFERENCED FROM NEARMAP, ACCESSED 25 JUNE 2020.
- BORINGS LB-1 THROUGH LB-4 AND INFILTRATION TESTS INF-1 AND INF-2 WERE DRILLED BY FREE STATE DRILLING INC. ON 1 JULY 2020 UNDER THE DIRECT SUPERVISION OF LANGAN ENGINEERING AND ENVIRONMENTAL SERVICES.
- FOR DETAILED DESCRIPTIONS OF THE SUBSURFACE CONDITIONS, SEE APPENDIX A FOR THE BORING LOGS.
- ALL BORING AND INFILTRATION TEST LOCATIONS ARE APPROXIMATE.

- LB-1** BORING LOCATION
- INF-1** INFILTRATION TEST LOCATION

We performed a geotechnical investigation on 1 and 2 July 2020 that consisted of drilling four borings and performing two infiltration tests. Subsurface conditions at the site generally consist of surficial topsoil or asphalt overlying successive strata of silt, upper clay, sand, and lower clay and are summarized as follows:
