LEAD-BASED PAINT INSPECTION REPORT

**293 South Converse Street
Spartanburg, South Carolina**

**Crossroads Environmental, LLC
1258 Boiling Springs Road
Spartanburg, South Carolina 29303
(864) 541-8736
CRE Project # 18098-IL**

PROJECT NUMBER: 18098-IL

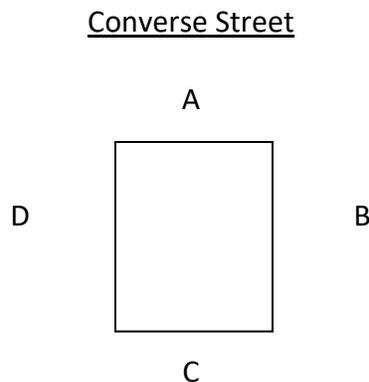
For report purposes, the following building/room side designations utilized in the results table included as Attachment I are as follow:

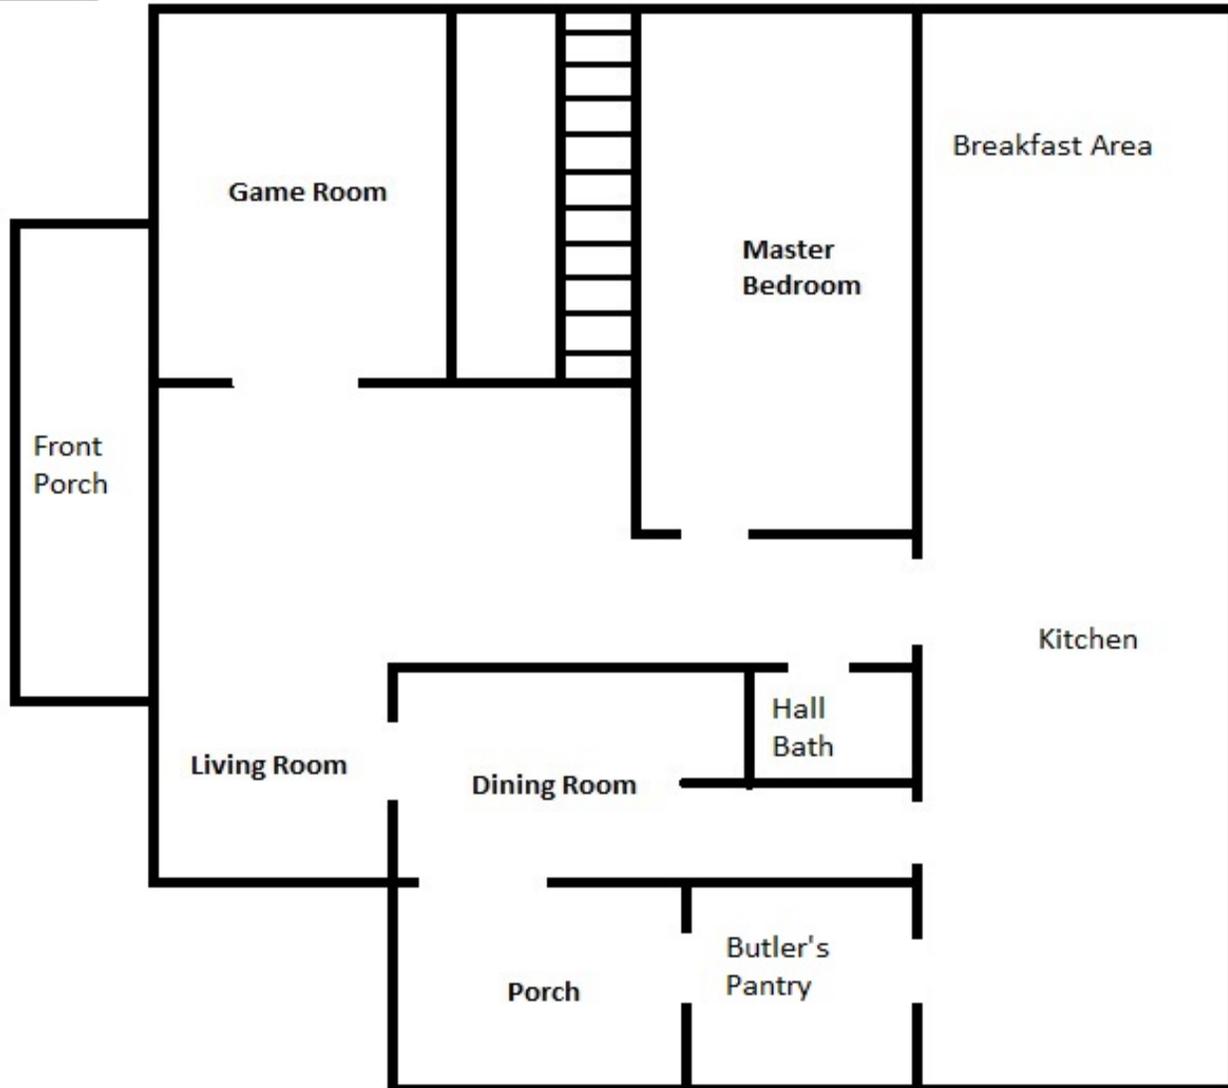
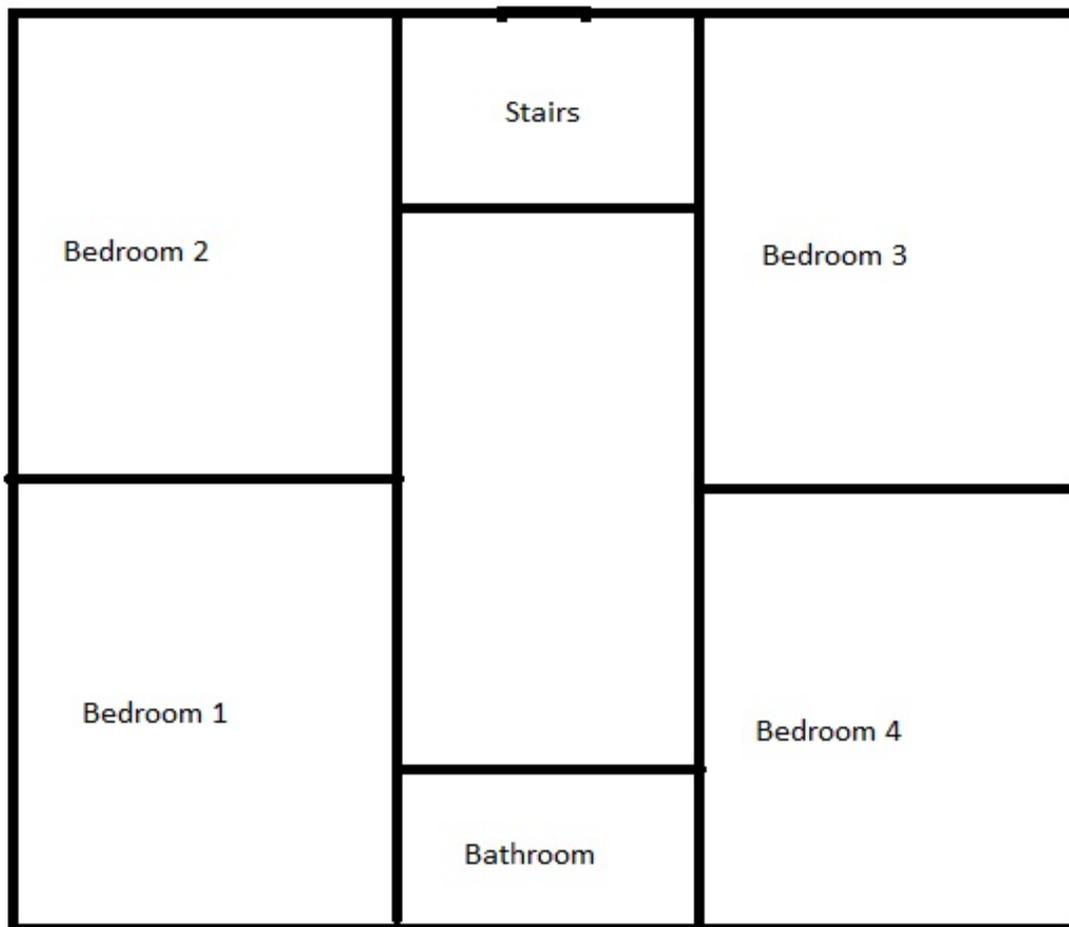
Porch

Butler's
Pantry

S. Converse Street

- ATTACHMENT I: LEAD RESULTS AND PCS SHEET FOR ANALYZER
- ATTACHMENT II: LABORATORY REPORT FOR SOIL SAMPLE
- ATTACHMENT III: FLOOR PLAN
- ATTACHMENT IV: INSPECTOR'S CERTIFICATION
