ADDENDUM 003

Charlie's Place

Site Vicinity Map		SCALE: AS SHOWN	FIGURE NO. 1
	Carver Street Infiltration Testing Carver Street Myrtle Beach, South Carolina		DATE: 12/12/18 PROJECT NUMBER 1463-18-050-107

Carver Street Infiltration Testing
 Carver Street
 Myrtle Beach, South Carolina

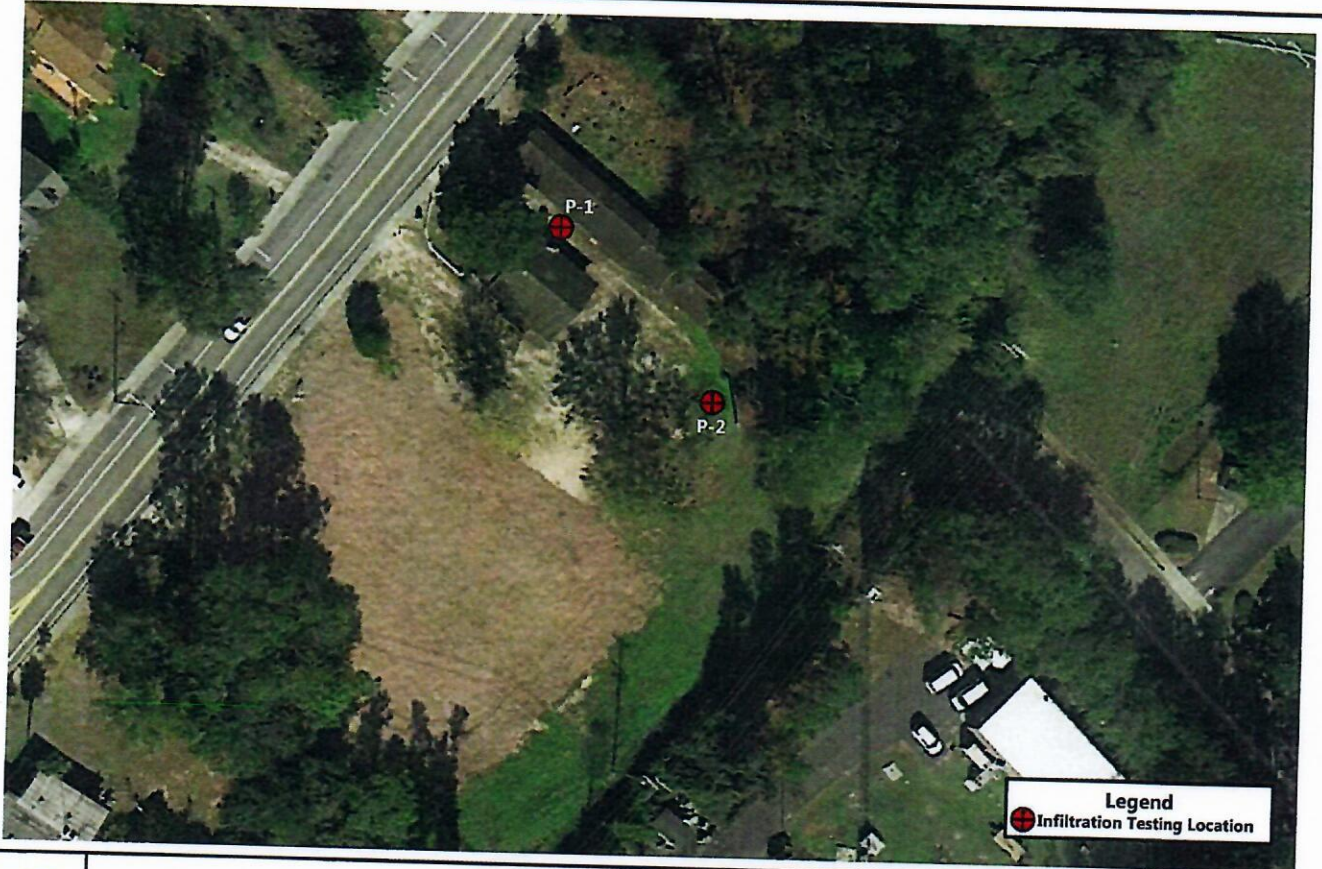
2

Legend
 ☒ Infiltration Testing Location

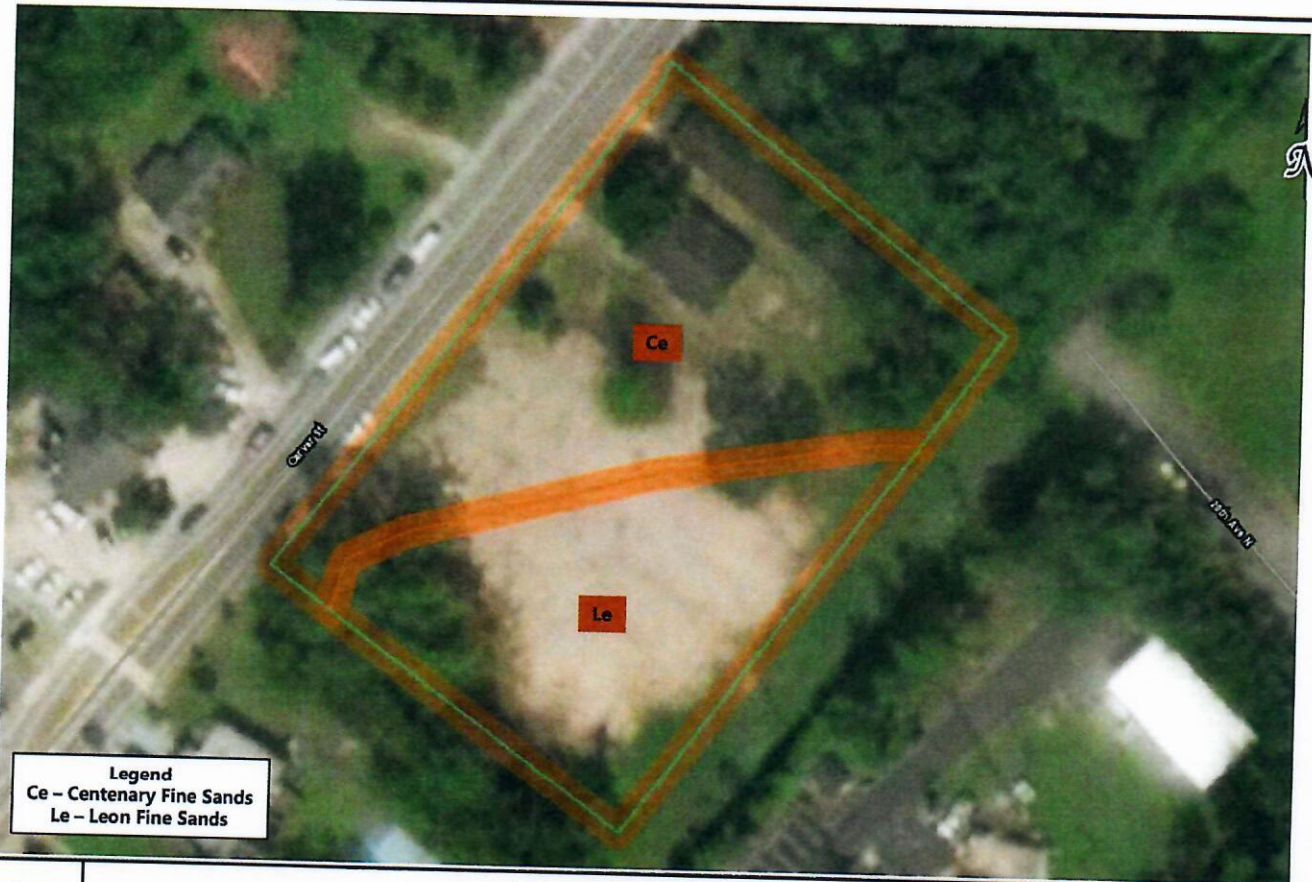
Legend
 Ce - Centenary Fine Sands
 Le - Leon Fine Sands

Carver Street Infiltration Testing
 Carver Street
 Myrtle Beach, South Carolina
