ADDENDUM NUMBER ONE

REPLACEMENT ROOFING SYSTEMS FOR JOHN A PATTEN YFD CENTER 3202 KELLYS FERRY ROAD, CHATTANOOGA, TN 37419

FOR THE CITY OF CHATTANOOGA, TENNESSEE

Contract Number Y-17-017

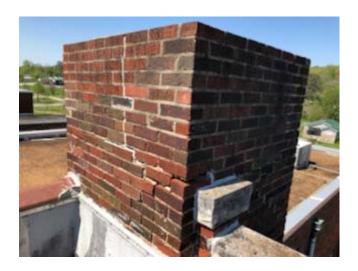
Q4: The chimney appears to have several loose bricks and bad mortar joints. In an effort to provide as water tight a building as possible, we would recommend that the brickwork in that area be repaired in conjunction to adding a new roofing system. Otherwise, it is possible that leaks to the chimney area would be mistaken as leaks to the new roofing system.

A4: The City would agree with that assessment. A line item has been added to the bid schedule for repair of the brickwork in that area.
