PRELIMINARY GEOTECHNICAL ENGINEERING REPORT

CAUSEWAY FLOOD PROTECTION FEASIBILITY
EVALUATION—MOSSY OAKS DRAINAGE IMPROVEMENTS
PORT ROYAL, SOUTH CAROLINA
FEBRUARY 15, 2019
INSIGHT NUMBER 19-0001

Re: Preliminary Geotechnical Report
Causeway Flood Protection Feasibility Geotechnical Evaluation
Mossy Oaks Drainage Improvements Project
Port Royal, South Carolina
Insight Group Number: 19-0001

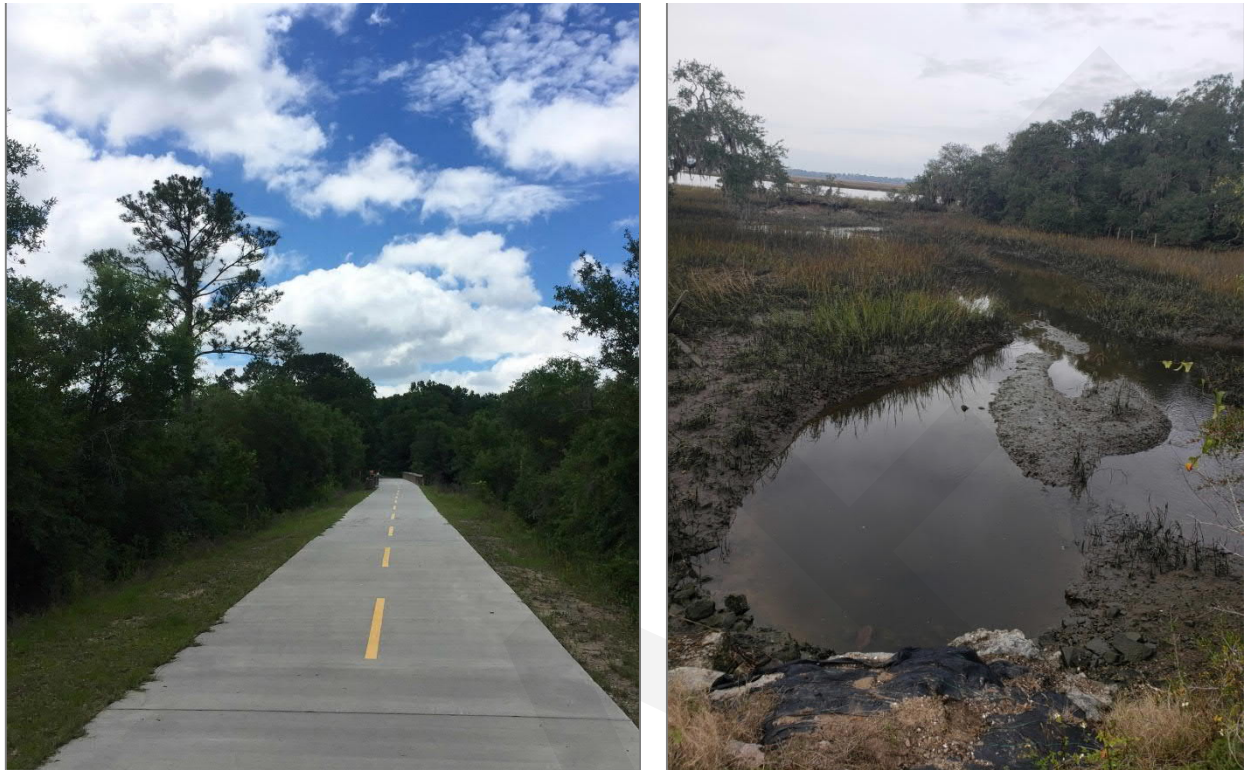
Figure 1. Spanish Moss Trail and Conditions at Outfall #2 Culvert (Looking West)

Approximate coordinates of the causeway at Basin 1 are 32.4069, -80.6985 and at Basin 2 are 32.3960, -80.7023. Figure 1 shows conditions of the causeway.

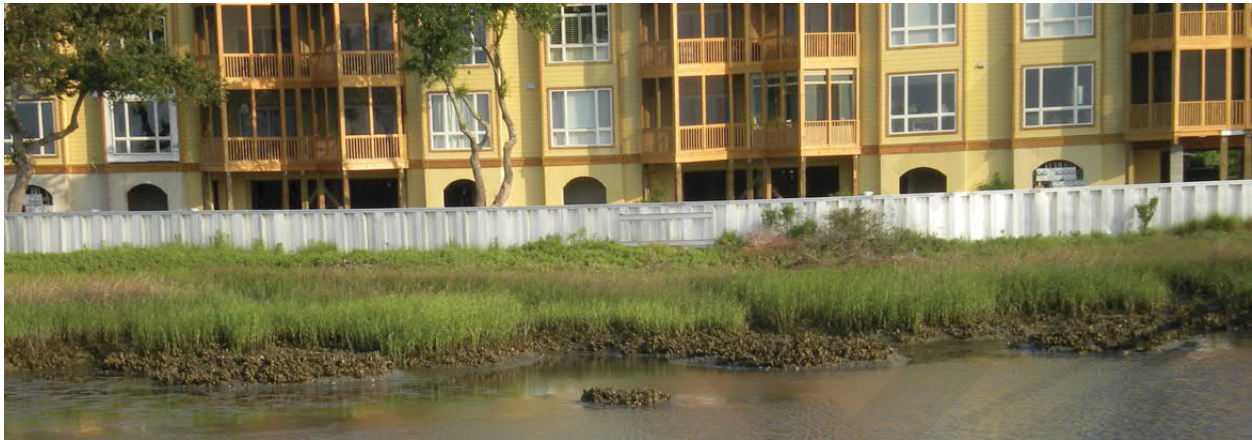
Figure 4. CMI Aluminum Sheet Pile Wall for Flood Protection (www.CMISheetPiling.com)

Figure 4 is an example wall installed in Mount Pleasant, South Carolina.
